Evaluating riprapping and other streambank stabilization techniques

Joe R. McBride □ Jan Strahan

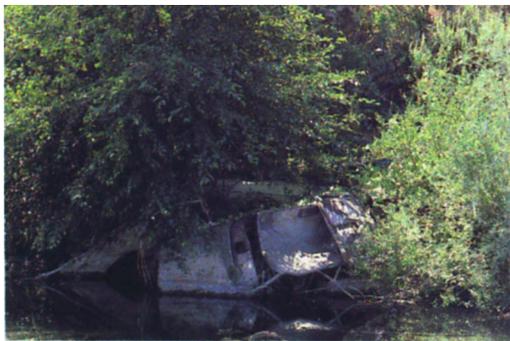
Car body riprapping

Car bodies, often in four or five tiers, are laced together by cables in stacks as long as 100 meters against cut banks. Sediment collects inside, providing a substrate for tree growth. In older stacks, only 20 percent of the car body surface is now exposed.

We found Oregon ash and box elder saplings and trees up to 40 cm in diameter, as well as red willow trees on older treatment sites. Development of tree cover is leading to a mixed riparian woodland type.

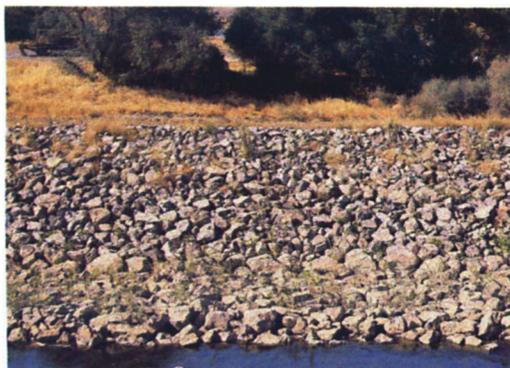
Rock riprapping

Riprapping with small rocks, used in a few areas along Dry Creek, requires a near paving of the banks with stones and leaves little space for sediment accumulation. We found no shrubs or trees established in any of the rock riprapped sites.

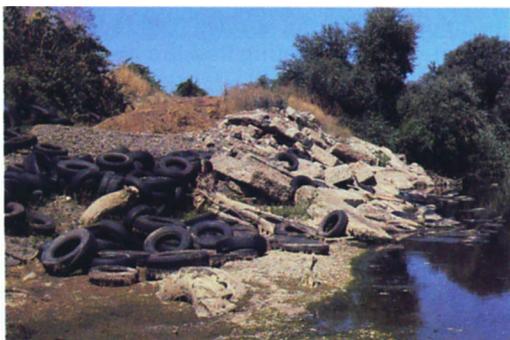
Concrete rubble and tire riprapping

Concrete rubble, in irregular pieces as large as 1 by 3 meters dumped onto the surface of cut banks, limits space for roots but collects some sediment.

Tree density averaged only one per 100 square meters, as compared with five per 100 square meters in car bodies. Sandbar and arroyo willow were well established. The presence of arroyo willow and absence of mixed riparian species may indicate droughty conditions resulting from shallow soil. Where concrete rubble riprapping is used, it

appears likely that willow-dominated woodlands will become naturally established, but not the successional more advanced mixed riparian woodland.

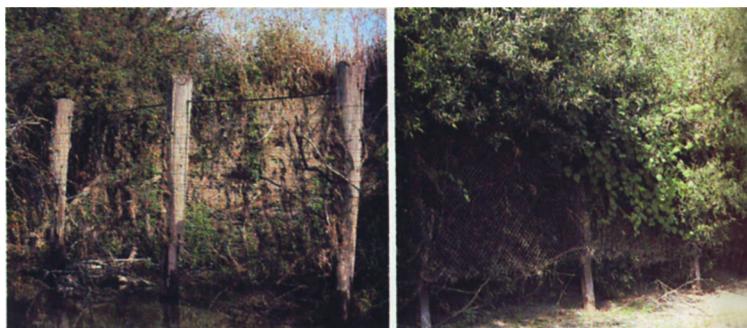
Hog-wire and chain-link fencing

Hog-wire and chain-link fences at the base of cut banks reduce stream velocity and collect floating debris, further absorbing erosional energy. Seedlings become established at the base and lower slopes of cut banks behind the fences.

The species observed (white alder, Oregon ash, Fremont cottonwood, sandbar willow, and red willow) suggest rapid development of the mixed riparian type. In all areas surveyed, we found saplings or trees of at least three riparian species.

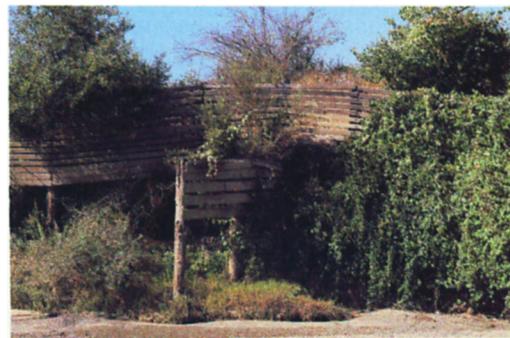
Wood fencing

Wooden fences built along lower Dry Creek in earlier years effectively protected cut banks. They were often 3 to 6 meters tall, over 50 meters long, and constructed with large-dimension lumber.

Establishment of vegetation behind these wooden walls differs according to the angle of the banks. Where they are steep, with a narrow space between the fence and bank surface, the shade-tolerant native grape dominates, growing through and descending down the front of the fence, improving its energy absorption.

Where cut banks are less steep, the available light and space has allowed yellow willow to become well established. The yellow willow may have been planted: this is the preferred species for planting, and it occurs naturally at a low frequency along Dry Creek. Although we found no evidence of further succession in the sample transect, we expect this process to lead eventually to a mixed riparian woodland.

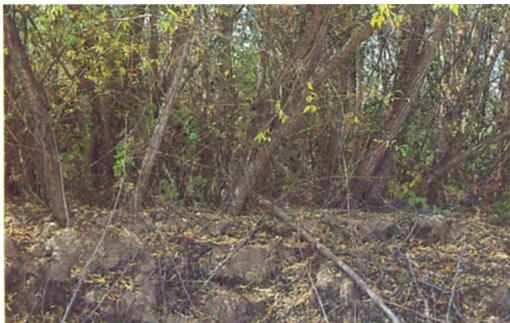
Willow planting

Yellow willow is commonly planted on the flood plain to develop a root mass that holds the soil. Sandbar willow is planted at the base of cut banks to absorb the energy of flowing water and prevent undercutting.

Our tallies in a yellow willow planting from the mid-1950s indicate that succession to the oak/bay woodland type is occurring. The numerous seedlings of both coast live oak and California bay (30 of each per 100 square meters) appear quite vigorous in the understory of yellow willow and can be expected to form a dominant crown cover within the next 30 years. Hind's black walnut will be a minor component of this type (five saplings found per 100 square meters). We did not sample sandbar willow plantings because of their narrow width.

The density and species composition within the yellow willow transect are substantially different from those in the other treatment areas. The high density of yellow willow results from its sprouting nature, but its clumped pattern provides enough light and ground surface for oak, bay, walnut, and willow seedlings and saplings. The species composition suggests that a rapid succession to climax riparian woodlands occurs in such plantings because of the light shade and less disturbed seedbed surface, as well as their location at the top of the flood plain with lower flood frequency.

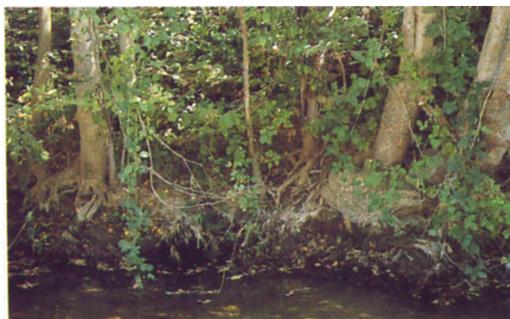
Undisturbed areas

We classified the riparian woodlands occurring outside the treatment areas along Dry Creek into four major types on the basis of dominant tree species: willow, cottonwood/willow, mixed riparian, and oak/bay woodland. Cottonwood/willow and mixed riparian woodlands are common; willow and oak/bay woodlands occur infrequently.

Although we found few tree seedlings in the woodlands along Dry Creek, numerous saplings were present, varying

in composition with the woodland type. The absence of seedlings may be caused by the thick cover of giant periwinkle (*Vinca major*), in most of the woodlands sampled.

Grape-dominated areas occur primarily on steep, eroded banks where subsequent channel migration has allowed establishment. The presence of saplings in these areas suggests succession to a riparian woodland type. However, climbing grapevines frequently kill young saplings, suggesting that, at most, only a sparse woodland will develop.
