OVERVIEW OF DAM

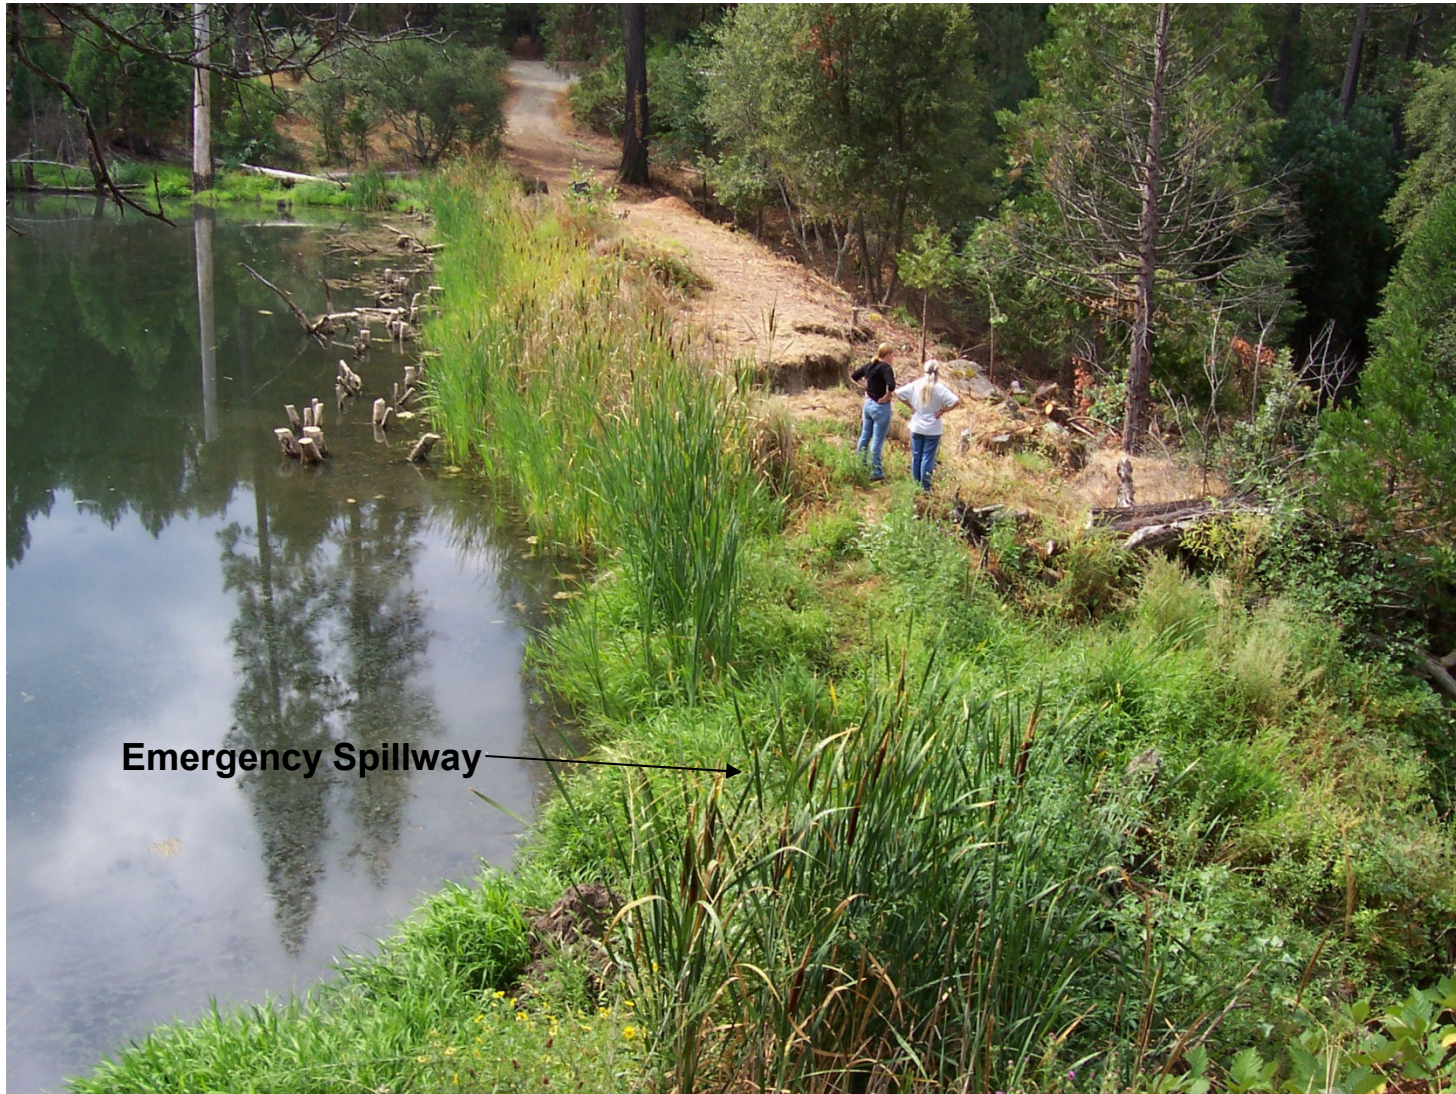
View of erosion to top of embankment, trees on embankment and vegetation in emergency spillway (8/16/05).

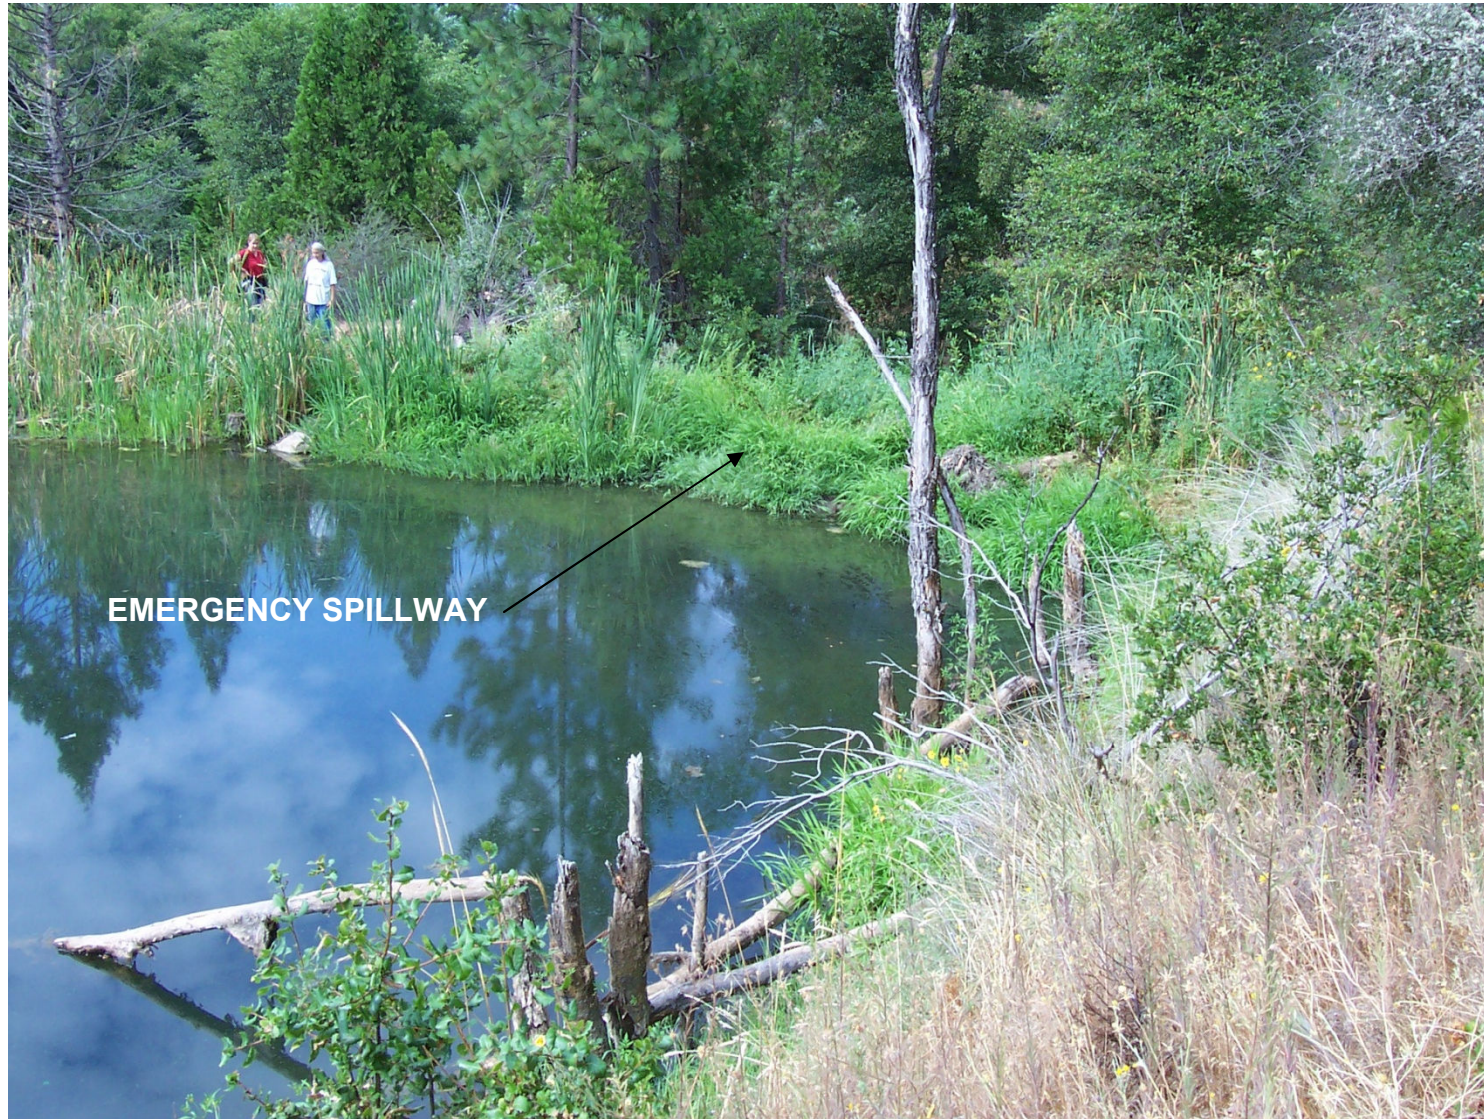
UPSTREAM VIEW OF EMERGENCY SPILLWAY

View of vegetation in emergency spillway from north side of reservoir (8/16/05).

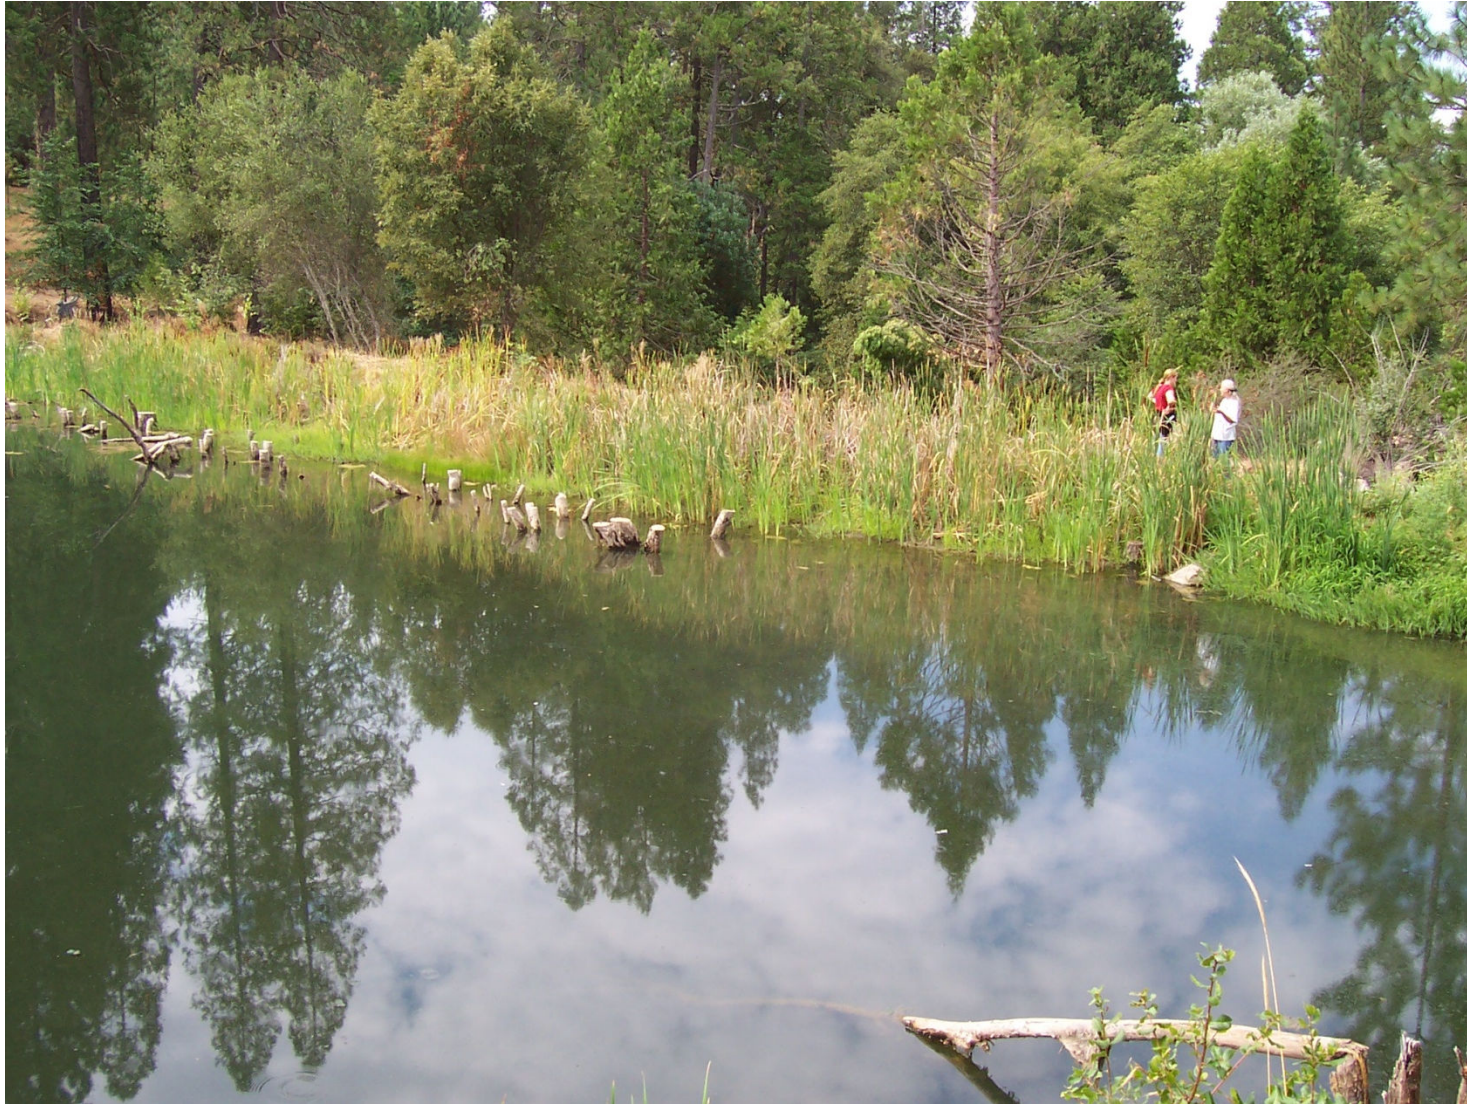
UPSTREAM DAM FACE

View of embankment from north side of reservoir (8/16/05).

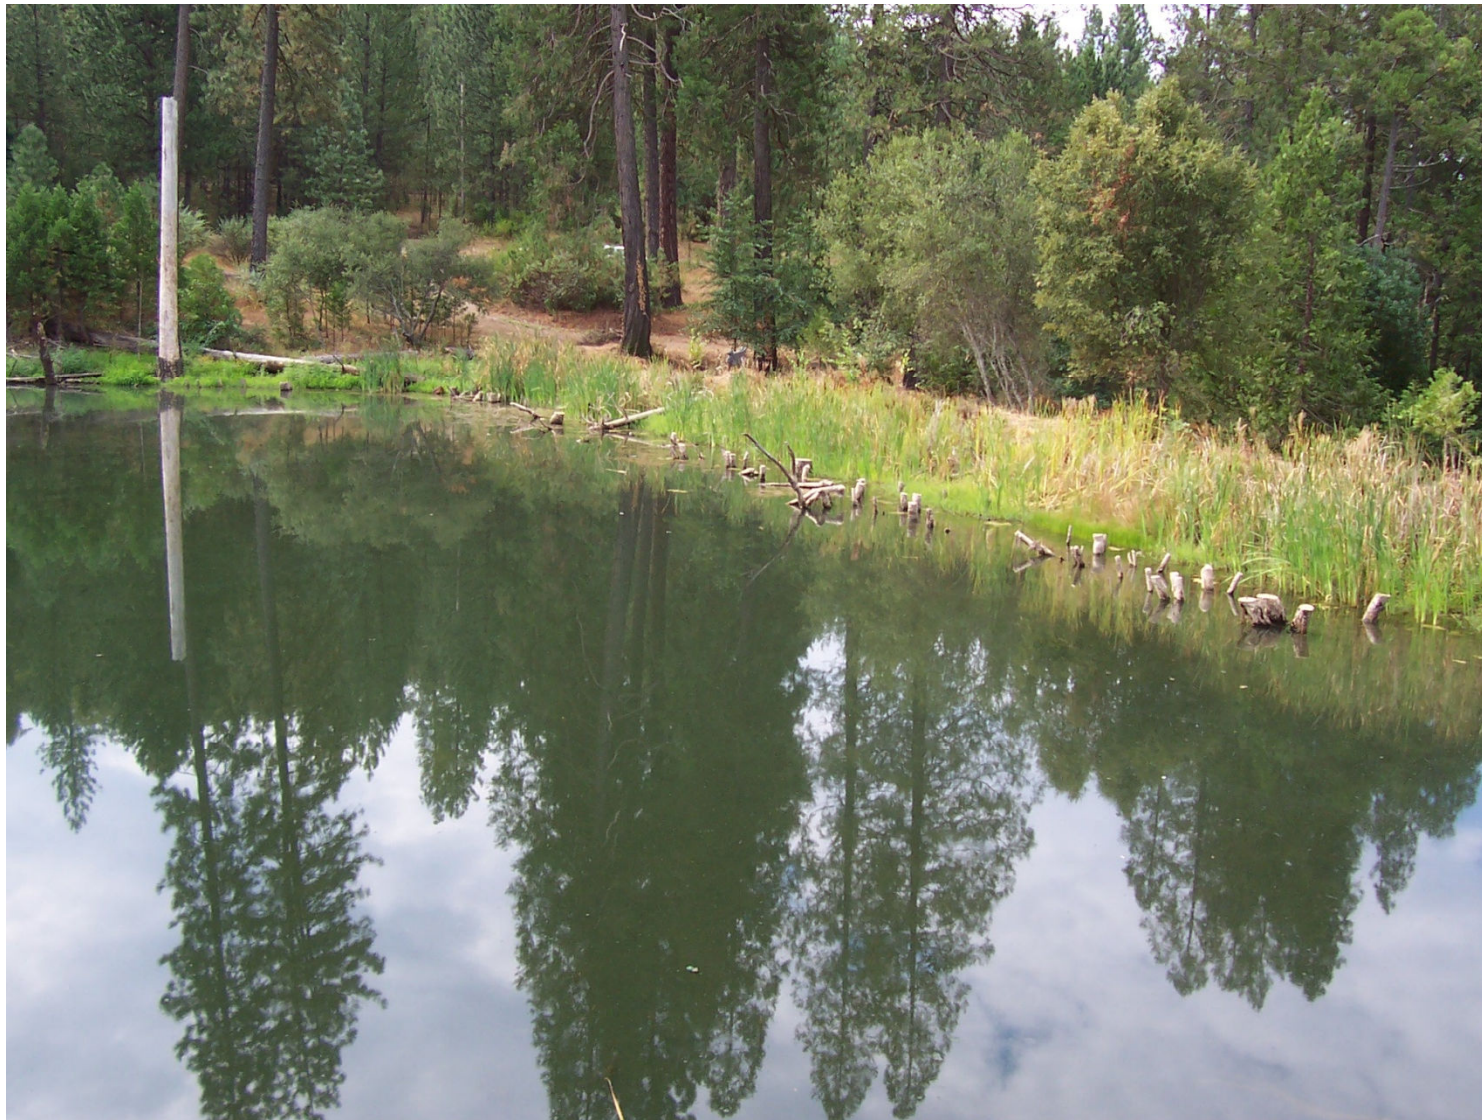
UPSTREAM DAM FACE

View of embankment from north side of reservoir (8/16/05).

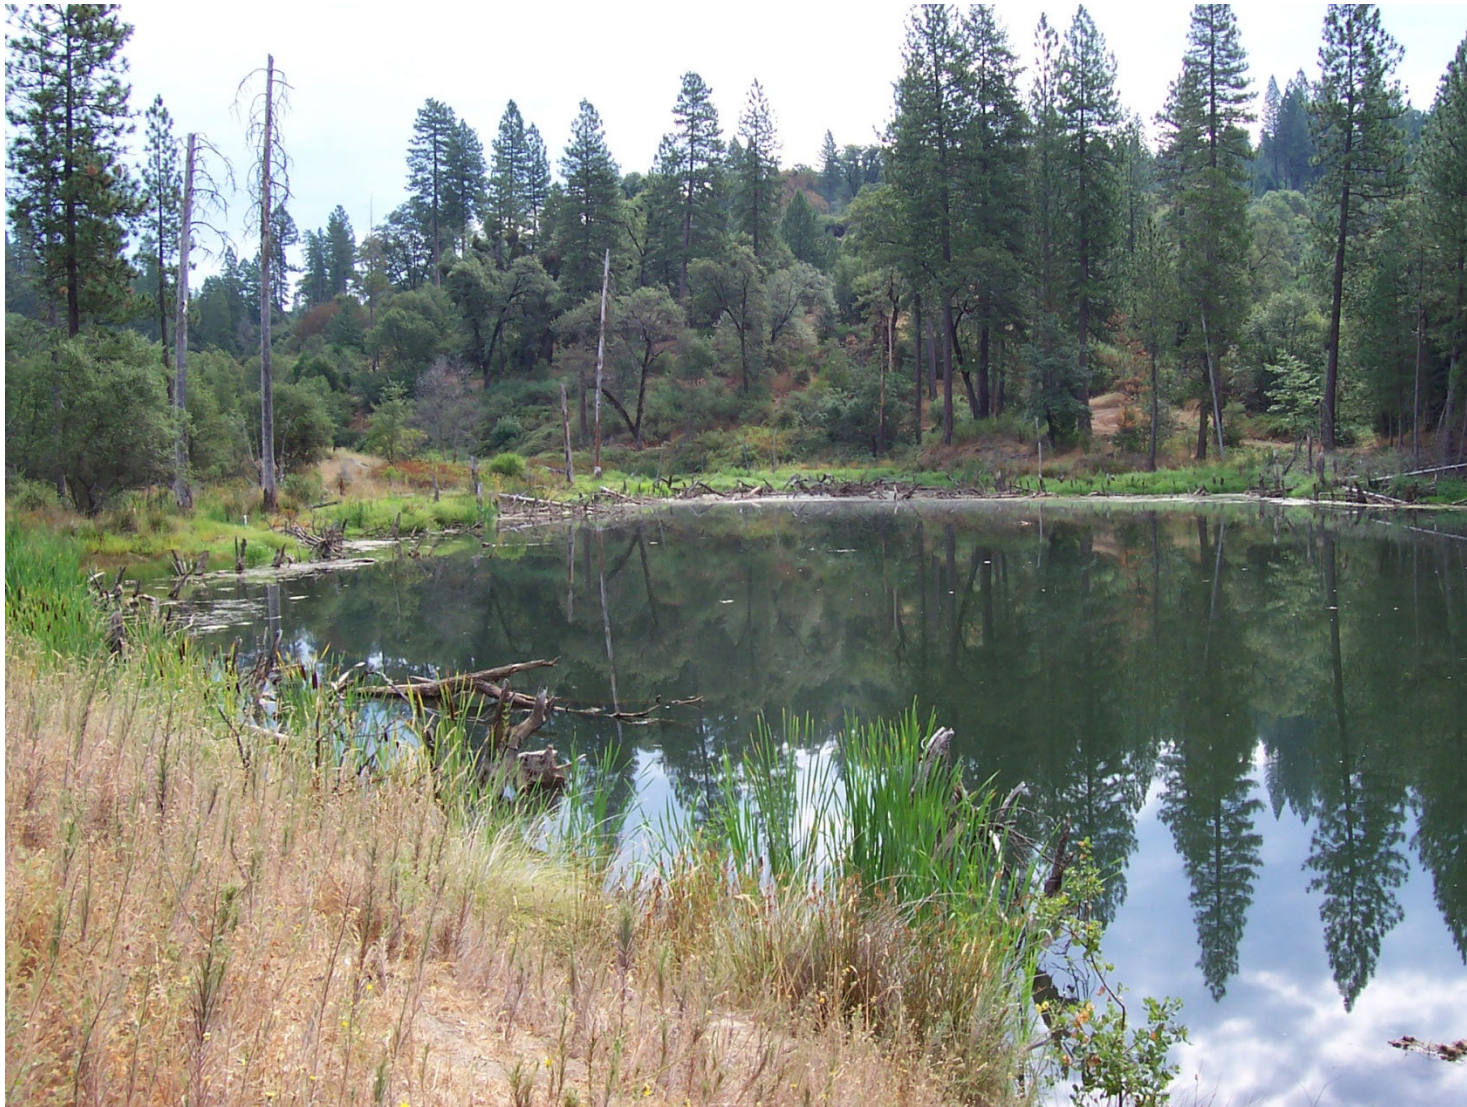
UPSTREAM DAM FACE

View upstream from north side of reservoir (8/16/05).

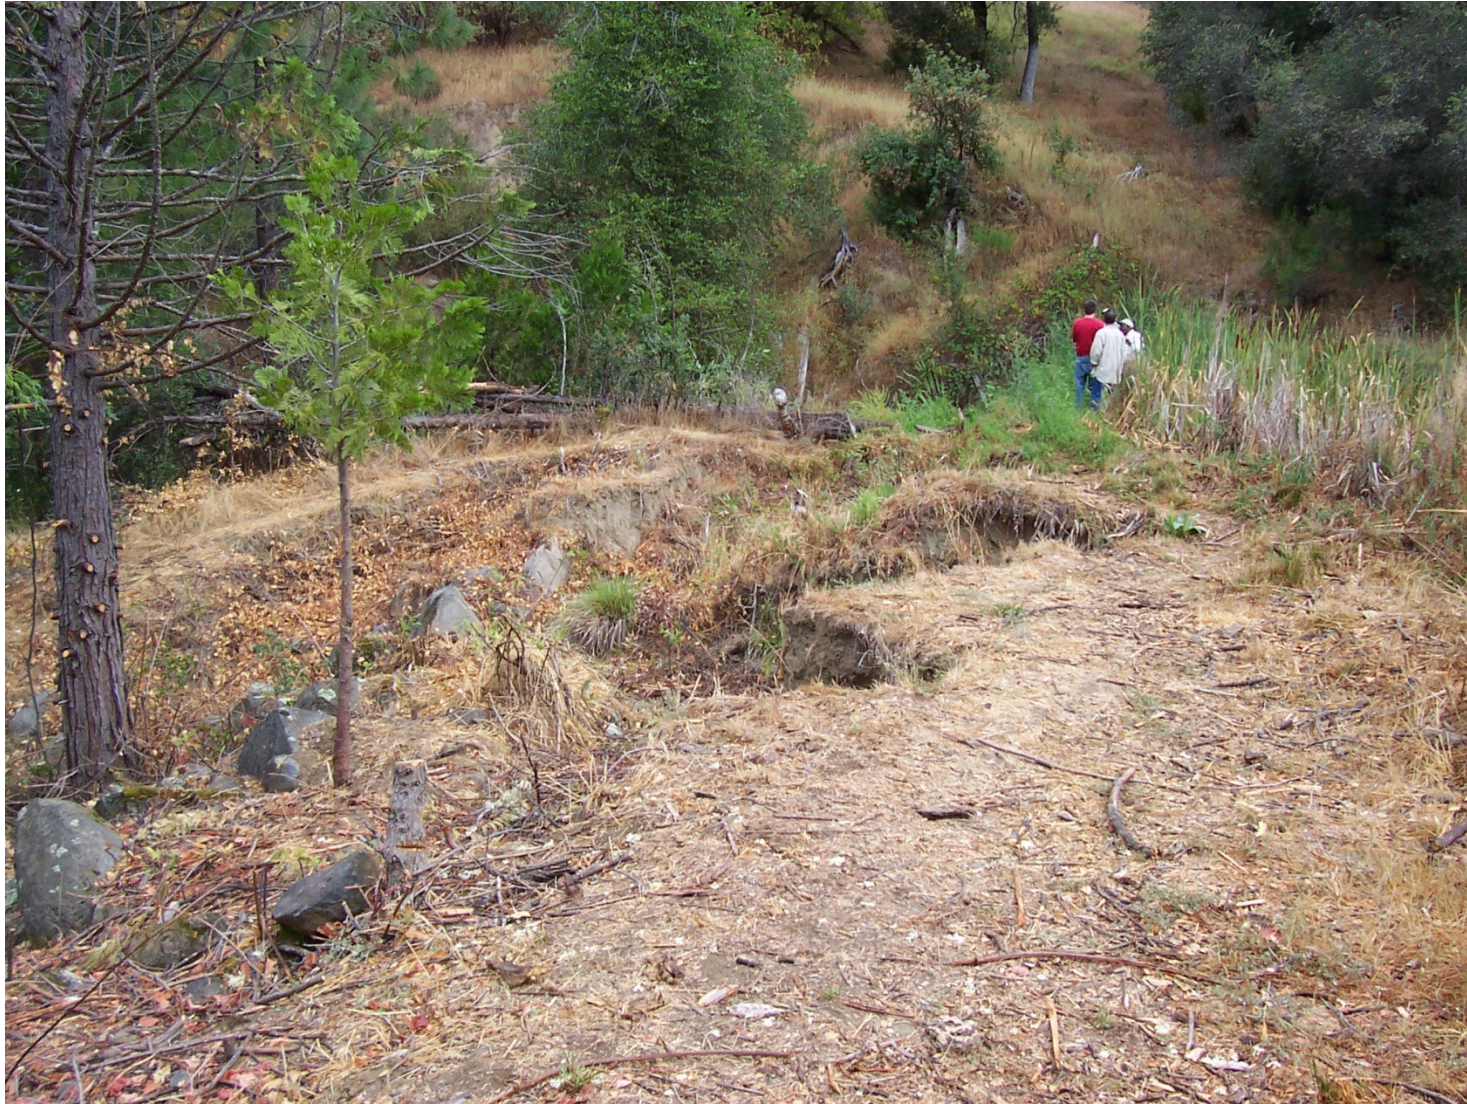
EROSION TO FILL IN DAM DUE TO OVERTOPPING

Top of embankment looking north at erosion to top of embankment (8/16/05).

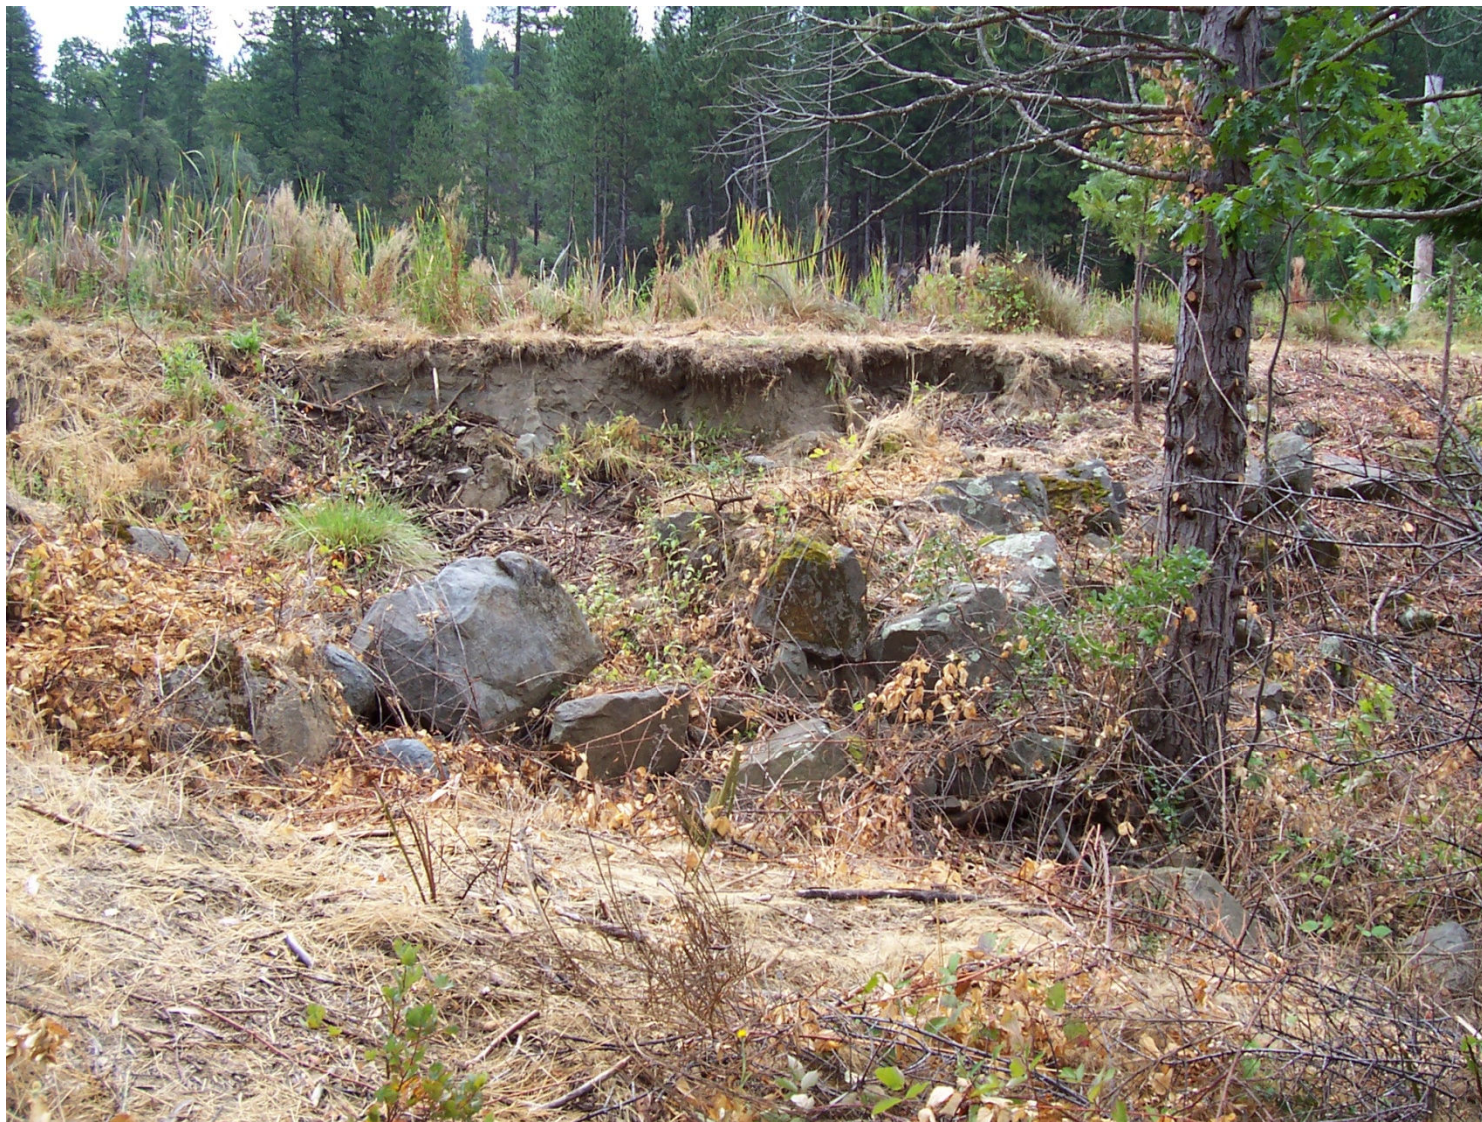
EROSION TO FILL IN DAM DUE TO OVERTOPPING

View of erosion to downstream face of dam (8/16/05).

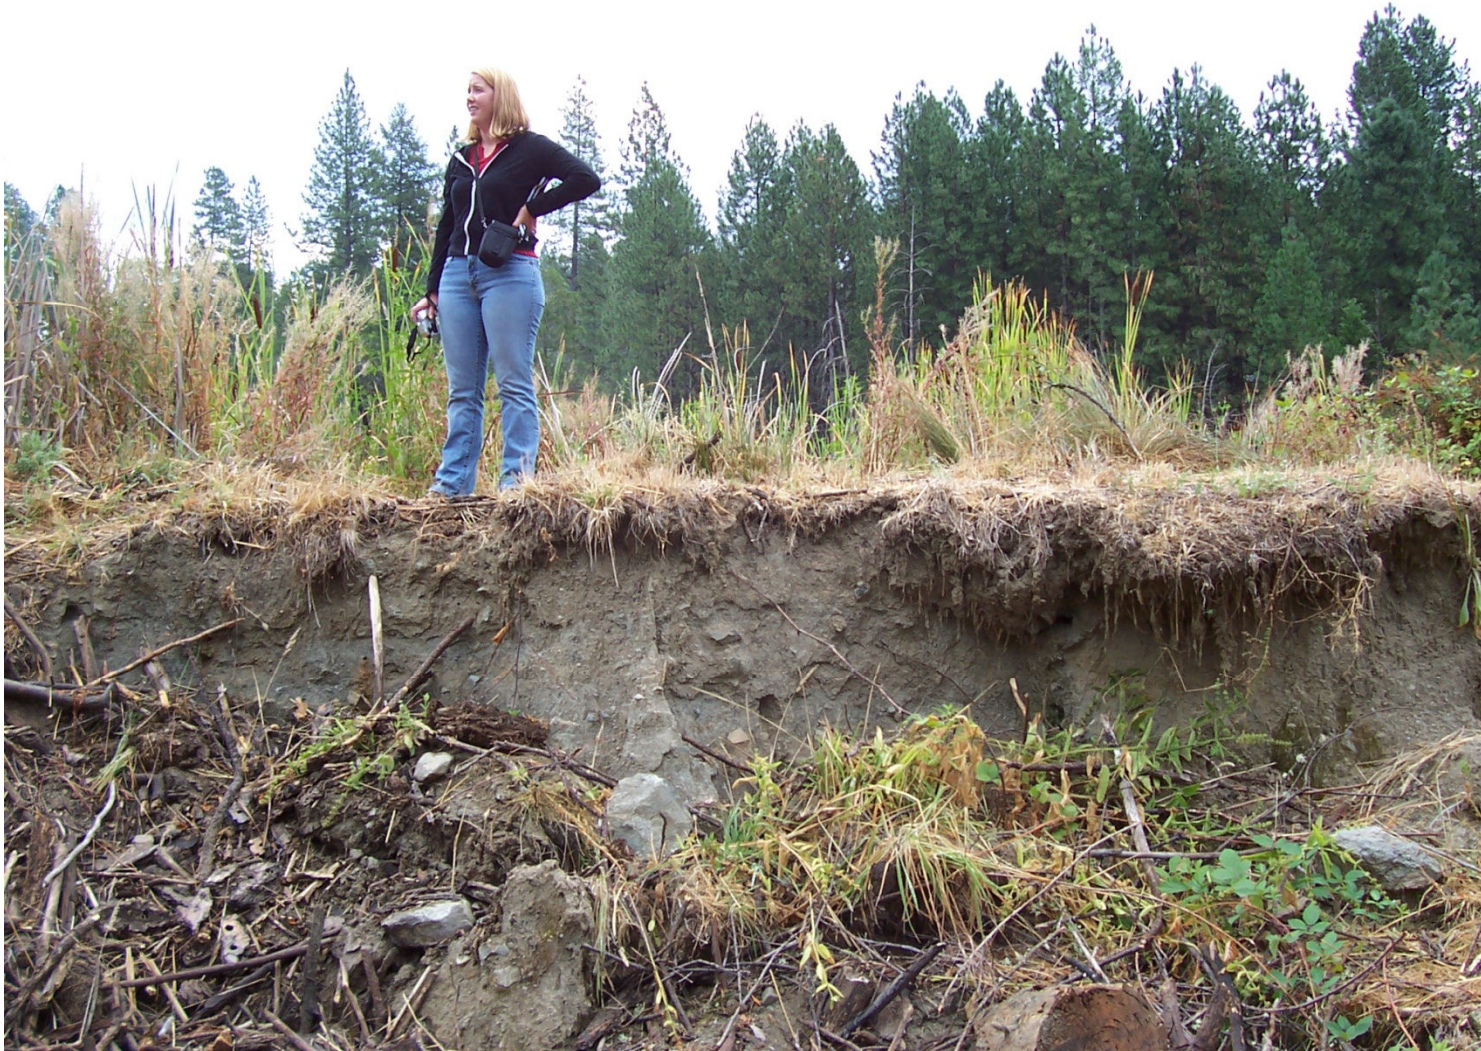
EROSION TO FILL IN DAM DUE TO OVERTOPPING

View of vertical face of headcut at top of embankment (8/16/05).

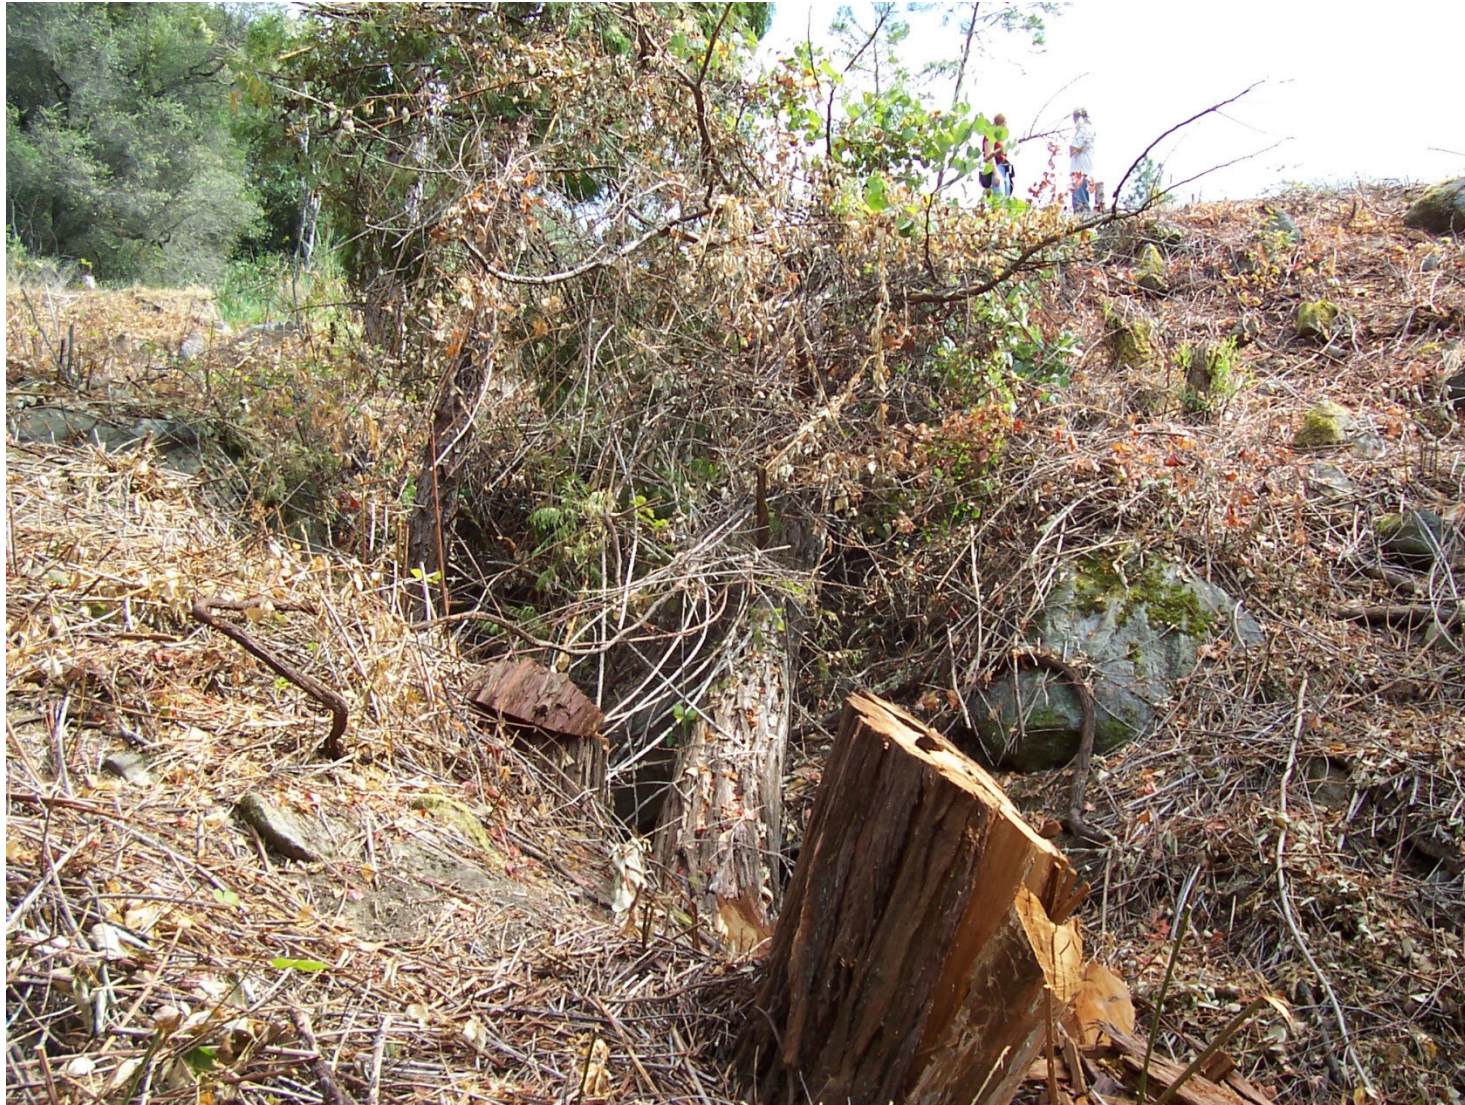
EROSION ON DOWNSTREAM FACE OF DAM

Vegetation to be cleared from lower portion of eroded embankment (8/16/05).

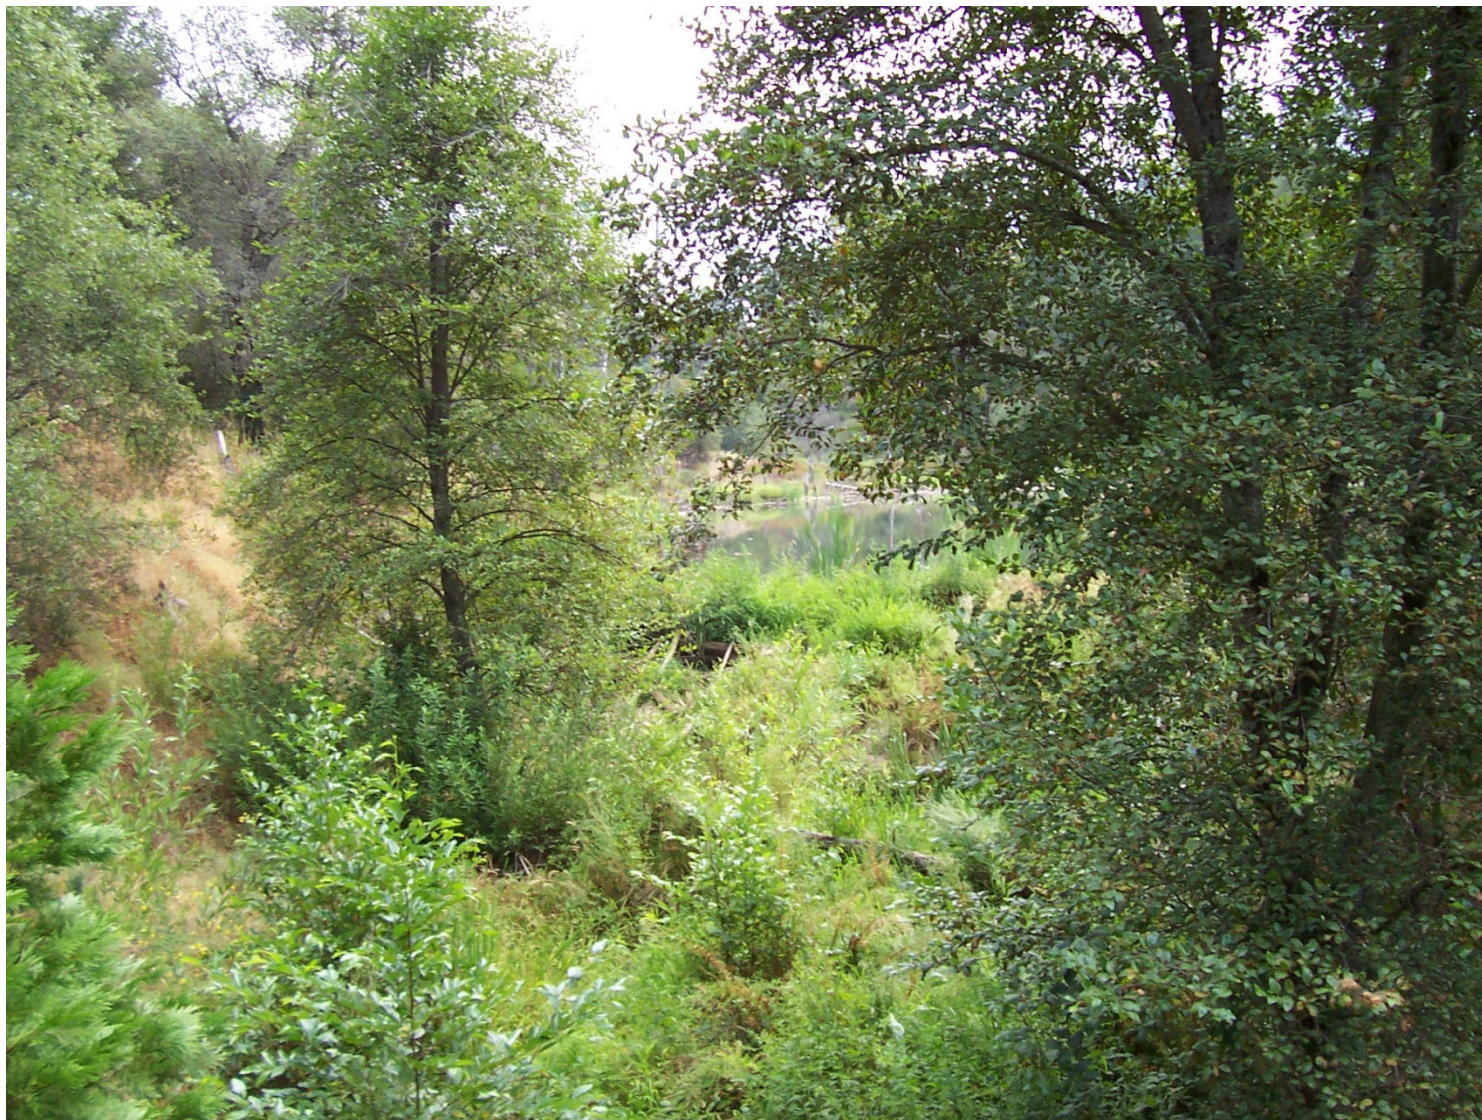
EMERGENCY SPILLWAY

View upstream at vegetation in emergency spillway exit channel (8/16/05).

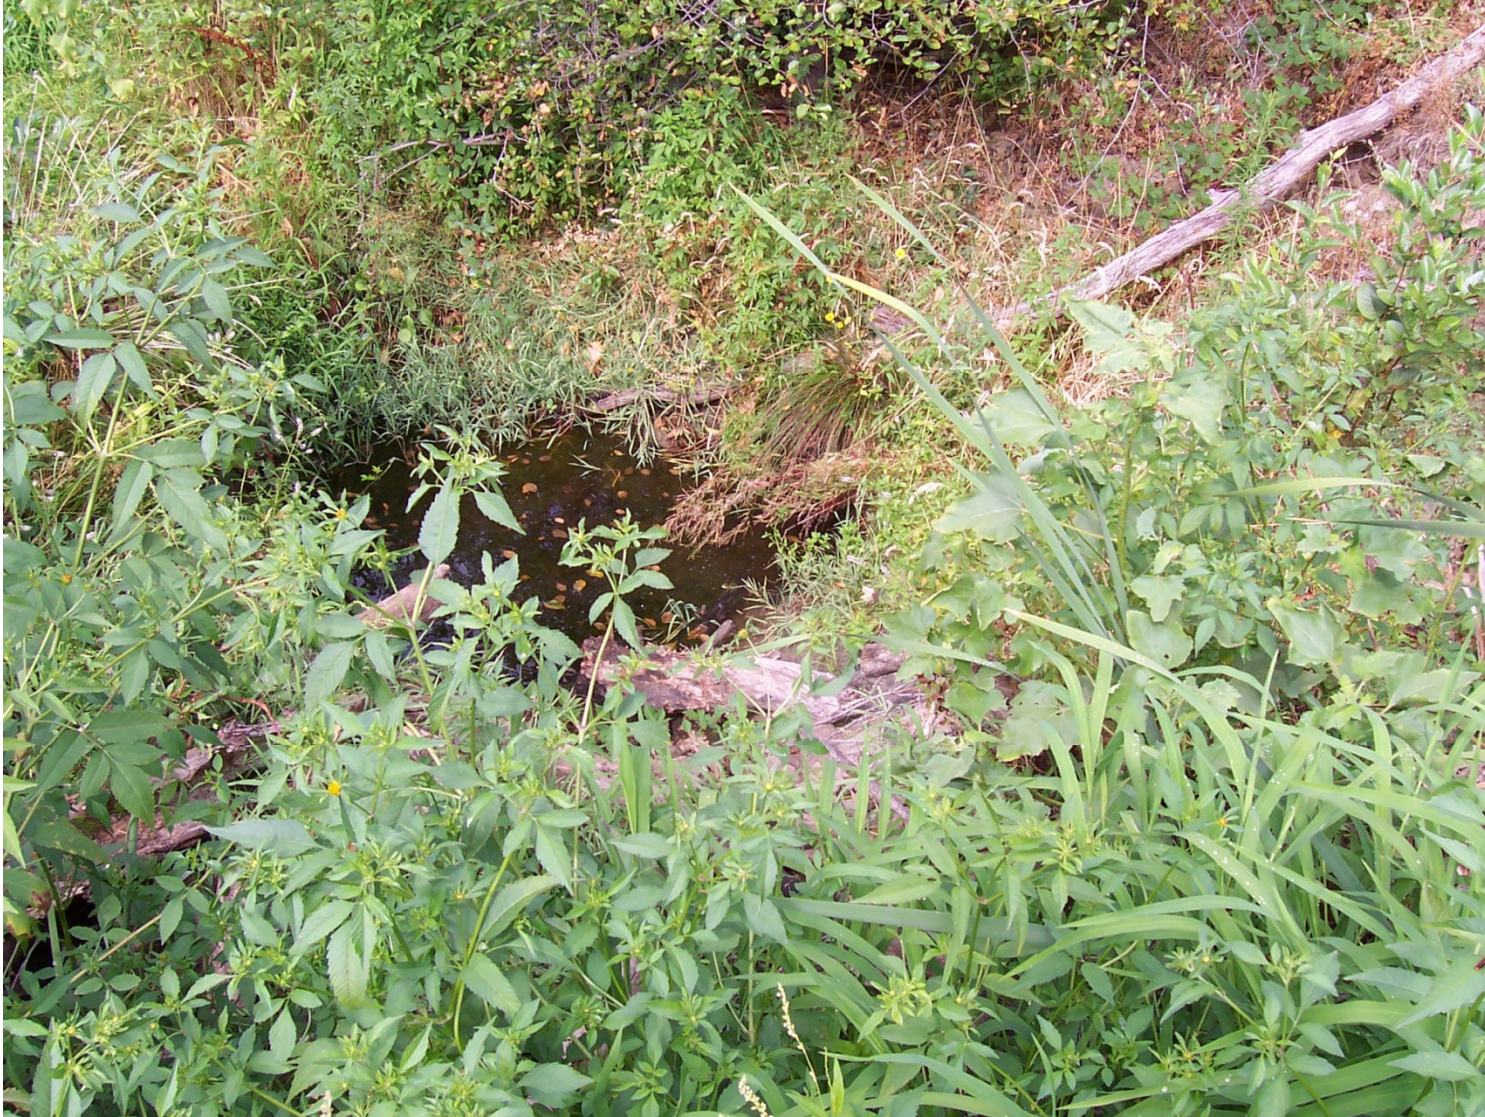
EMERGENCY SPILLWAY WITH STANDING WATER

Standing water in emergency spillway exit channel. Flow from right to left. (8/16/05).

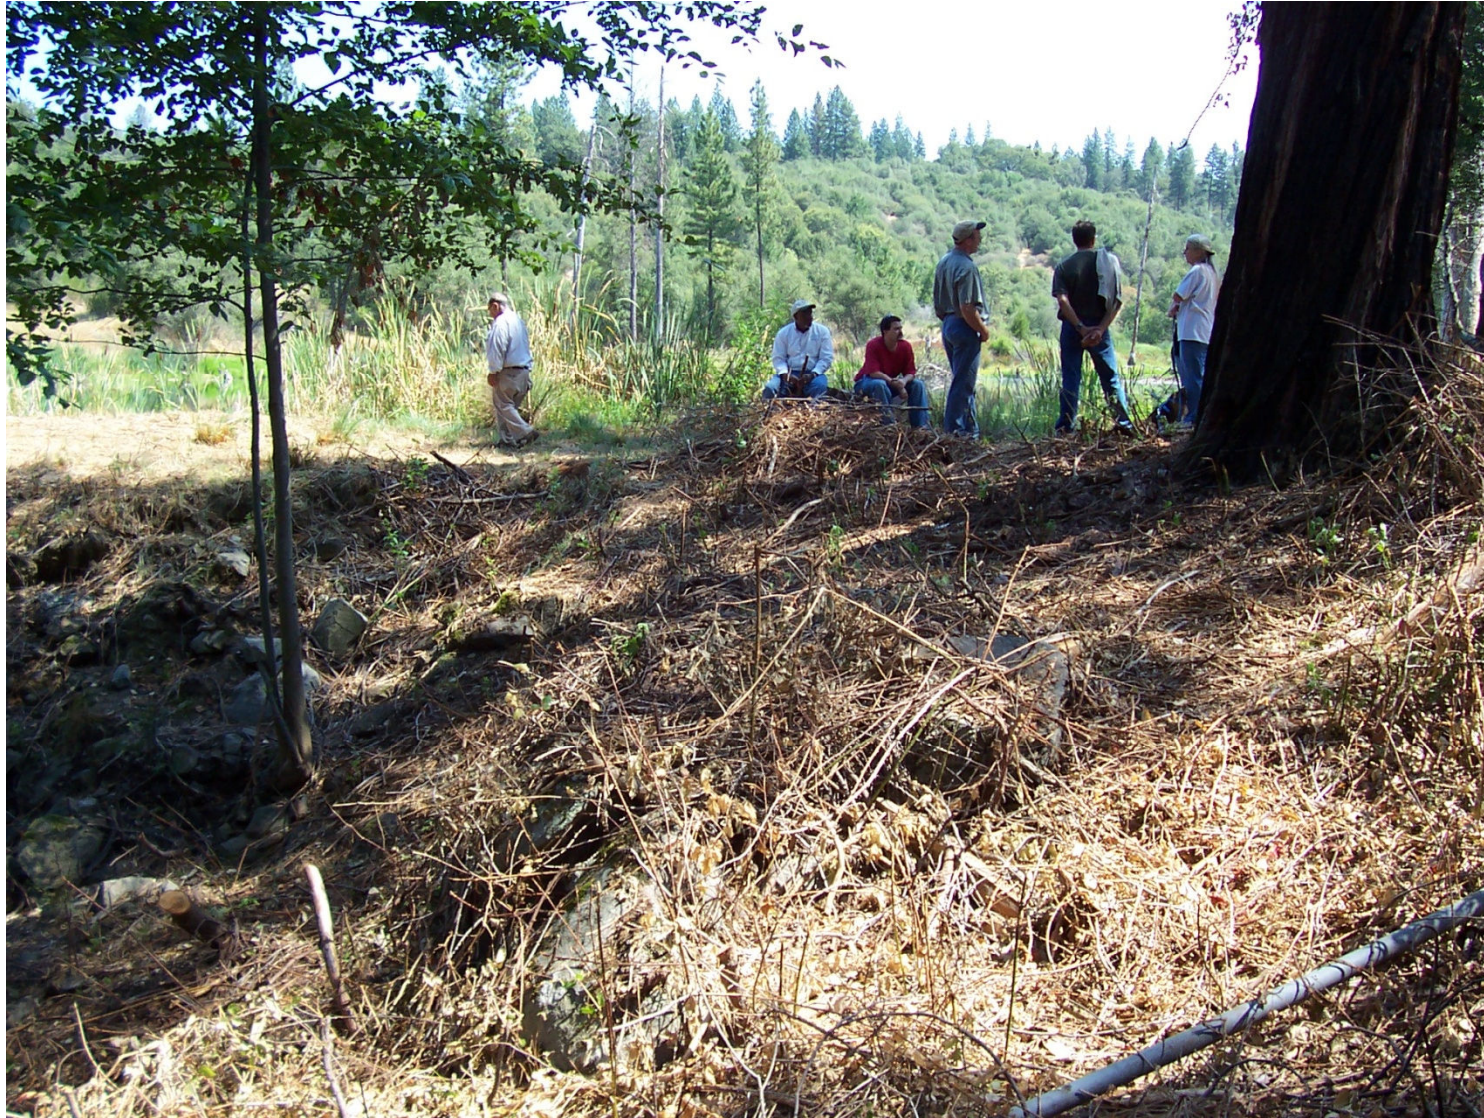
EROSION AND BRUSH ON DAM

View of minor erosion to downstream face of embankment near south abutment past small tree. (8/16/05).

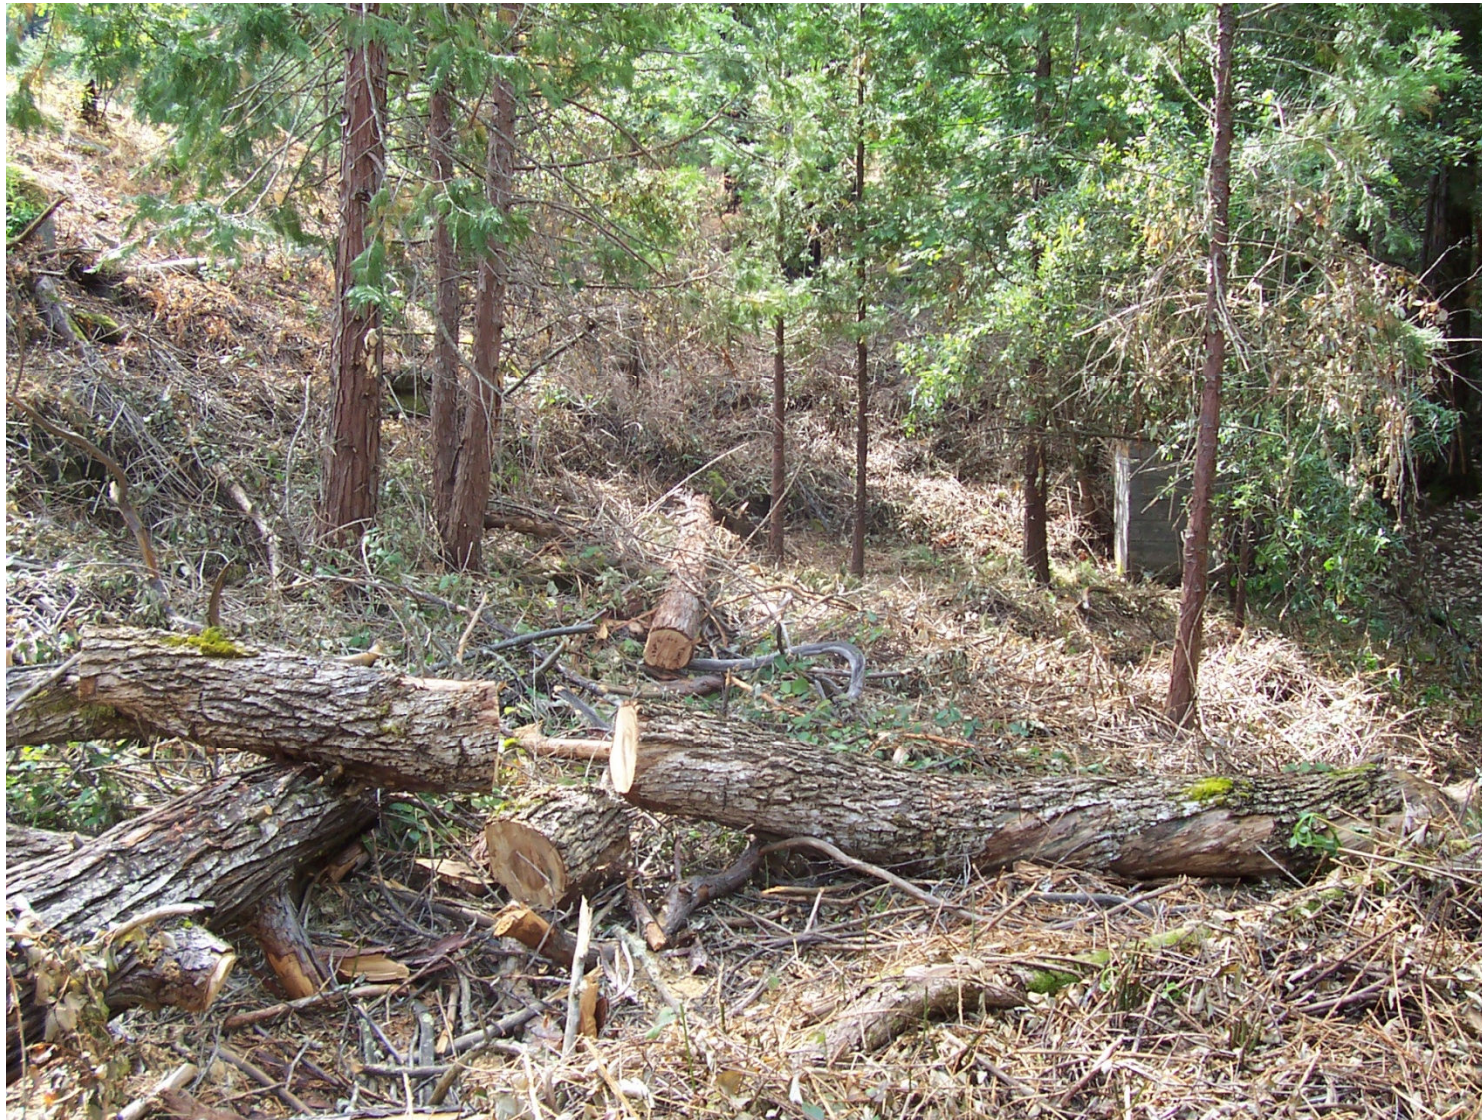
TREES AND HEAVY BRUSH ON DAM

View of downstream face of embankment toward pump house. (8/16/05).

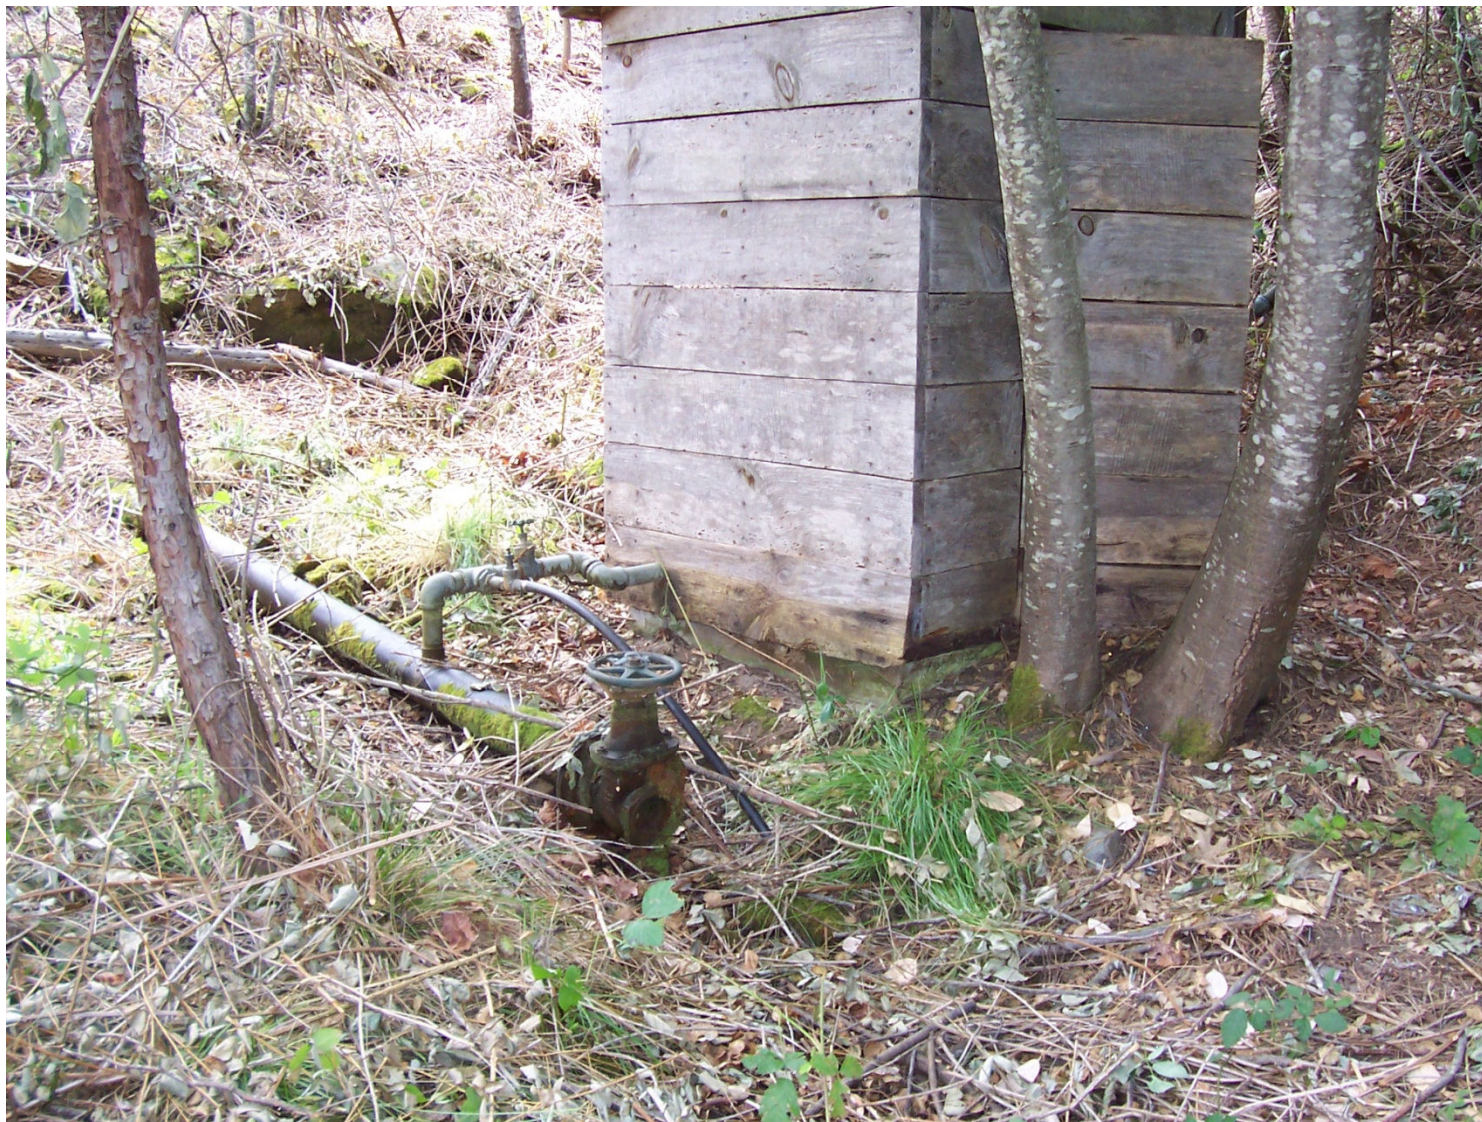
PIPE THROUGH THE DAM

Outlet pipe and valve at downstream toe of dam. (8/16/05).
