OVERVIEW OF DAM

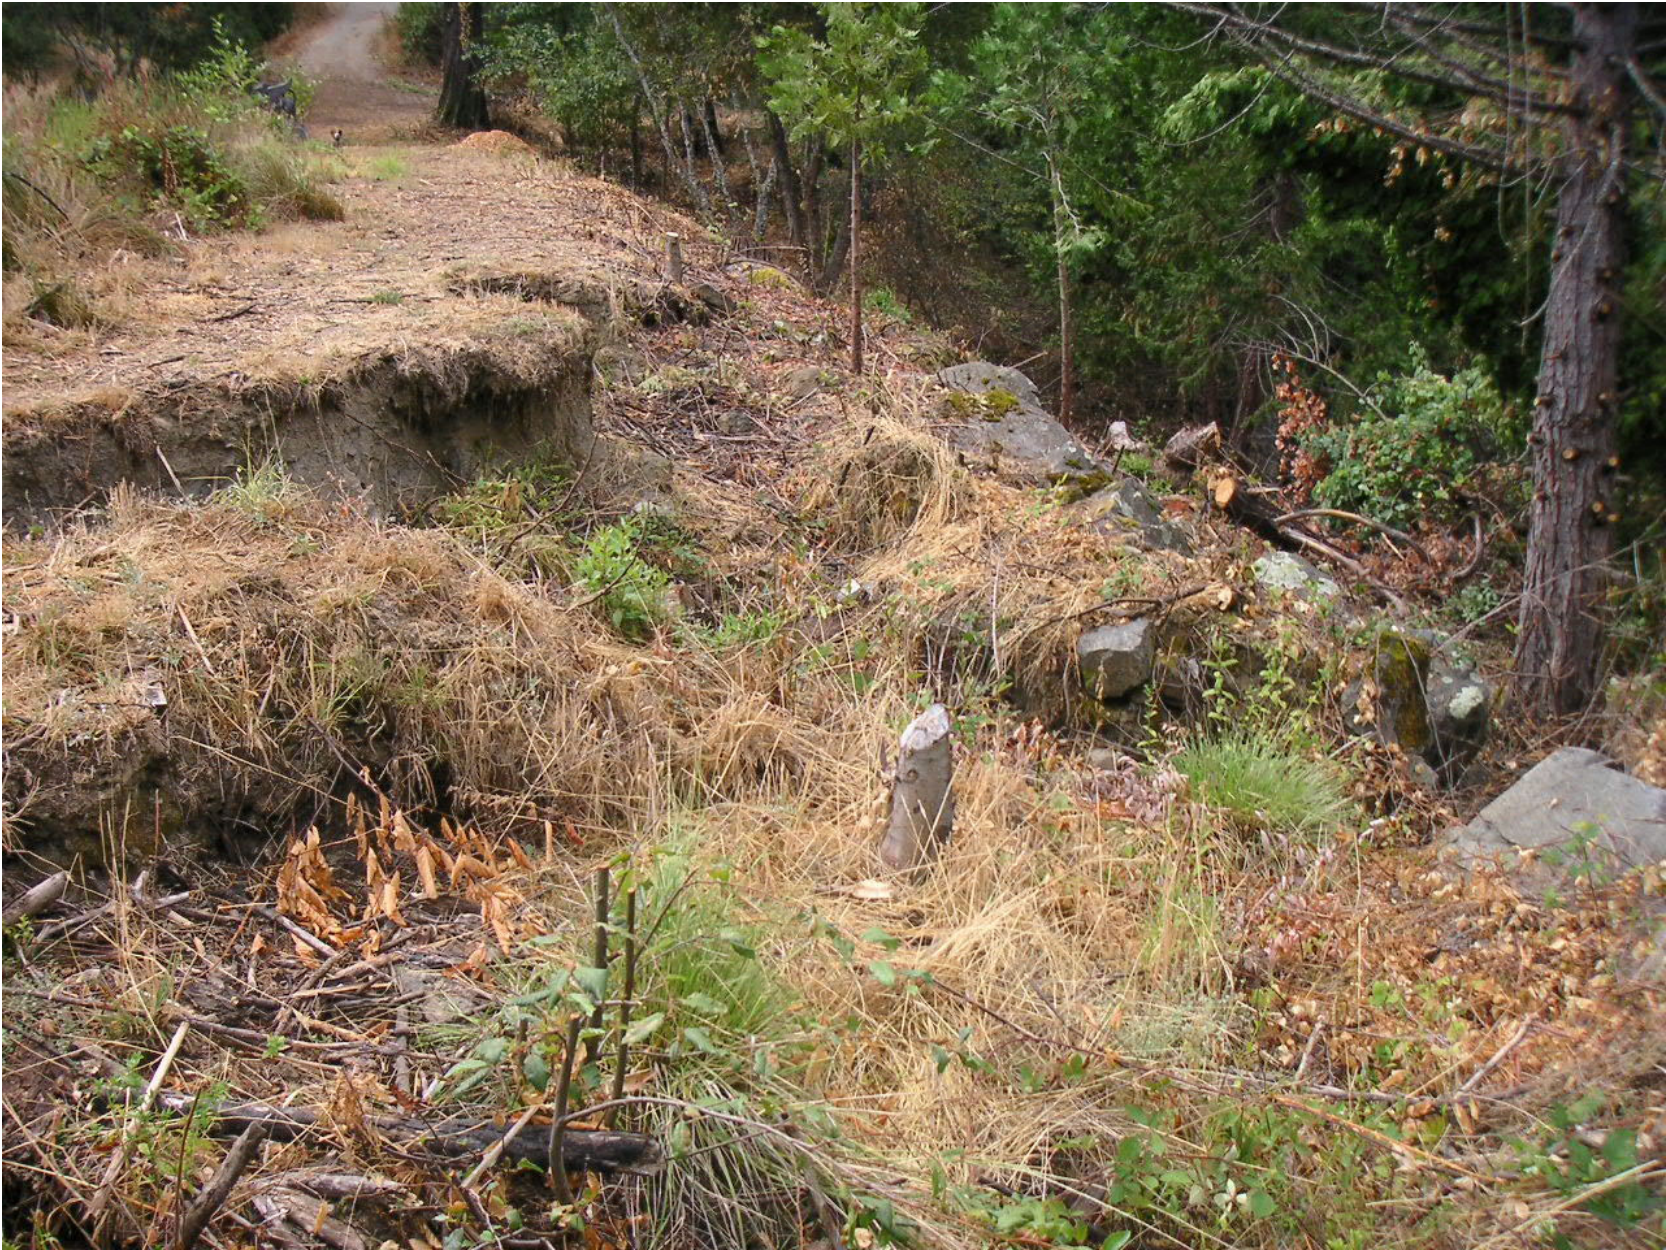
DAM BEFORE REPAIR

Note tree on right side of picture.

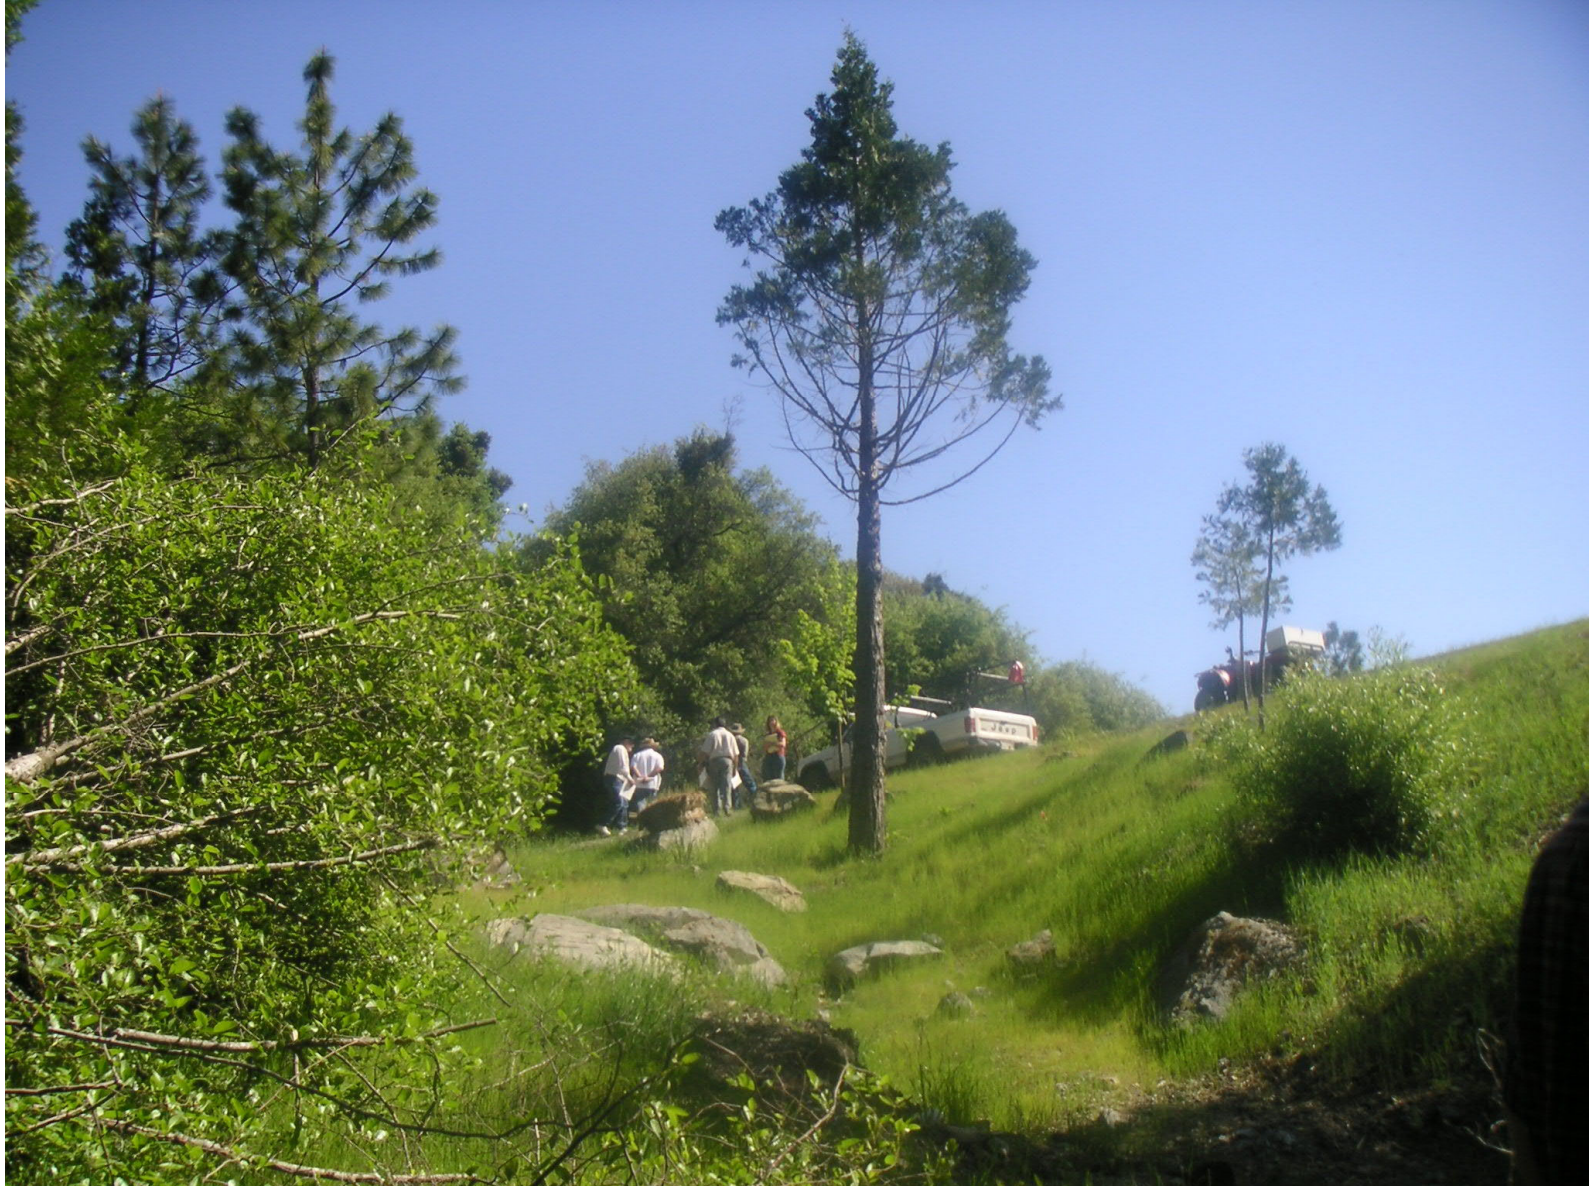
DAM AFTER REPAIRS

Note tree in center of picture as reference point.

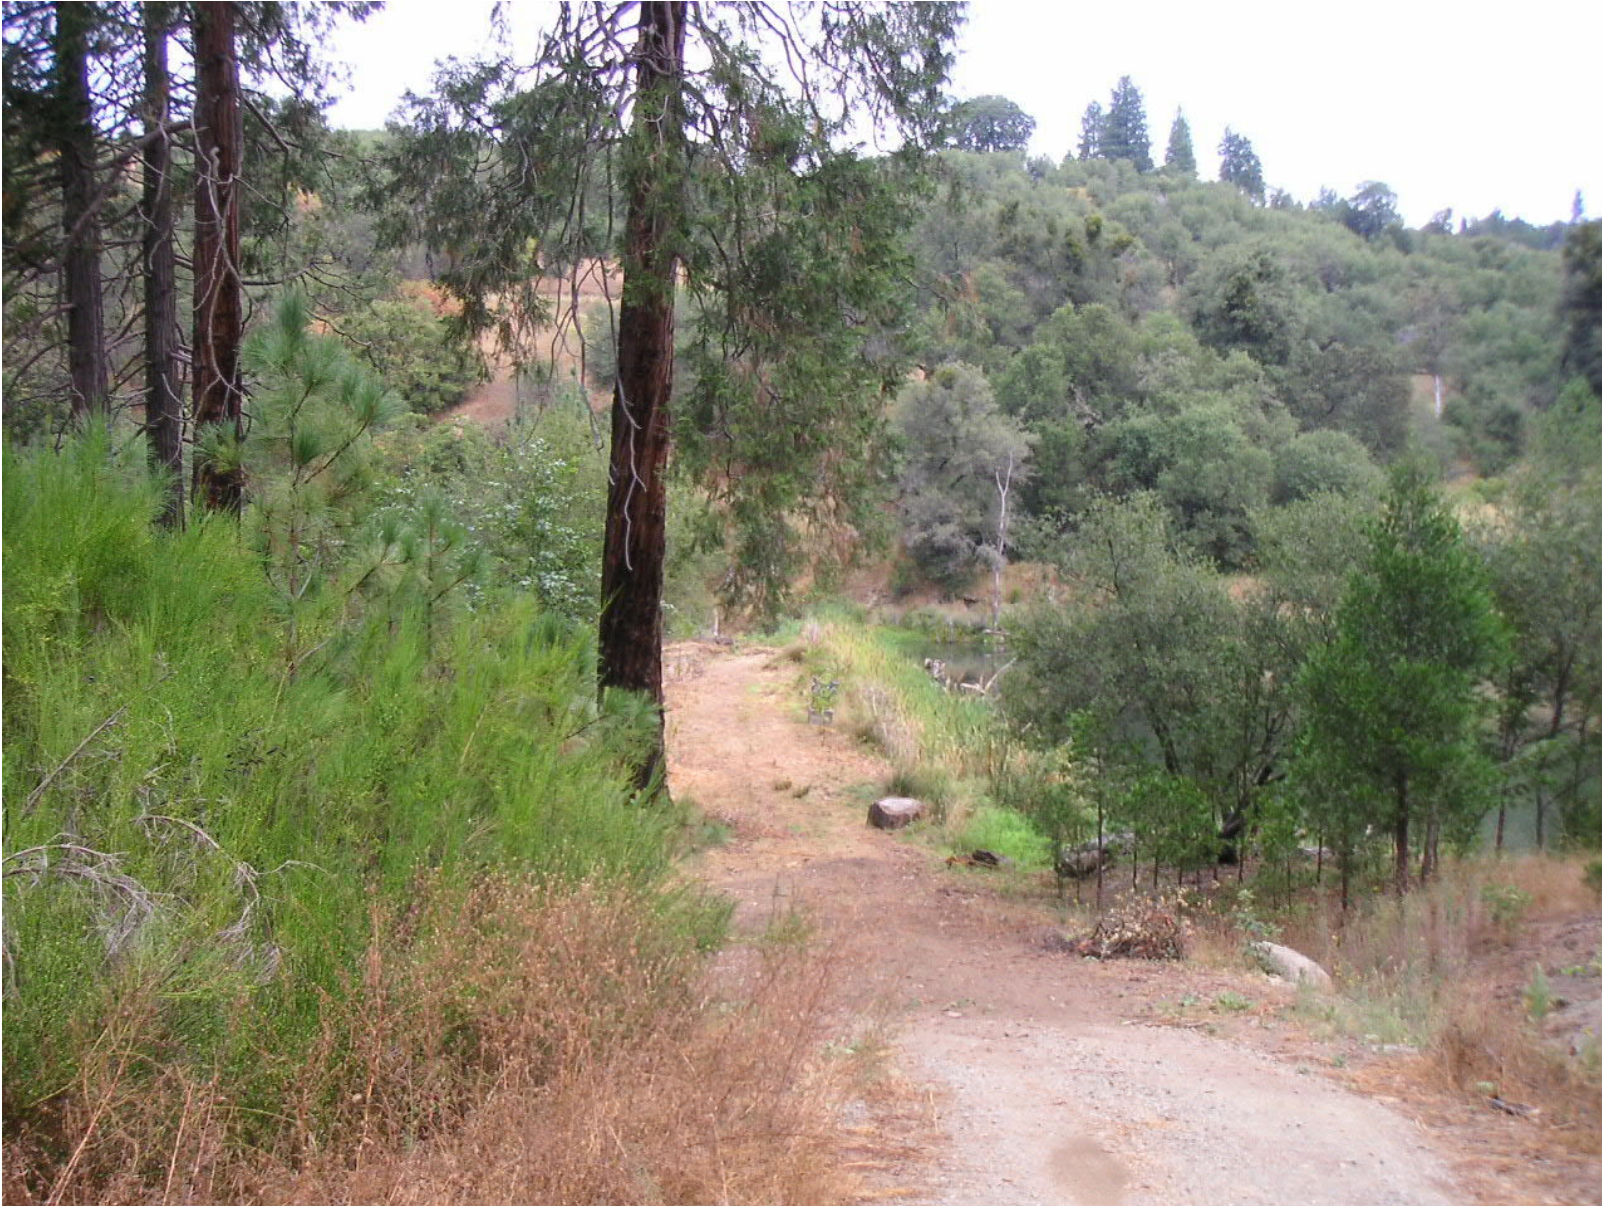
DAM BEFORE REPAIR

Top of Dam looking toward emergency spillway.

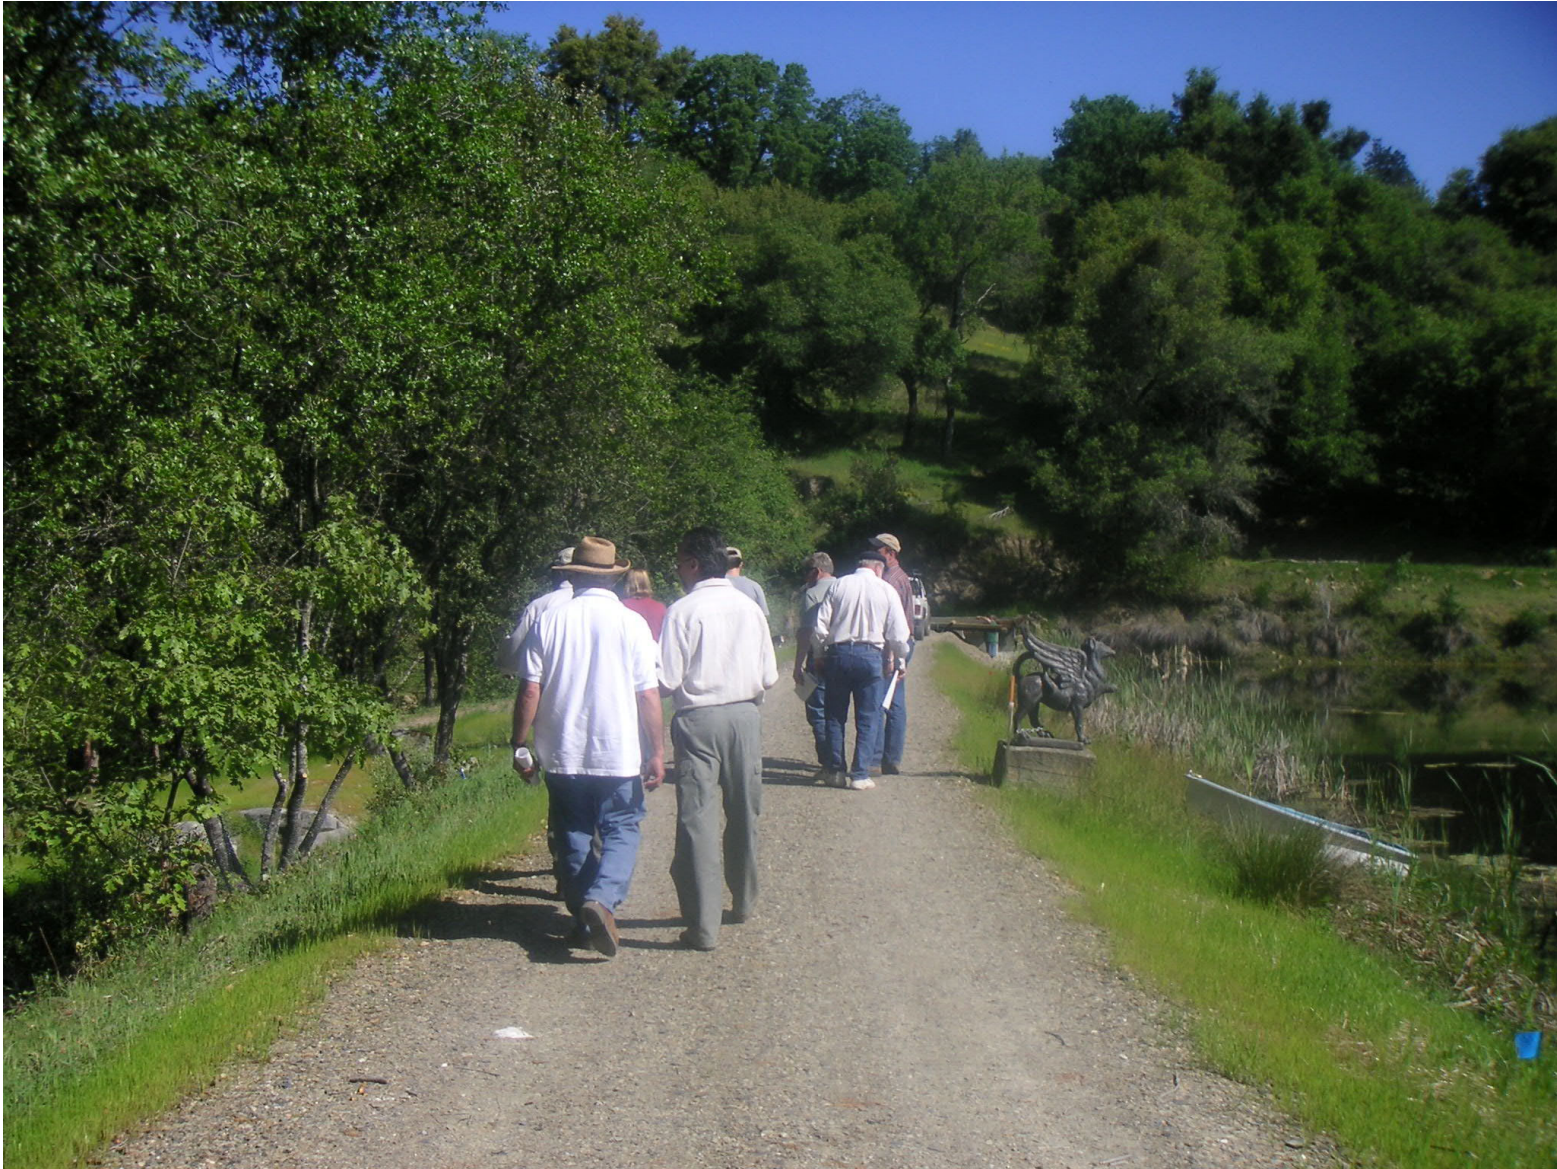
DAM AFTER REPAIRS

Note repair to erosion on top of dam.

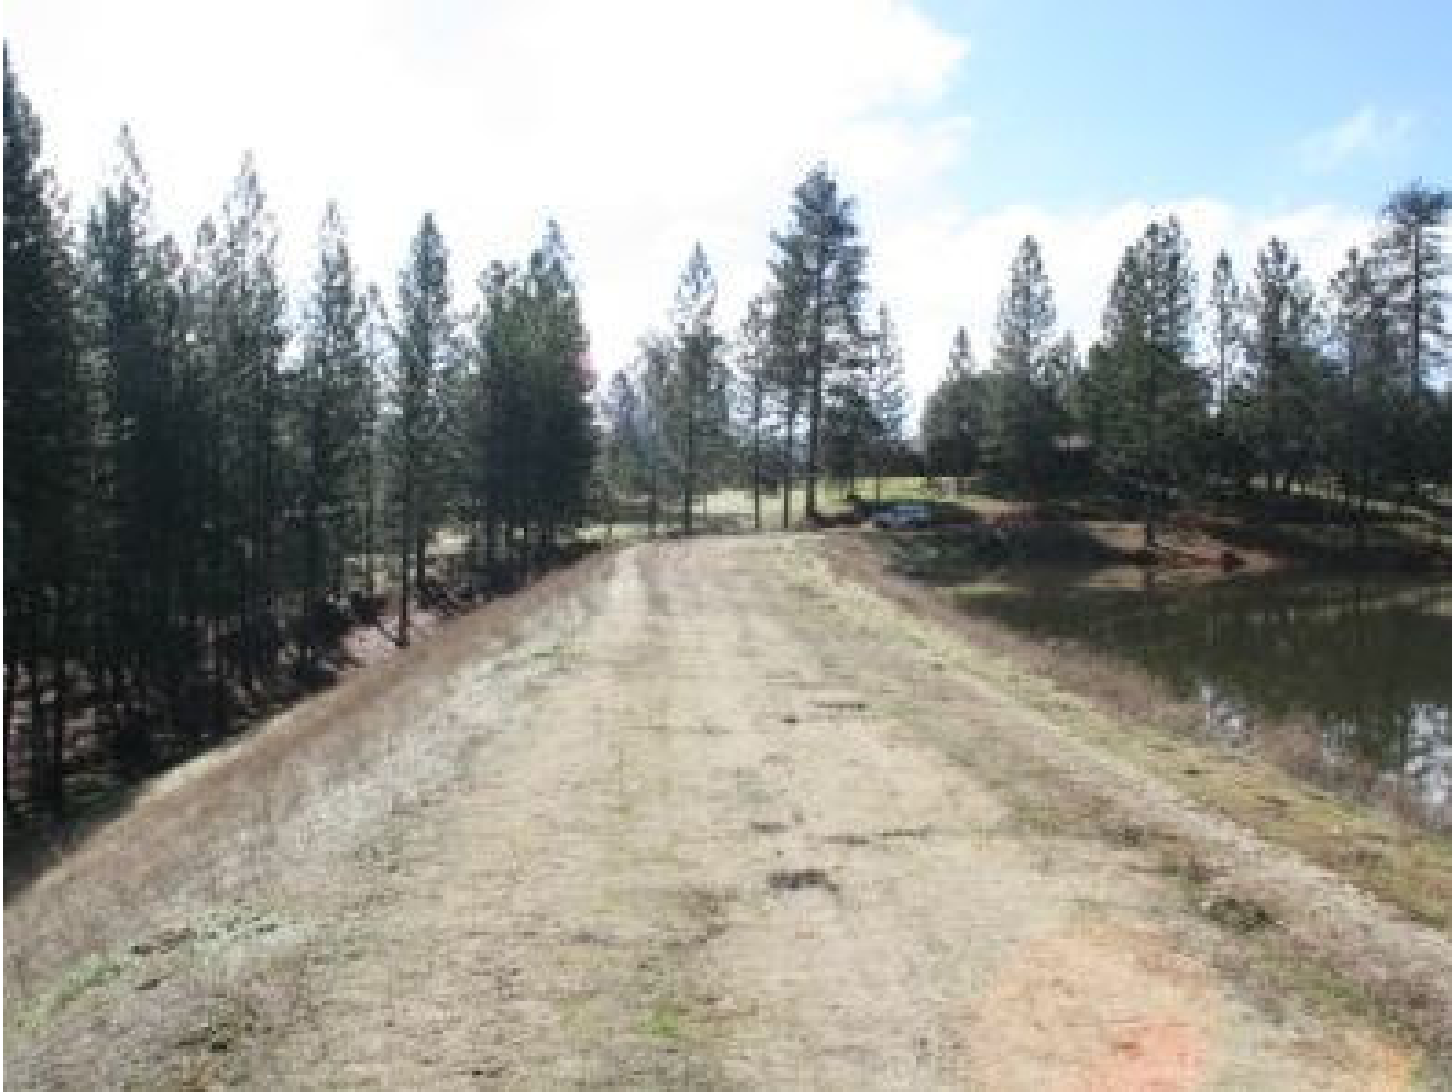
EXAMPLE OF GOOD DAM

- No trees on fill
- Good vegetation
- Wide top width sloped into pond

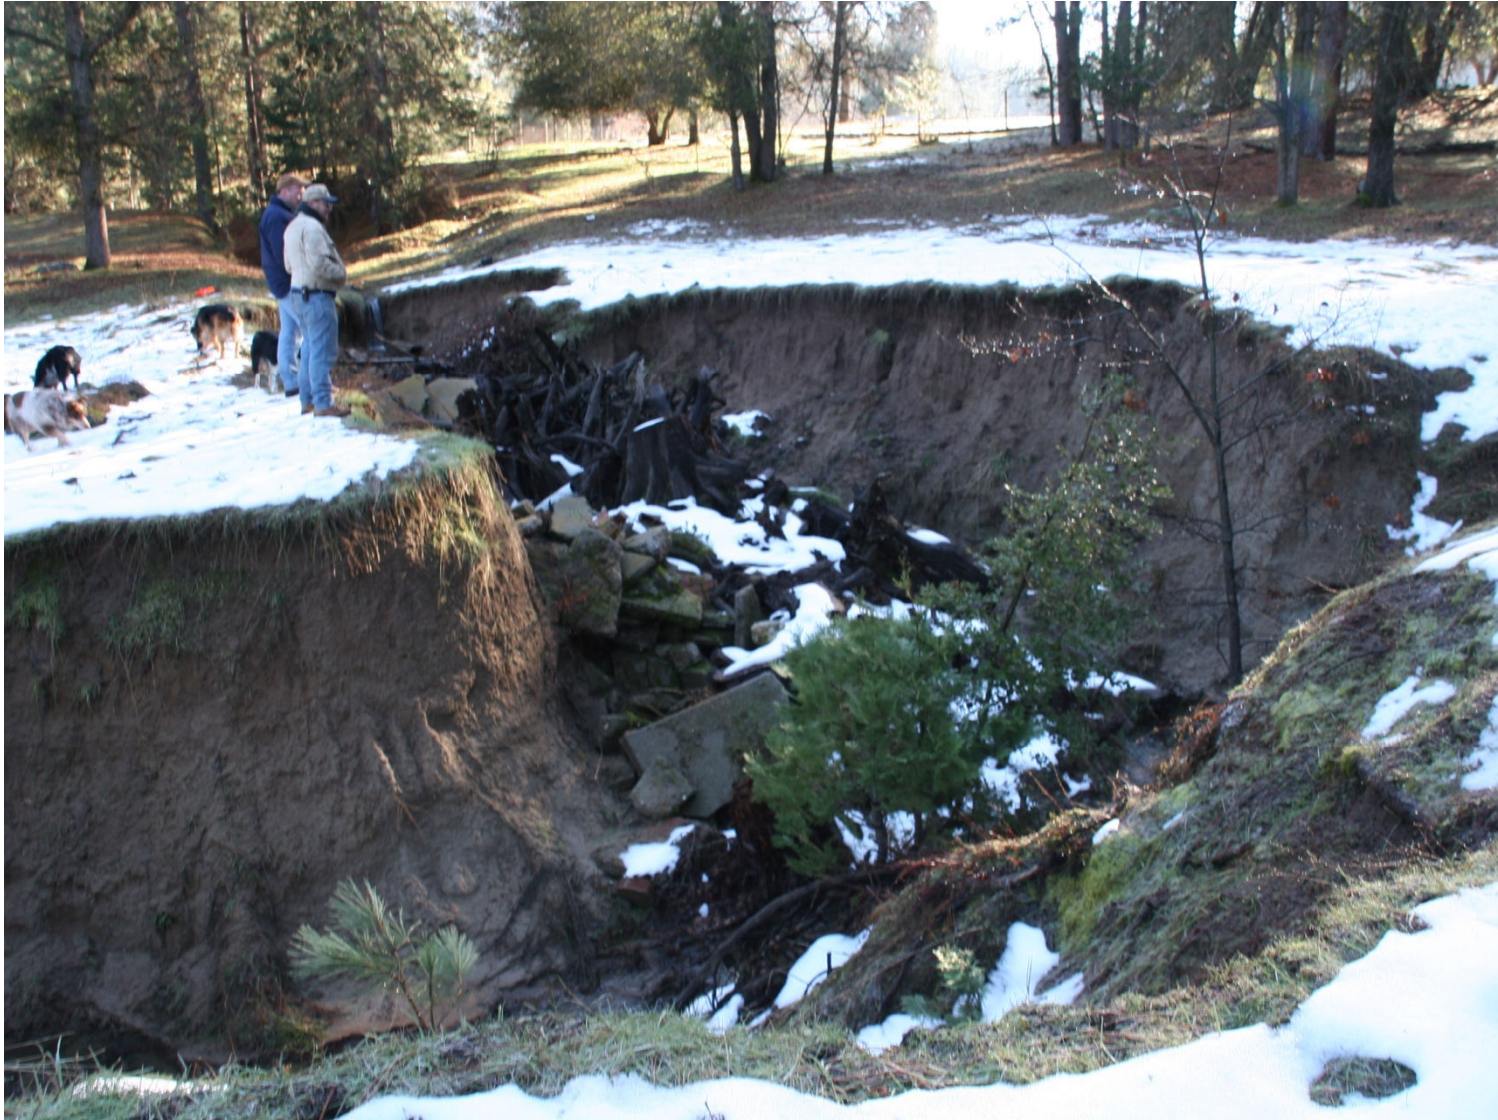
HEADCUT IN SPILLWAY

- Sides are too steep to be stable
- Excessive debris in outlet
- Active Headcut(s)

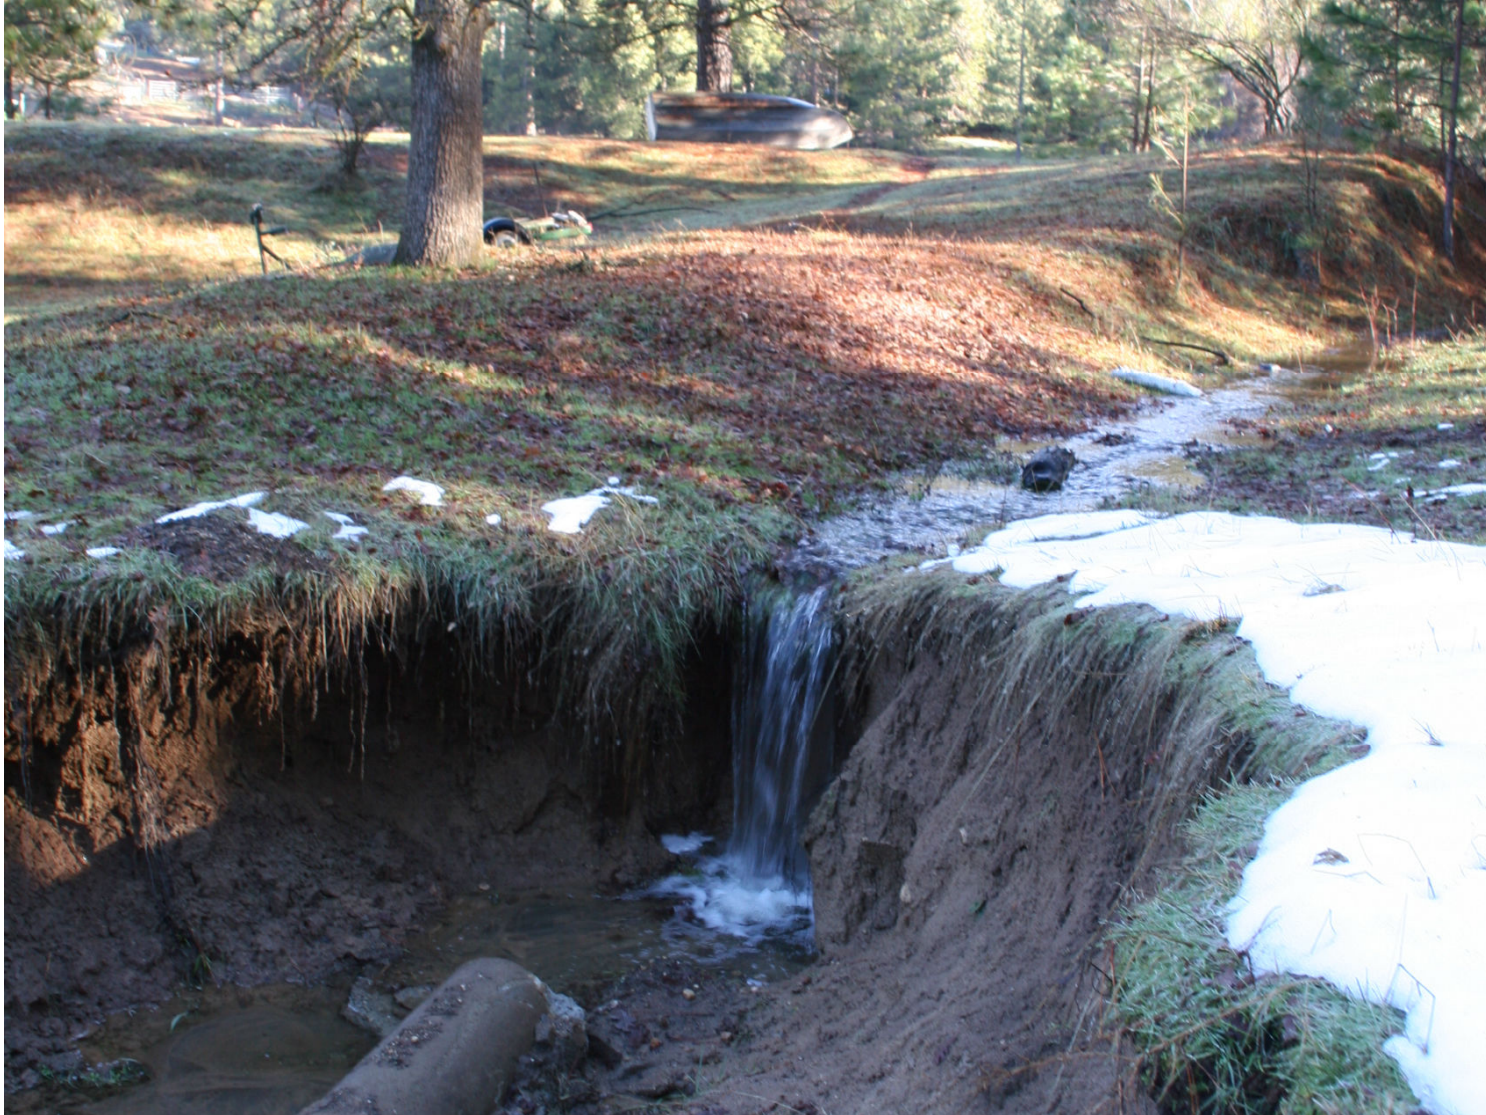
ACTIVE HEADCUT

Slope sides

Lay geotextile fabric

Place angular to sub-angular rock riprap

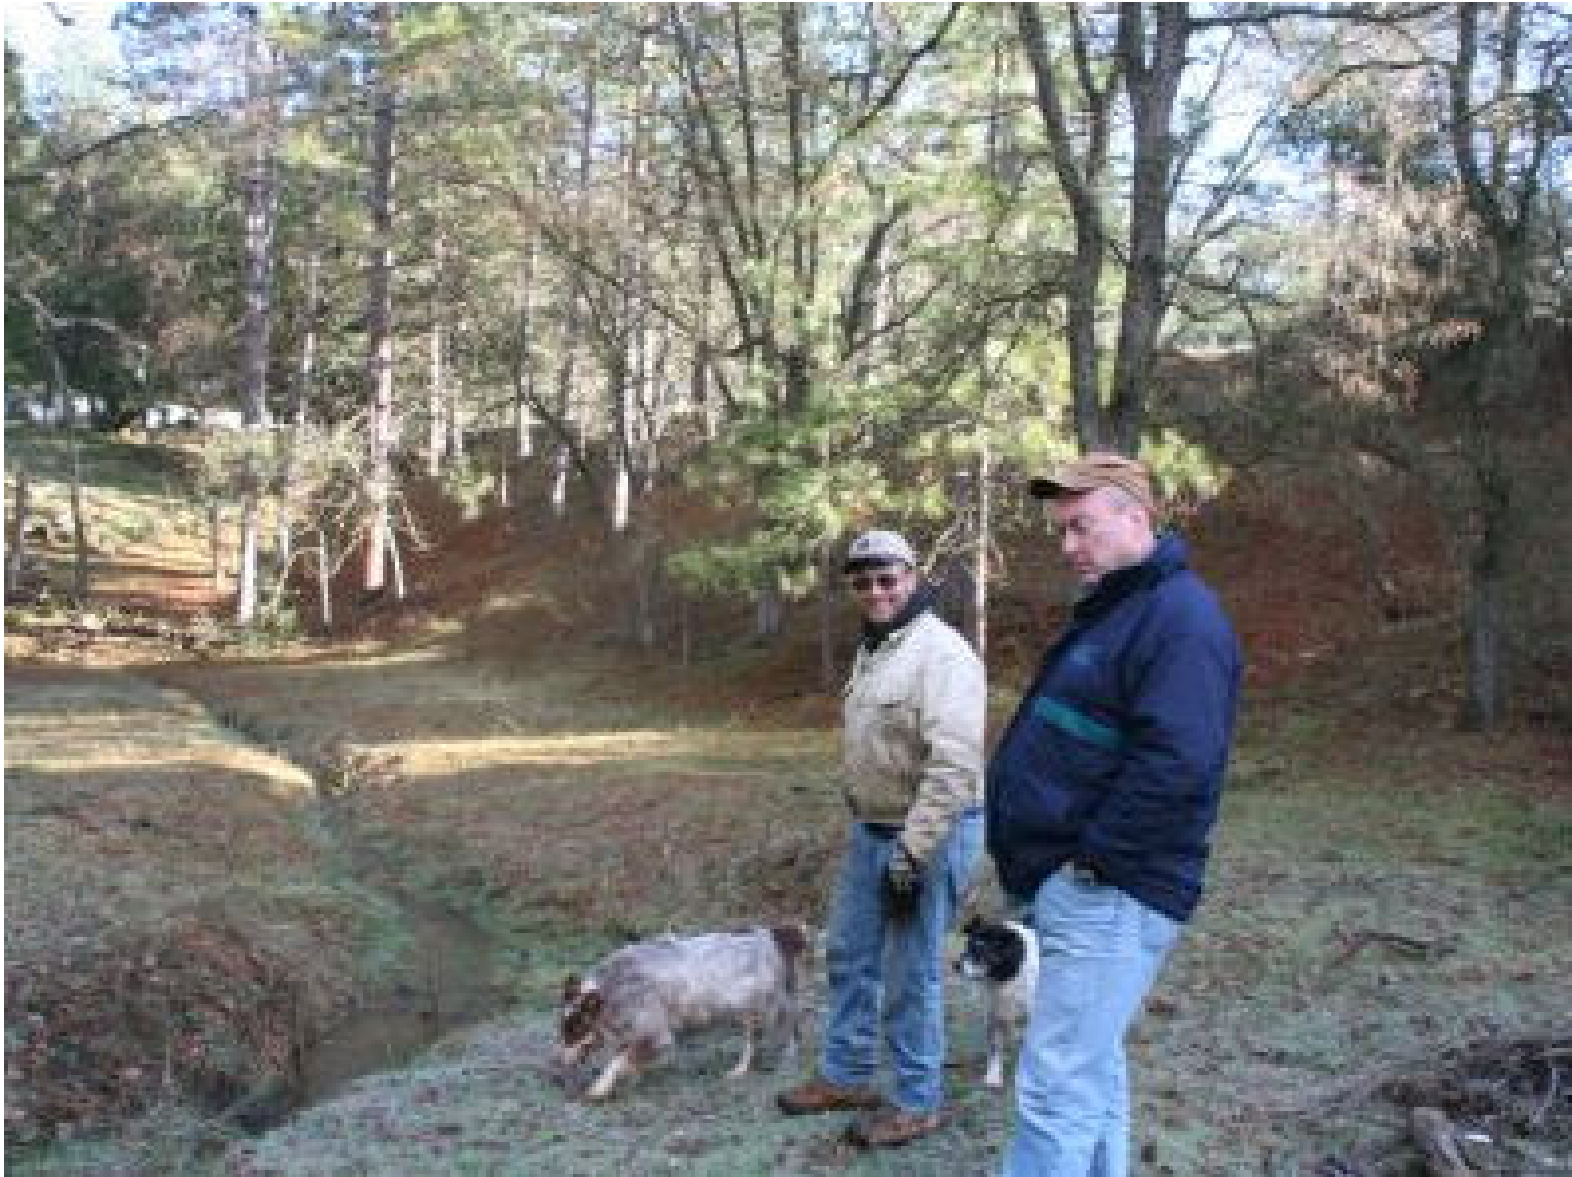
TREES ON DAM

•Note how emergency spillway runs in front of dam

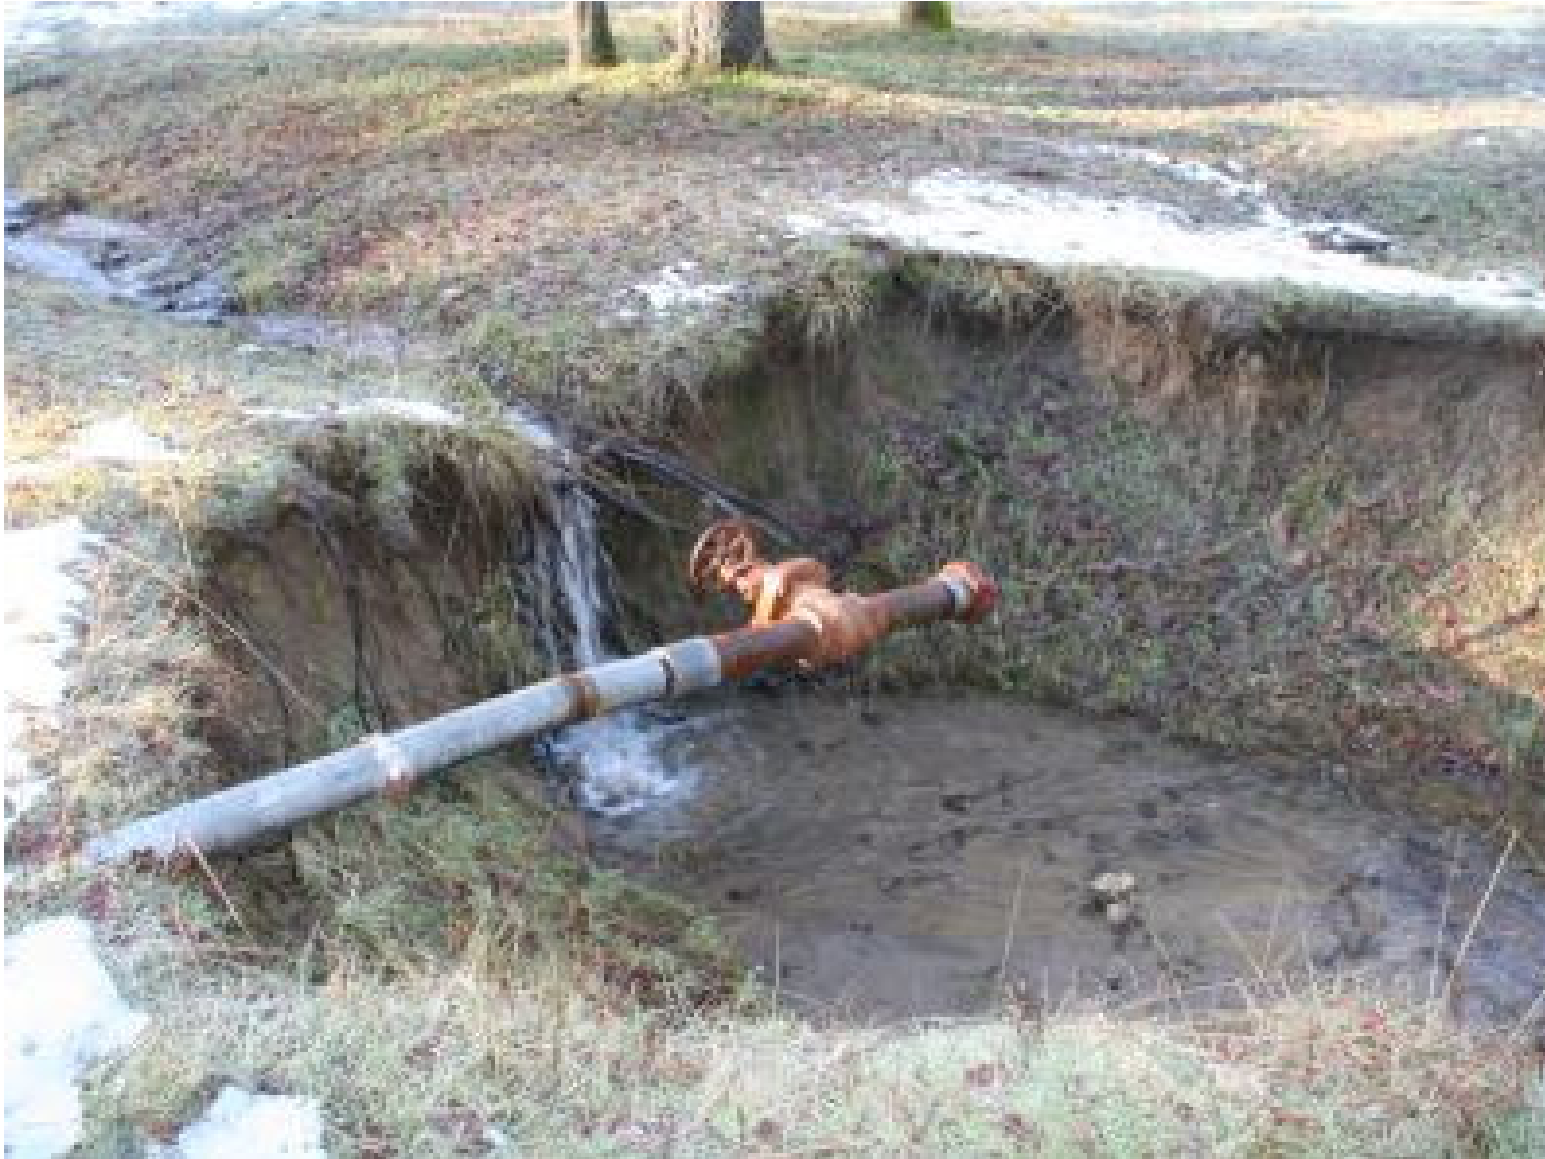
IRRIGATION PIPE OUTLET

- Headcut
- Outlet induced
