Pasadena Windstorm Tree Failure Analysis

July 2012

Davey Resource Group

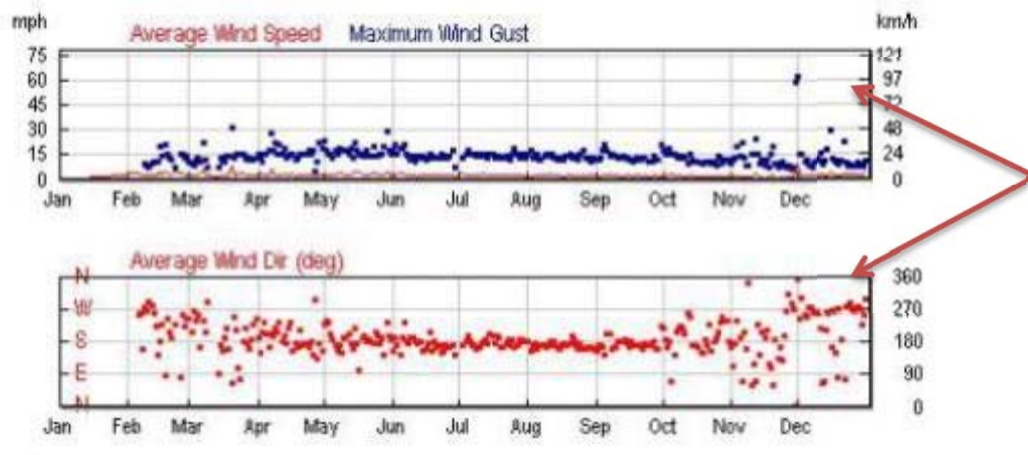
Figure 1. Annual Wind Data for Pasadena – 2011

From a historical perspective, this wind event was unique in both wind speed and direction (see Figure 1 below). A contributing factor to the strength of the winds was a high-pressure system in Northern California and a low-pressure system over Arizona that squeezed fast-moving cold air into Southern California, particularly in the Pasadena and Alta Dena foothills. Additionally, the direction of the winds during this particular storm came from the north, rather than the more typical northeast direction of Santa Ana winds (Patzert, 2011). This intensified the force of the winds for this event (Duginski, 2011).

Weather station KCAPASAD11, located in Pasadena at Hill Avenue and the I-210 freeway, confirms wind gusts in excess of 60 mph as well as winds coming from the North during the storm event (weatherunderground.com, 2011). Official quality controlled reports from the National Oceanic and Atmospheric Administration (NOAA) for the weather station located 10 miles away at the Burbank Airport supports this data, reporting wind gusts up to 55 mph coming from the North (weathersource.com, 2011). This is the nearest official NOAA station and is situated in a geographically different area than Pasadena.

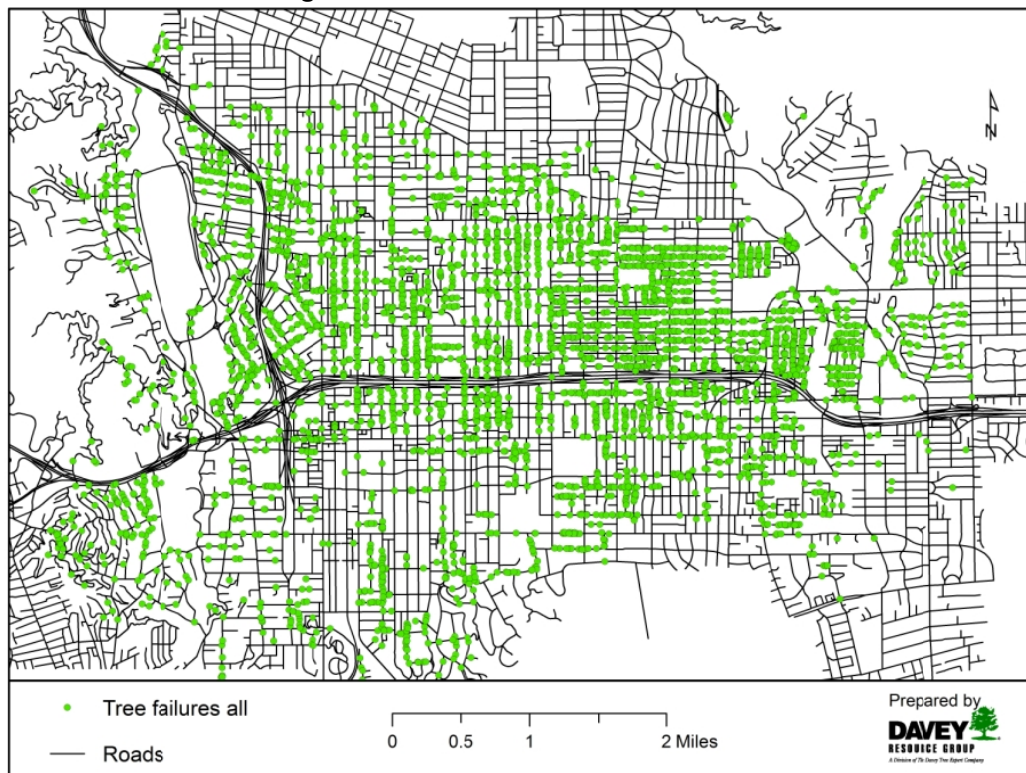
Figure 2. Street Tree Failure Overview

Based on location data received from the City, DRG mapped locations of all reported tree failures that occurred during the windstorm. The figure below demonstrates the widespread damage that occurred to the City's urban forest.

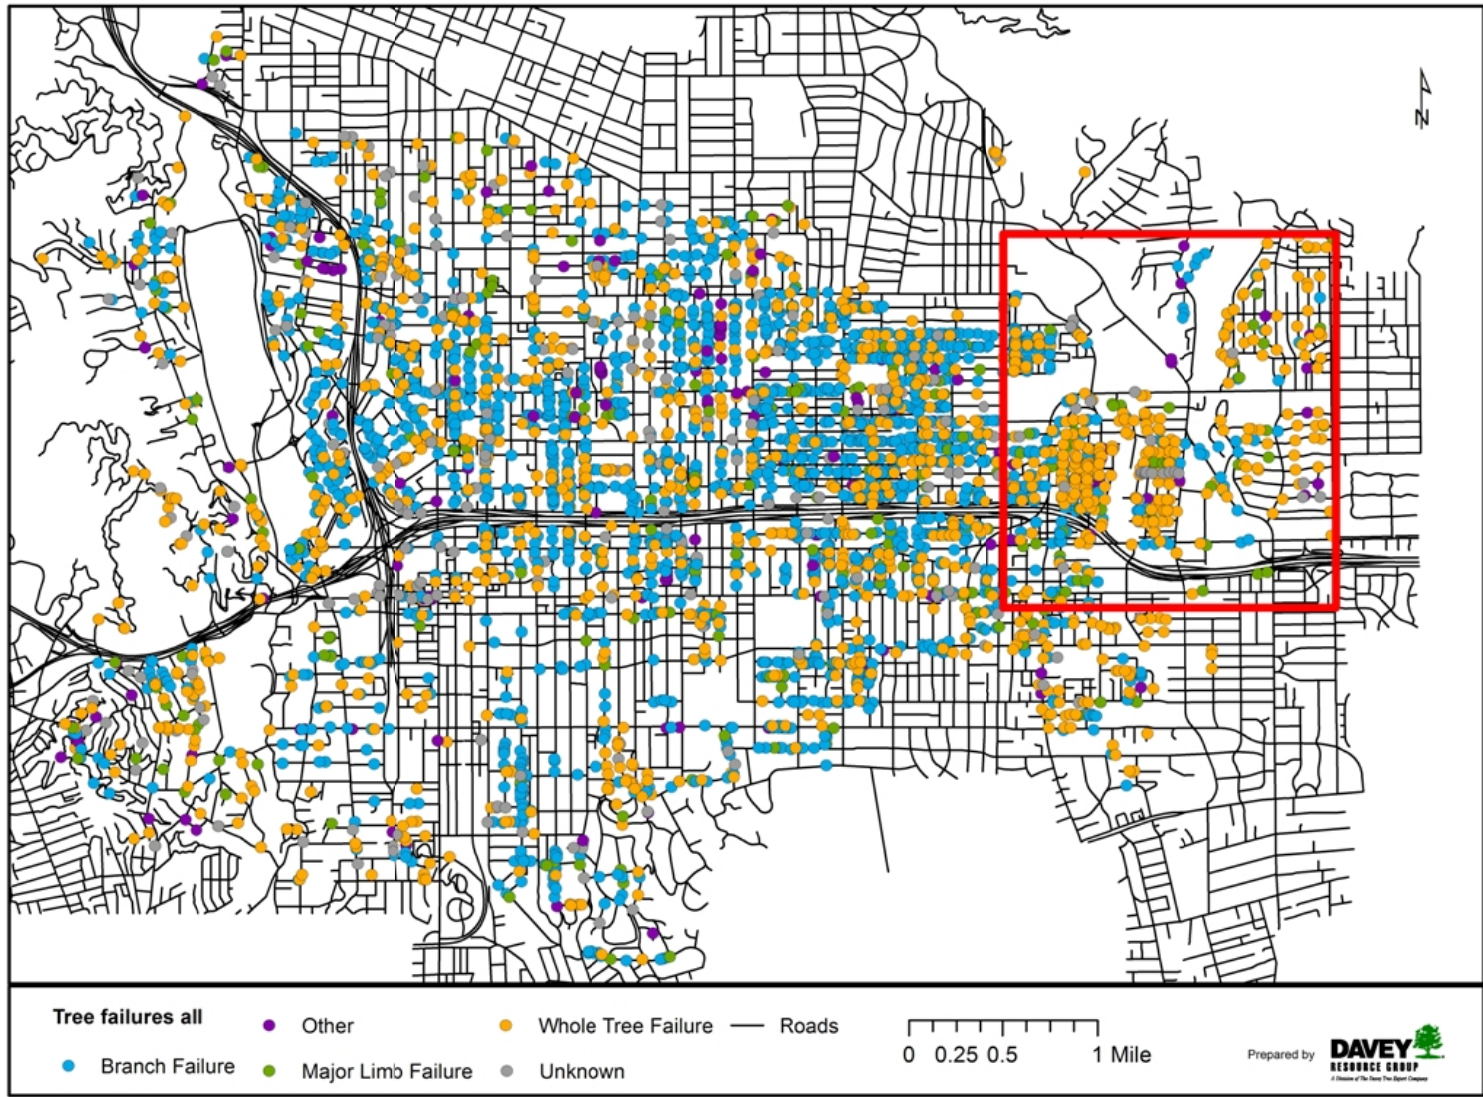
Figure 4. Tree Failure Types

From the mapping data presented earlier, it is clear that the tree damage was widespread throughout the City. There also appears to be a concentration of damage occurring north of the I-210 Freeway between North Hill Avenue and South Michillinda Avenue. When the map is delineated according to tree failures as shown below in Figure 4, it is evident that the area on the East side of the City, North of the I-210 Freeway near South Michillinda and Sierra Madre Boulevard experienced a higher concentration of whole tree failures than did the rest of the City.

Based on field observations and analysis of Figure 4 on page 10, whole tree failures and, to some extent, branch failures were more prevalent in the area of concentrated winds. In addition, trees on streets that are oriented east to west also had a higher quantity of failures than north to south oriented streets. This pattern lessened as the wind spread out to other areas of the City.

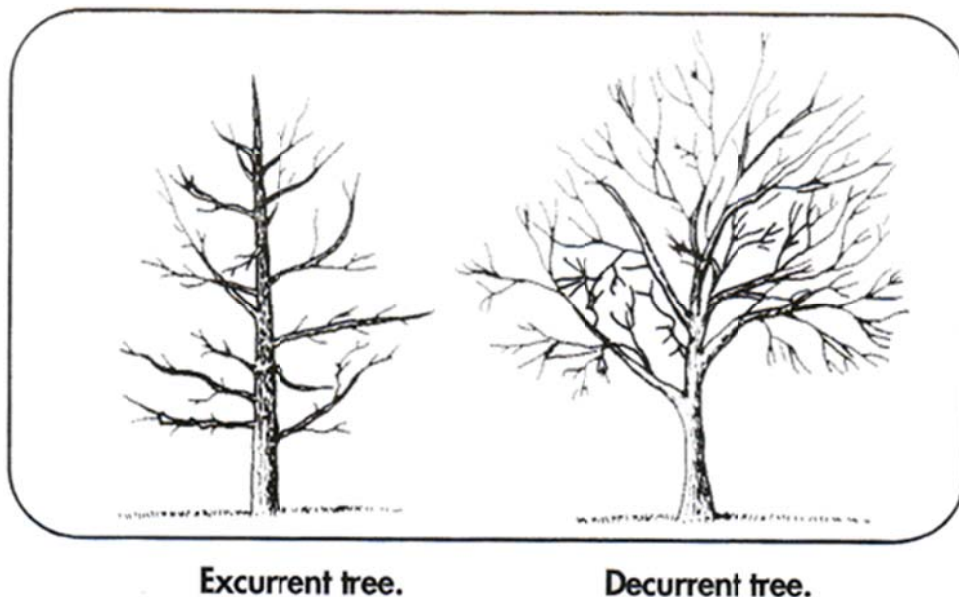
Figure 5. Tree Growth Types

No data was specifically collected by City staff or in the tree inventory on growth habit versus failure types, but general observations were made during the field inspections and cursory analysis was made using Appendix 1 in this report. Analyzed damage reports indicated that excurrent trees experienced branch failures or whole tree failures while decurrent trees experienced somewhat more branch and major limb failures rather than whole tree failures.

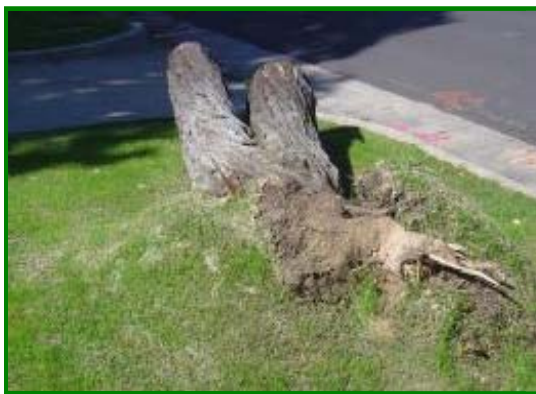
Root Failure

When complete failure of a tree occurs (the entire tree falls over), two basic types of failures can normally be identified visually: root failure and soil failure. Evidence of root failures include the base of the trunk (root plate) broken off with few roots lifted out of the ground. When roots fail, it may indicate decay in the root plate with weakly attached roots to the base of the trunk (Figure 6). Soil failures typically result in the majority of the root ball being lifted out of the ground, lifting sidewalks and turf along with it. This type of failure indicates a weak structural topsoil, saturated soil, or shallow soil. Roots are normally healthy but were unable to “hang on” to the soil when faced with above ground stress.

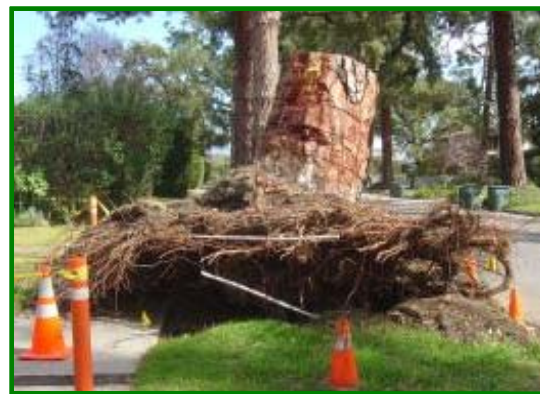
Soil Failure

During field inspections by Davey Resource Group, 11 sites presented evidence of whole tree failures. Of these, ten clearly indicated soil failures, while only one site displayed evidence of root failure. While most whole tree failures were in irrigated sites, the root failure observed was in a heavily irrigated turf parkway. There is no information on resident irrigation frequency or duration for any tree failure sites, but soil moisture plays a role in soil stability and the potential for root decay as discussed in the next section.

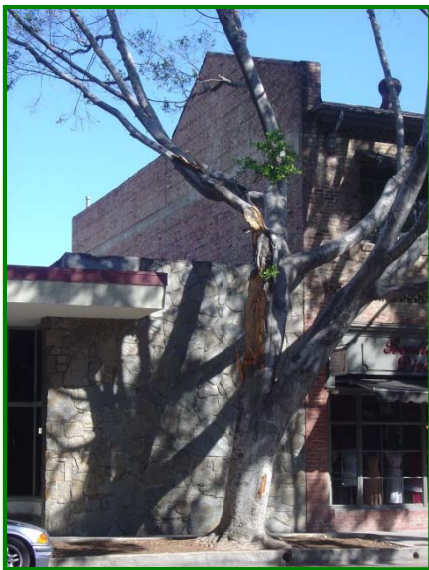
A similar pattern was observed in downtown areas or other areas with taller buildings that served as protection from the northern winds. It was observed in the field that trees next to one-story buildings or open areas like parking lots were provided little protection from the high winds. This was especially true for Indian laurel figs in the downtown area, which had excessive thinning of the lower canopies as discussed in the next section.

A single story building provided little protection for this fig tree.
