Two Related Cases of Abiotic Palm Trunk Failure

DONALD R. HODEL AND RHONDA WOOD

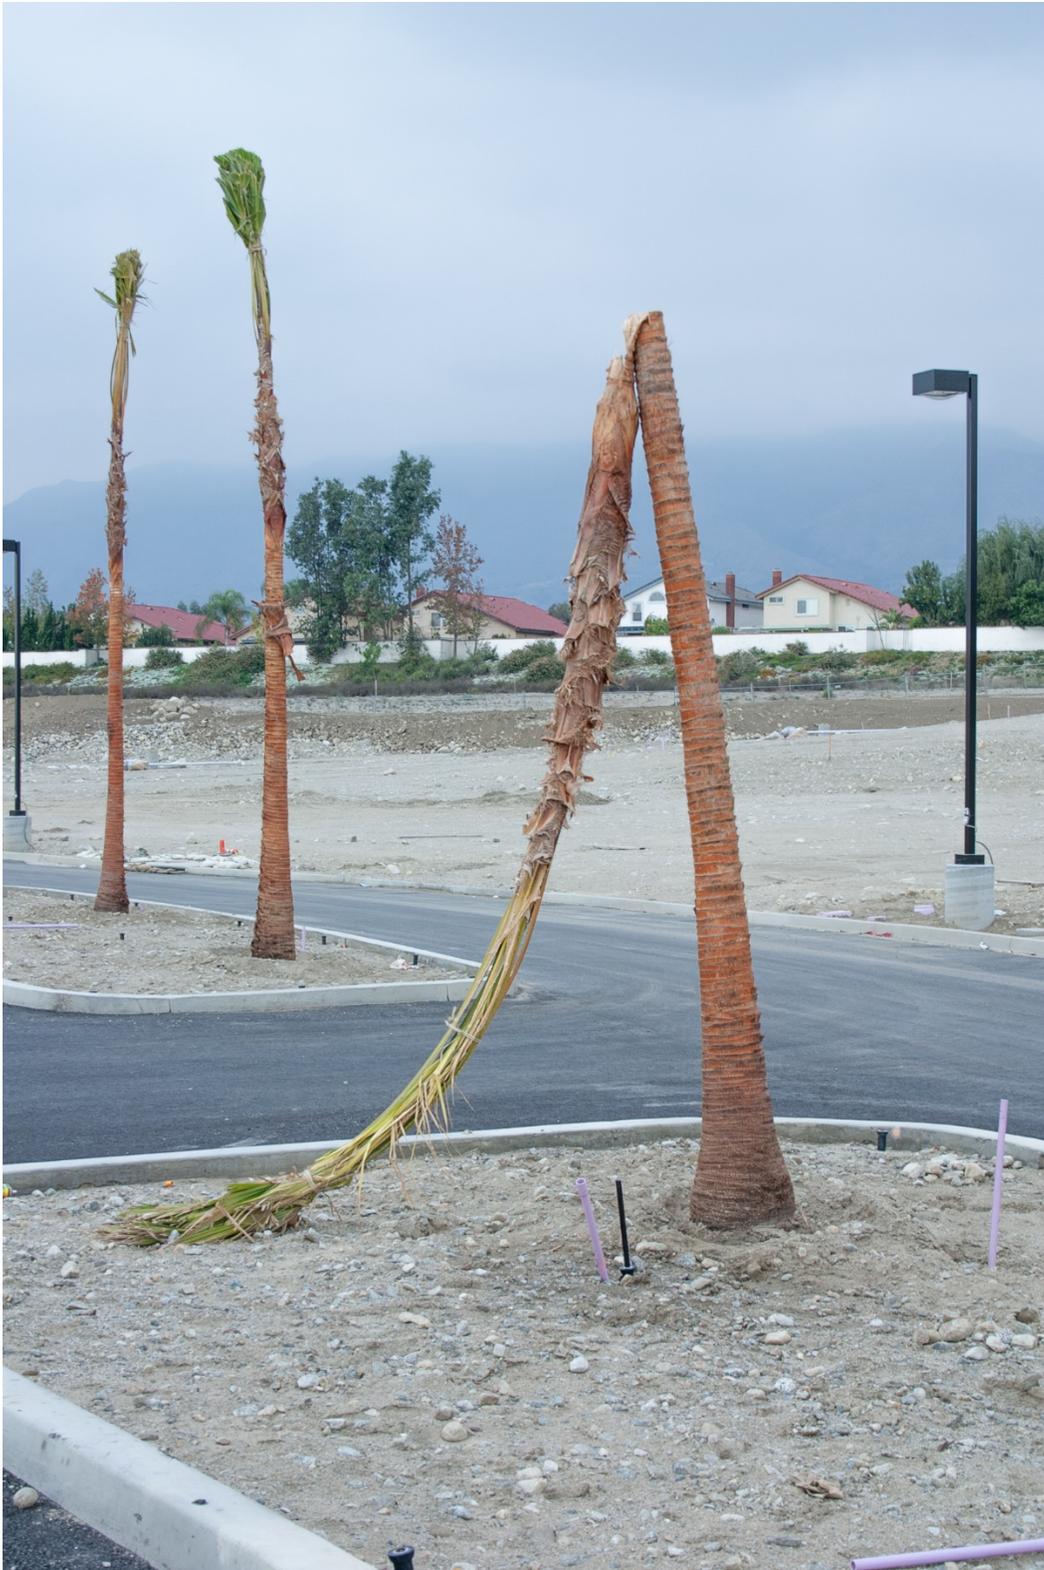
1. A recently transplanted Mexican fan palm had trunk failure in a November, 2004 Santa Ana wind event in Rancho Cucamonga, California. In this case the trunk broke nearly completely. (D. R. Hodel).

Most of the palm trunks that failed broke or snapped while a few buckled or bent but did not break about two to three m above the ground (**Figs. 1–3**). A few others simply were left leaning and did not return to an upright position once the winds stopped (**Fig. 4**).

At both the Rancho Cucamonga and Anaheim events, the breakage, buckling or bending, or leaning mostly occurred about halfway or more up the trunk, an area where the tissues were still young and had not anywhere nearly attained maximum hardness and strength. The unusually slender or “stretch-out” trunks likely exacerbated this condition. Vertical trunk elongation at the expense of adequate lateral development likely adversely affects the nature of the vascular bundles and their sheathing support as well as the surrounding parenchyma cells, making the trunk weaker and more susceptible to failure, especially in high-wind events like severe Santa Ana episodes. Anatomically, cells and tissues are likely arranged differently and are inherently weaker in palms with such “stretched-out” trunks.

Landscape managers or other qualified personnel should inspect palms prior to installation and planting and reject those with abnormally slender trunks and excessively long leaves. In addition to the abnormally slender trunk, they can check trunk internodes and petiole length, indicators of light levels and/or crowding and features that should be discernable even on palms prepped for transplanting, and reject those with abnormally long internodes and petioles.

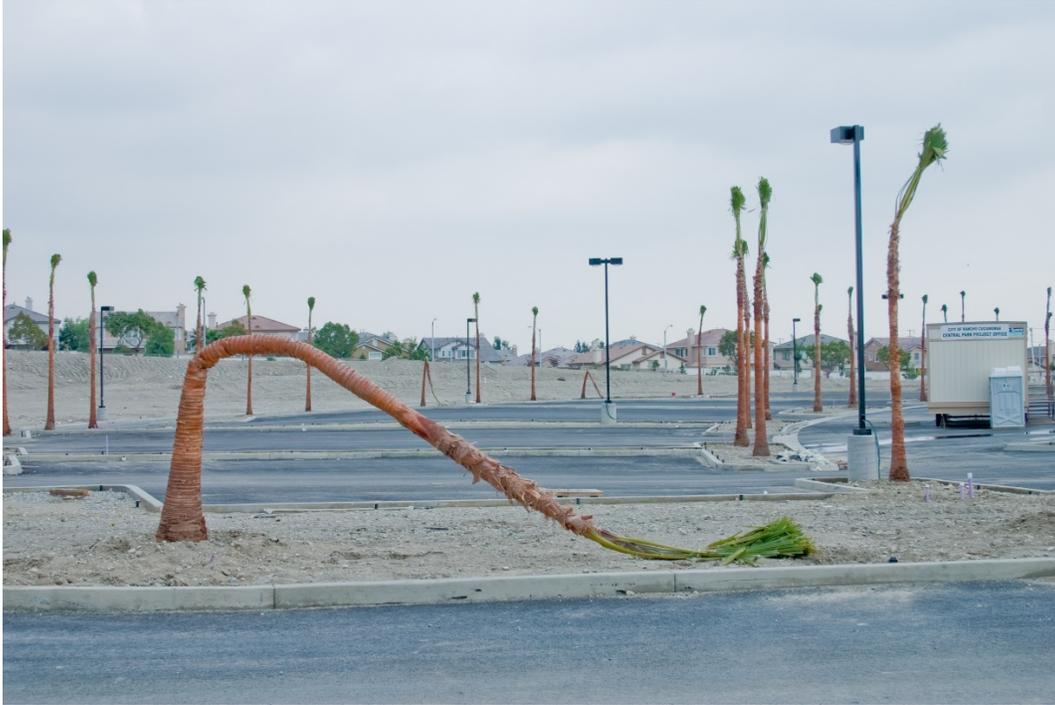
2. Another Mexican fan palm with trunk failure in the November, 2004 wind event in Rancho Cucamonga, California. In this case the trunk buckled or bent but did not break. Note the bent trunks on the palms in the background. (D. R. Hodel).

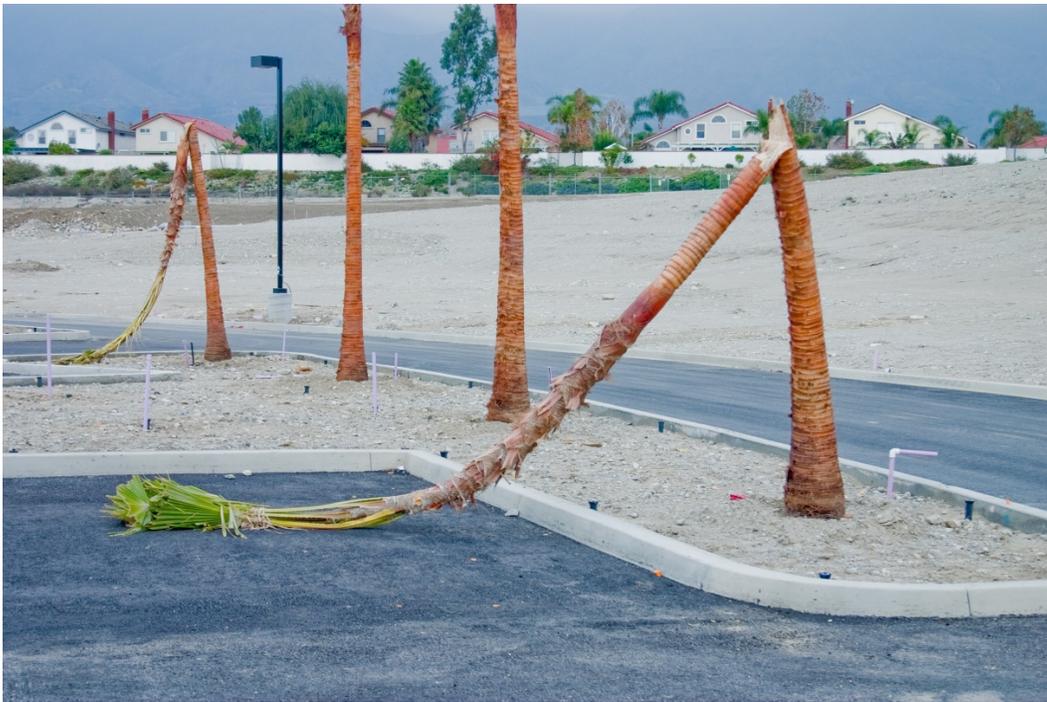
3. Here are more Mexican fan palms with trunk failure in the November, 2004 wind event in Rancho Cucamonga, California. (D. R. Hodel).

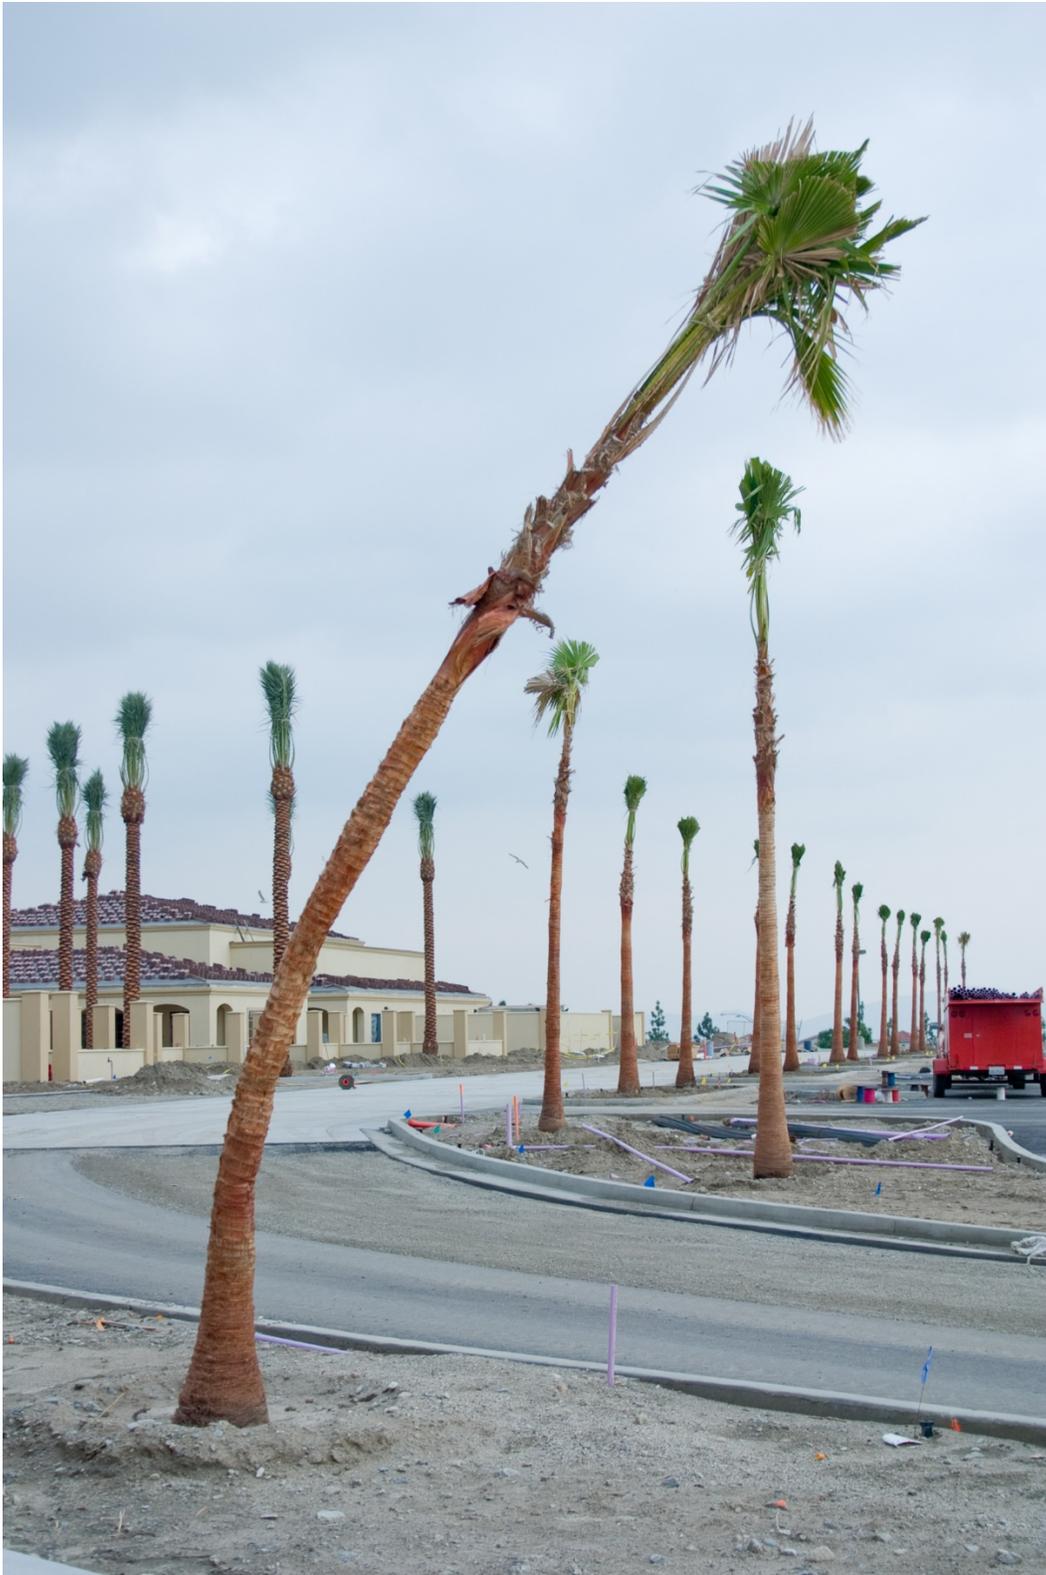
4. This Mexican fan palm had a trunk that leaned significantly but did not break in the November, 2004 wind event in Rancho Cucamonga, California. It did not return to a normal upright position after the wind event. (D. R. Hodel).

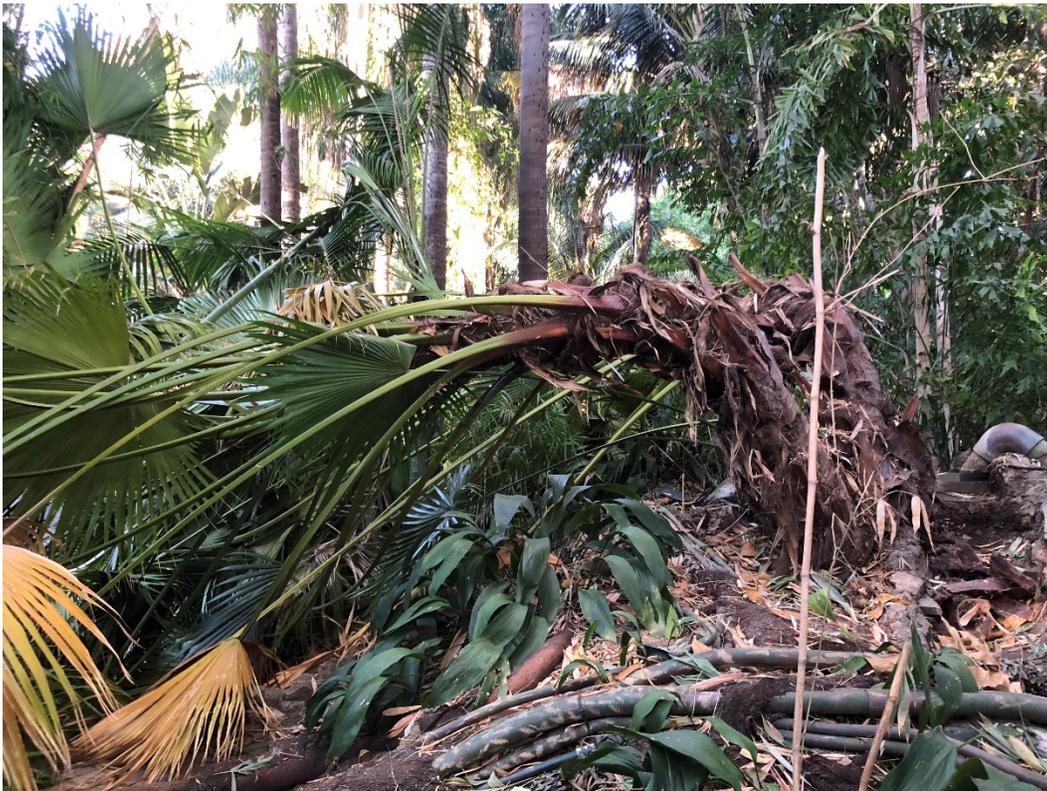
internodes for this species, the latter about five cm long. The slender trunks and exceedingly long petioles and internodes are evidence that these palms were grown in excessively crowded, low-light conditions. Indeed, overtopping trees and encroaching vegetation were present.

Trunks of both palms buckled once or twice and bent but did not break about 1.5 m above the ground, the canopy of abnormally elongated leaves spreading out horizontally and just touching the ground (**Figs. 5–9**).

5. These established Chinese fan palms growing in the shade of taller trees had trunks that bent in the November, 2020 Santa Ana wind event in Anaheim, California. Note the excessively and abnormally long petioles. (R. Wood).

In established plantings, landscape managers can check for the same trunk and petiole features: abnormally slender trunks with abnormally long internodes and petioles. They can also assess the site for excessive crowding and overtopping trees and/or encroaching adjacent vegetation that could create low-light conditions and cause excessive and abnormally elongated trunks. If these features or conditions are detected, remedial action, such as selective removal of crowded palms to allow adequate space for remaining specimens and thinning out overtopping and encroaching vegetation to allow more light, should be implemented.

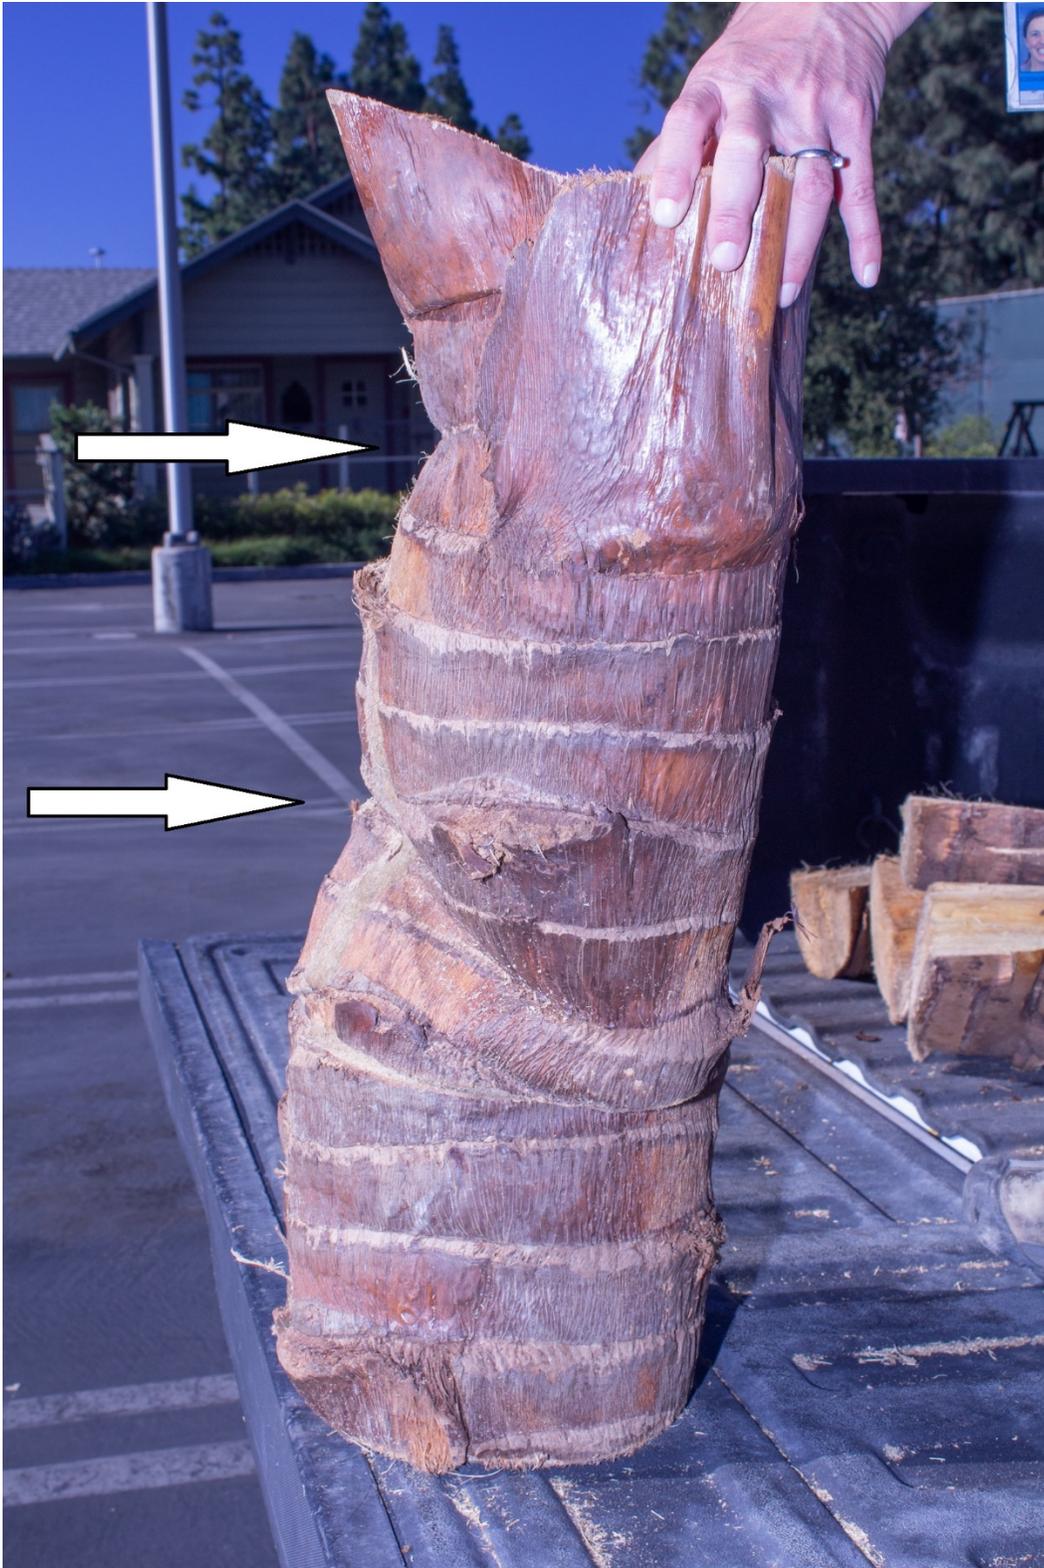
6. The trunk of this Chinese fan palm that failed in the November, 2020 wind event in Anaheim, California bent or buckled in two places (arrows). (D. R. Hodel).

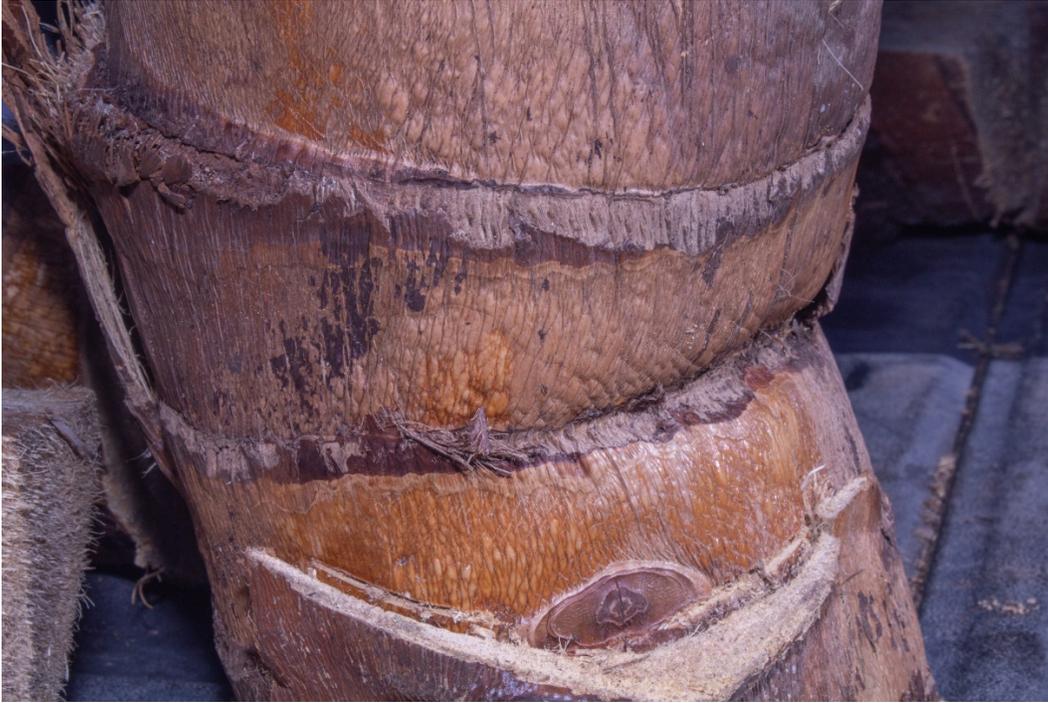
7. The trunk of this Chinese fan palm bent in the November, 2020 wind event in Anaheim, California (D. R. Hodel).

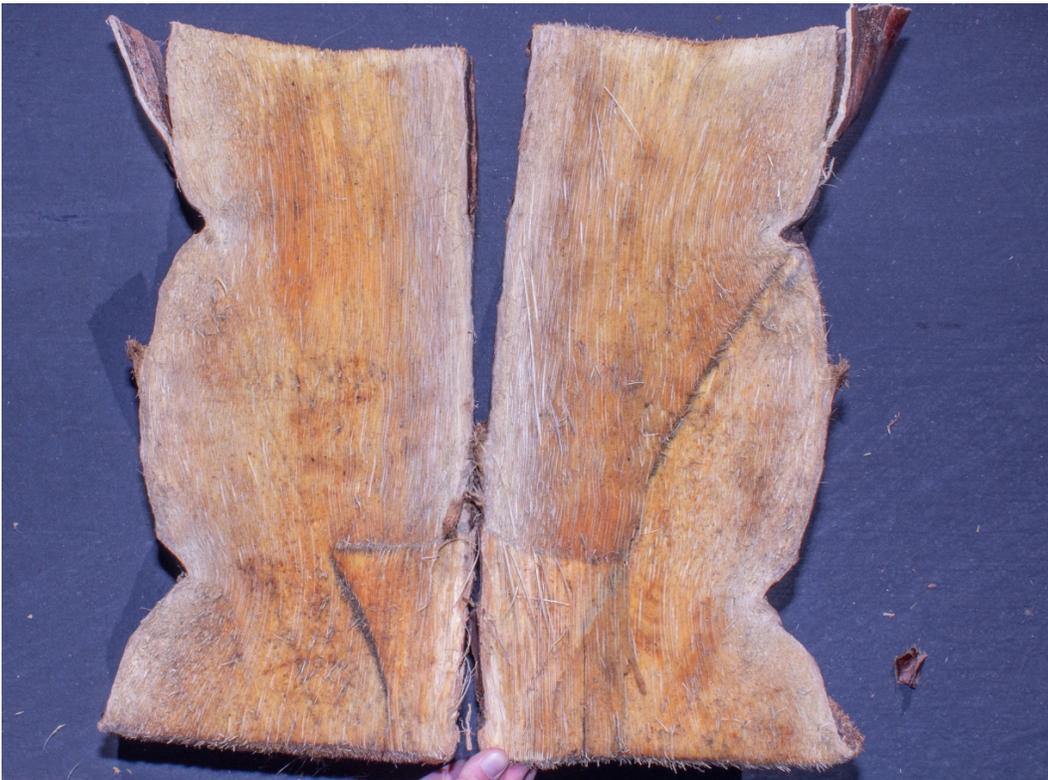
8. Longitudinal section of the trunk of this Chinese fan palm shows it bent in two places in the November, 2020 wind event in Anaheim, California. (D. R. Hodel).

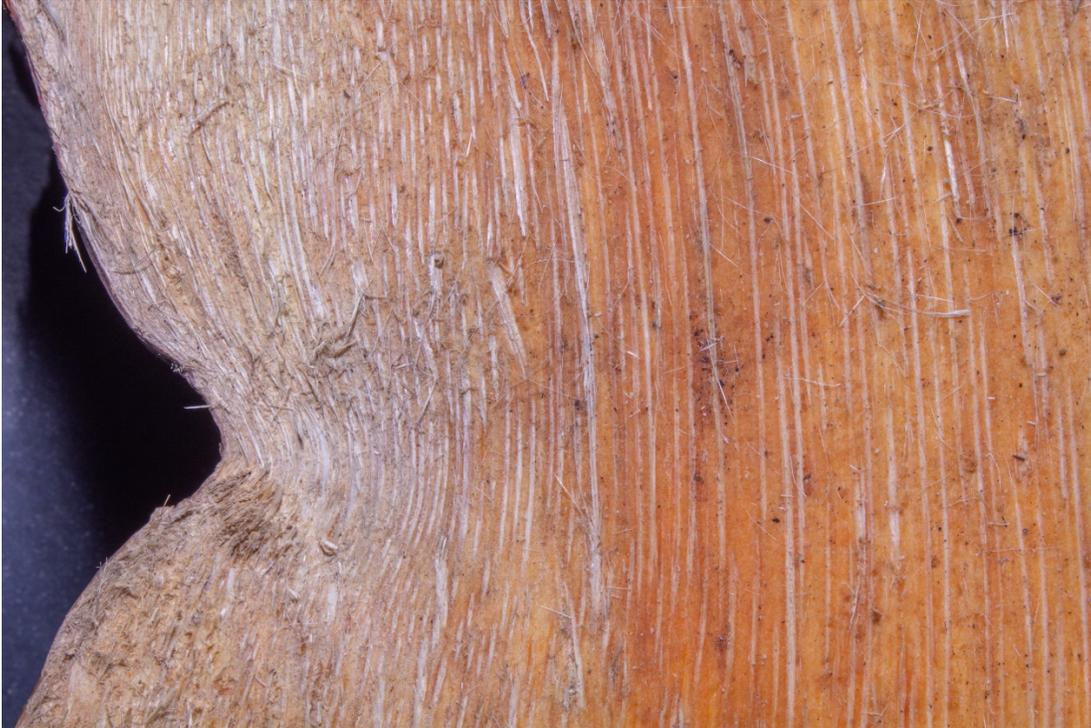
9. Longitudinal section of the trunk of this Chinese fan palm that bent in the November, 2020 wind event in Anaheim, California shows the slender, vertically arranged, white vascular bundles and brownish orange parenchyma tissues. Note how the vascular bundles are more densely arranged to the left or periphery of the trunk. The parenchyma cells were soft and spongy. (D. R. Hodel).
