ASSESSING IRRIGATION-RELATED PROBLEMS IN HILLSIDE ORCHARDS IN LAKE COUNTY

Bruce Lampinen, Rachel Elkins, Steve D'Agostini, and Sam Metcalf

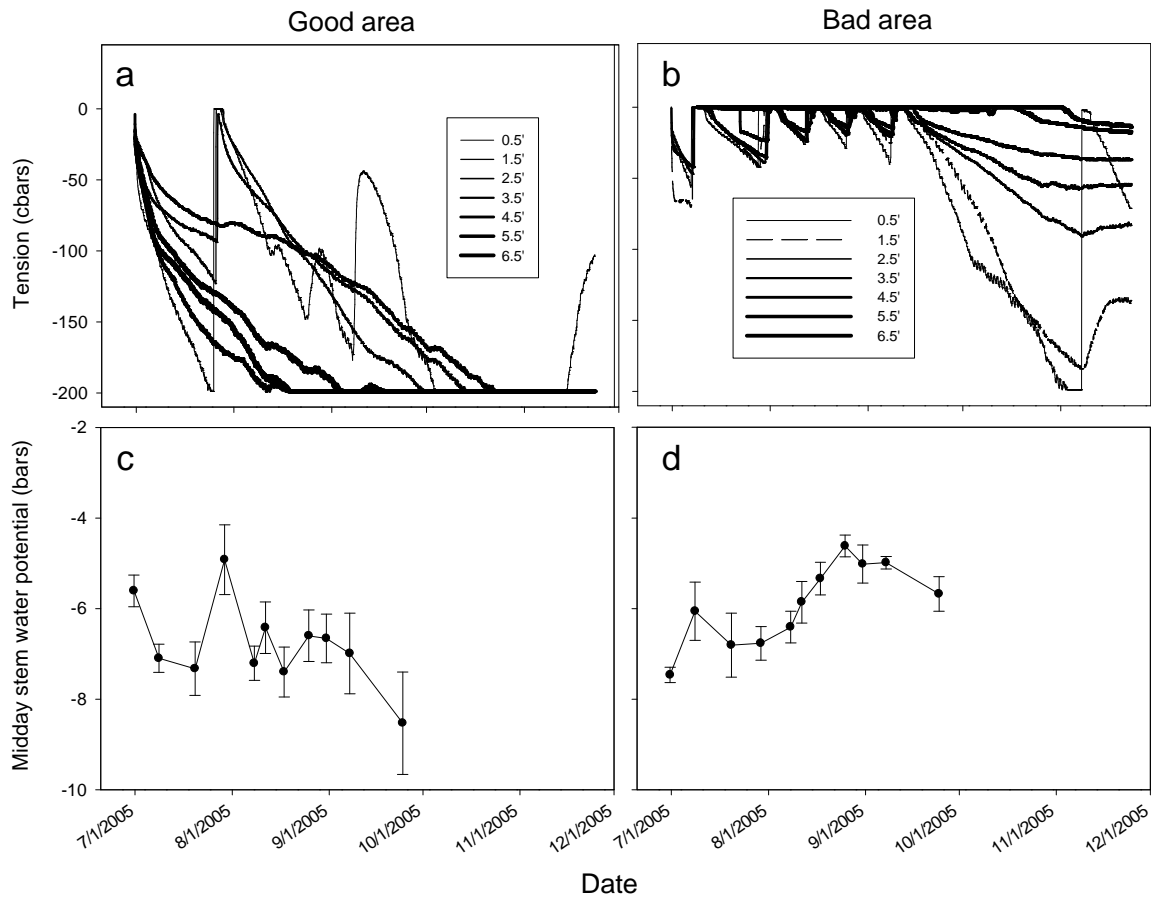
As the season progressed, the soil moisture dried down at the good logger site with the most dramatic drying taking place at the shallowest and deepest depths initially (Fig. 1). The irrigation event in late July was the only irrigation in which each side of the tree was irrigated on simultaneous days before the alternate row system described above was started. This irrigation only reached to the 2.5 foot depth (Fig. 1). There were two later irrigations (one on each side of the logger at 11 day intervals) and these smaller irrigations only reached the 0.5 foot depth (Fig. 1). Below that depth, the soil dried continuously through the season until by mid-October, all sensors at the good area logger site were registering at their minimum readings, which is -200 centibars (Fig. 1). Midday stem water potential readings at the good area logger site ran from the -5 to -8 bar range through the season (mildly to moderately stressed). Some trees in this area showed visual symptoms of water stress by late summer. The fact that the lowest water potentials reached in these trees only averaged about -8 bars while moisture sensors to 6.5 feet were very dry suggests that roots were accessing moisture below the 6.5 foot depth of moisture sensors.

In the poor growth area, soil moisture results were quite different. At the beginning of the monitoring period in July, moisture sensors at all depths were registering as very wet (Fig. 1). After each irrigation event, moisture sensors at all levels returned to near zero levels. This is generally not a healthy situation but the trees in this area tolerated this fairly well with few visual symptoms of damage by season end. The likely reason for this tolerance of these conditions is that previously, these trees had been subjected to twice as much water at each irrigation event so they were likely very shallow rooted and adapted to deal with the situation. When irrigation was ceased in preparation for harvest, the shallower depth dried down quickly while lower depths remained wet (Fig. 1). Midday stem water potentials tended to run in the -5 to -7 bar range which is more stressed than you would expect based on wet soil moisture conditions. This suggests either that many roots were active above the shallowest 0.5 foot sensor and/or that root function was compromised by the overly wet conditions.

Fig. 1. Soil moisture tension over season by depth for a) good growing area of orchard b) poor growing area of orchard and midday stem water potential over season for c) good growing area and d) poor growing area.

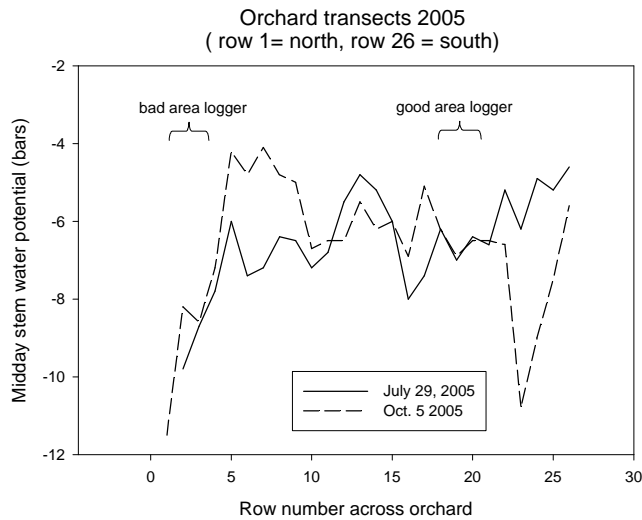
Water potential transects were done twice during the season spanning across the orchard between the good and poor growing areas. Generally, the poor growth area was slightly more stressed early in the season and less stressed later in the season compared to the good growth area (Fig. 2). The relatively high midday stem water potential in the poor growth area late in the season followed by a rapid drop as shallower soil depths dried down (Fig. 1d) suggests that the trees were shallow rooted.

Fig. 2. Water potential transects across orchard on two dates in 2005. On July 29, 2005, irrigation was approximately 6 days past the good area logger and was 2 rows to the north of the bad area logger (soil surface was wet at both logger sites). On October 5, 2005, irrigation had ended for the season and soil surface was dry.
