Creekside Plantings and Restoration in California Rangelands

CREEKSIDE PLANTINGS AND RESTORATION IN CALIFORNIA RANGELANDS

Louise Jackson, Amanda Hodson, Katherine Fyhrie, Valerie Calegari

HABITAT RESTORATION PRACTICES FOR CALIFORNIA RANGELAND RIPARIAN CORRIDORS

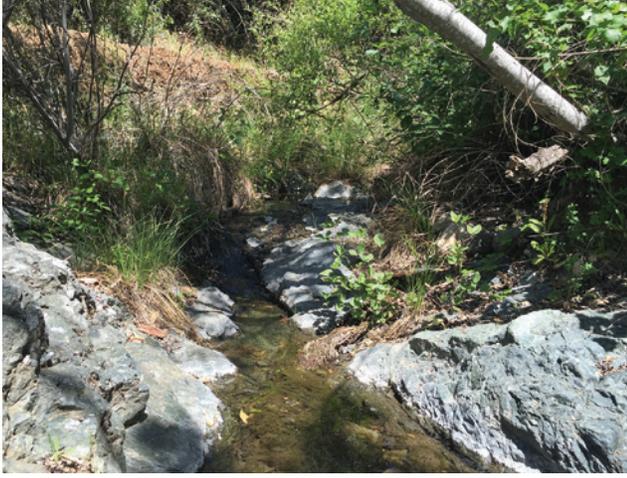
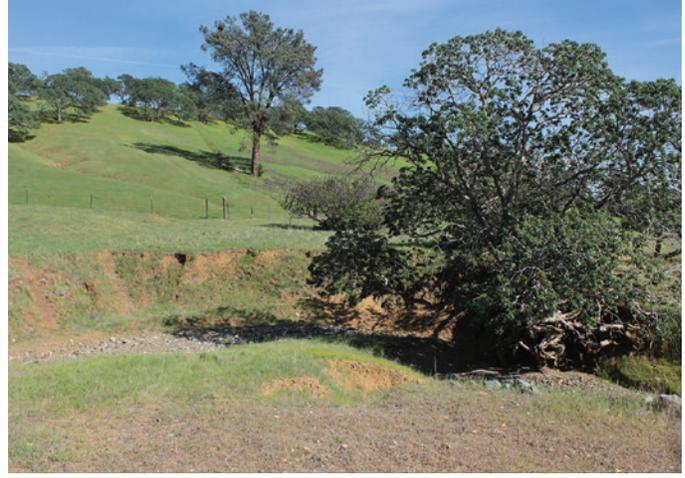
FIGURE 1. Riparian corridors in grazed oak woodlands in California, with ephemeral or perennial streams.

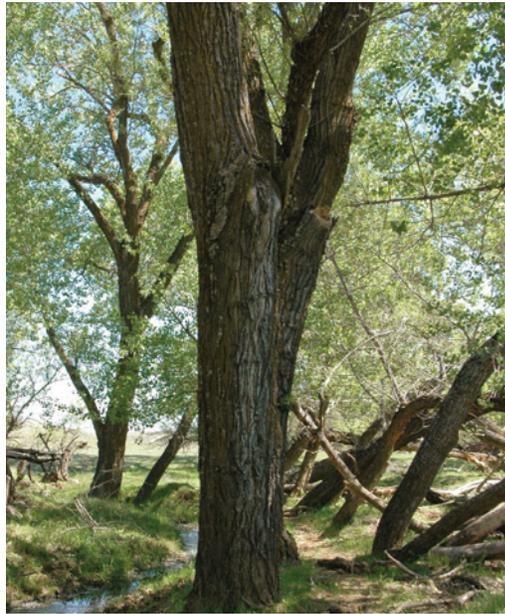
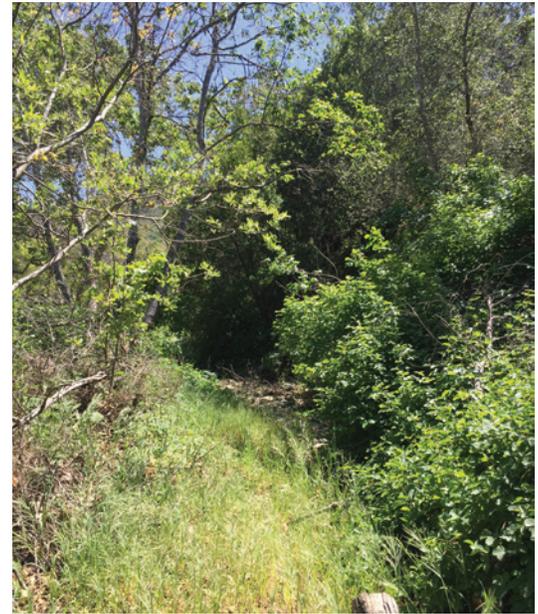
FIGURE 2. TubeX shelters with tree and shrub seedlings in a riparian corridor in an oak woodland which was subsequently grazed by cattle. It was not feasible to use drip irrigation due to variations in microtopography, the large reach (>1 mile), distance from a reliable water source, and trampling of the drip tubing by cattle. Hand-watering and DRIWATER® were used (Table 3).

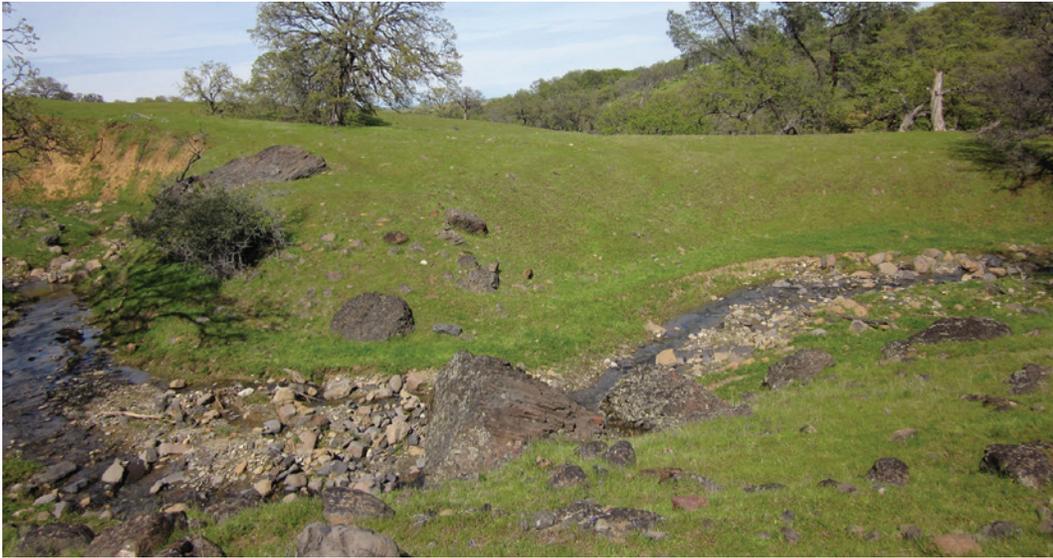
FIGURE 4. Variation in microtopography along a riparian corridor in California rangeland.

The hilly rangelands in Central California often have narrow riparian corridors that contain high spatial variation in short distances along a reach. The deposition of sediment is patchy, either due to steep slopes or fluvial scouring when storm flushes occur. Compared to waterways in flatter terrain in valleys, rangeland riparian corridor sites contain more heterogeneity in soil characteristics and topography (Young-Mathews et al. 2010). As an example, a detailed analysis of two riparian corridors at the Audubon Bobcat Ranch in Yolo County showed a very large range in soil texture (up to 5-fold difference in clay content), soil total carbon (10-fold) and nitrogen (5- to 7-fold), and soil moisture (up to 5-fold) in the zone of about 75 feet from the water's edge (Table 2) (Hodson et al. 2014). The patchiness of soil and rocks is thus a major factor in designing restoration projects in upland riparian corridors. Situations with high variation over short distances and abrupt rather than gradual shifts in substrate require detailed analysis of microsite conditions and management options (Figure 4).

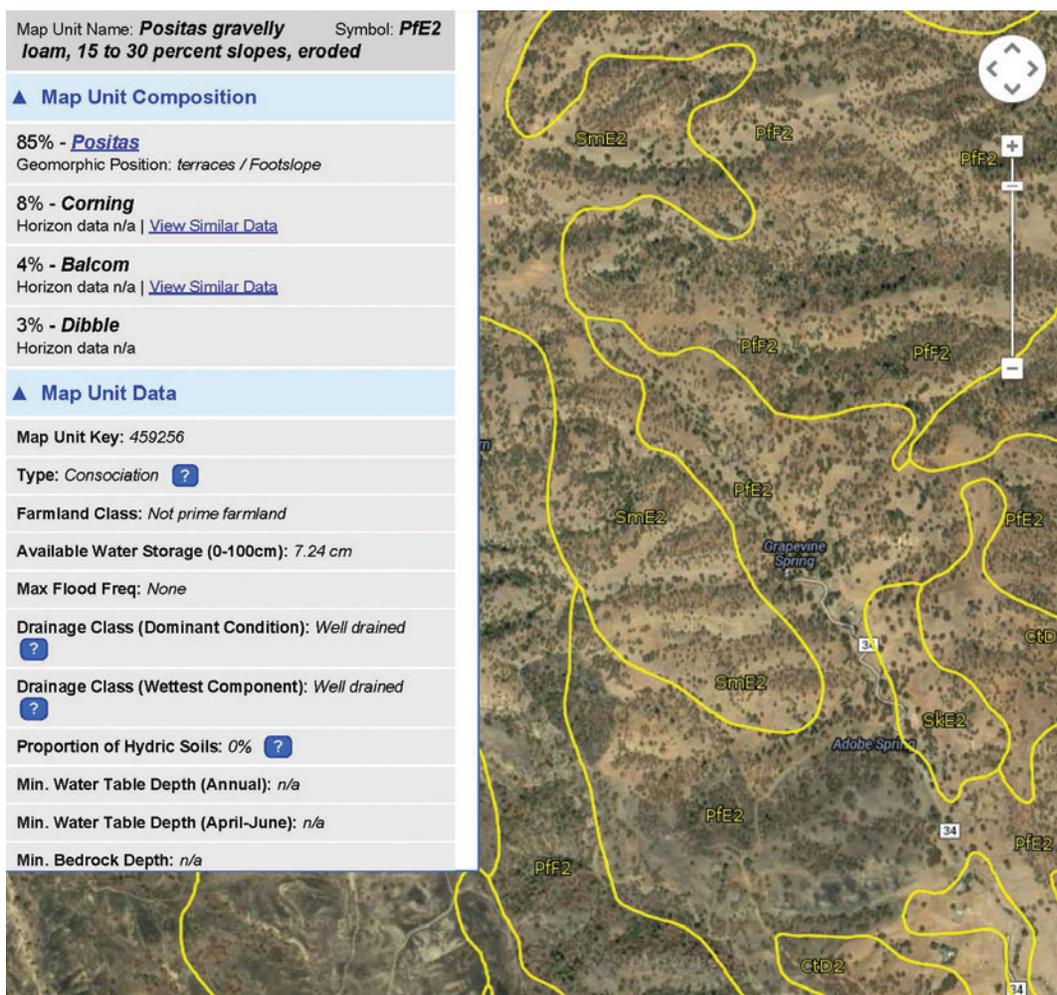
FIGURE 5. Example of a riparian corridor and surrounding soil map units as shown on SoilWeb: An Online Soil Survey. By clicking on a point in a PfE2 polygon, the information on the map unit is shown on the left. The map unit contains 85% Positas gravelly loam, 15 to 30 percent slopes, eroded, with smaller areas of Corning, Balcolm and Dibble soil types. The location is west of Winters, California.

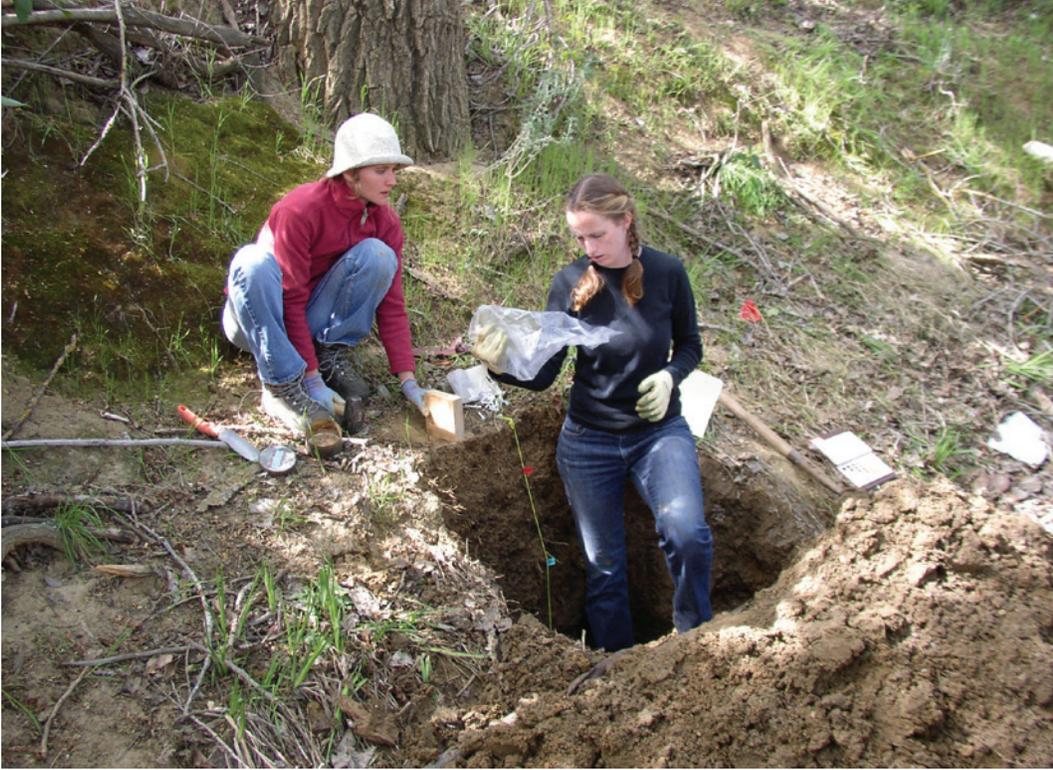
FIGURE 6. Soil pit description and sampling along the floodplain of a rangeland riparian corridor.

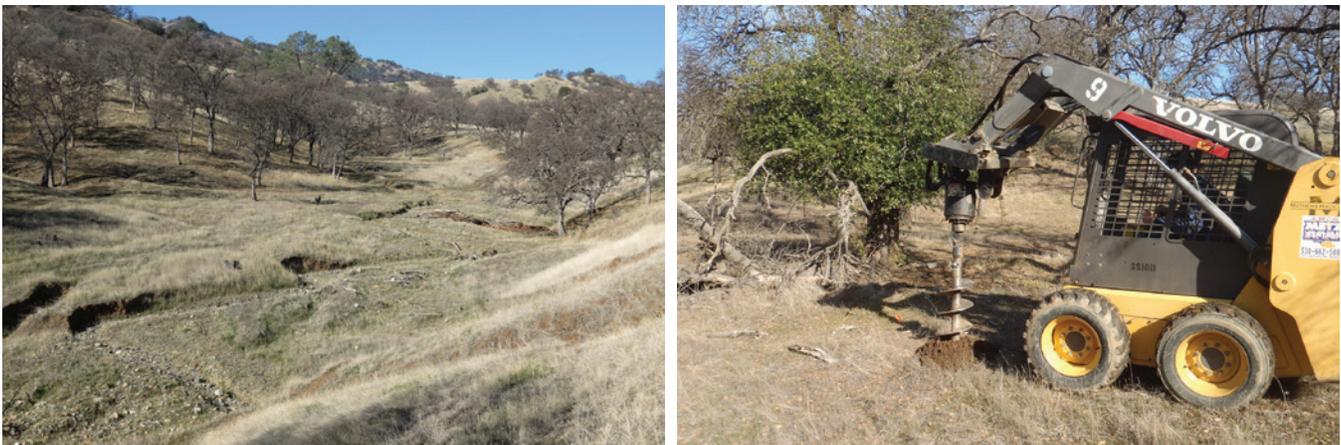
FIGURE 7. Auguring 1- to 2-ft deep holes prior to planting seedlings or acorns. The landscape view shows the slope of the terrain that permits access with the excavator/digger machinery.

Auguring deep, wide holes for planting is an alternative to disking and grading a site (Figure 7). This loosens the soil for exploration by seedling roots and disrupts hardpans that block root access to deeper layers where soil moisture is likely to be higher. Adding a small amount of compost and/or rock phosphate or bone meal to the planting hole improves nutrient availability, and the backfilled hole as well as the surrounding soil around the hole should be moist at planting time (Earnshaw 2004).

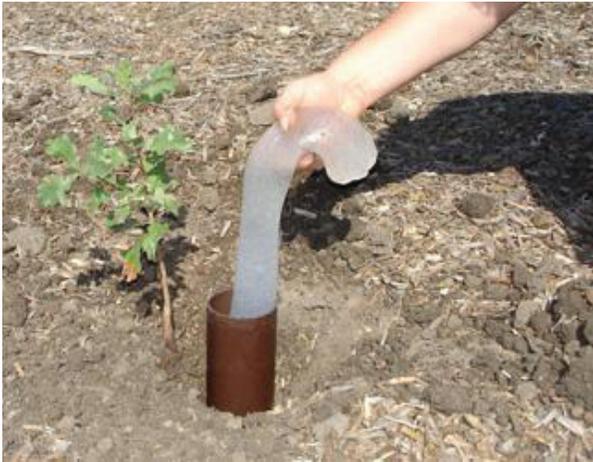
FIGURE 8. DRiWATER® gel is inserted into a biodegradable plastic tube or cardboard carton that is placed a few inches from a planted seedling, and is easily refillable. Photos are from the DRiWATER® website (<http://www.driwater.com/>).

“DRiWATER® is made from 98% potable water and 2% food grade ingredients. These ingredients bind the water into a solid gel. When the gel comes in contact with naturally occurring enzymes in soil, the enzymes slowly break down the gel, releasing moisture into the soil delivering moisture to plants between 40 and 90 days. DRiWATER® is not an absorbent polymer or a wetting agent – DRiWATER® is natural and environmentally safe.”

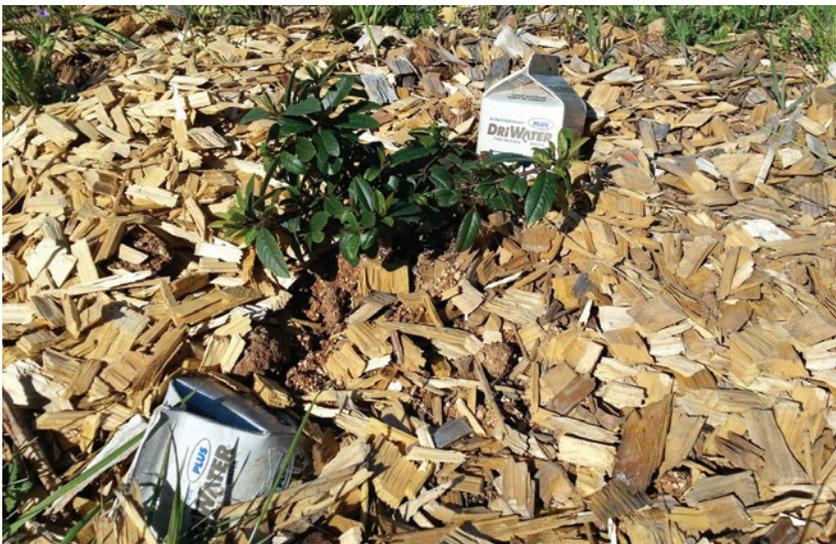
FIGURE 9. Cartons of DRiWATER® gel on each side of a coffeeberry seedling.

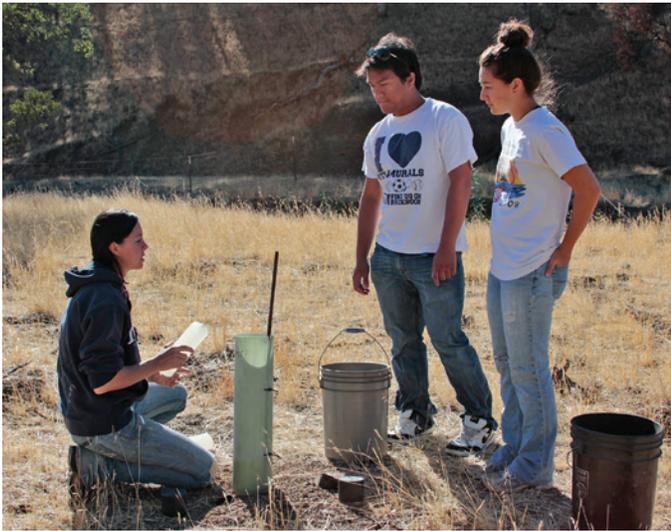
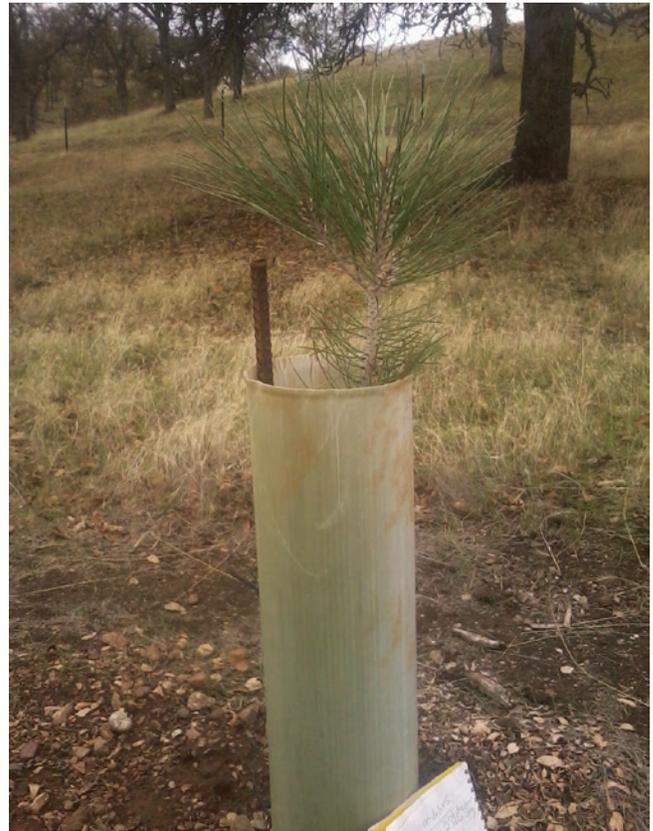
FIGURE 10. Foothill pine in a TubeX tube tree shelter.

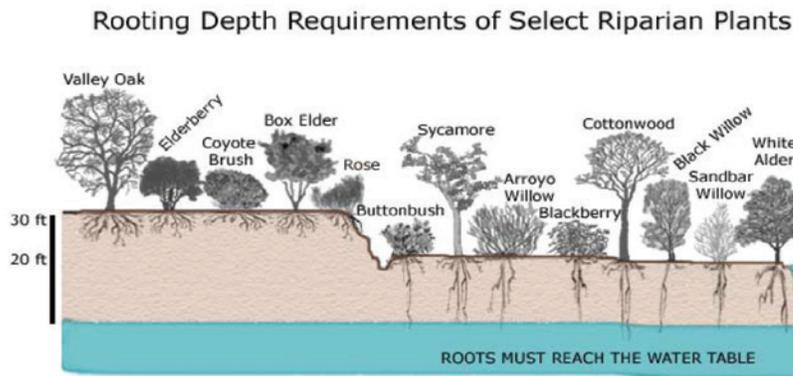
FIGURE 11. Rooting depths of selected riparian plants, according to the depth of the water table. Knowing the depth of the water table across the restoration site will help decide on the spatial distribution of species that will establish well and persist over the long-term. Excerpted from Griggs (2009).

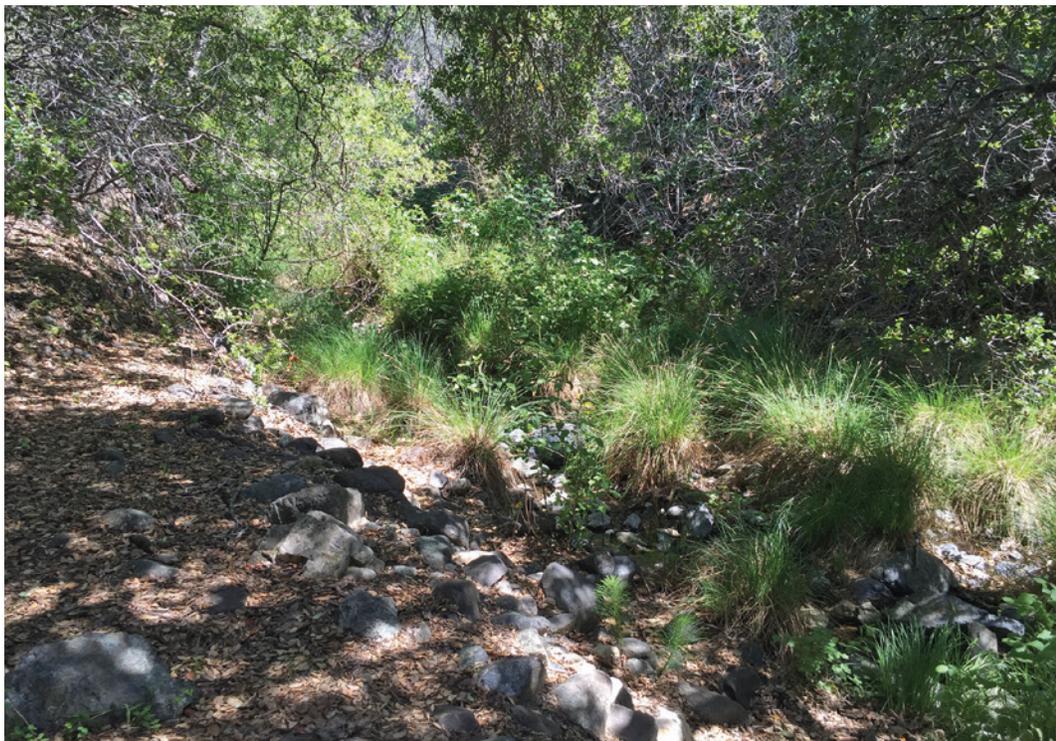
FIGURE 12. Several layers of riparian vegetation occur along rangeland streams that are less disturbed. Almost all the species are perennials, and both deciduous and evergreen woody trees and shrubs are present.

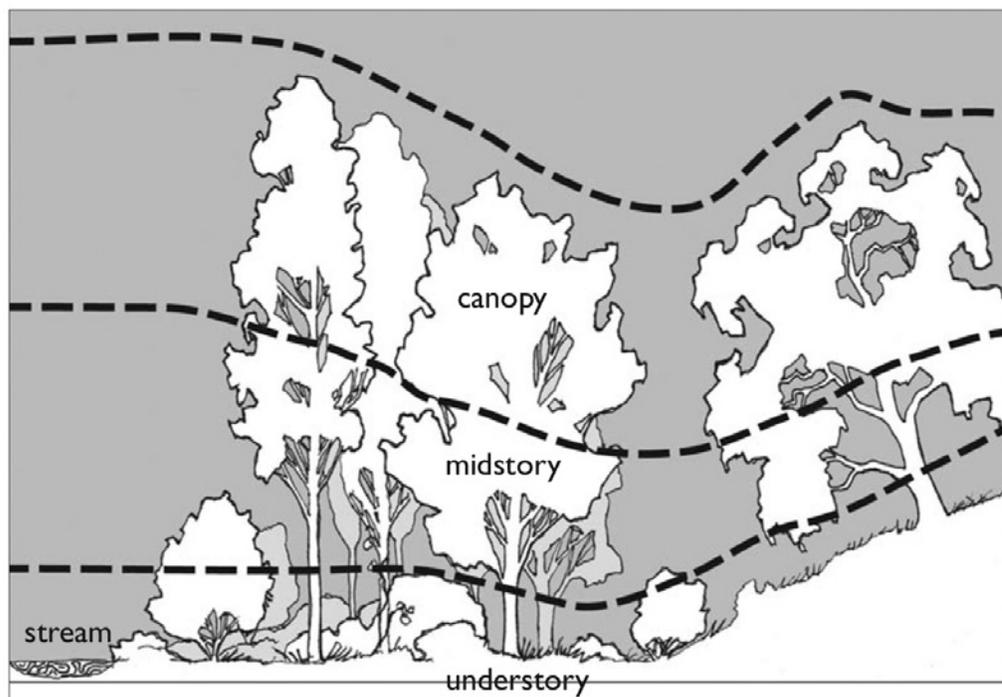
FIGURE 13. Schematic diagram of different zones along an upland rangeland riparian creek. Excerpted from CalPIF (2008).

A practical set of recommendations for upland rangeland riparian corridors is to plant rushes, grasses, and sedges in the low-flow channel streambank zone (Figure 13); shrubs tolerant of inundation (e.g., willows) in the lower floodplain zone; and a mixture of grasses, shrubs, and trees in the upper floodplain zone (Howard and Robins 2002). The choice of species also depends on the existing vegetation, due to habitat preferences of different shrubs and trees. For example, in the study at Audubon Bobcat Ranch (Section 4.1 and Table 3), the establishment of buckbrush (*Ceanothus cuneatus*) was negatively affected by proximity to native perennial grasses (Hodson et al., Part II of this booklet). Foothill pine (*Pinus sabiniana*) grew better under a shaded tree canopy. Examining the details of different species' preferences and attributes can help with designating planting spots in sites where perennials are already prevalent.

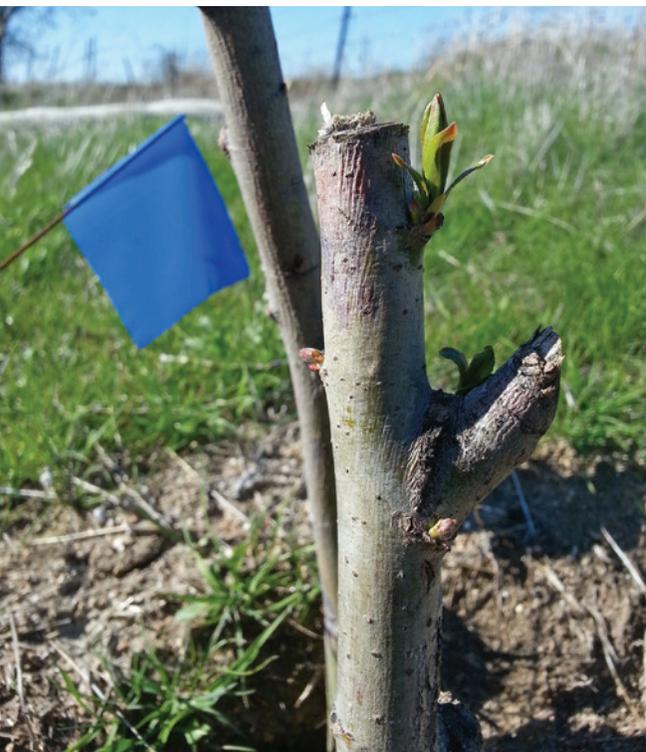
FIGURE 14. a) Willow stake beginning to leaf out along the stem nodes.

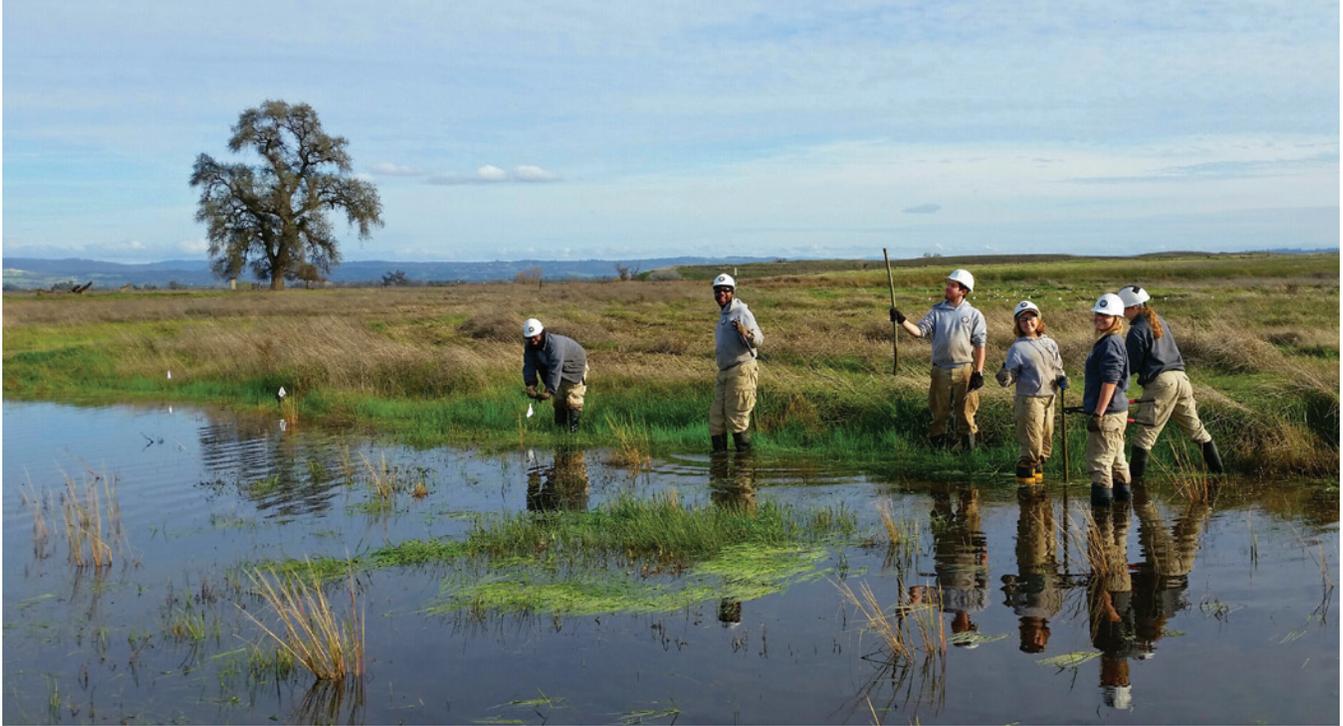
FIGURE 14. b) Work crew planting the stakes along a creek in Placer County.

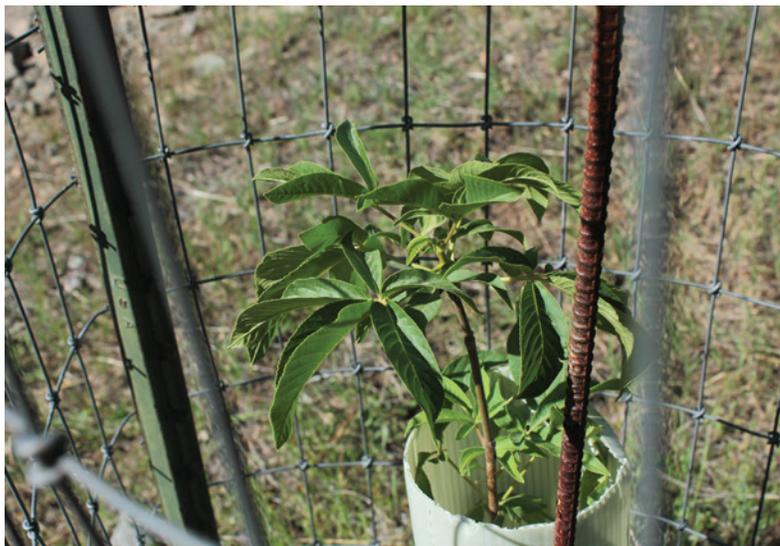
FIGURE 15. TubeX treeshelter around a buckeye (*Aesculus californica*) secured by heavy posts and surrounded by a cage.

To protect plants from herbivore browsing, fencing or cages are essential. One opinion is that 4- to 5-foot tall wire fencing is most effective (Howard and Robins 2002). By making a circular enclosure at least 3-foot in diameter around individual plants, and staking it down with rebar or stakes, the plant has space to grow out of the reach of browsing animals. If, instead, the entire area is fenced to prevent livestock trampling, erosion, and deposits of fecal matter, restoration may be more successful. A potential tradeoff for the rancher, however, is that livestock access to water may be affected if large areas are fenced off (Kroeger et al. 2010). Placing rigid, translucent double-walled plastic tubes (commonly known as treeshelters, tree tubes, or Tuley or TubeX tubes) over individual seedlings protects them from a variety of animals, including deer and cattle (McCreary and Tecklin 2001; 2005). Accelerated shoot growth of the seedlings can occur in the treeshelters. Securing the shelters with heavy metal fence posts prevents damage from cattle rubbing against them (Figure 15), but cattle and deer still clip the shoots that extend over the tops of tree shelters, which slows growth. Cages around the tubes prevent grazing.

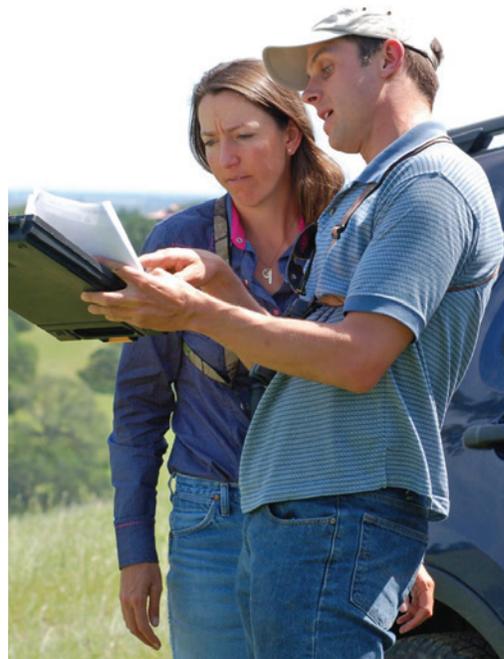
FIGURE 16. Assessing species composition at Audubon Bobcat Ranch (Courtesy of Phil Hogan).

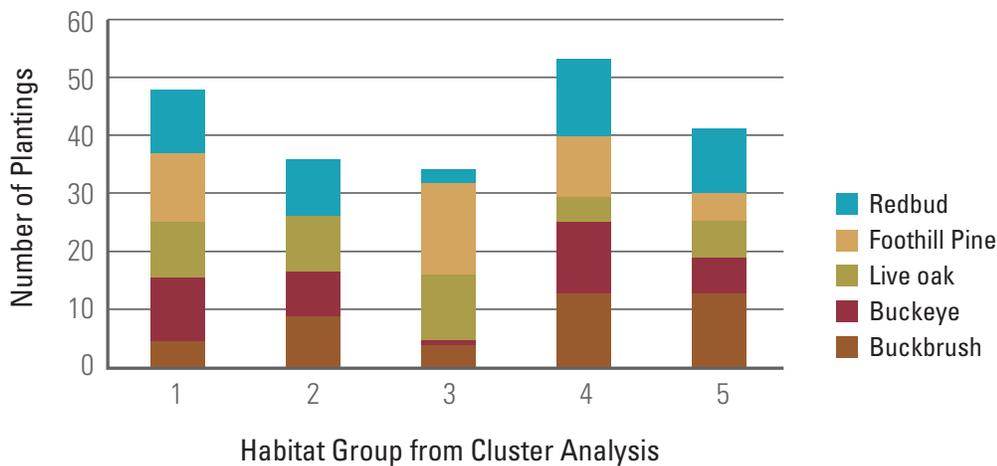
FIGURE 1. The number of restoration plantings in each habitat category identified by cluster analysis at the Audubon Bobcat Ranch in California. Colors correspond to the species composition of plantings assigned to each cluster using Ward’s hierarchical cluster analysis.

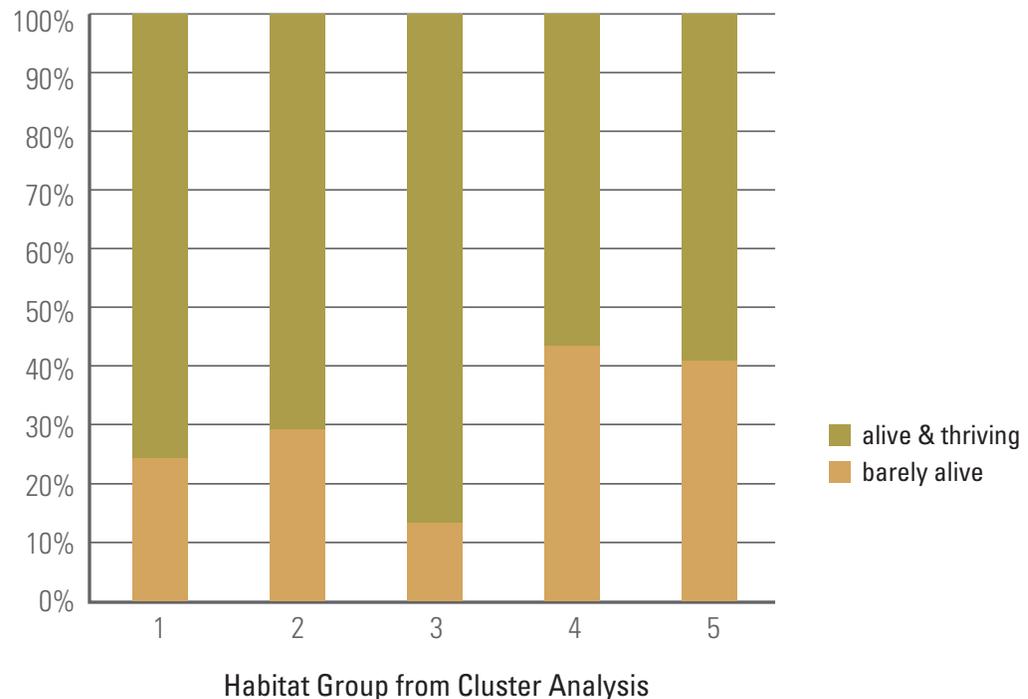
FIGURE 2. Distribution of plant health scores of restoration plantings between habitat group categories identified using Ward’s hierarchical cluster analysis at the Audubon Bobcat Ranch restoration site in California. Plantings were categorized as either ‘barely alive’, ‘alive’ or ‘thriving’. Here the number of ‘alive’ and ‘thriving’ plants have been summed.

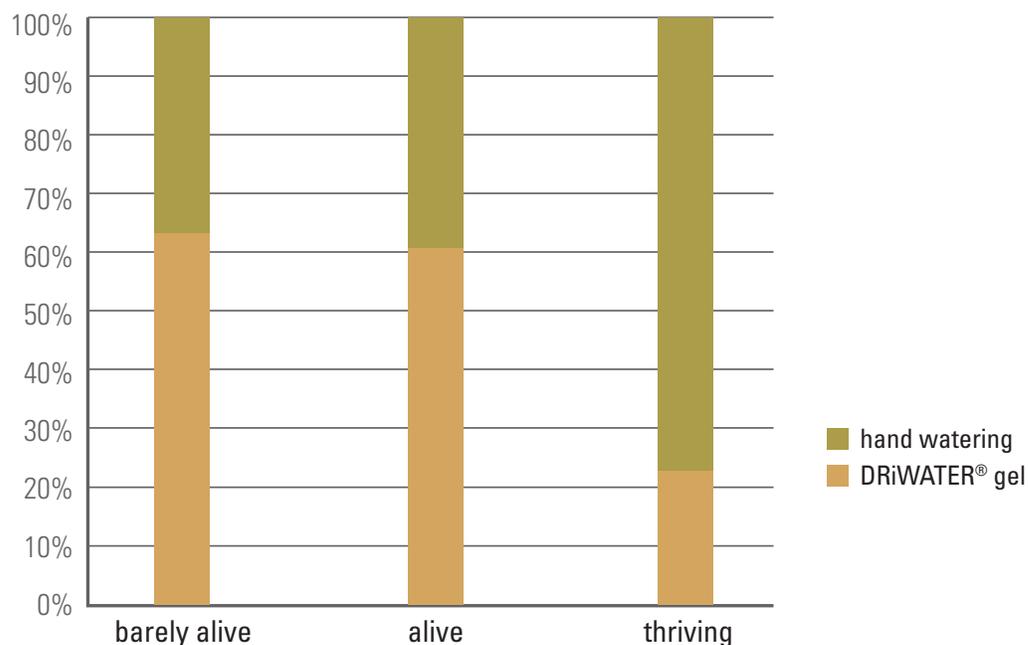
FIGURE 3. The distribution of plant health scores for buckbrush between two management options, DRiWATER® gel or hand watering once a month.

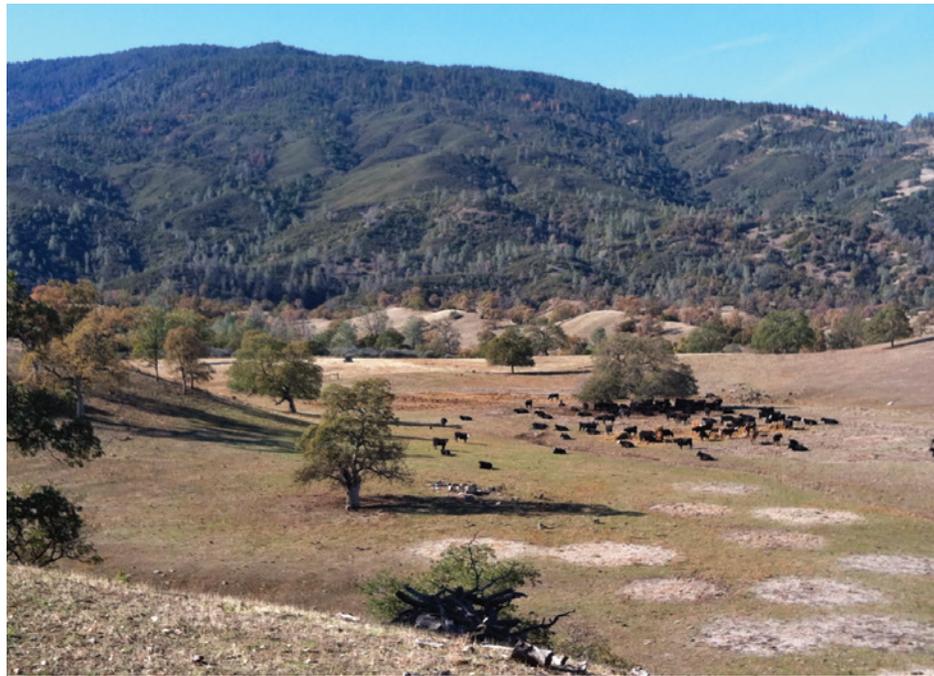
Cattle are concentrated in one small field (25 acres) during the fall, without access to the riparian corridor. They are given supplemental feed and water pumped into troughs.

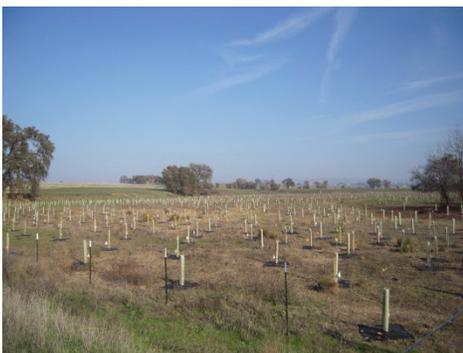
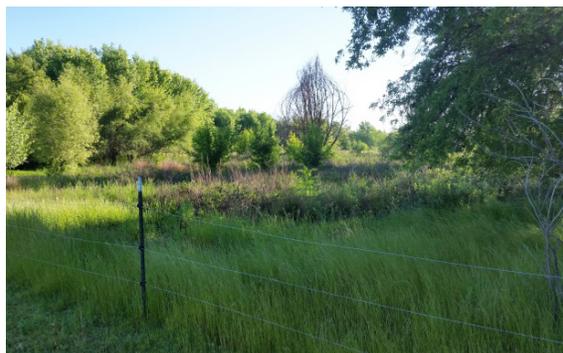
Riparian Floodplain Restoration on Doty Ravine Preserve (2008 California Regional Water Quality Control Board – Supplemental Environmental Project (SEP)). On the left is from the 2006-7 season showing dense thatch of medusahead. The right-hand photo from 2015 shows trees planted in 2008.

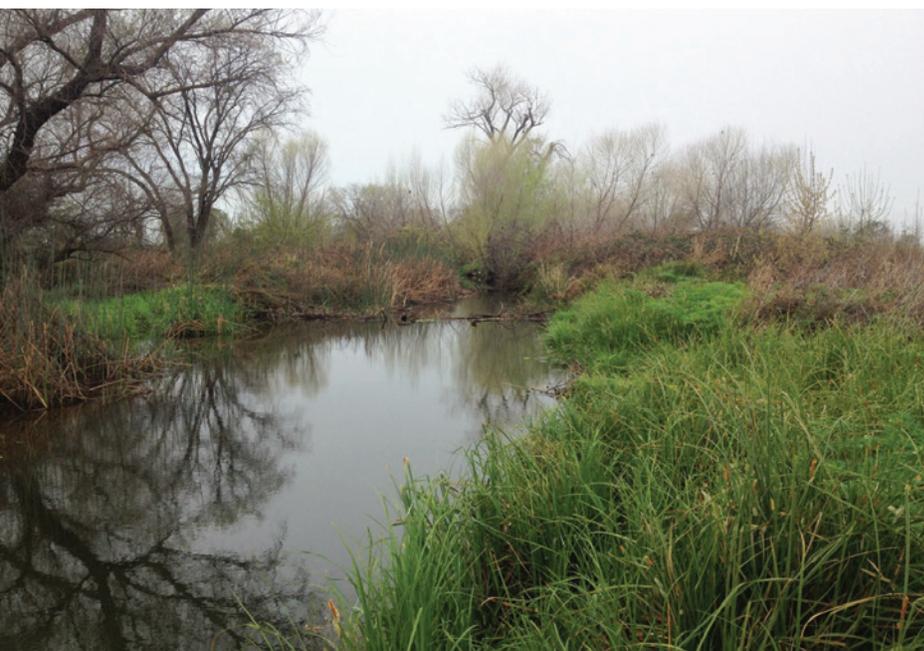
A planting of Santa Barbara sedge on the edge of Doty Ravine Creek (foreground) with Himalayan blackberry on the far edge of the creek. The native sedge prevents the non-native Himalayan blackberry from spreading.

The Santa Barbara sedge, also known as valley sedge or white root, is another species that has been useful for bank stabilization. It produces prolific rhizomes that anchor soil and also allow the plants to spread rapidly. Planting this sedge on the edge of the Doty Ravine creek has deterred invasive plants such as poison hemlock. It has been planted to replace Himalayan blackberry, which initially dominated much of the bank, and once established, keeps out the blackberry.

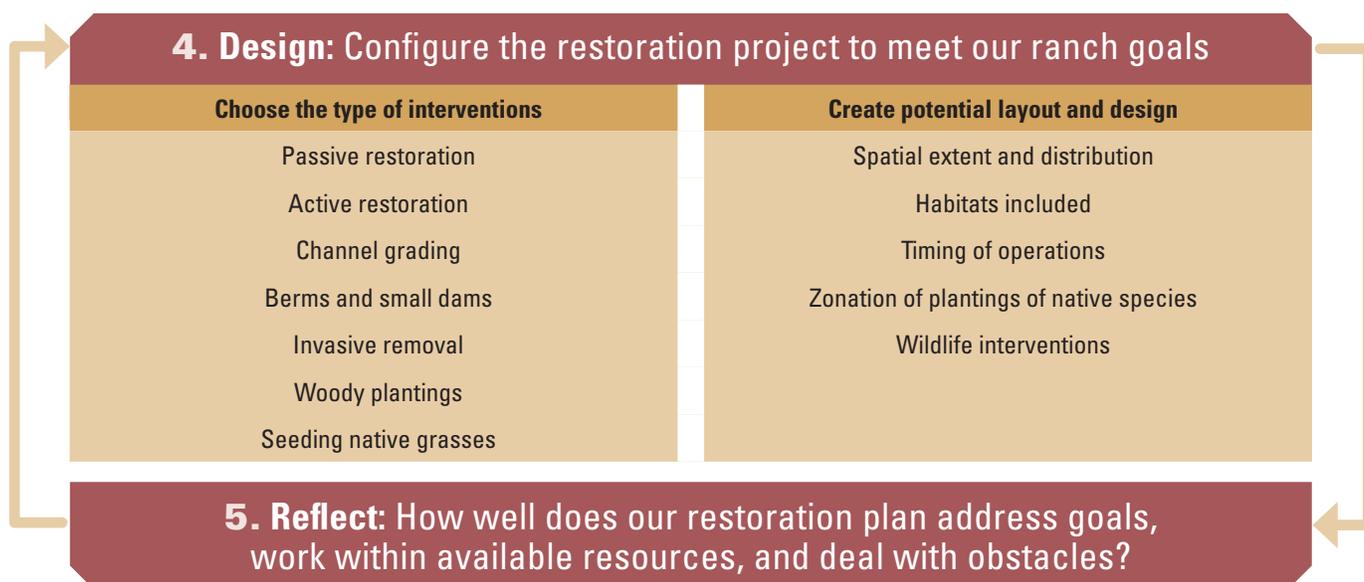
FIGURE 1. Diagram for the riparian habitat planning worksheet for California rangelands, showing an Objectives Phase and a Design Phase. The idea is for you to work through the five steps sequentially; each is numbered on the diagram. The arrows follow the conceptual pathway. For example, Step 1 on goal setting is revisited after re-evaluating the available resources (Step 3). The Design Phase begins after Step 1 (goals) and Step 2 (resources) have been re-clarified. The actual design (Step 4) consists of choosing the types of interventions and practices, then creating a potential layout and site design. Step 5 has you reflect on goals, resources, and obstacles, in order to continue refining the actual design (Step 4) before it is implemented.
