# Fungal Damage in Buildings with Emphasis on *Meruliporia* 'poria' *incrassata*

prepared by

Stephen L. Quarles, Ph.D.

University of California Cooperative Extension Advisor Emeritus

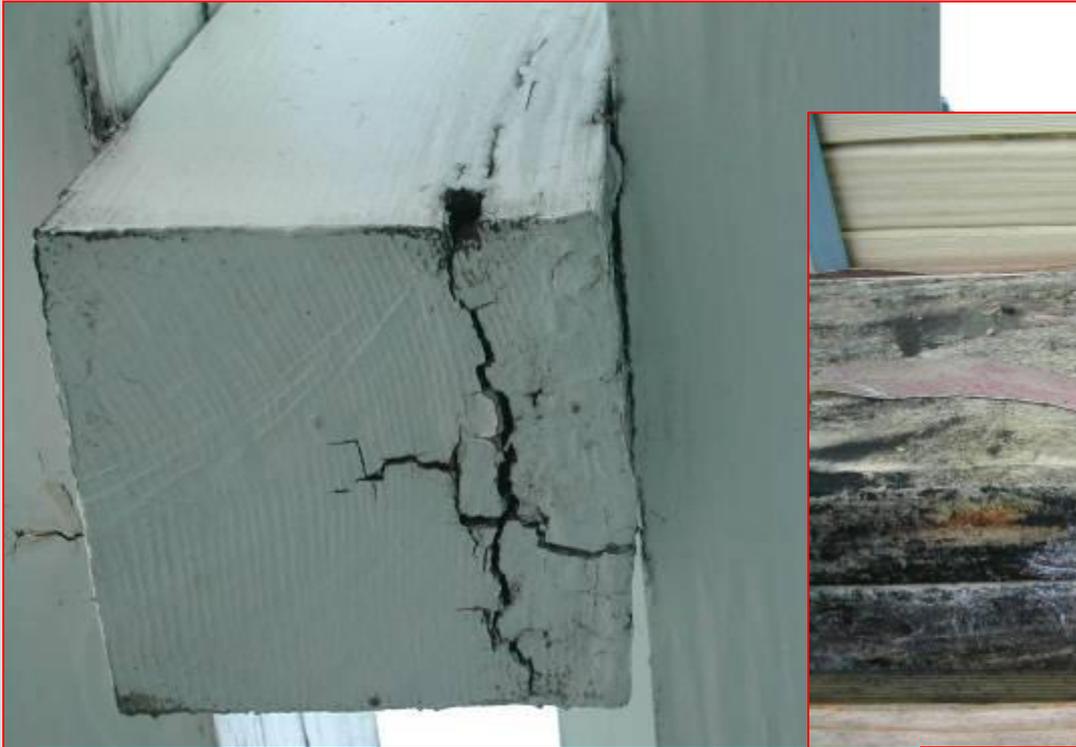
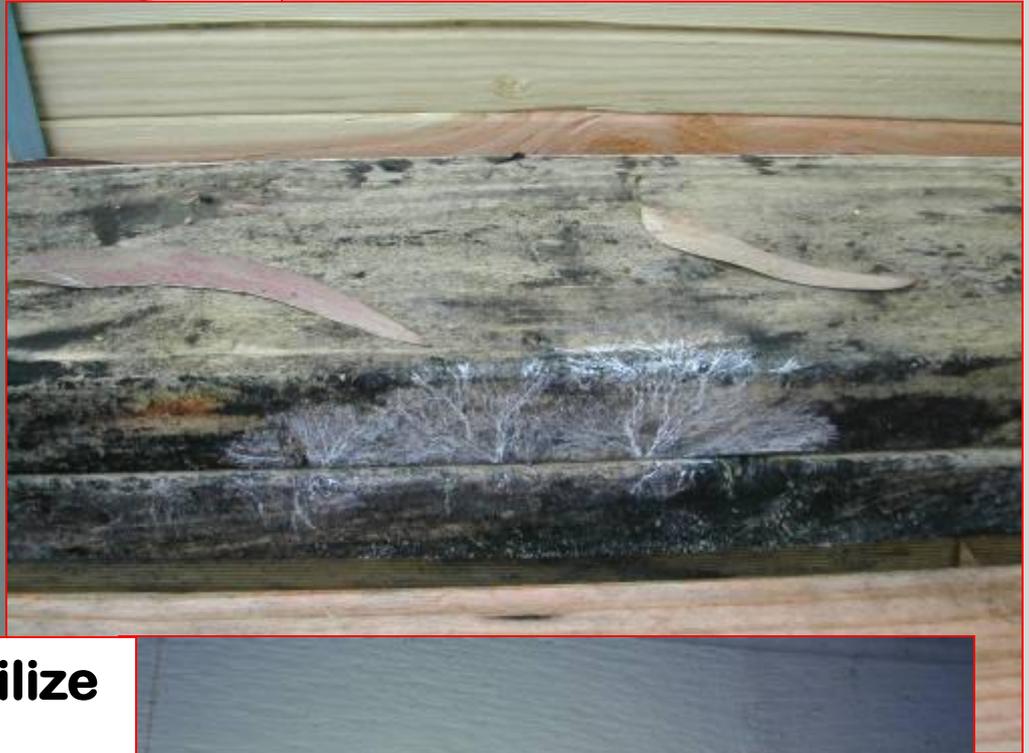
**Many species of fungi can utilize one or more components of wood and wood-based products for food. Some fungi can structurally degrade wood, and some cannot, depending on the chemical constituents of wood that they can utilize for food.**

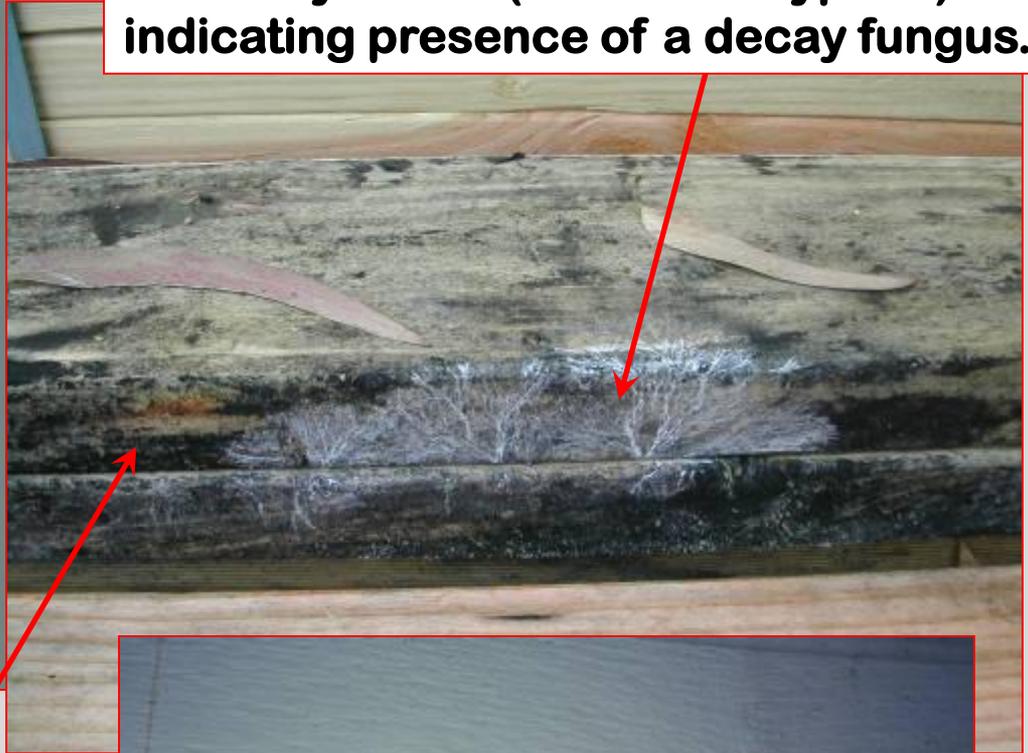
**Dark growth, spore producing  
portion of a sapstain (bluestain)  
fungus. This fungus doesn't  
structurally degrade wood – it  
uses sugars found in storage cells  
found in the sapwood (the wood  
located near the bark).**

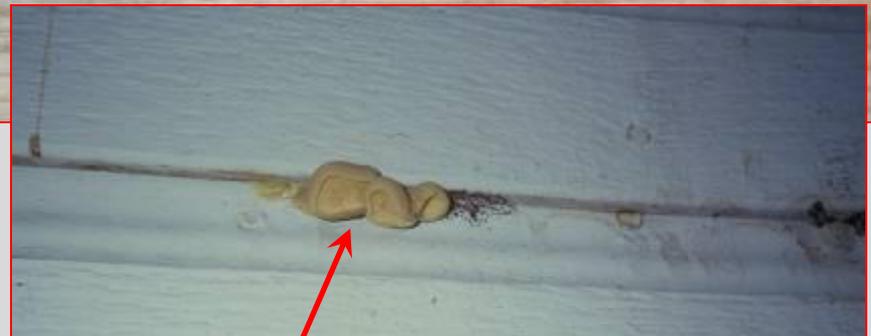
**Spore-producing fruiting body from  
a decay fungus, emerging from  
behind this wood-composite siding  
product.**

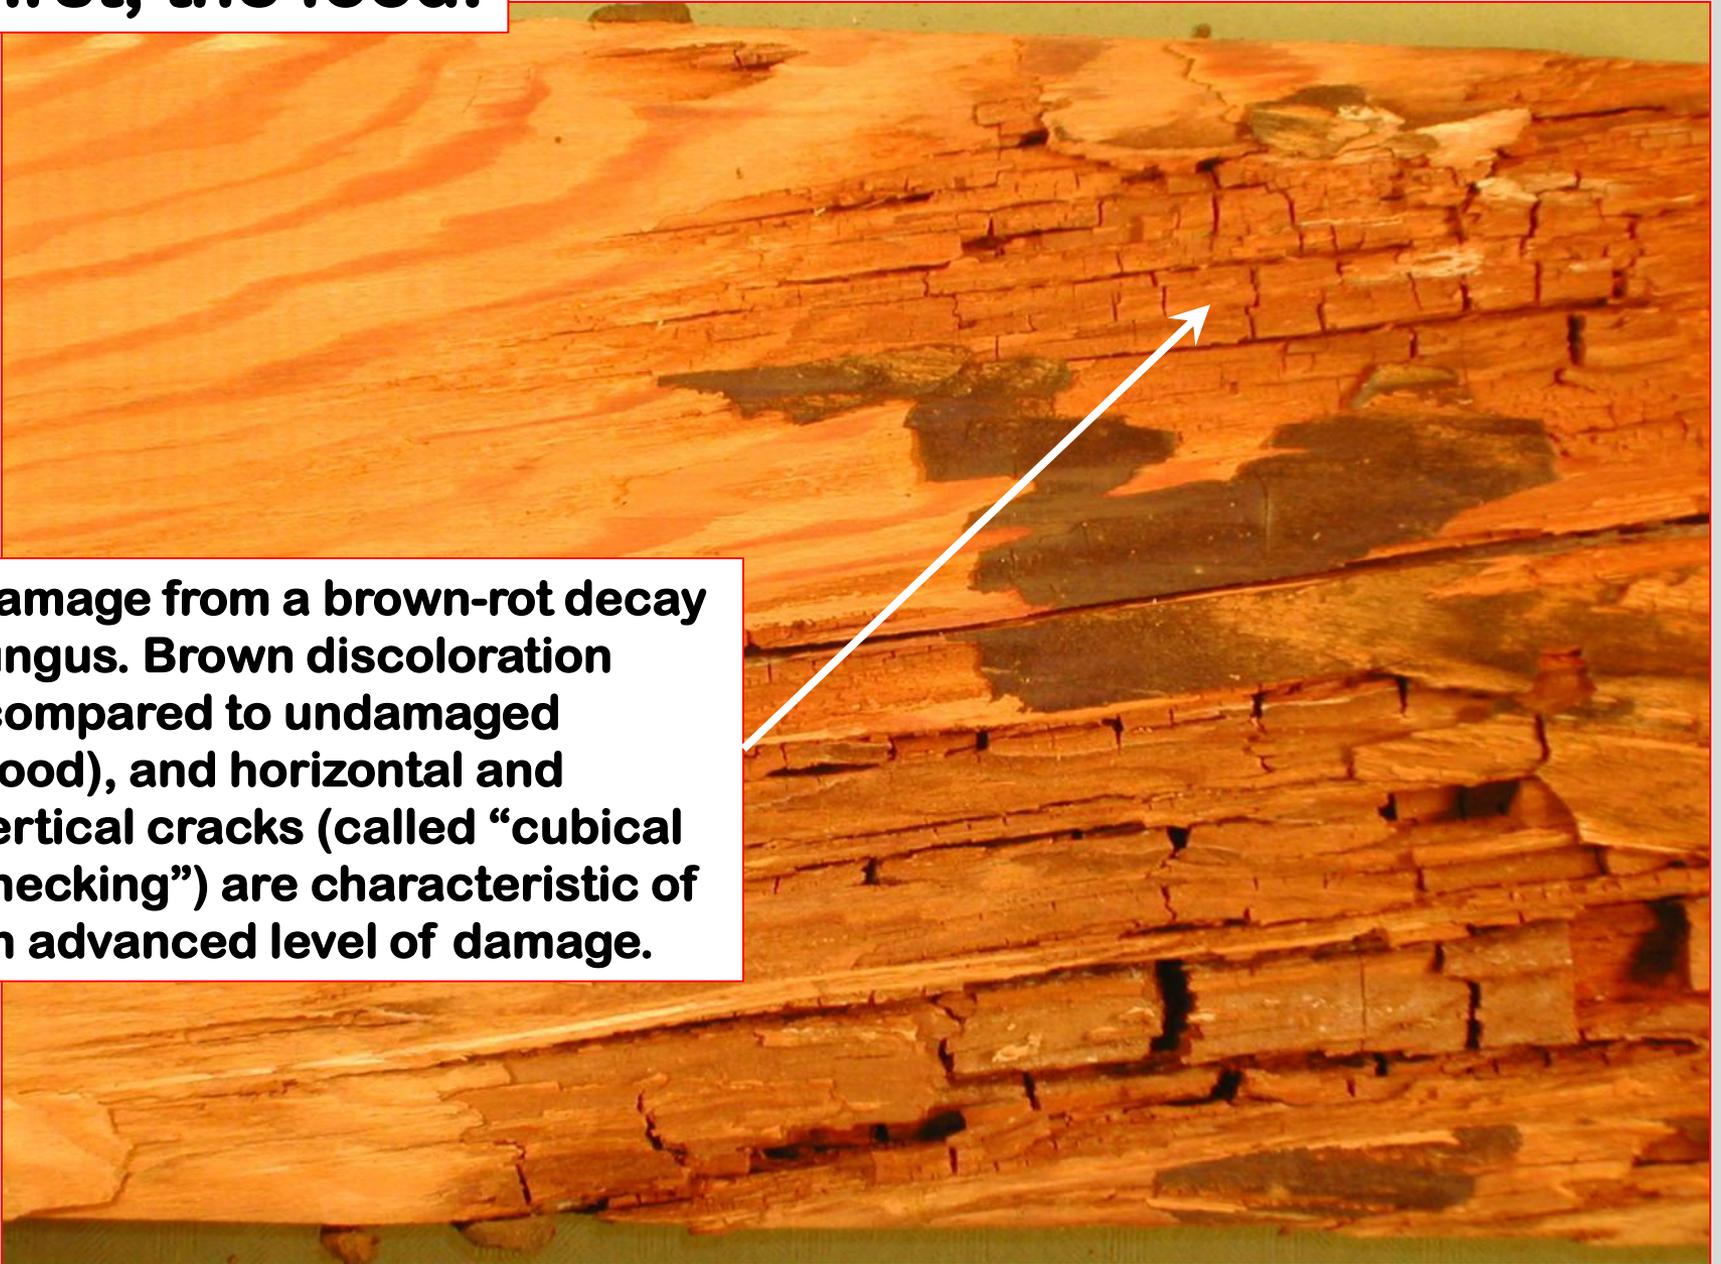
**Damage from a brown-rot decay fungus. Brown discoloration (compared to undamaged wood), and horizontal and vertical cracks (called “cubical checking”) are characteristic of an advanced level of damage.**

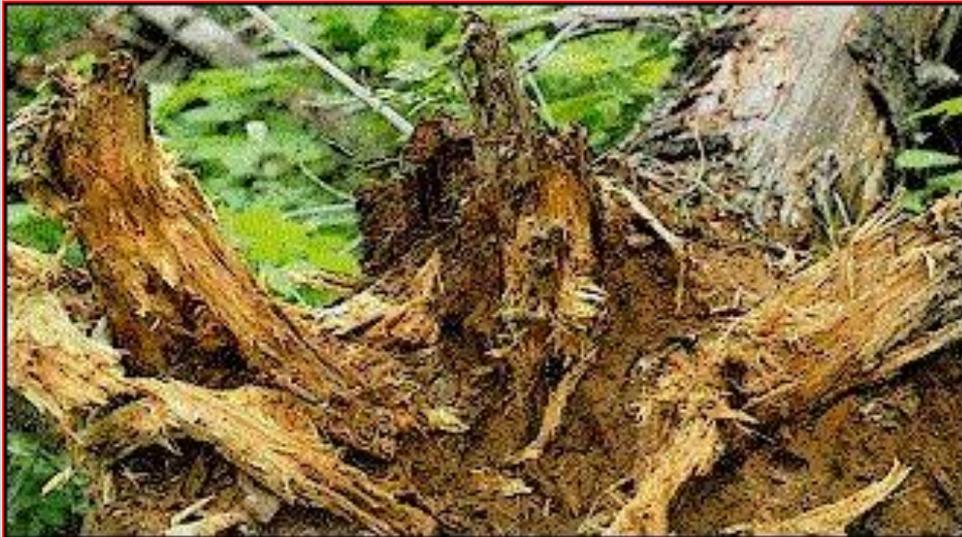
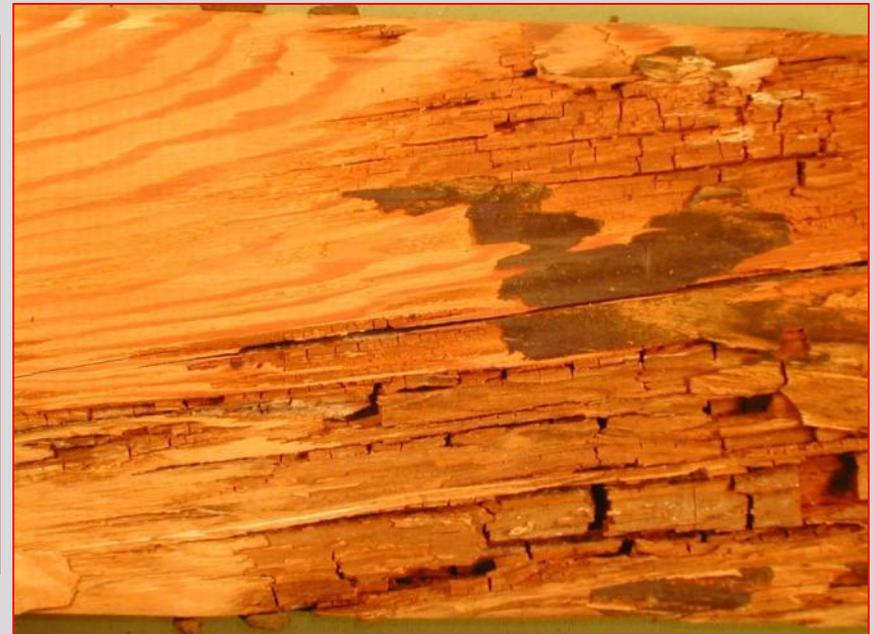
**The natural color of lignin is brown. Because brown rot decay fungi cannot fully utilize lignin, the wood attacked by brown rot fungi is brown in color because of the remaining lignin residue. White rot decay fungi can fully utilize lignin (and the cellulose and hemicellulose polymers), and therefore wood attacked by these fungi is white in color.**

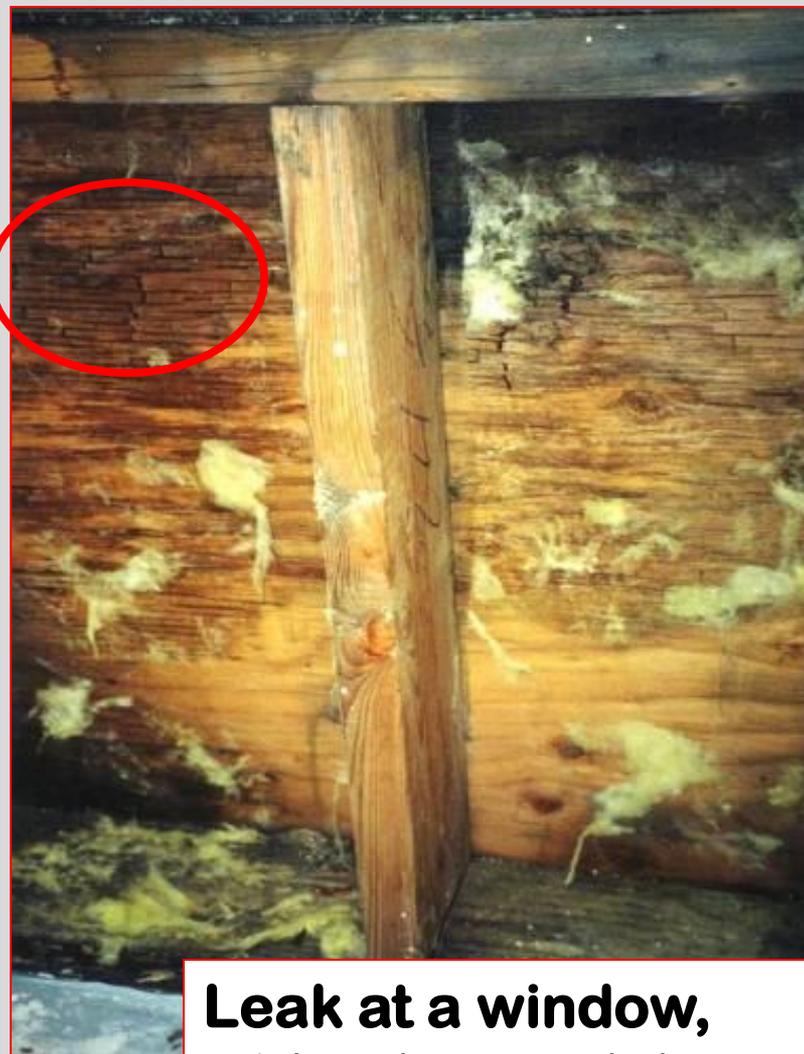
**Leak at a window, with advanced decay in plywood sheathing.**

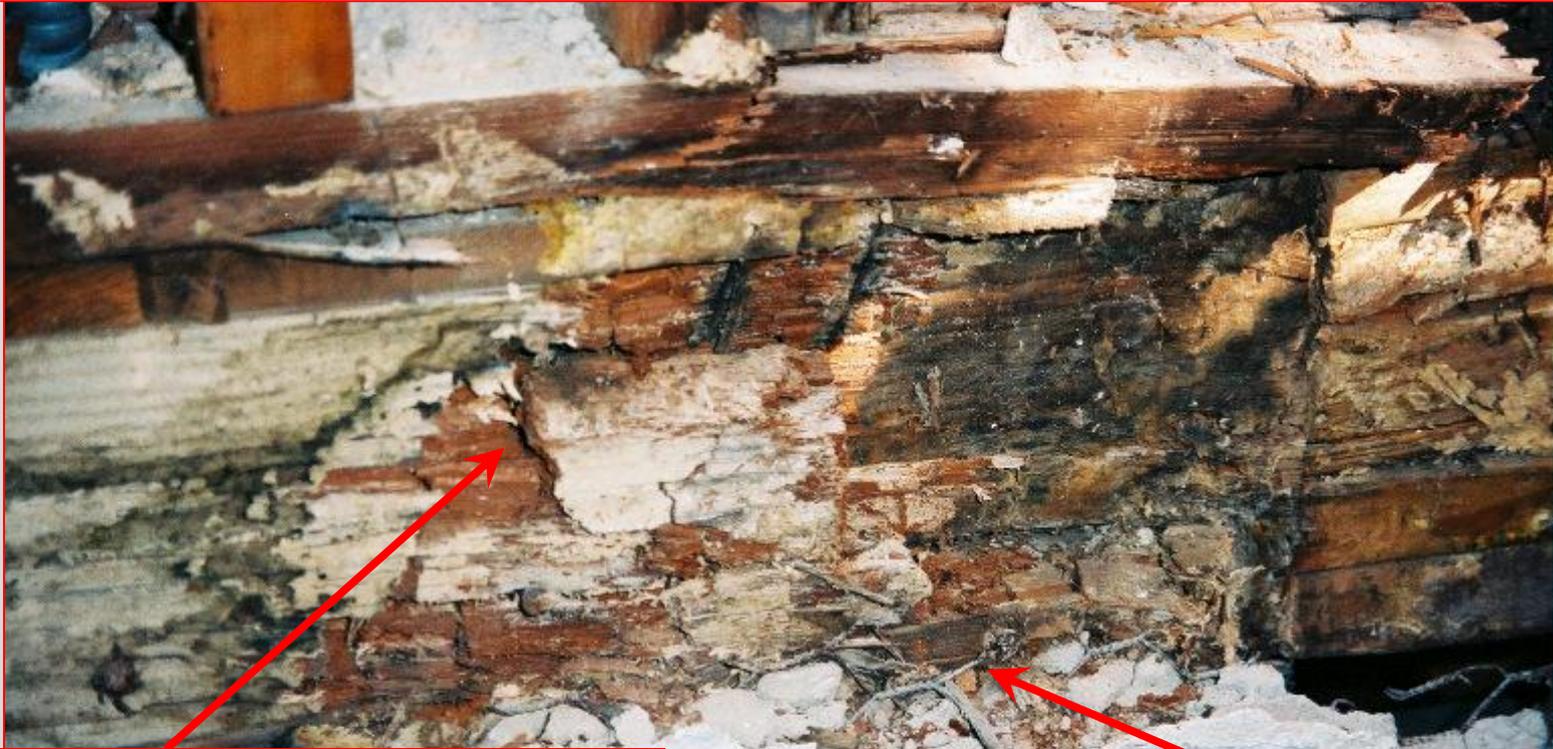
**Brown-rotted wood...**

**Rhizomorph**

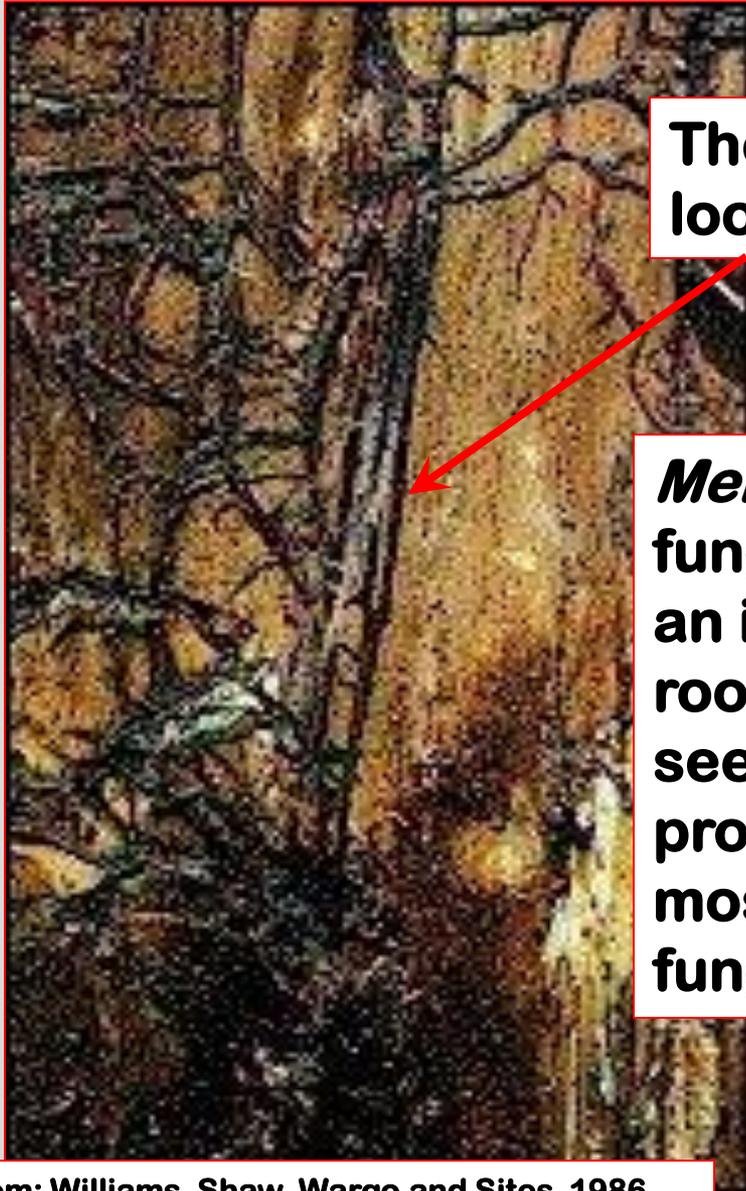
**The rhizomorph of decay fungi can look like this.**

***Meruliporia* is a common decay fungus found in forest soils and plays an important role in decomposing roots and other woody debris. As seen here, it isn't the only fungus that produces a rhizomorph, but is the most common "water-conducting" fungus found in buildings.**

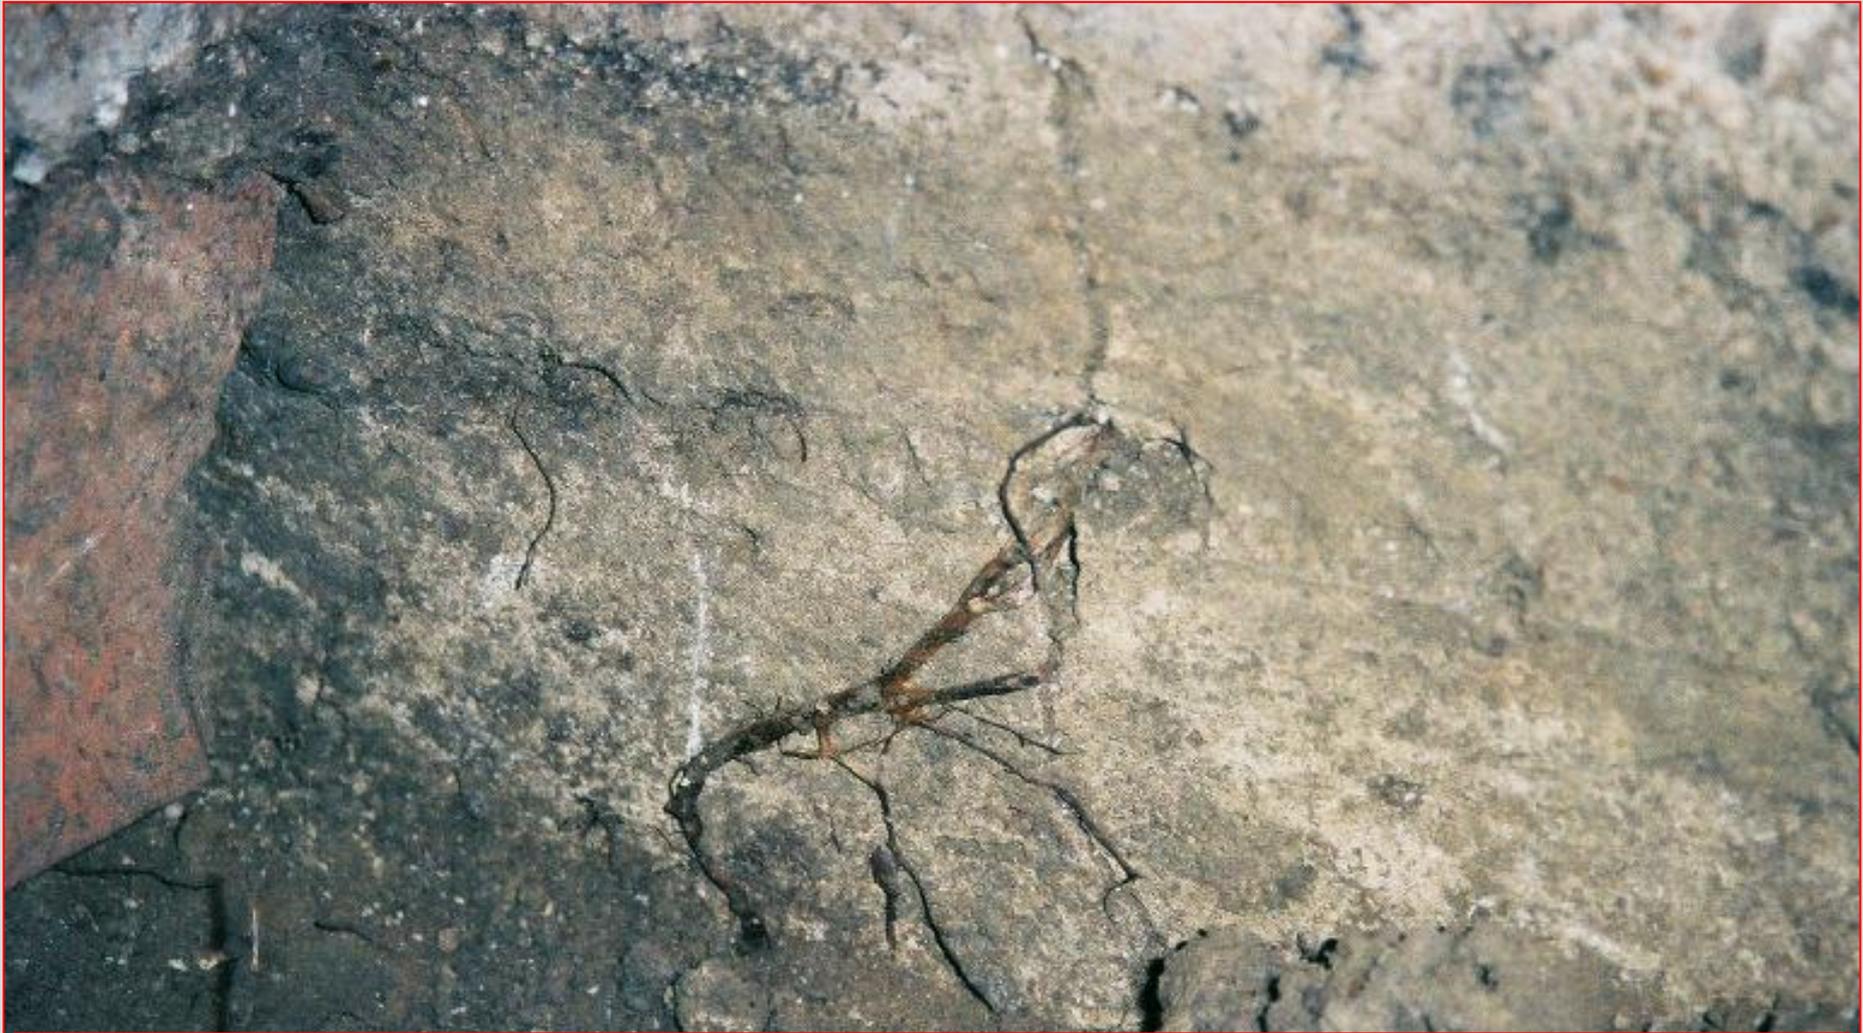
**Rhizomorphs, moving through a crack in the external foundation wall. They look like roots, but without bark. If you break them open, they will have a mushroom odor.**

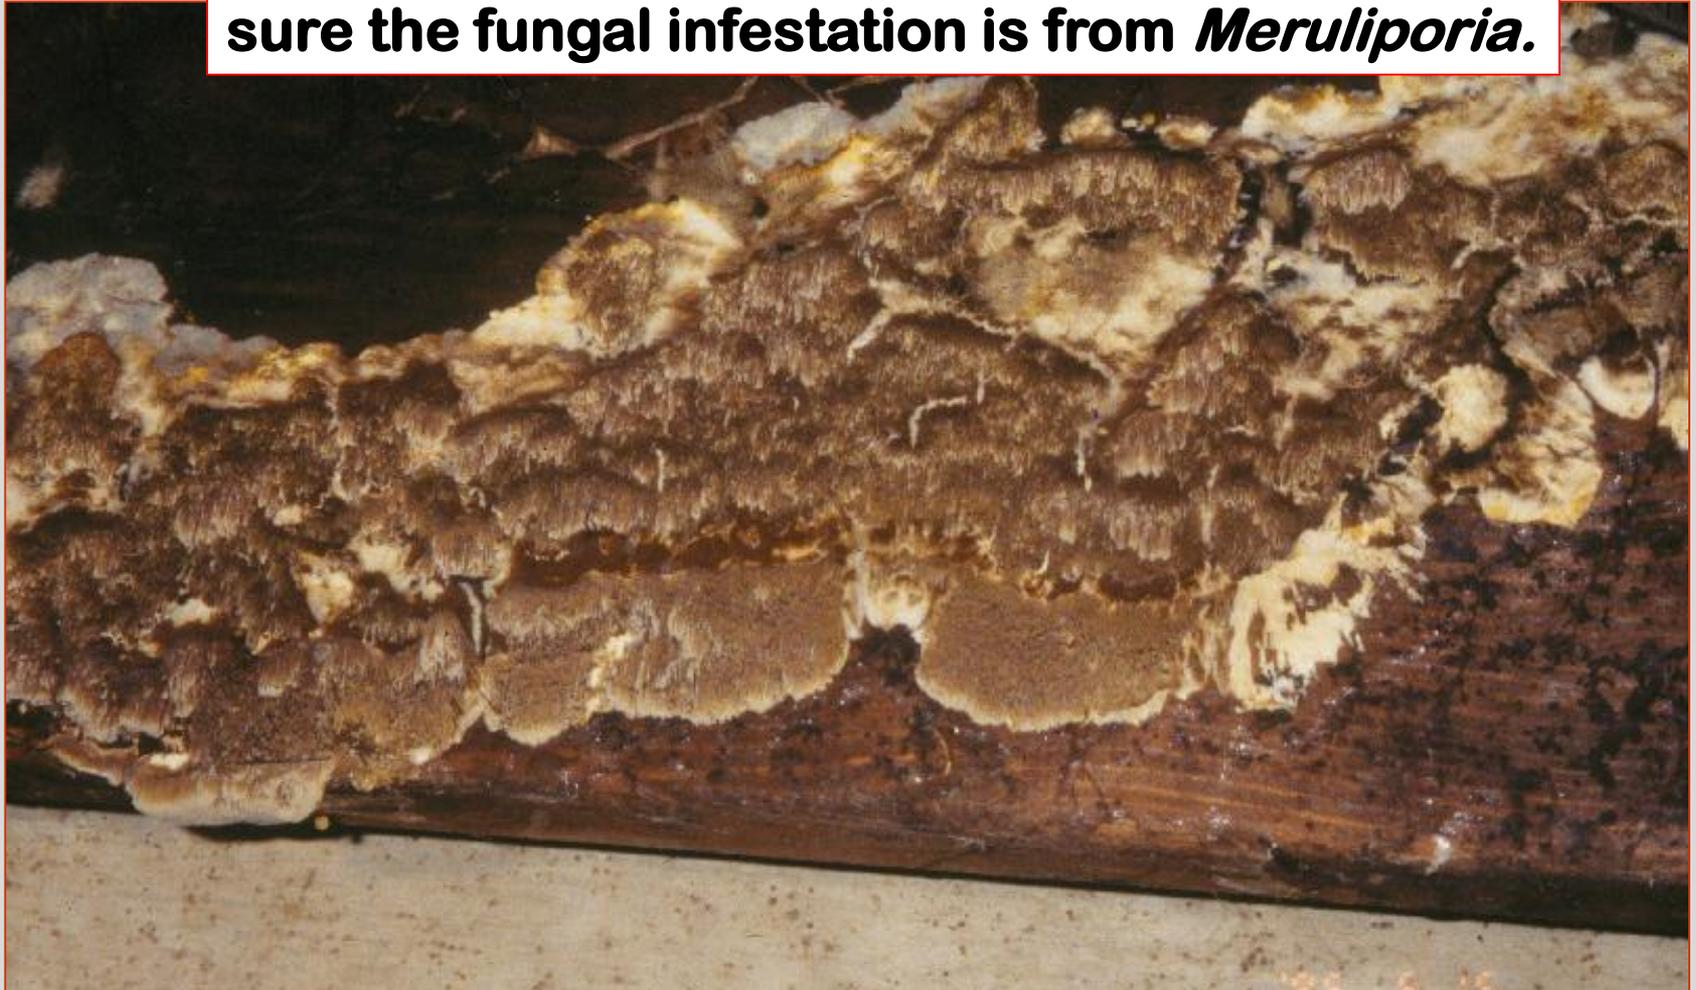
**Mature fruiting (spore producing) body of *Meruliporia*. The mature fruiting body produces a lot of brown colored spores. When touched, it feels a little like cream cheese.**

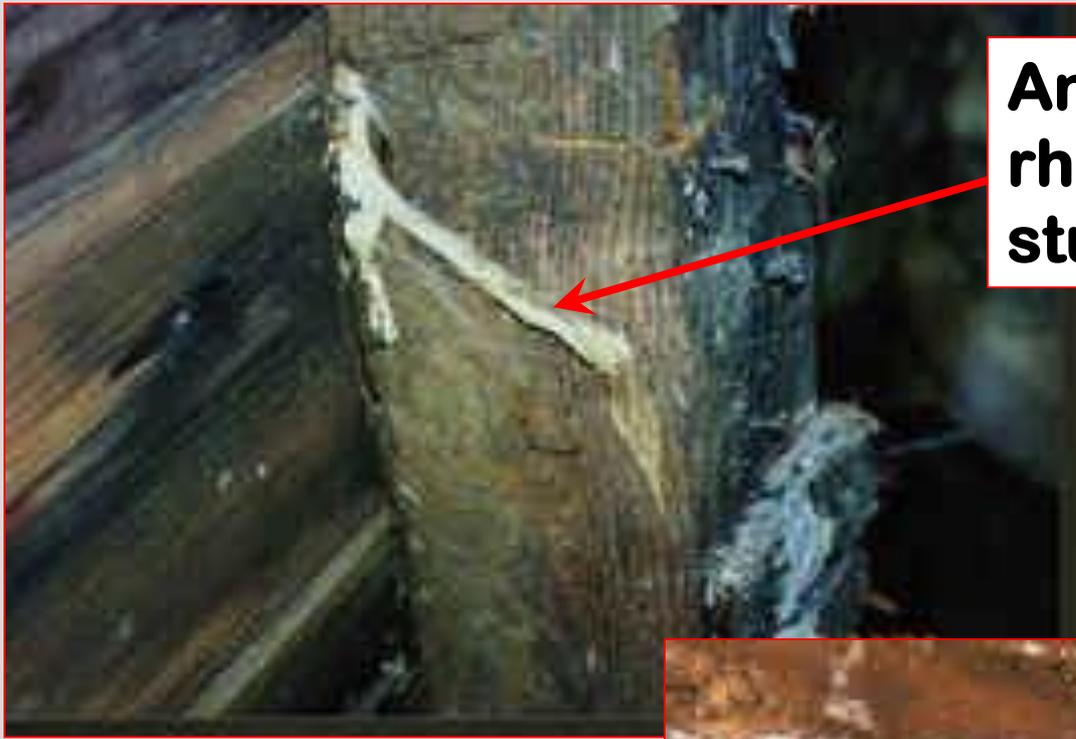
**Another view of a rhizomorph in a stud cavity.**

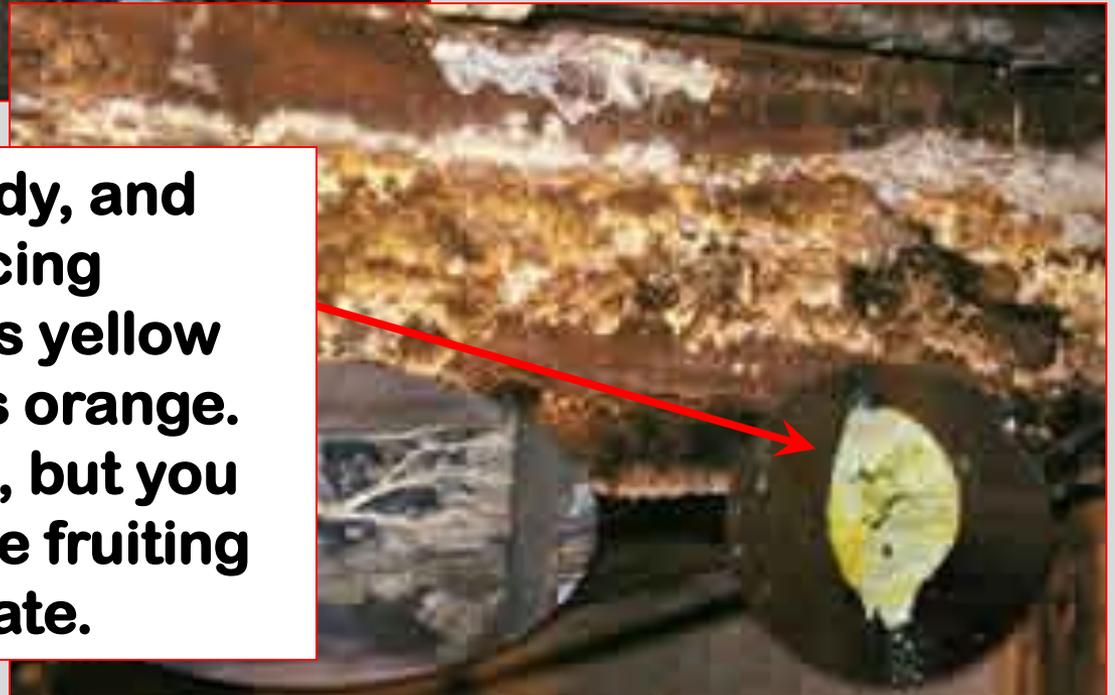
**An immature fruiting body, and therefore not yet producing spores. Although it looks yellow here, it more often looks orange. This is a good id feature, but you aren't as likely to see the fruiting body in the immature state.**

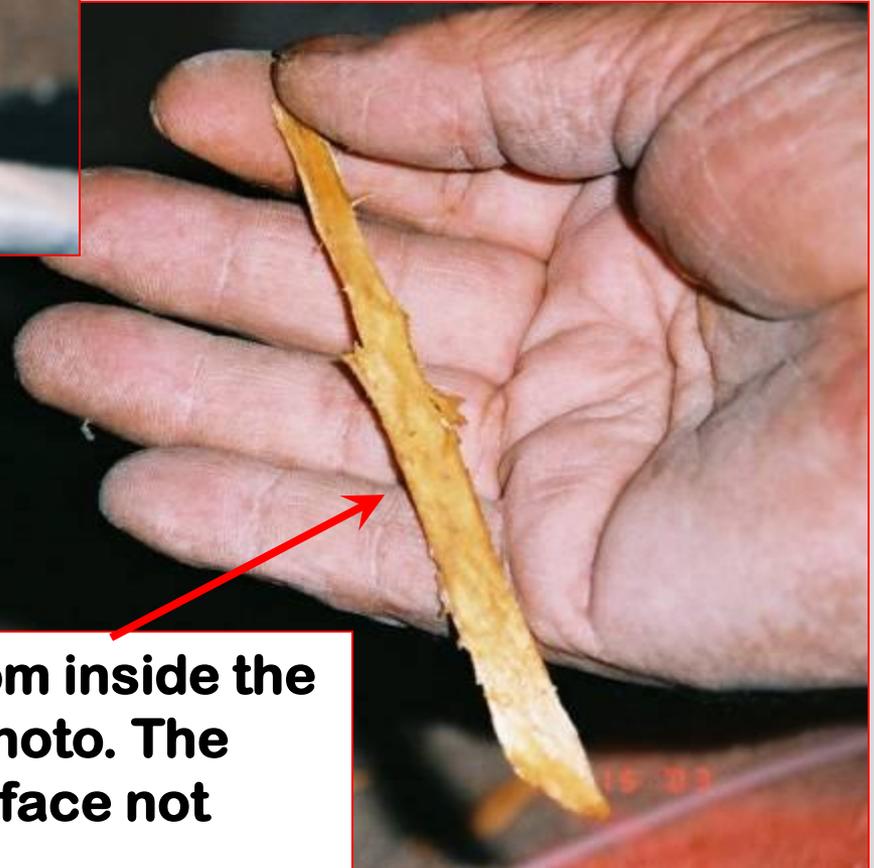
A fresh rhizomorph, taken from inside the girder shown in the top left photo. The girder was opened up on the face not visible in the above photo.

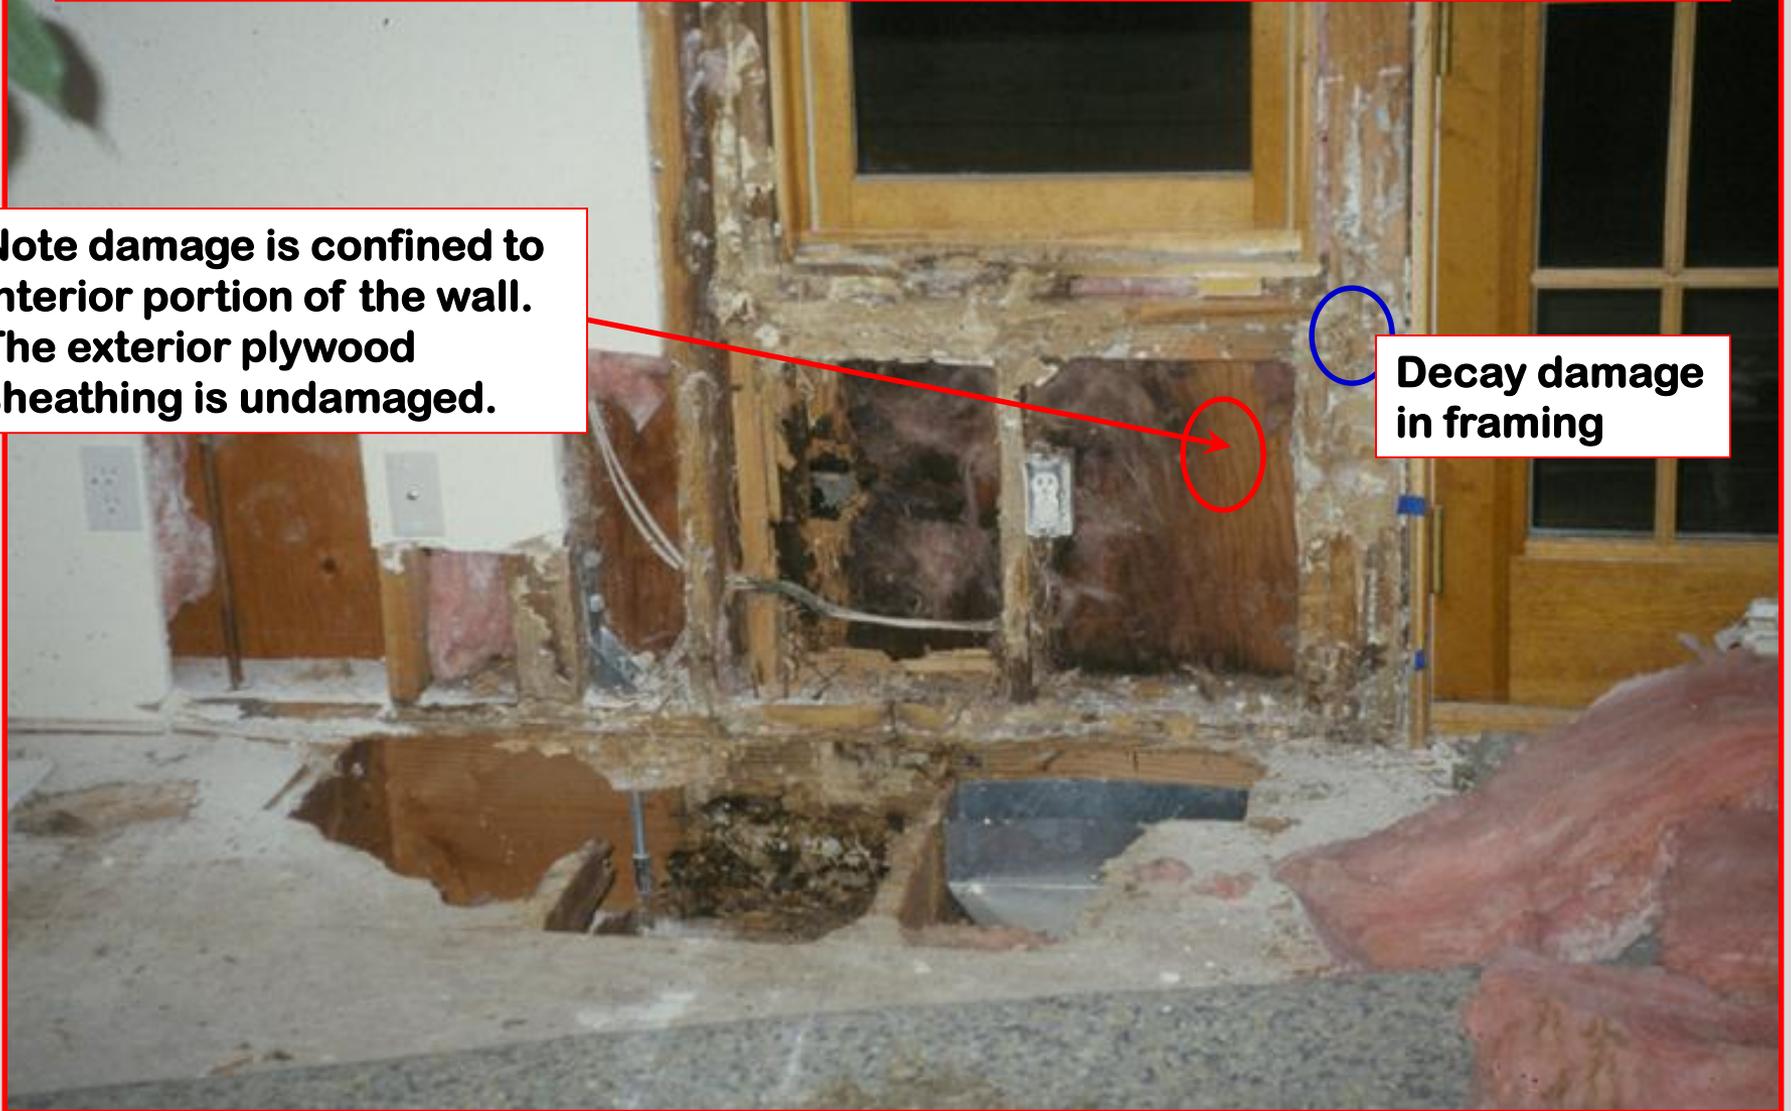
**Is this damage from *Meruliporia*, or a 'normal' decay fungus that is relying on a leak at the window?**

**Note damage is confined to interior portion of the wall. The exterior plywood sheathing is undamaged.**

**Decay damage in framing**

**Yes, the damage is  
from *Meruliporia***

**If you assumed the source of water  
was from a window leak, and either  
replaced the window, or tried to  
repair the window flashing, your  
efforts would not solve the problem.**

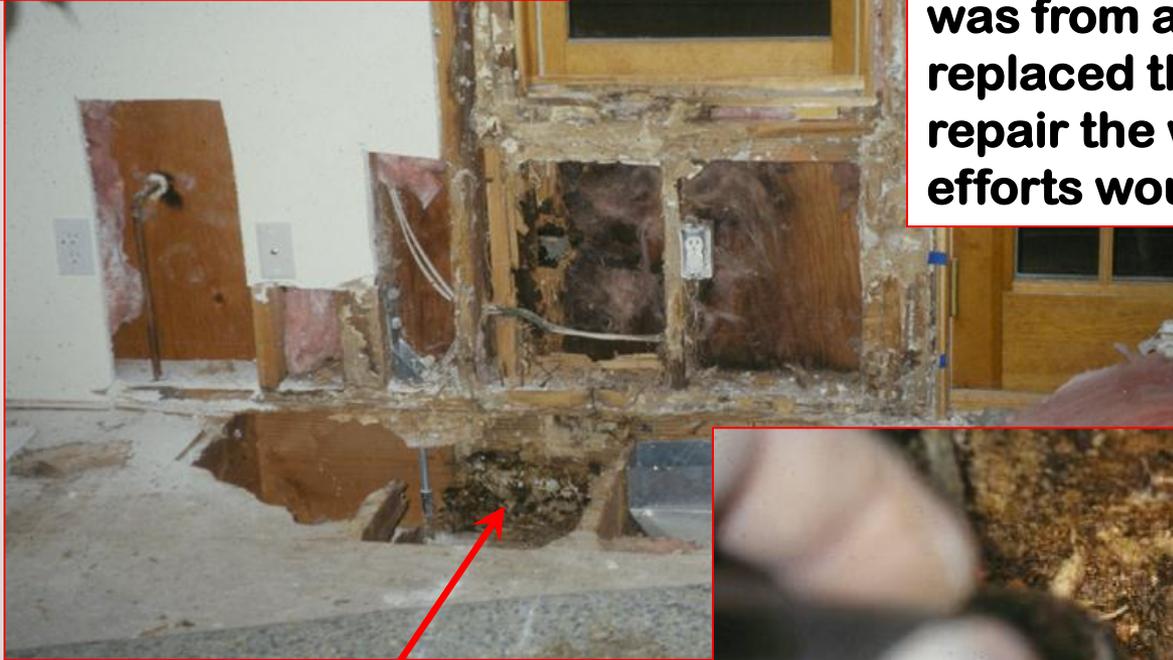
**rhizomorph**

Yes, it is damage from *Meruliporia*

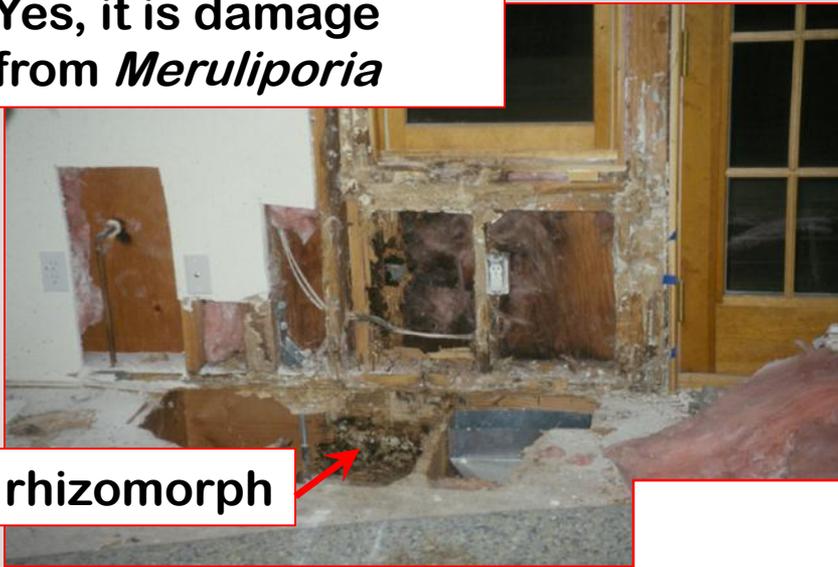
rhizomorph

At this house the outside grade was the same level as the inside floor framing. The rhizomorph grew through the gravel bed that was underneath the exterior concrete slab patio, and was able to enter and infest the 'between joist' blocking .

concrete slab

gravel bed

soil

Floor joist and blocking above a partially complete full-height crawl space.

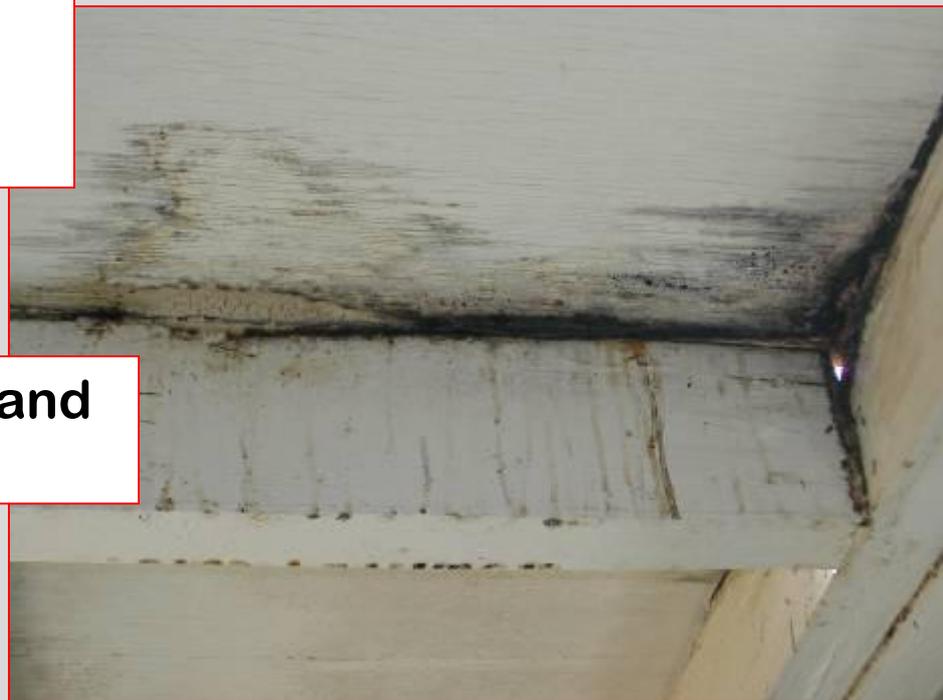
**What would be an appropriate repair for the decay damage observed in the roof support system on this leaking roof?**

**Answer: Fix the roof leak and replace damaged wood.**

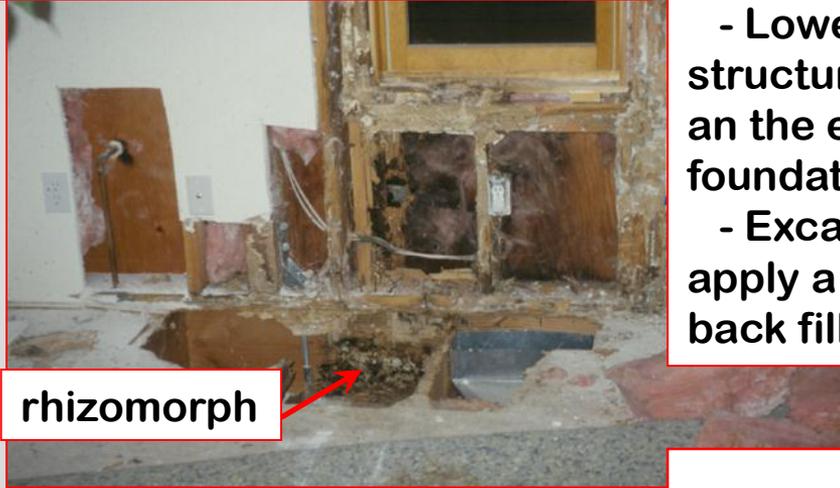
rhizomorph

solid membrane

concrete slab

gravel bed

soil

Floor joist and blocking above a partially complete full-height crawl space.

- Lowering the exterior grade, all around the structure. This would force a rhizomorph to move over an the exposed concrete on the exterior of the foundation. This is an expensive repair.
- Excavate around the perimeter foundation and apply a solid membrane (torch applied), and then back fill. Reasonable expense.
