Attic and Crawlspace Ventilation: Implications for Homes Located in the Urban-Wildland Interface

Stephen L. Quarles and Anton TenWolde

Woodframe Housing Durability and Disaster Issues

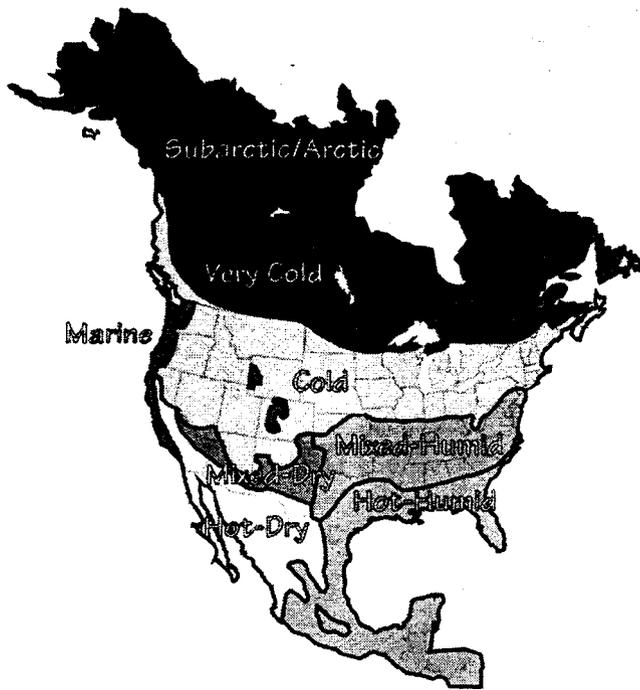
Figure 5. ~ Climate map of North America (courtesy of Joe Lstiburek, Ph.D., Building Science Corporation, Westford, MA).

Climate zones in North America are shown in Figure 5. In the United States, wildfires that have resulted in significant structure loss have been in hot-humid climates (Florida), cold climates (much of the western United States), hot-dry climates (southern California), and marine climates (coastal California). There never has been any technical evidence that in hot, humid climates and hot, dry climates, venting of the roof is

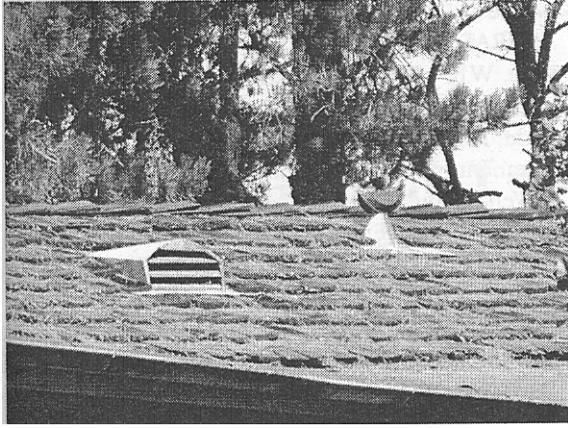
Figure 7. ~ An example of a dormer-type through roof vent that would be vulnerable to both wind-driven rain and flames and embers from a wildfire. Debris from nearby pine trees and the untreated shake roof also pose significant problems for this structure.

In some high wildfire hazard areas, soffit and eave vents are being eliminated, sometimes without consideration to the potential negative impact on the moisture management function of the vent. Where applicable, vents are selectively eliminated, for example only on the side where the wildfire would most likely approach. In some cases, soffit and eave vents are being converted to through roof vents, on the lower slope of the roof (**Fig. 6**). Some existing through roof vents can be vulnerable to both rain (particularly wind-driven rain) and flame and ember entry (**Fig. 7**).

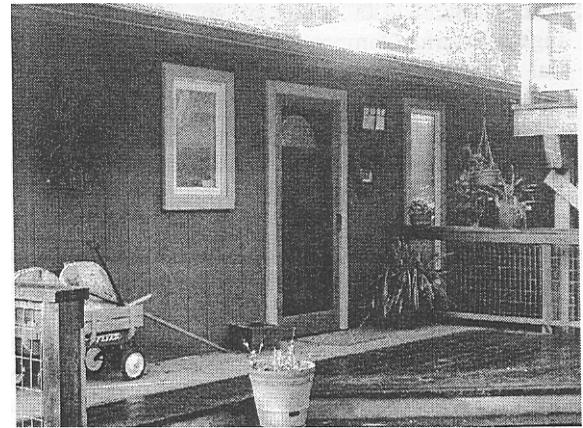
Figure 8. ~ Wide overhangs on this structure protect the cladding and penetrations (windows and door) from rainfall. Note the dry deck boards near the house, and the wet deck boards away from the house.

Overhangs have been shown to significantly reduce the occurrence of moisture-related durability problems, particularly those related to water entry into the building enclosure at penetrations and intersections. Alternative design and use of ignition-resistant materials that would allow for retention of a wide overhang, yet still provide for a fire-safe structure, would be an overall plus for the durability of a structure.
