ALMOND ORCHARD IRRIGATION MANAGEMENT

Richard P. Buchner – UCCE Tehama

Allan E. Fulton – UCCE Tehama

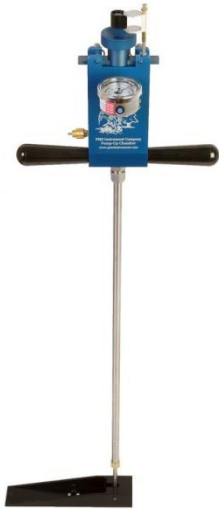
Hand held
manual pump
up version

Three types of pressure chambers “pressure bomb” for plant based monitoring

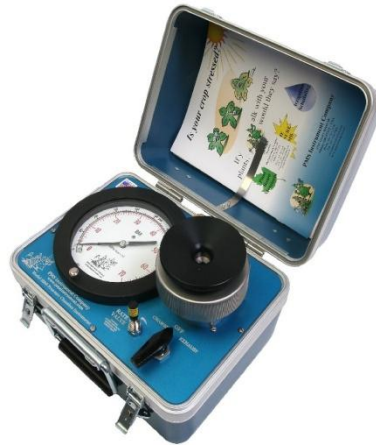
PMS suitcase
style with external
pressure tank

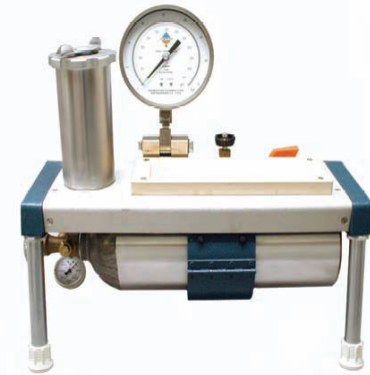
Soil moisture
equipment console.

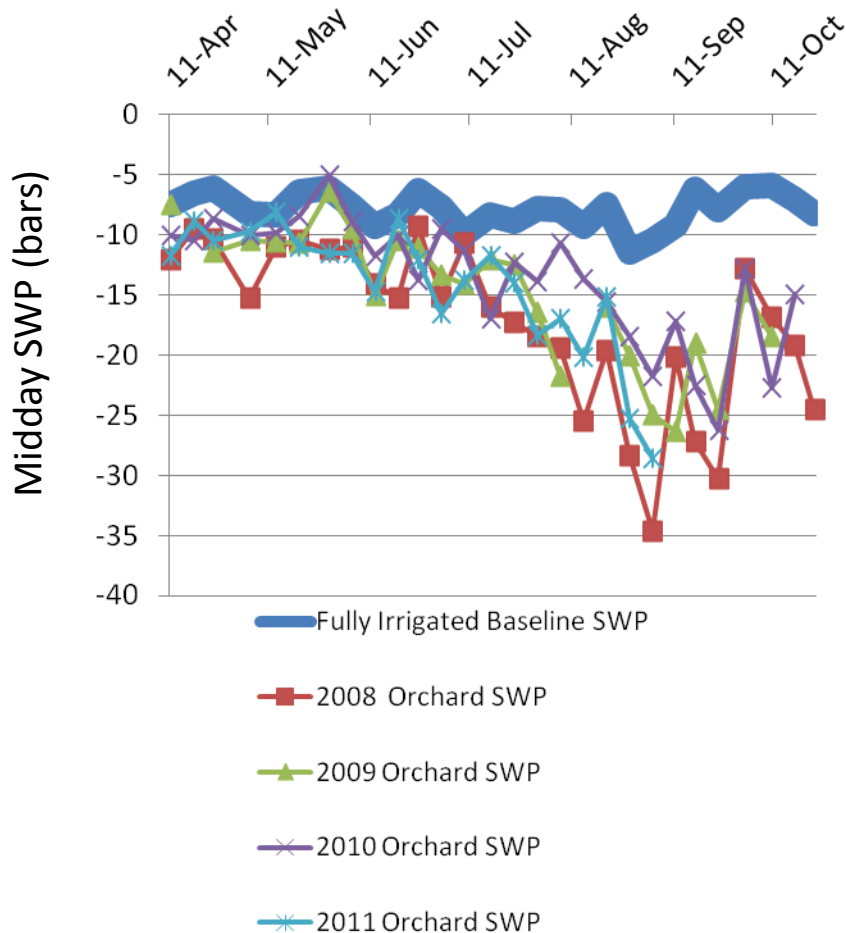
Example of orchard water status (pressure chamber)

Pressure Chamber Reading (- bars)	ALMOND
0 to -6.0	Not commonly observed
-6.0 to -10.0	Low stress, indicator of fully irrigated conditions, ideal conditions for shoot growth. Suggest maintaining these levels from leaf-out through mid June.
-10.0 to -14.0	Mild to moderate stress, these levels of stress may be appropriate during the phase of growth just before the onset of hull split (late June).
-14.0 to -18.0	Moderate stress in almond. Suggested stress level during hull split, Help control diseases such as hull rot and alternaria, if diseases are present. Hull split occurs more rapidly
-18.0 to -20.0	Transitioning from moderate to higher crop stress levels
-20 to -30	High stress, wilting observed, some defoliation
Less than -30	Extensive defoliation has been observed

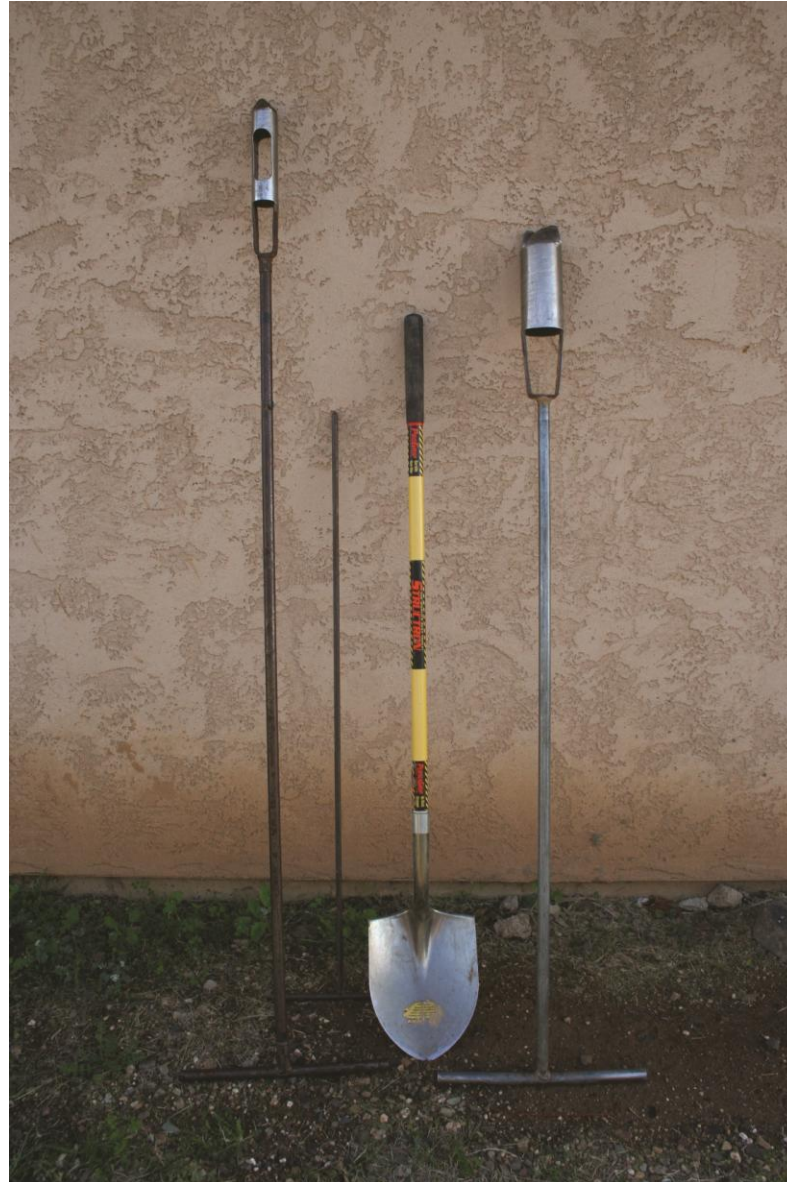
Soil augers and shovel

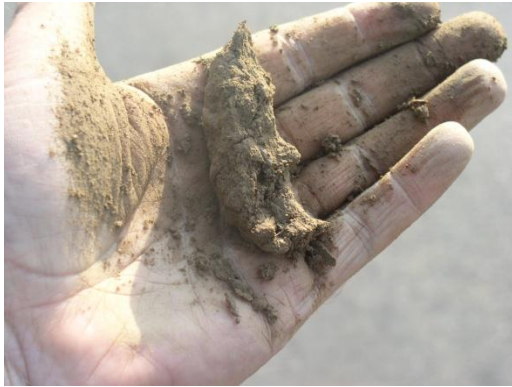
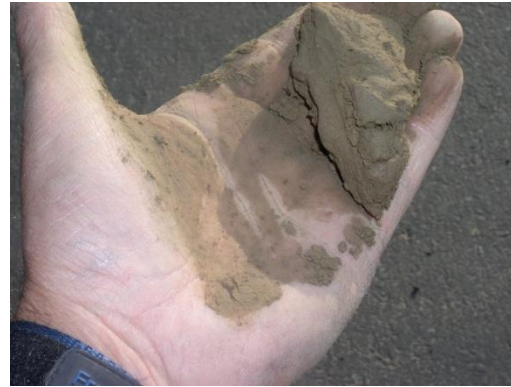
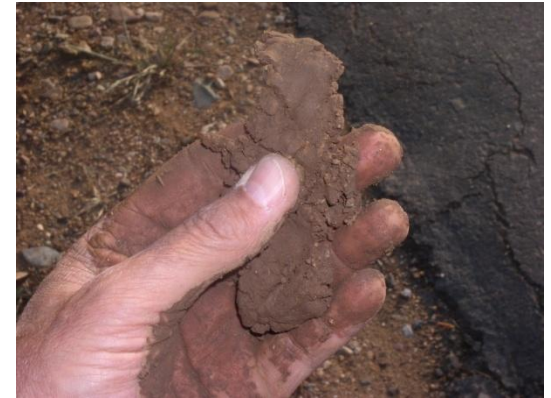
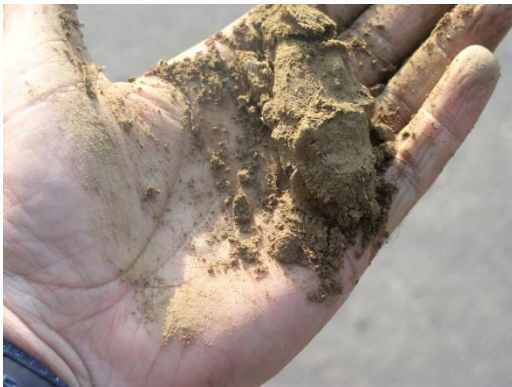
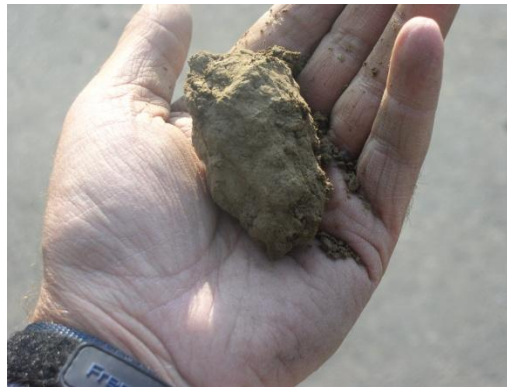
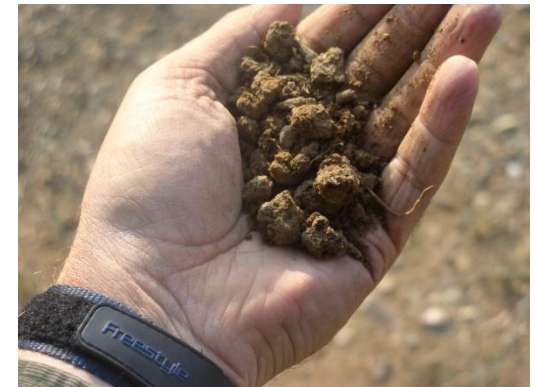
Direct, Qualitative Measurement

Sandier

More
Clay

Wetter

Drier

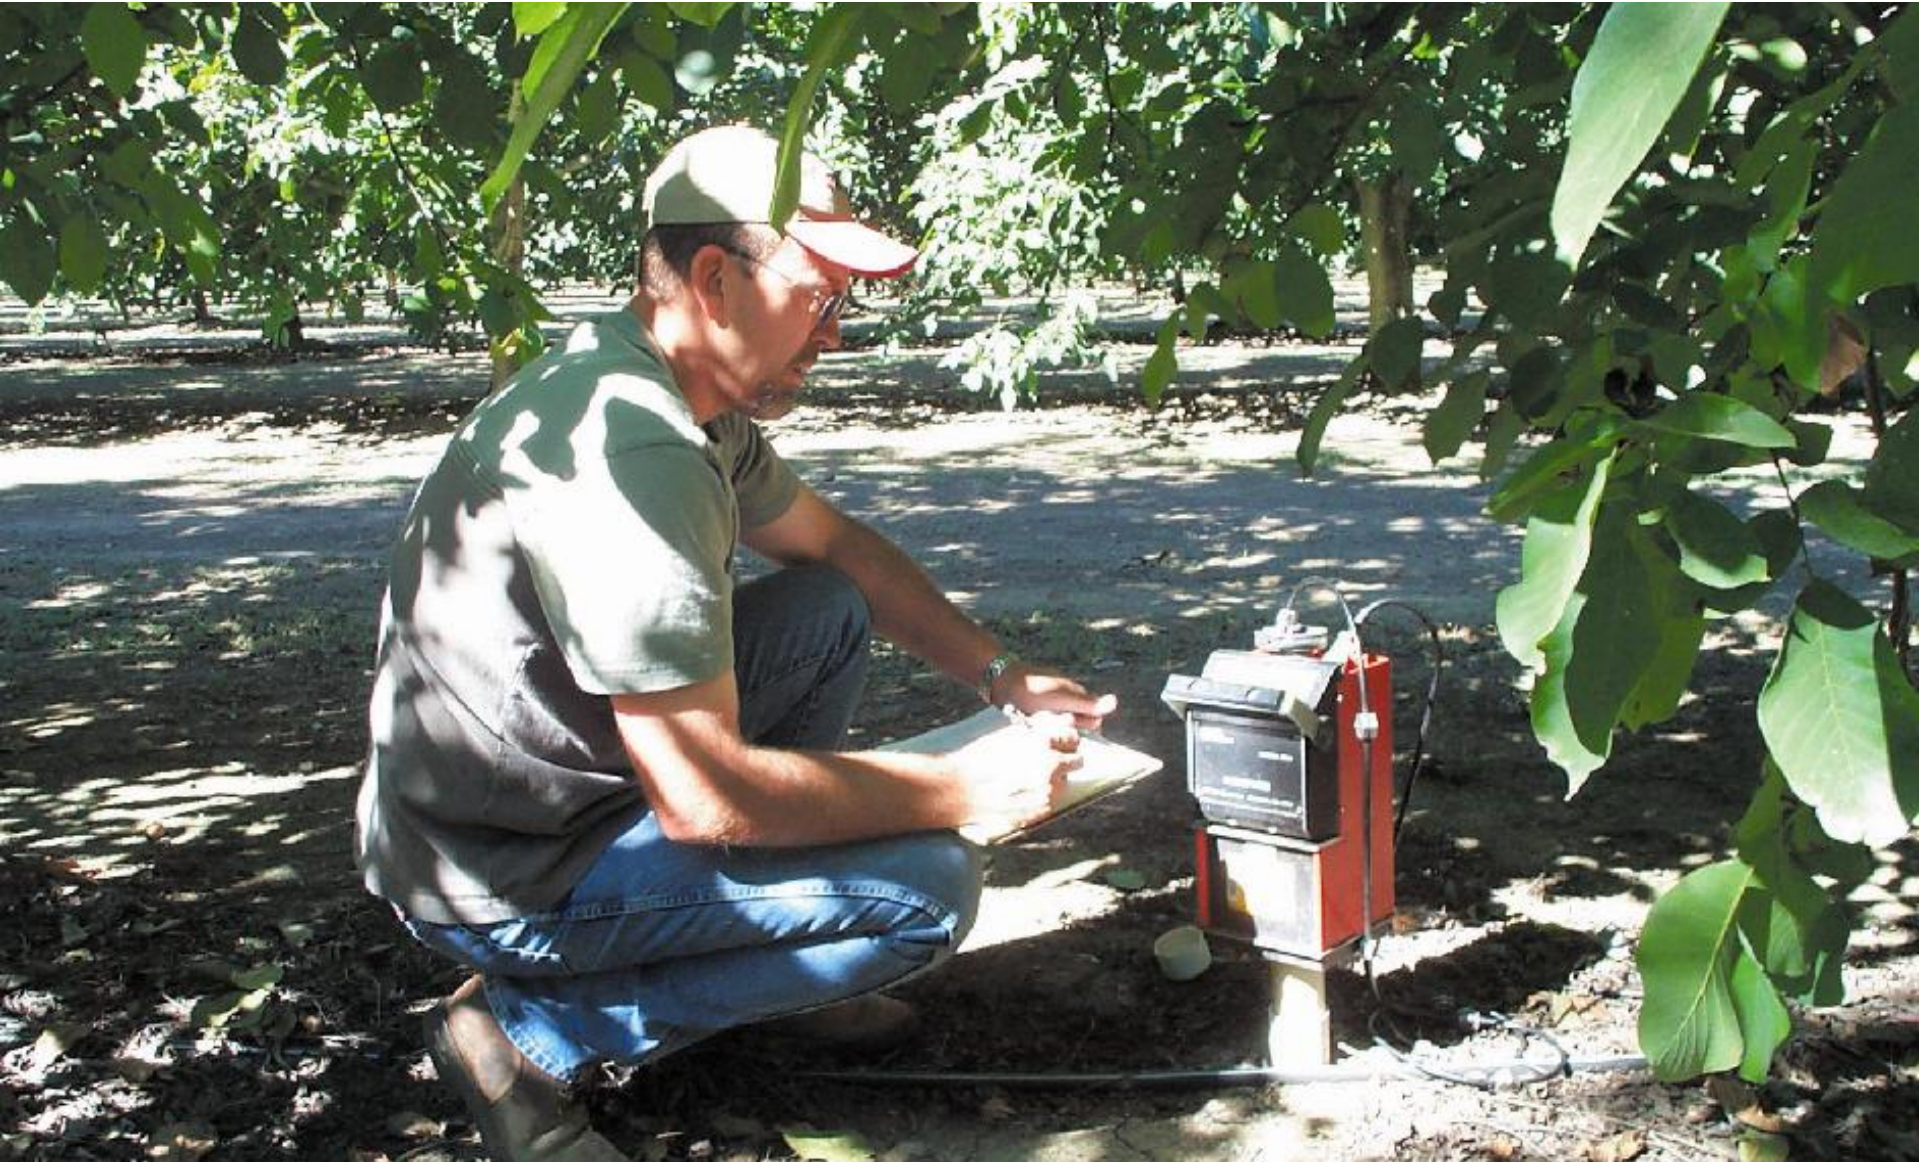
Neutron Probe Moisture Meter

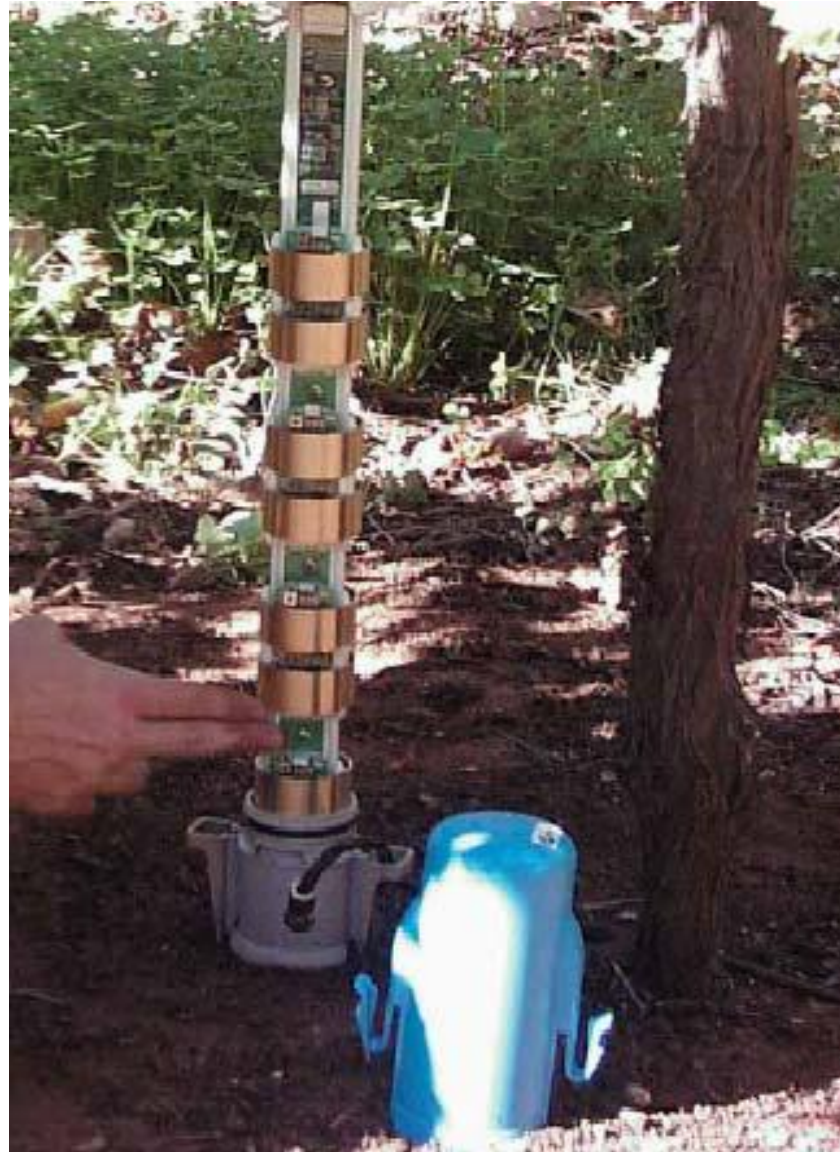
Capacitance Probe

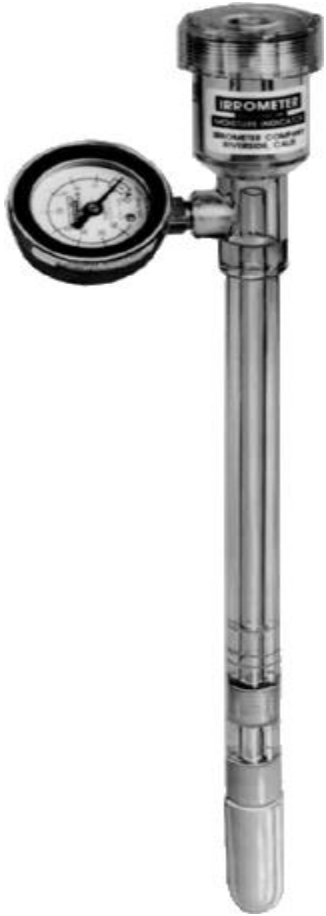
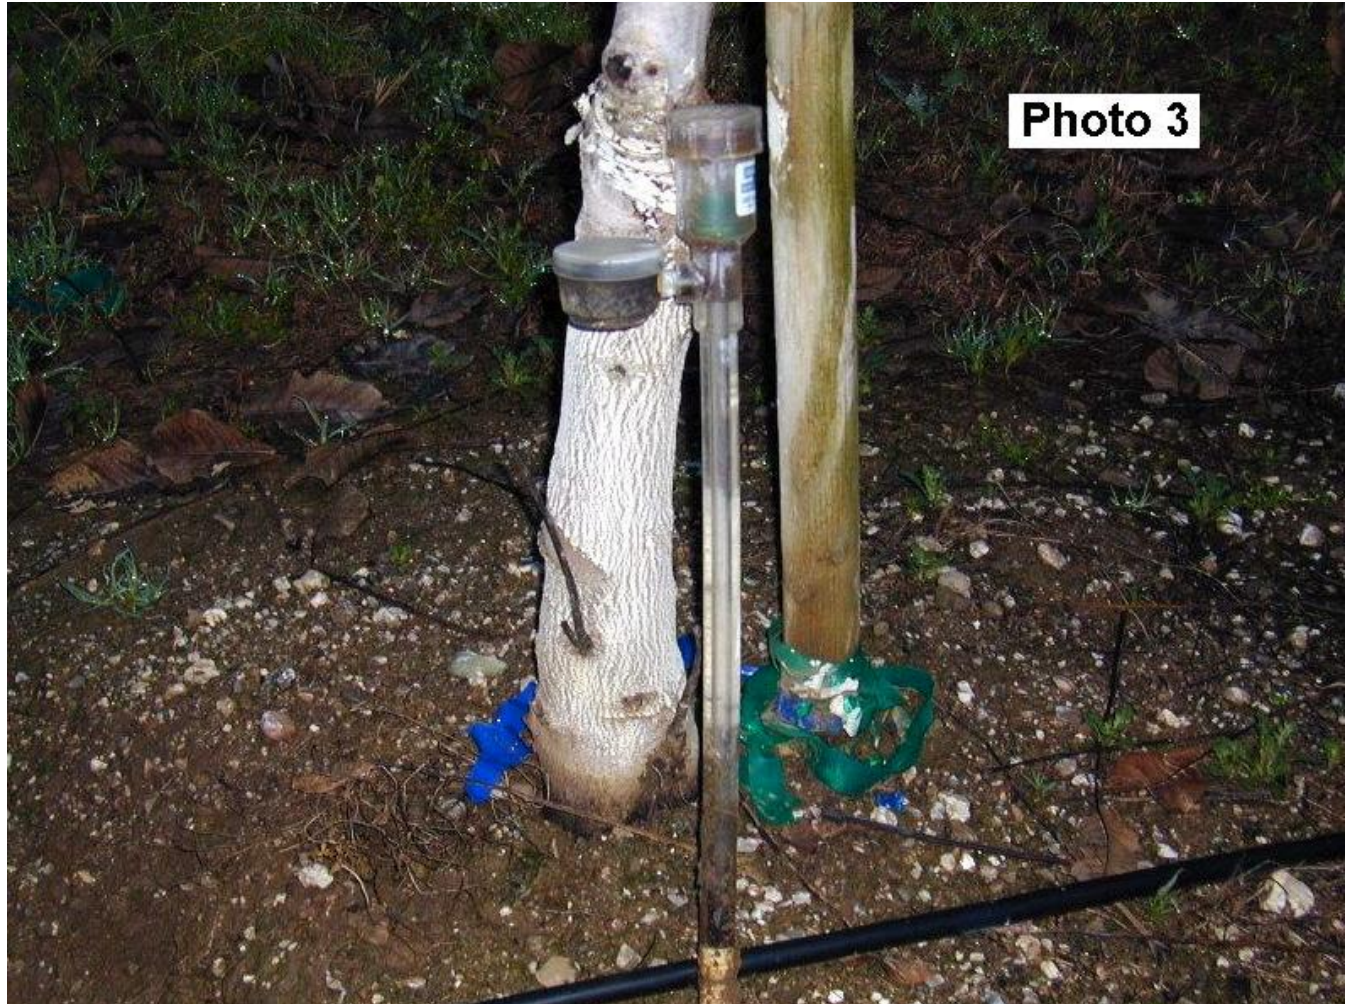
Tensiometers

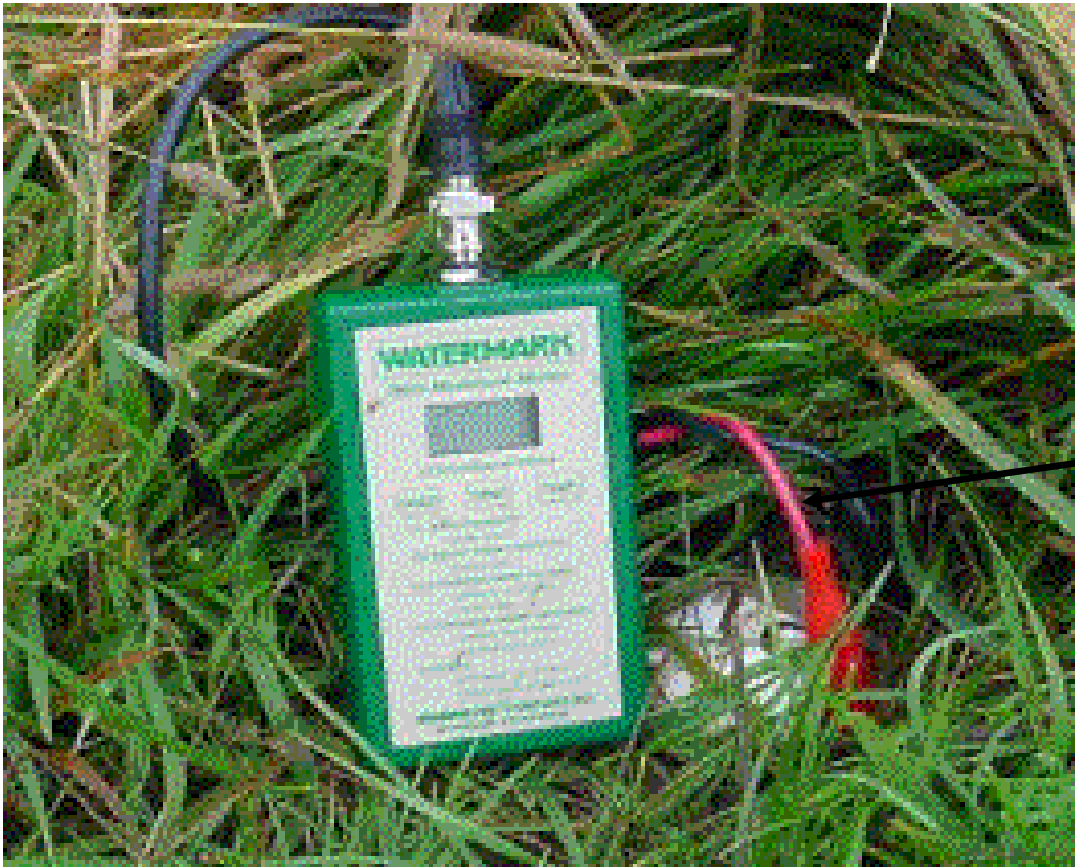
Watermark soil moisture tension

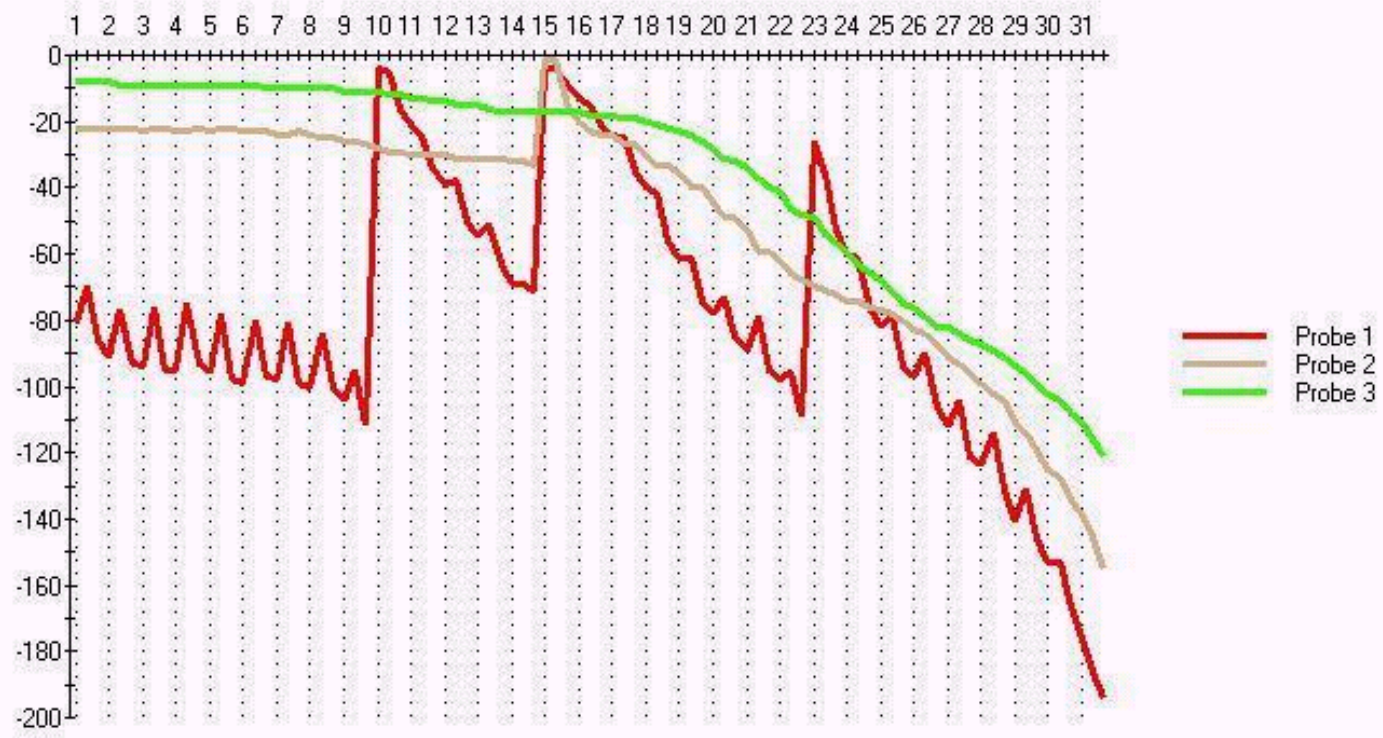
Chart 3 KangergaSection16 - May, 2001

- Probe 1
- Probe 4
- Probe 7
- Probe 2
- Probe 5
- Probe 8
- Probe 3
- Probe 6

May 2001
