# Irrigation system evaluation Report #3

Written by Gerry Spinelli, Production Horticulture Advisor UC Cooperative Extension, San Diego

**Dates:** 9/2, 9/16, 9/17, 9/23, 10/1, 10/13, 10/18/2021; **Nursery:** Altman Plants, 2575 Olive Hill Rd, Fallbrook

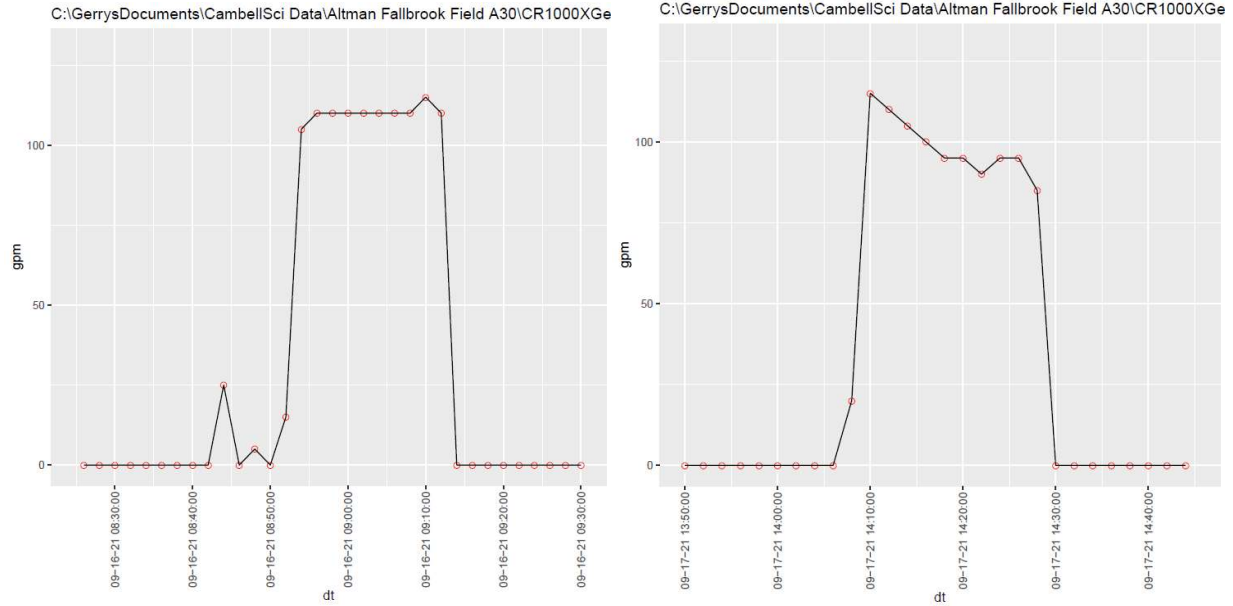
Figure 1. Examples of flowrate during irrigation events with constant pressure (left) and of irrigation event with decreasing pressure (right) recorded on 9/16 and 9/17.

The pressure at the field A30 is very variable (Figure 1). This is because irrigators have the freedom to turn on irrigation valves as they please. Pressures during distribution uniformity measurements ranged from 19 to 38 psi at valve 20 and from 32 to 71 psi at valve 21 (Figure 6). I recommend making an irrigation schedule that all irrigators need to follow.

Pumps produce high pressures at low flowrates and low pressures at high flowrates. The total flowrate is roughly determined by how many sprinkler heads are being used to irrigate, or how many blocks are irrigated at the same time. This phenomenon causes the pressure to drop when one irrigates more blocks (requiring higher flowrates from the pump) and to increase when smaller areas are irrigated. This is the cause of the highly variable pressure experienced at the irrigation block. The Hunter PGP Ultra require about 40 psi of pressure. High pressures can be addressed by installing pressure regulators at each block. Low pressures can be addressed by turning on the booster pumps, but these have a limited capacity, so there is only so much area that can be irrigated at once without dropping pressure below 40 psi. If the pressure is too low, one irrigation block needs to be turned off to avoid dropping the pressure for other blocks being irrigated at the same time. To avoid this conflict, other nurseries have adopted a timeslot approach where each irrigator is allowed to use the water only during a specific time window, e.g. from 8:00 am to 11:00 am.

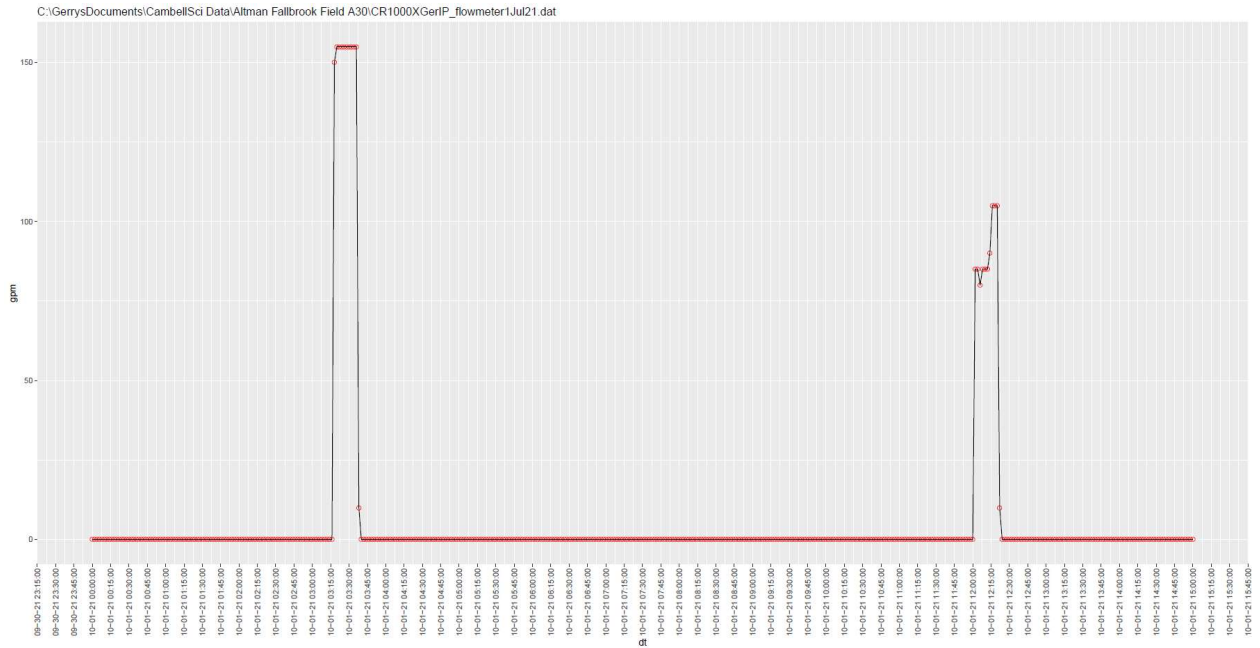
Figure 2. Example of two irrigations measured by the flowmeter at high and low pressure, resulting in high and low flowrates.

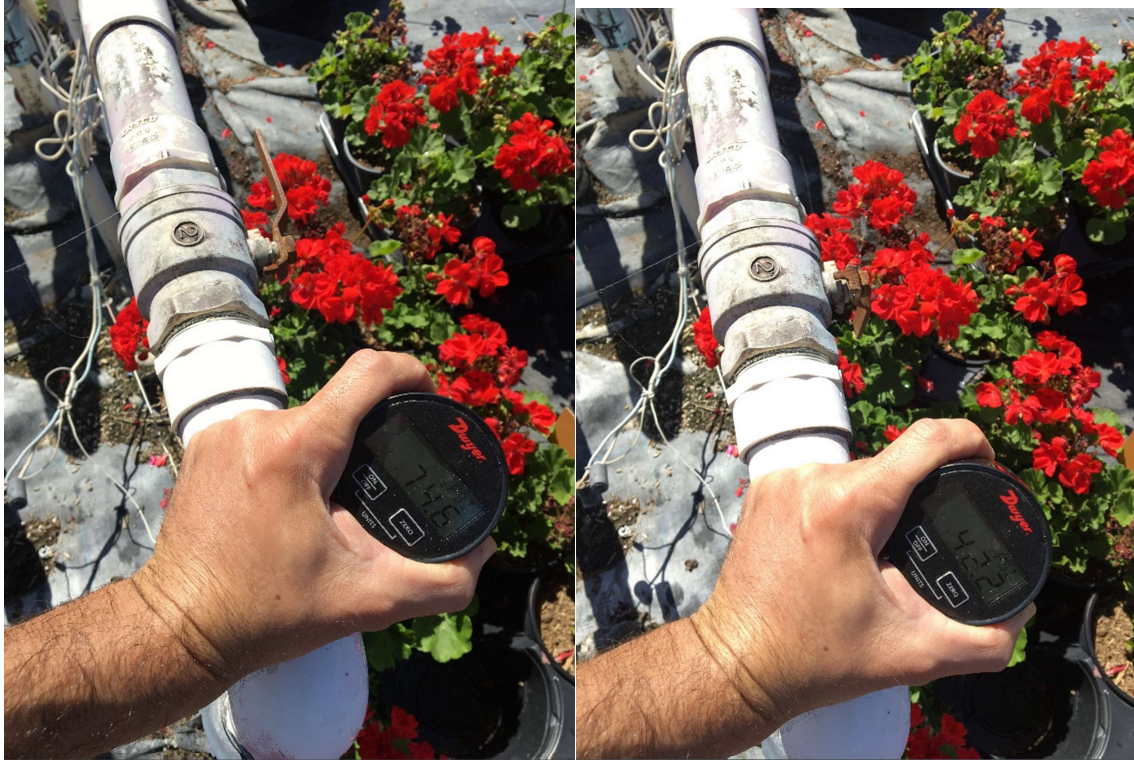
Figure 3. Example of “throttling”. The pressure was 74 psi and by partially closing a valve we reduced it to 42 psi. The same result can be achieved with a pressure regulator.

- 1- The pressure at the field A30 is highly variable and the irrigators do not have control over it. This is one of the main issues to be addressed. Pressure gauges or Schrader valves can be installed at each block valve to measure pressure. When the pressure is too high, the irrigator needs to adjust it down by throttling the block valve. Alternatively, pressure regulators can be installed at each block valve. When the pressure is too low, the irrigator needs to call Pedro to turn on the booster pumps. If the pressure is still too low, the irrigator should not irrigate. Another way to improve pressure is to repair the VFD controller at the pond pumps. The VFD will keep the pressure constant regardless of how many blocks are being irrigated (within the pump power capacity).

At the pumping station near the retention pond there is a VFD, that is a device that allows pump to maintain a constant pressure regardless of the flowrate that is required. In other words, one has the flexibility to irrigate at the same time more or less blocks and the VFD will maintain the pressure constant. However, there is still an upper limit on how much area can be irrigated at once and this is determined by the pump power. Pedro indicated that the VFD and the automatic blending of pond and freshwater are not working anymore. Also, it seems that the sand media filters are not operational. I suggest getting this equipment serviced to improve pressure at the irrigation blocks.

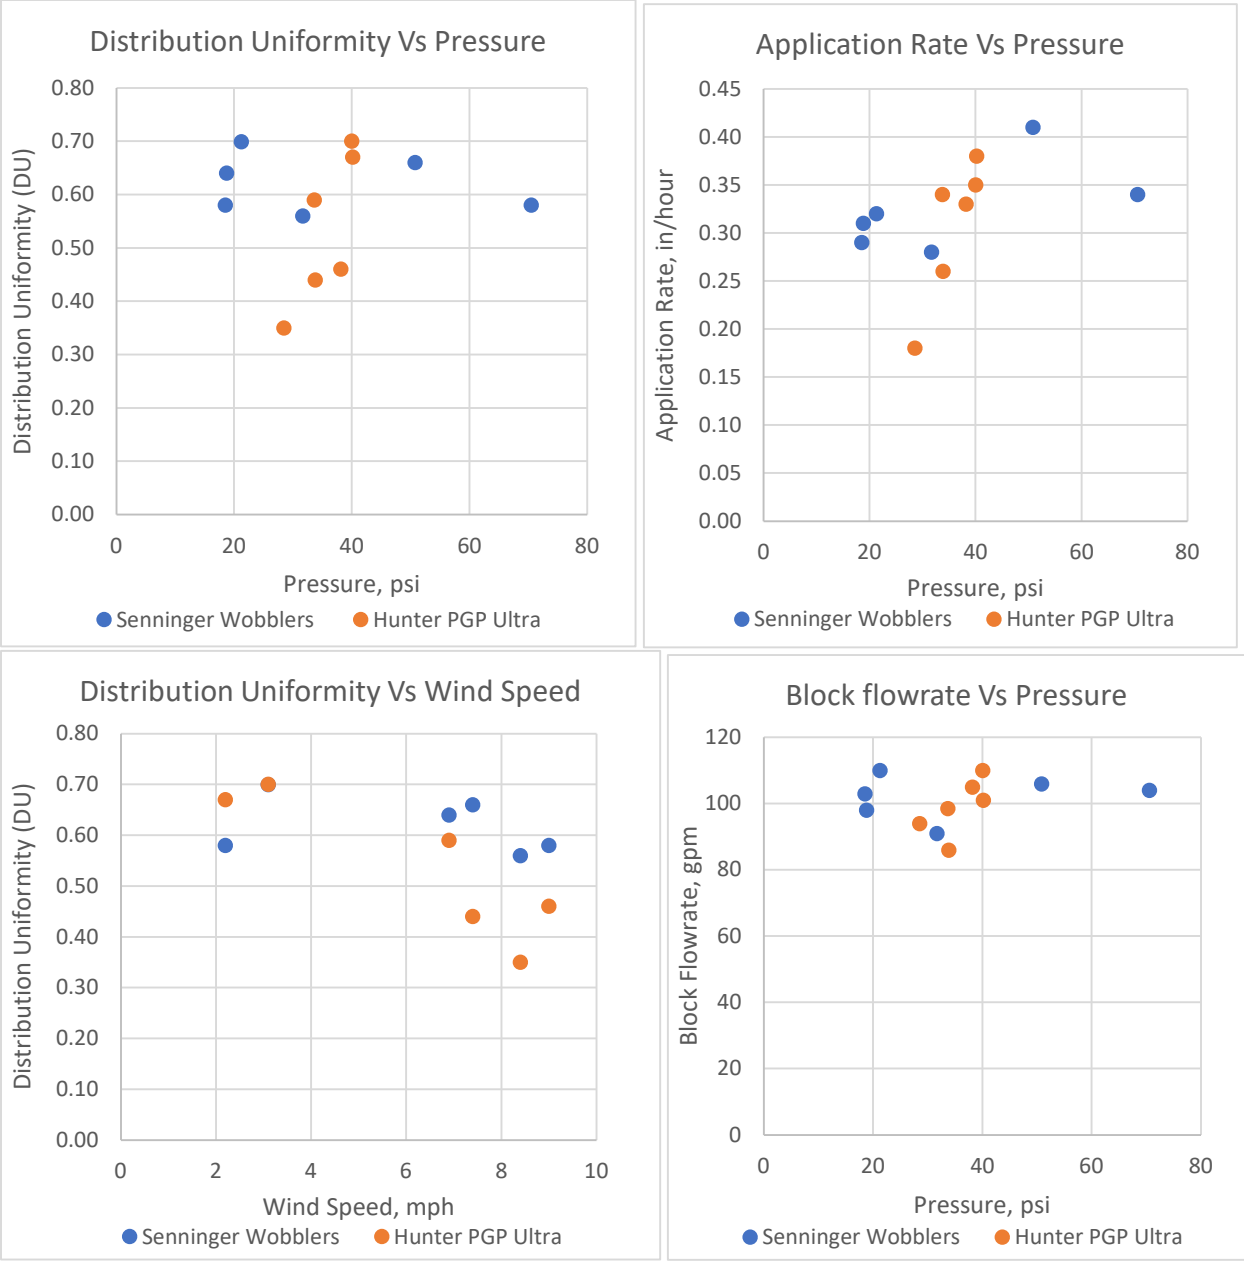
Figure 7. Distribution uniformity, pressure, application rate, flow rate and wind speed measurements

The results show that valve 20 generally has lower pressures than valve 21, but the wobblers produced a higher distribution uniformity (DU) at any given pressure (Figure 6). The wobblers performed well at pressures as low as 20 psi as indicated in the specs in Figure 5. We installed a pressure regulator at each wobbler sprinkler head so the flowrate of the whole irrigation block was independent of differences in pressure and kept relatively constant (Figure 7). The PGP sprinklers generally performed worse than the wobblers showing DU as low as 0.35, associated with low pressures and high wind speeds. However, when the pressure was 40 psi and the wind speed lower than 4 mph, the PGPs produced a DU as high as 0.7. Wind speeds negatively affected DU for both sprinkler heads, particularly when above 6 mph, but the wobblers performance seemed less sensitive to winds speed (Figure 7).

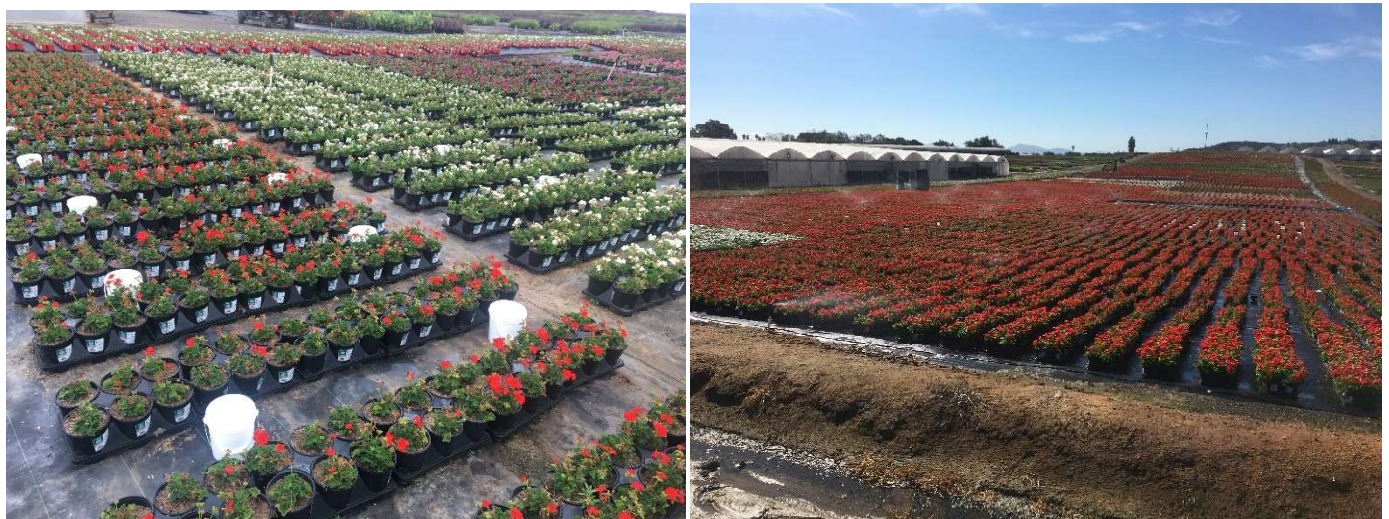
Figure 10. Buckets set up at the nursery to measure distribution uniformity

We installed Senninger Xcel Wobbler sprinkler heads at block 20, leaving the Hunter PGP Ultra at block 21 and we measured distribution uniformity three times, on 9/16, 9/17 and 9/23. Then we swapped the sprinkler heads installing the Wobblers at block 21 and the PGPs at block 20 and we measured distribution uniformity on 10/1, 10/13 and 10/18. Distribution uniformity was measured by setting up two areas of 36 buckets (a grid of 6 x 6) in each block of sprinkler

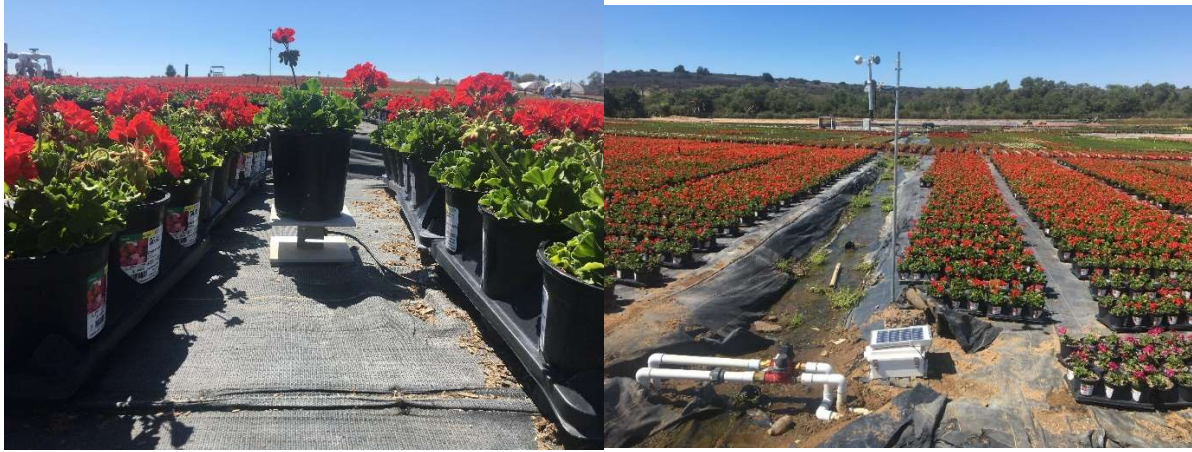
Figure 13. The load cell (left) and the flow meters and anemometer installed at the site.

We also installed a load cell in the field to measure the weight of one container continuously for the period 9/15/21 to 10/5/21 (Figure 12). The load cell indicated that the container weighted about 950 grams maximum (Figure 14). This evidence indicates that the containers did not reach container capacity (that is around 1500 grams) and presumably they would have reached commercial size earlier if the water content of the containers had been kept closer to container capacity. Simply weighting ten pots per block every couple of weeks would have provided the grower and the irrigator a lot of useful information to drive irrigation scheduling decisions. For example, the grower could have responded with lengthening one irrigation (40 minutes instead of the usual 20 minutes) in order to bring the containers closer to container capacity.

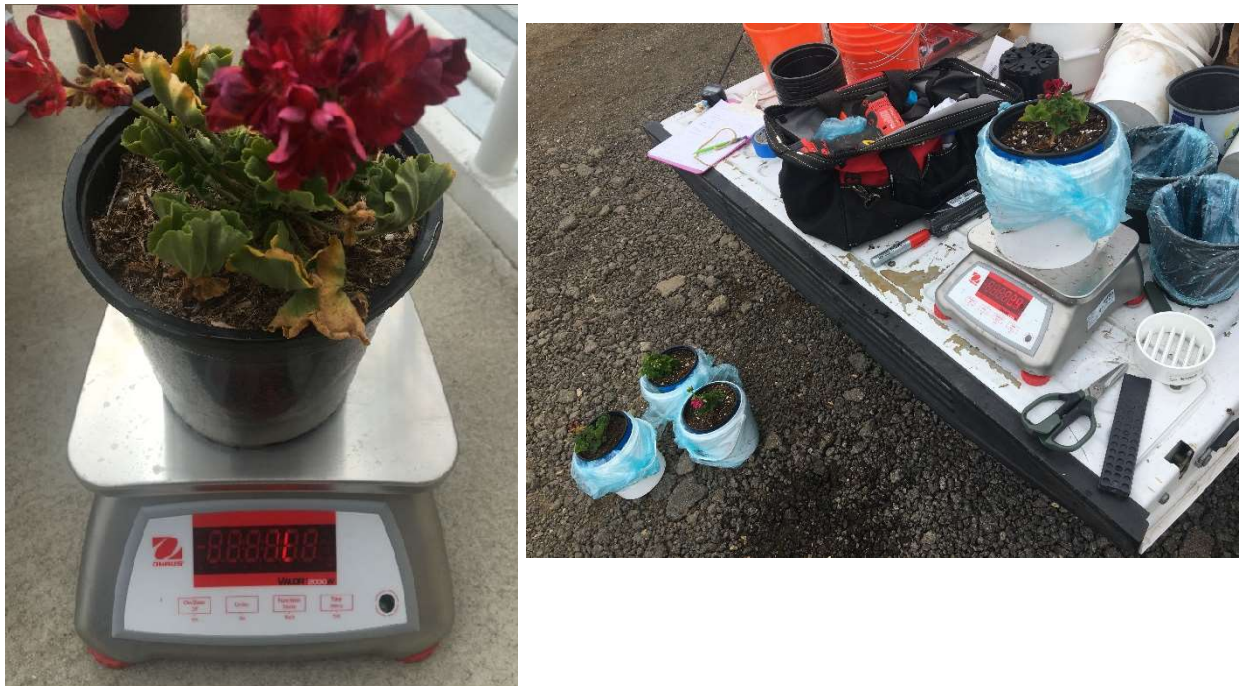
Figure 14. Weighing containers on 9/2/21

On 9/2/21 we performed an experiment where we weighted 5 containers before and after irrigation and then after irrigating abundantly until reaching container capacity (Figure 13). The containers, plant and media weighted about 1050 grams before and 1125 grams after irrigations. At container capacity the container, plant and media weighted about 1500 grams (~3 lbs). Then, we let the container dry without irrigation for three weeks and weighted them again. The container, media and plant after drying for 3 weeks without any irrigation, weighted 358 grams.

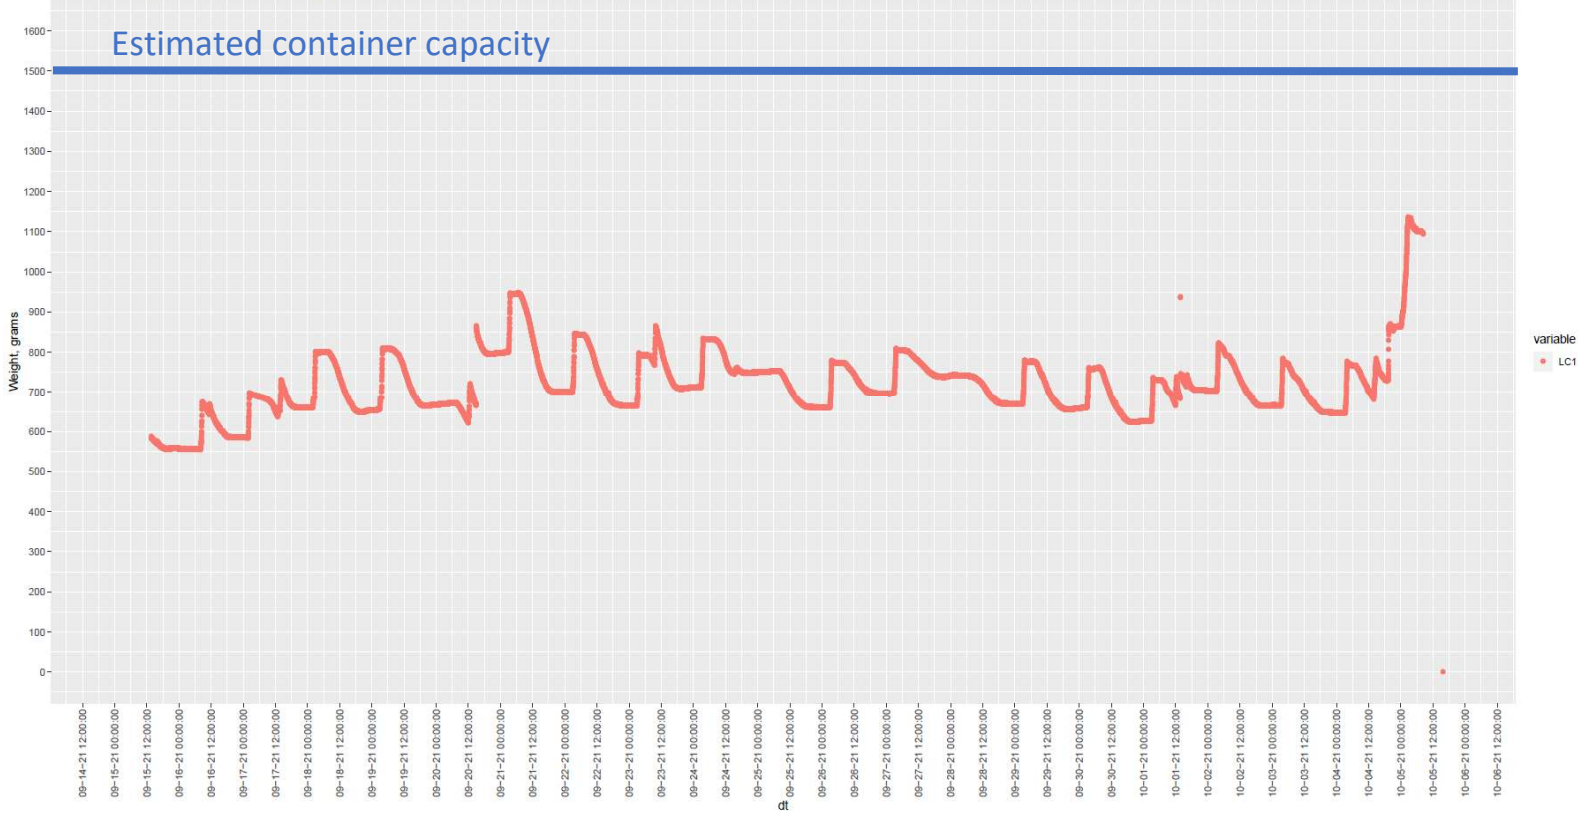
Figure 15. Weight of a container measured continuously. The blue line indicates the weight of the container at container capacity.

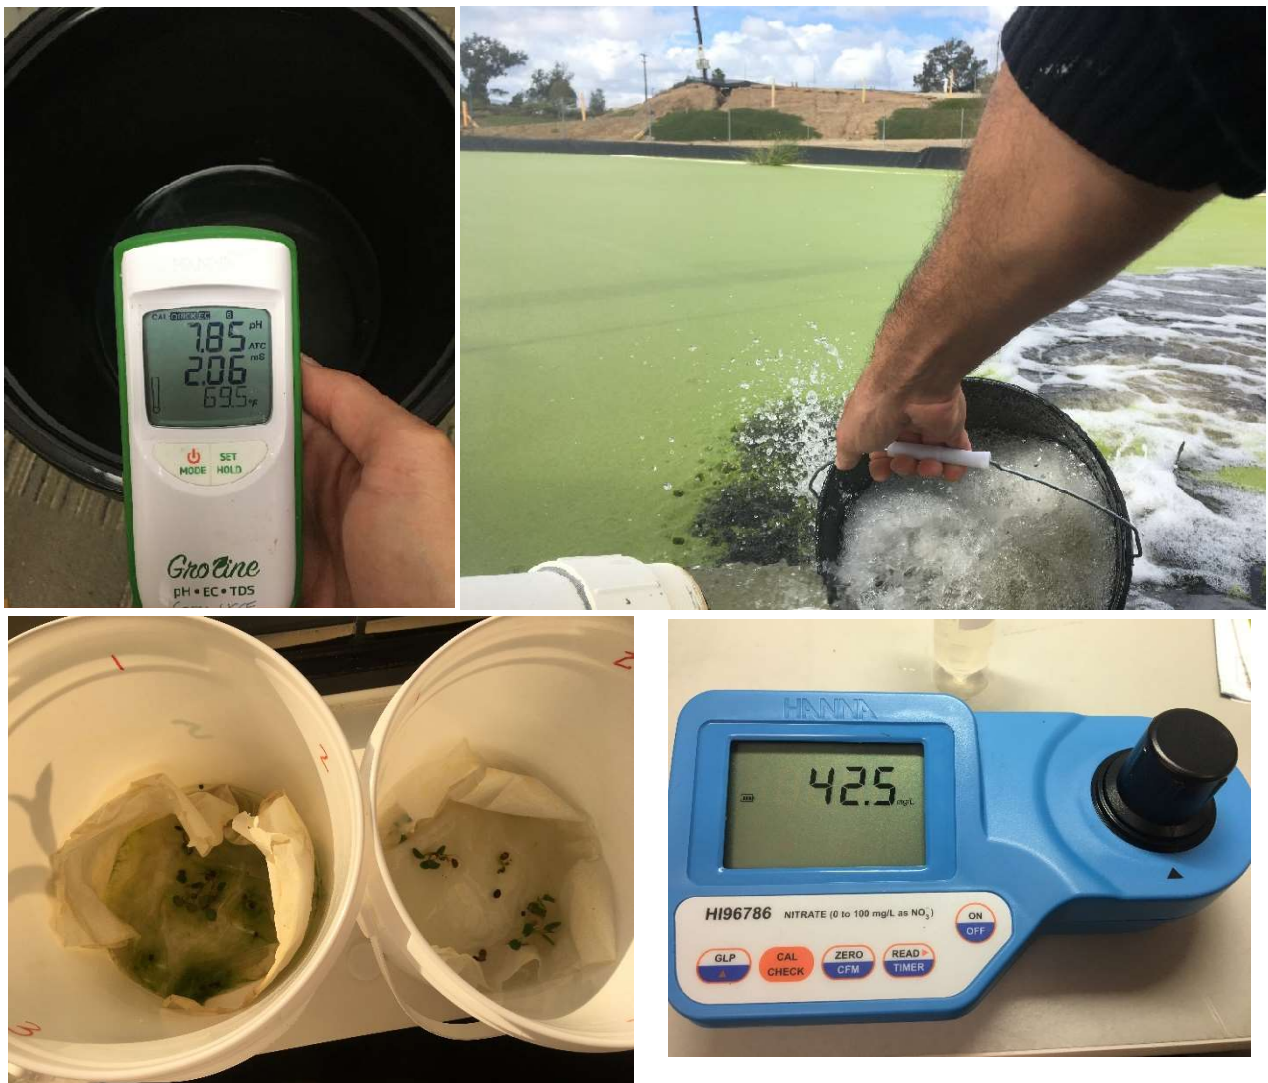
We took a sample of water from the retention pond and we measured nitrate concentration, pH and salinity. We obtained a relatively low nitrate concentration (42 ppm of  $\text{NO}_3^-$  or 9.5 ppm of  $\text{NO}_3^-$ -N), high pH (7.85) and very high salinity (EC = 2 dS/m). We recommend blending the pond water with fresh water before using for irrigation and possibly correcting the pH. Pedro said that there used to be an automatic system that blended pond and municipal water based on EC measurements. Repairing this system would be beneficial. We baited for *Phytophthora* with apple fruits and with lupine seedlings but failed to detect *Phytophthora* in the pond sampled water.

Figure 16. Measurement of EC and nitrate concentration in the pond water and baiting for *Phytophthora* with lupine seeds

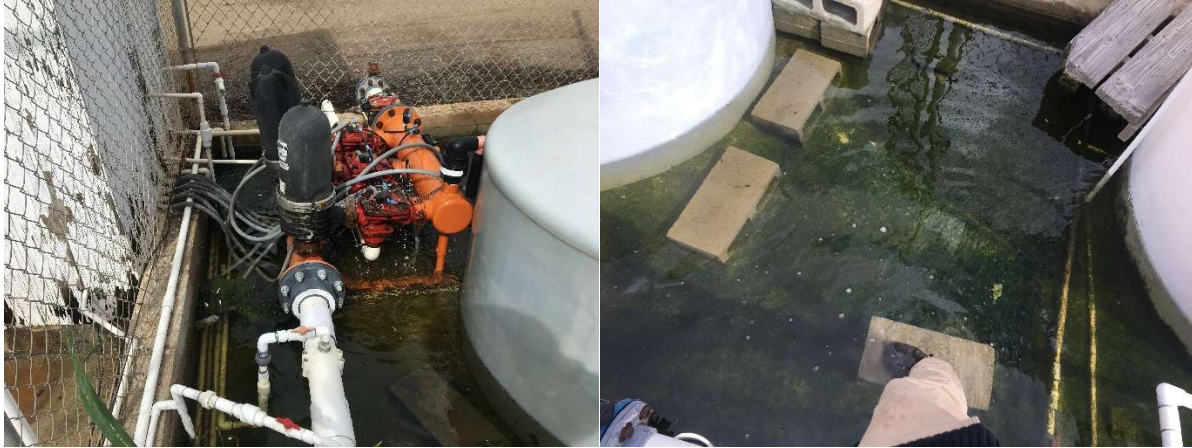
We recommend improving maintenance of all irrigation system components, including valves, filters, sprinkler heads, risers, fittings etc. We recommend fixing all leaks in a timely manner. A leak from the disc filter at the A30 injector flooded the tank containment area and went unrepaired for a long time. It would be beneficial to task one maintenance staff with driving around to each block being irrigated to repair all leaks and breakages in the irrigation system. This person could also be in charge of measuring pressure at each block to make sure that is within the specs of the sprinkler heads.

- 5- Generally, better maintenance could be provided the irrigation system. For example, a leak from the filters at the injector station has caused the injector filter area to flood for months.
