# **Design and Evaluation of Selected Machine Components to Reduce Injuries caused to California Table Olives Mechanically Harvested**

2006 Project Report to COC January 26th 2007

Uriel A. Rosa, Chris Gliever, Louise Ferguson, Carlos Crisosto  
Jackie Burns, Kitren Glozer, Dave Smith of DSE

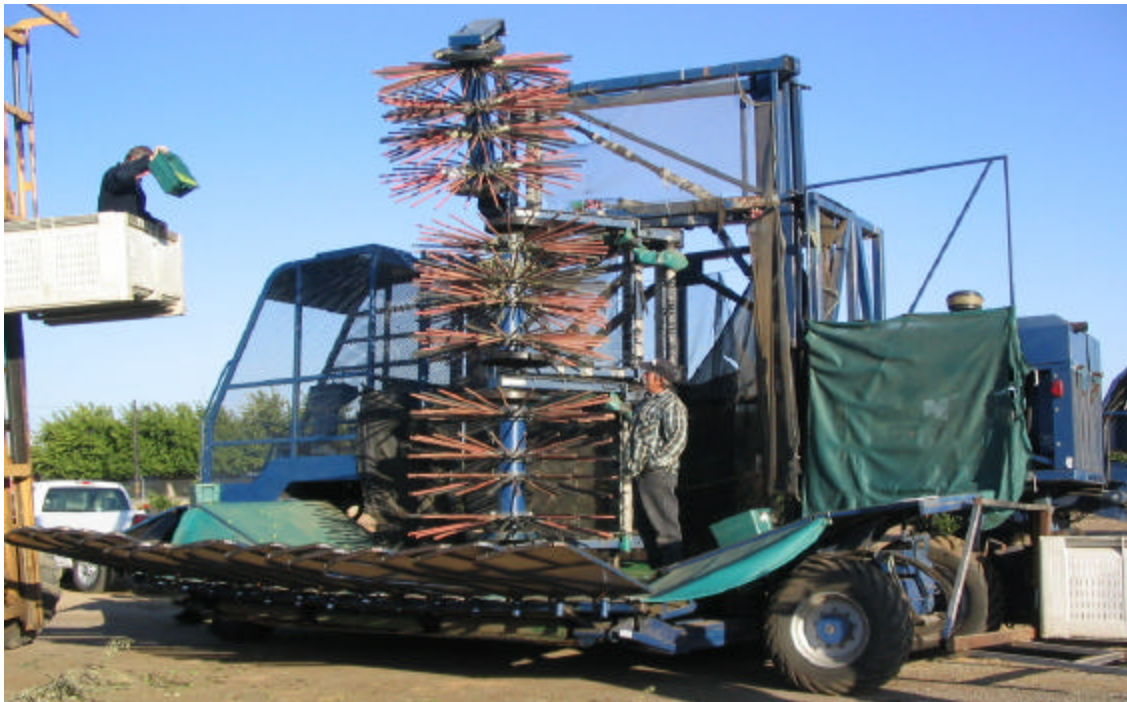
In Figure 1 olives are being dropped from eight feet to simulate damage occurring after being detached by the drum at that height. These olives were then gathered and evaluated for injuries by Dr. Carlos Crisosto at UC Kearney Experimental Station and the data analyzed at UC Davis by the Bio-Automation lab (BAL). Olives were also sent to two olive processors. The olive processor's data will be available to us by February 2007. Based on the results of the processor's analysis we will incorporate the interpretation of those results to suggest improved design changes to the Korvan-DSE harvester.

Figure 1 Catch frame drop test at 8 feet

We dropped olives to simulate three heights of spiked drums heights; four, eight and twelve feet. The olives were poured over a wide circulate pattern upon the catch frame so that damage was unbiased by landing position. In other words, it was equally likely that an olive lands on any part of the catch frame. The three different heights were repeated random times relative to each other so that no time biasing occurred. Additionally, this test was repeated in the afternoon adding nine additional drops to our data set. Therefore, our drop test constituted of 18 sets of data. This doesn't include our six control sets of data which were olives that did not interact in any way with the mechanical harvester. These olives were gently hand picked and therefore were expected to experience as little damage as possible.

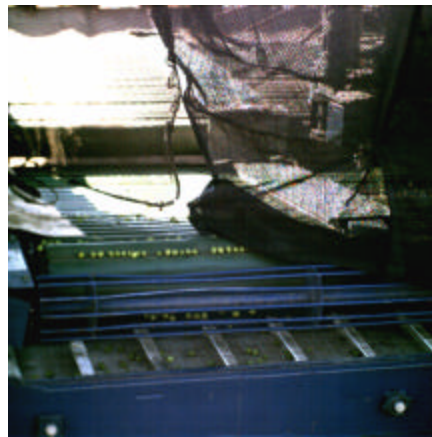
Figure 3 Rear transport belt.

Figure 11 shows the evaluated sample results from the bin drop test (figure 4) and the back belt drop test (figure 3). The control olives are also included in this figure. The olives that dropped into the storage bin seem to have less average damage then the control olives. This observation can be justified by the variability of the olive samples used in this study. The average damage for the rear belt dropped olives seems slightly higher then the control olives. This will also be further investigated using SAS in 2007.

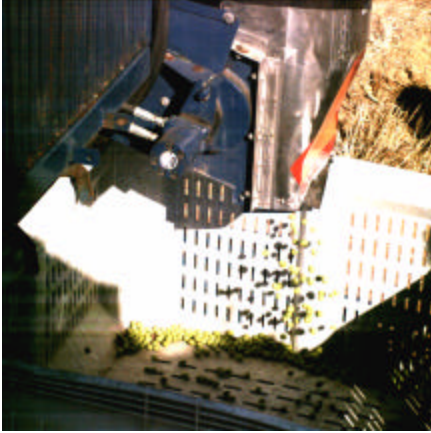
Figure 4 Storage bin drop.

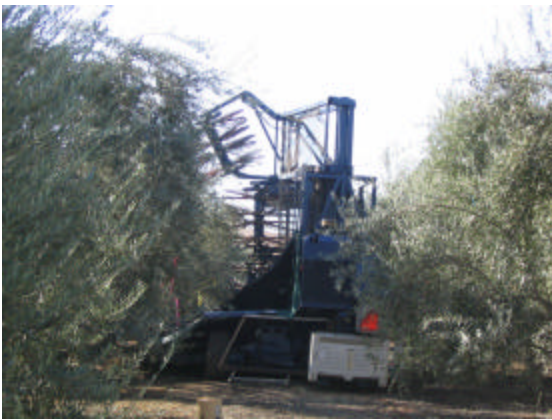
The olive sample generated with the above procedures isolate damage cause by the harvester after the olives detach from the tree canopy. To isolate damage cause by the spiked drums detaching the olives, a soft black fabric tarp was laid across the catch frame. The harvester was then run across either half or a quarter of a tree to detach olives from that portion of that tree as seen in Figure 5. Spiked drum speed was set to 180 or 220 RPM to evaluate the effect of drum speed on olive damage.

Figure 5 Harvester spiked drums interacting with Olive tree canopy

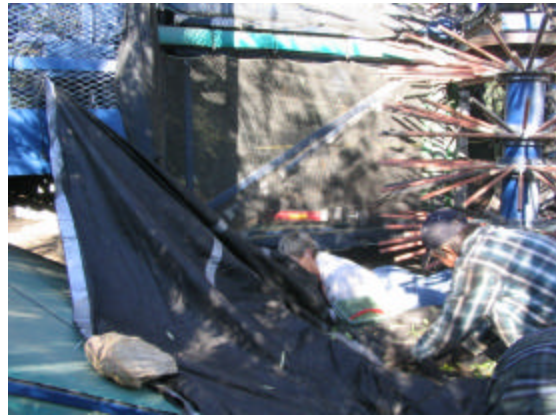
After the harvester passed through either half or a quarter of the tree, the olives softly landed upon the black cloth tarp (Figure 6). These olives were hand collected off the tarp and stored for later evaluation. Twenty one samples of olives were collected using this procedure over two days in the mornings and afternoons. As controls for this procedure, hand picked olives were dropped from twelve feet onto the soft tarp covered catch.

Figure 6 Soft black cloth tarp used to isolate spiked drum and tree interaction

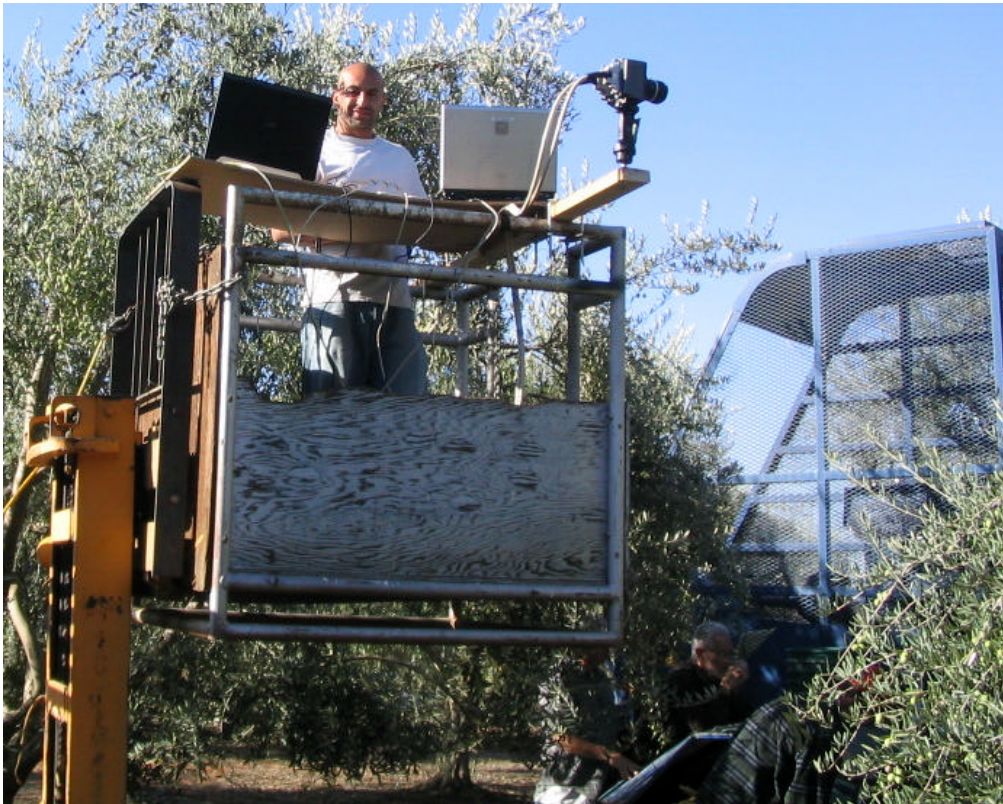
Figure 7 shows the stereo video camera system. The system consists of two high speed cameras each connected to its own high speed solid state image memory controller. Each camera is six inches from the end of the same eight foot wooden beam. After the camera platform is fork lifted into place, both camera are aimed and focused on an indexed target. The exposures for both cameras are set for a compromise between sun and shadow as seen in Figure 8. The targets are removed from the area of focus and the olives are set in motion. After the “Pickle Switch” is pressed, each high speed image memory controller fills with 1024 images, each. Since each image is 1024 X 1024 X 3

Bytes, each sequence of images is over 3 Gigabytes per camera. Each high speed image memory controller is connected to a separate laptop and each laptop to a separate external hard drive. It takes 2 seconds to record the images and 10 minutes to save upon the external hard drive. The indexed target image from each camera for each image sequence needed post processing. An added grid was necessary for the 3D tracking software to obtain a 3D solution from two 2D images.

Figure 7 High speed stereo video recording platform on a forklift

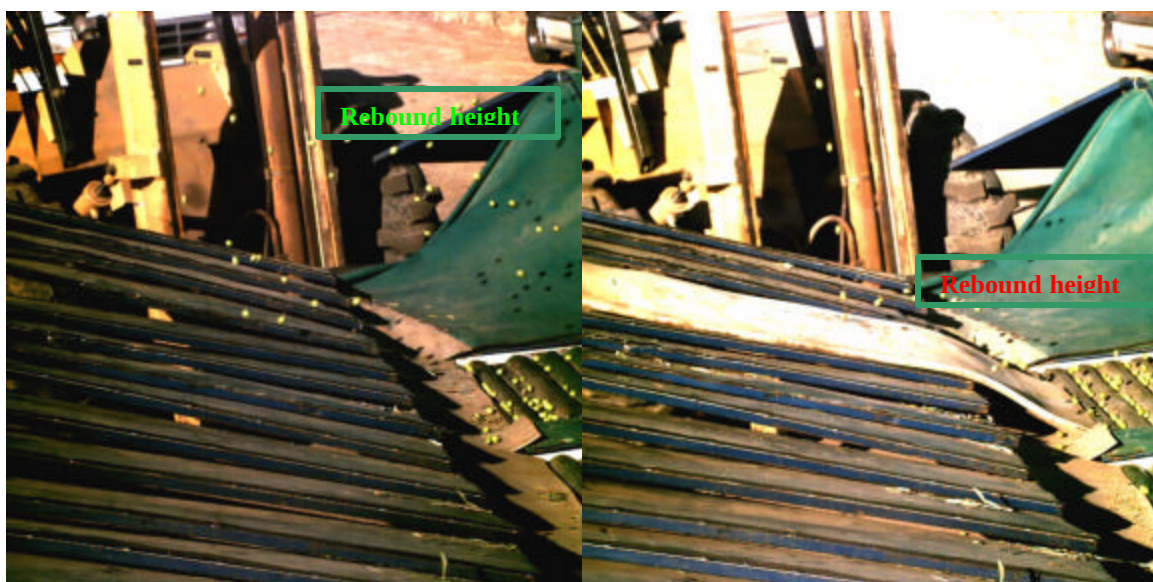
Olives in figure 15 impact the catch from without and with extra padding. The difference in return heights indicates that the "NoBruze" foam absorbs about 80% of olives kinetic energy as compared to the unpadded catch frame.

Figure 15 Front folding portion of catch frame without extra padding and with white "NoBruze" padding

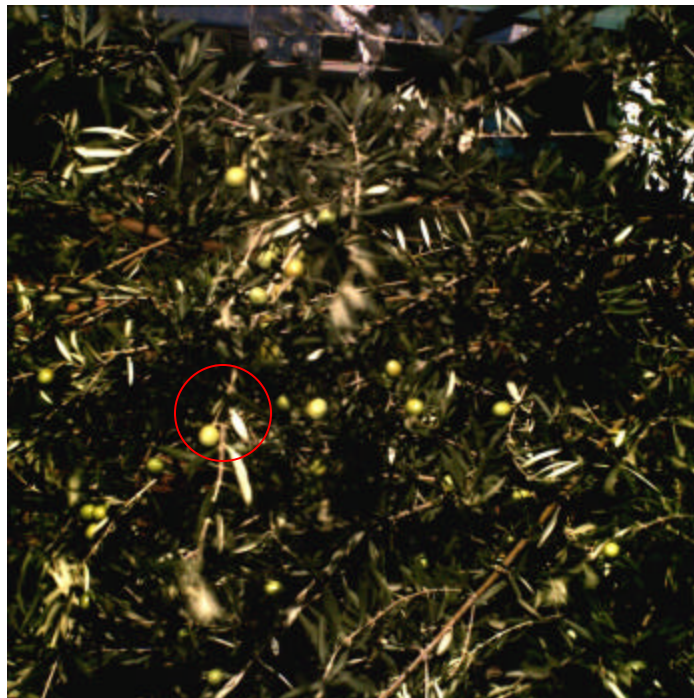
Figure 17 Stem whipping action detached the circled olive

Figure 16 shows an olive being hit by a drum spike from the left and right camera view. These images illustrate the strong nature of olive detachment by drum spike. However, the majority of the olives seem to be detached by the whipping action of the branched that is accentuated by the whipping action of the olive stem (Figure 17). The willowy nature of the olive branches means that much energy must be transferred to the tree canopy before fruit detachment occurs.
