Creekside Plantings and Restoration in California Rangelands

CREEKSIDE PLANTINGS AND RESTORATION IN CALIFORNIA RANGELANDS

TABLE OF CONTENTS

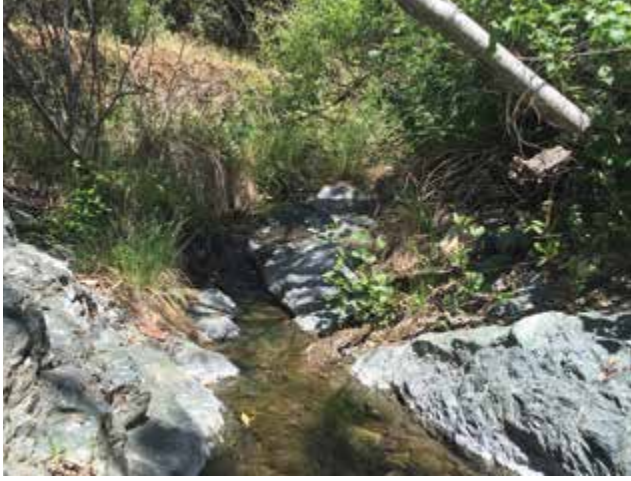
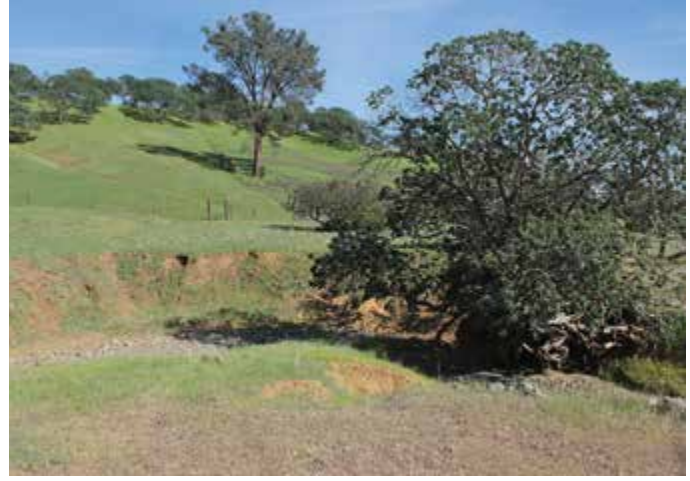
FIGURE 1. Riparian corridors in grazed oak woodlands in California, with ephemeral or perennial streams.

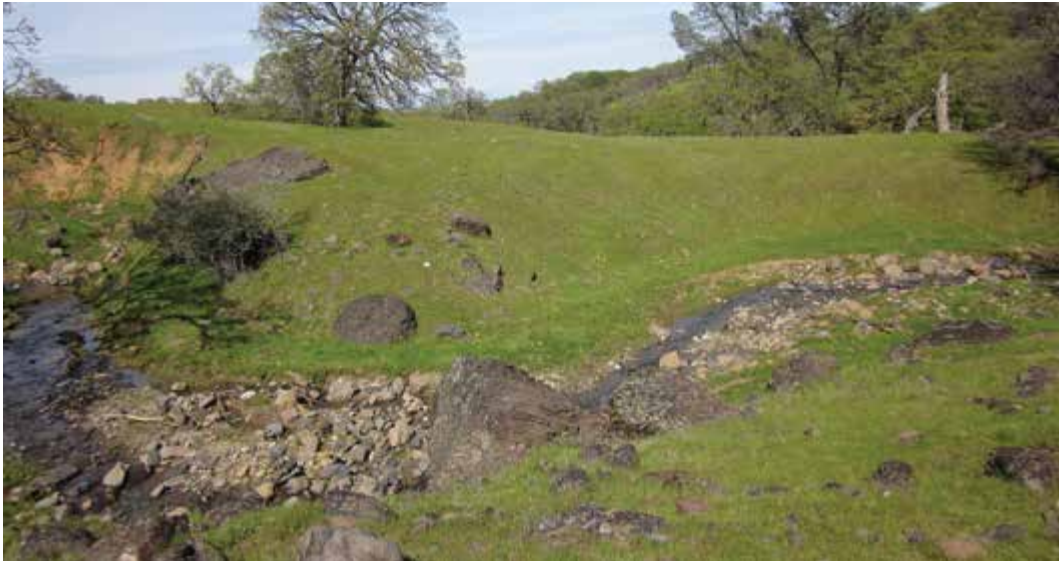
FIGURE 4. Variation in microtopography along a riparian corridor in California rangeland.

The hilly rangelands in Central California often have narrow riparian corridors that contain high spatial variation in short distances along a reach. The deposition of sediment is patchy, either due to steep slopes or fluvial scouring when storm flushes occur. Compared to waterways in flatter terrain in valleys, rangeland riparian corridor sites contain more heterogeneity in soil characteristics and topography (Young-Mathews et al. 2010). As an example, a detailed analysis of two riparian corridors at the Audubon Bobcat Ranch in Yolo County showed a very large range in soil texture (up to 5-fold difference in clay content), soil total carbon (10-fold) and nitrogen (5- to 7-fold), and soil moisture (up to 5-fold) in the zone of about 75 feet from the water's edge (Table 2) (Hodson et al. 2014). The patchiness of soil and rocks is thus a major factor in designing restoration projects in upland riparian corridors. Situations with high variation over short distances and abrupt rather than gradual shifts in substrate require detailed analysis of microsite conditions and management options (Figure 4).

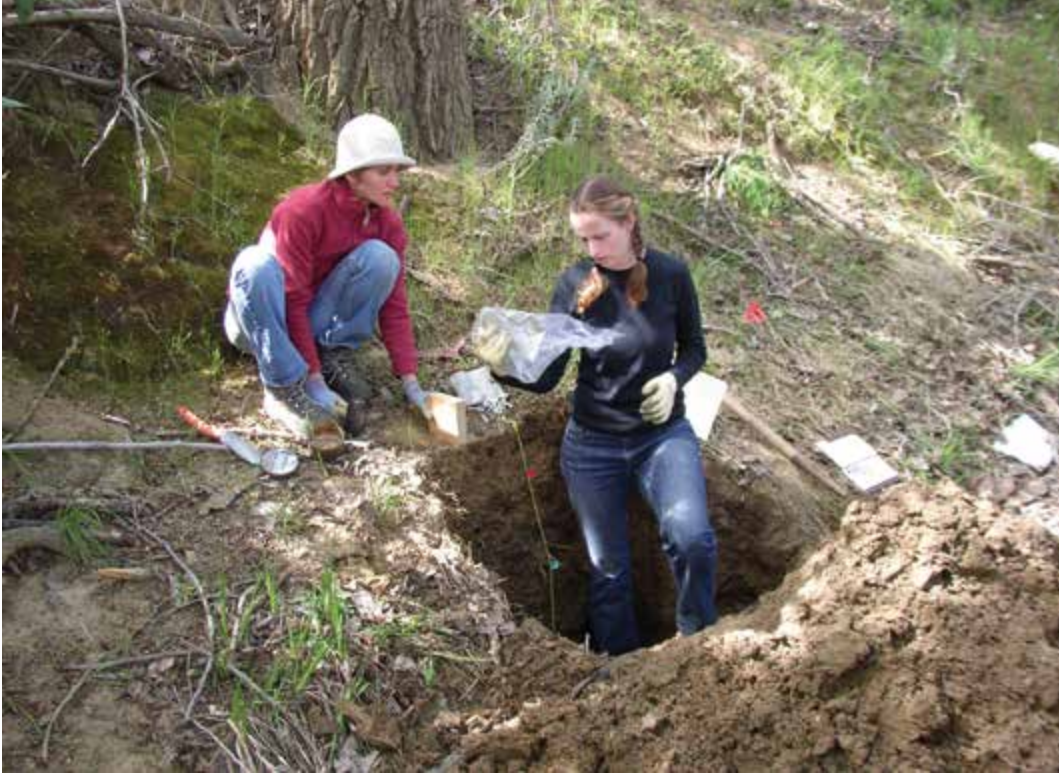
FIGURE 6. Soil pit description and sampling along the floodplain of a rangeland riparian corridor.

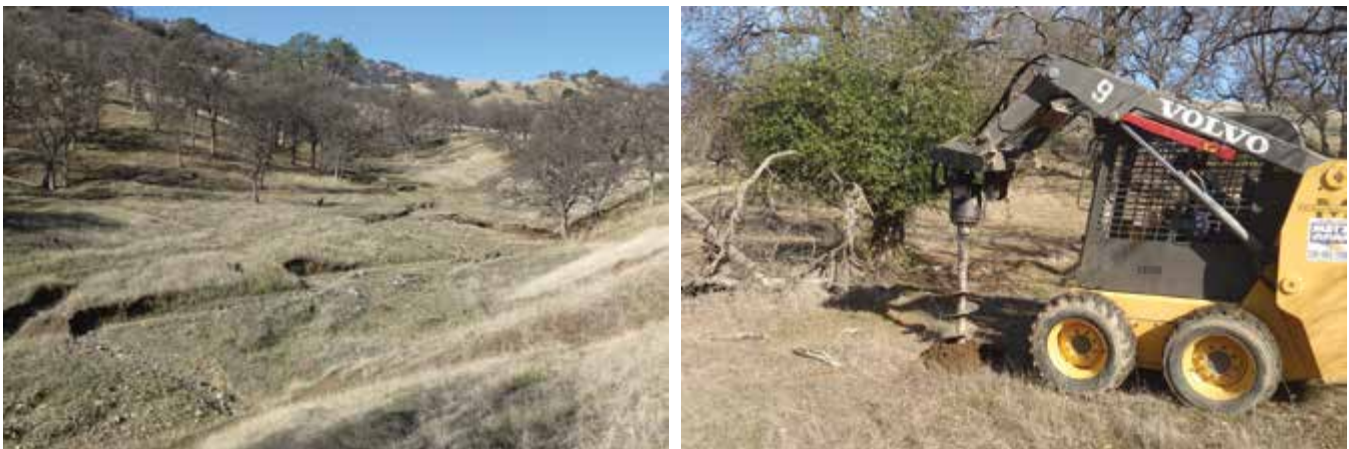
FIGURE 7. Auguring 1- to 2-ft deep holes prior to planting seedlings or acorns. The landscape view shows the slope of the terrain that permits access with the excavator/digger machinery.

Auguring deep, wide holes for planting is an alternative to disking and grading a site (Figure 7). This loosens the soil for exploration by seedling roots and disrupts hardpans that block root access to deeper layers where soil moisture is likely to be higher. Adding a small amount of compost and/or rock phosphate or bone meal to the planting hole improves nutrient availability, and the backfilled hole as well as the surrounding soil around the hole should be moist at planting time (Earnshaw 2004).

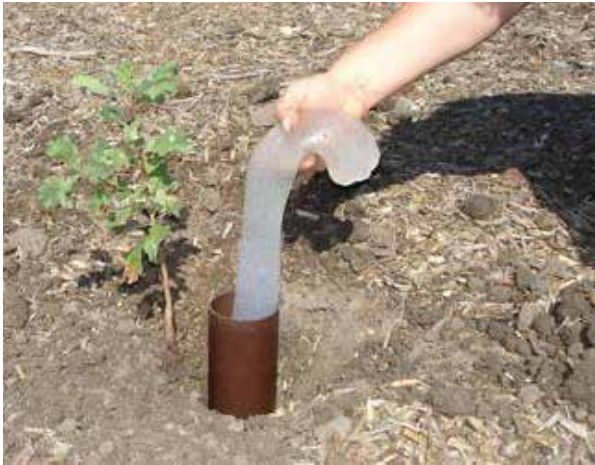
FIGURE 8. DRiWATER® gel is inserted into a biodegradable plastic tube or cardboard carton that is placed a few inches from a planted seedling, and is easily refillable. Photos are from the DRiWATER® website (<http://www.driwater.com/>).

Since irrigation in remote upland rangeland riparian habitats is so difficult to maintain, there is interest in other options for increasing soil moisture. For example, DRiWATER® (<http://www.driwater.com/>) is a patented, natural gel made of food-grade vegetable gums that gradually breaks down when exposed to soil (Figure 8 and 9). It apparently has had success among landscapers and nurseries. The product is described as follows:

“DRiWATER® is made from 98% potable water and 2% food grade ingredients. These ingredients bind the water into a solid gel. When the gel comes in contact with naturally occurring enzymes in soil, the enzymes slowly break down the gel, releasing moisture into the soil delivering moisture to plants between 40 and 90 days. DRiWATER® is not an absorbent polymer or a wetting agent – DRiWATER® is natural and environmentally safe.”

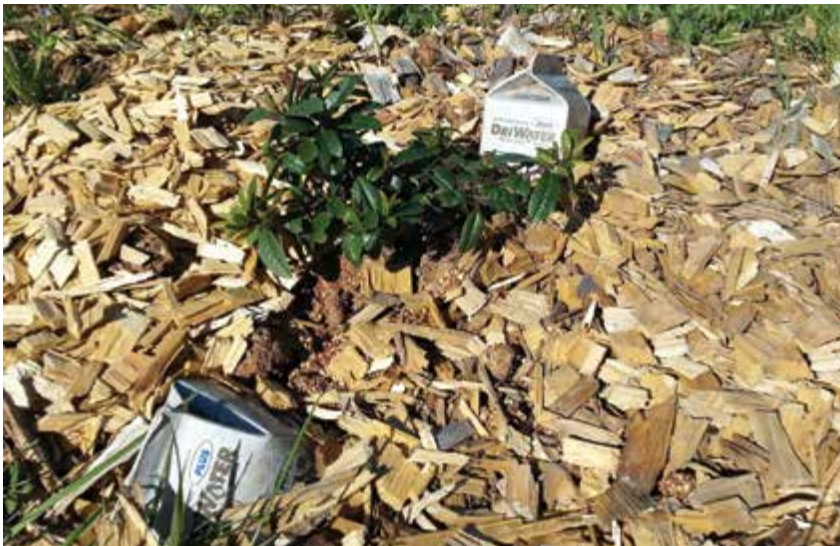
FIGURE 9. Cartons of DRiWATER® gel on each side of a coffeeberry seedling.

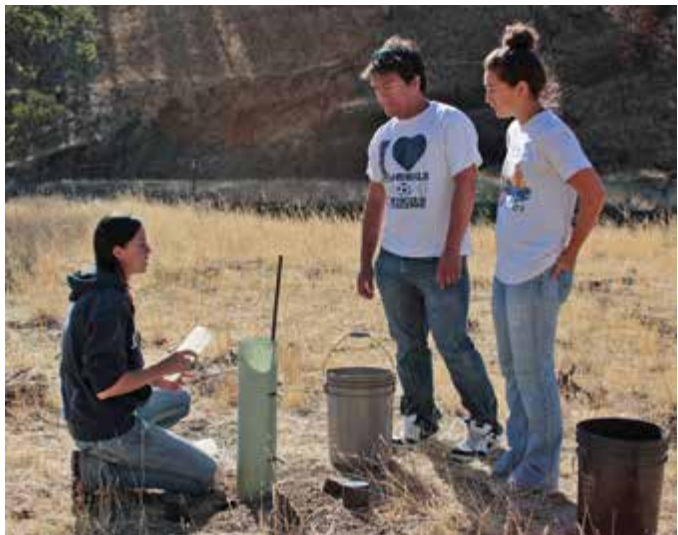
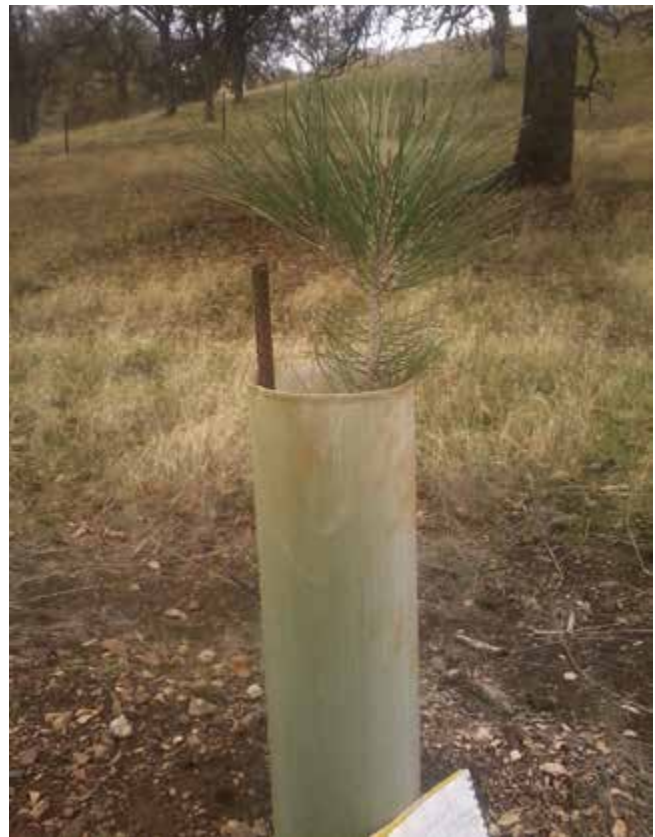
FIGURE 10. Foothill pine in a TubeX tube tree shelter.

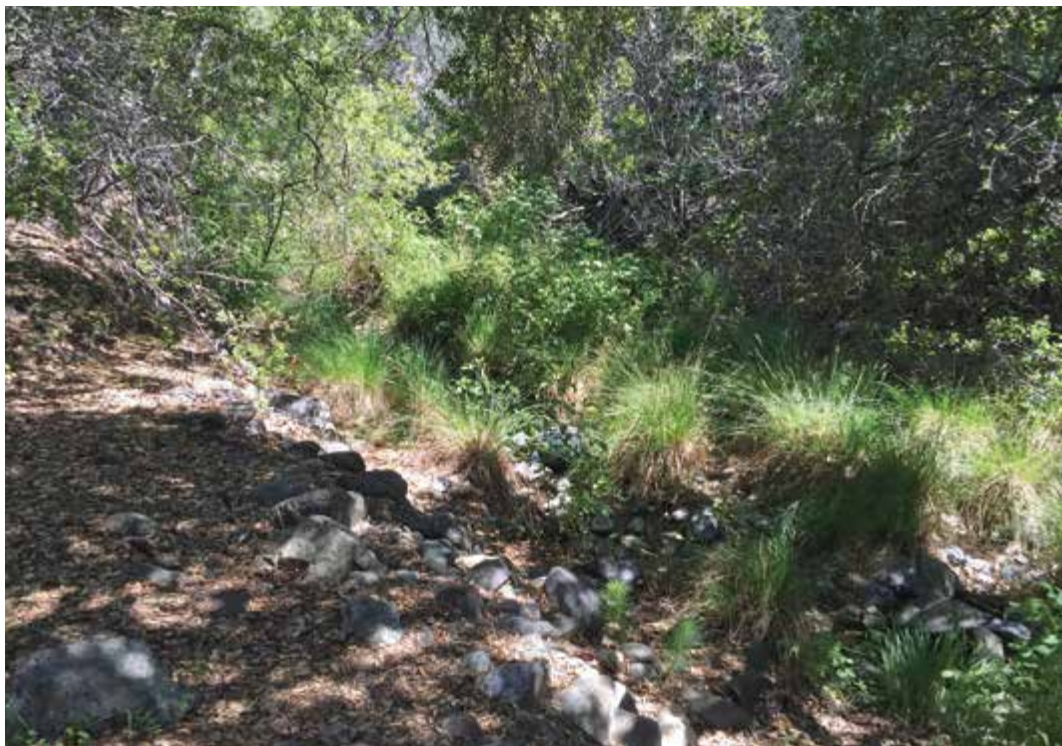
FIGURE 12. Several layers of riparian vegetation occur along rangeland streams that are less disturbed. Almost all the species are perennials, and both deciduous and evergreen woody trees and shrubs are present.

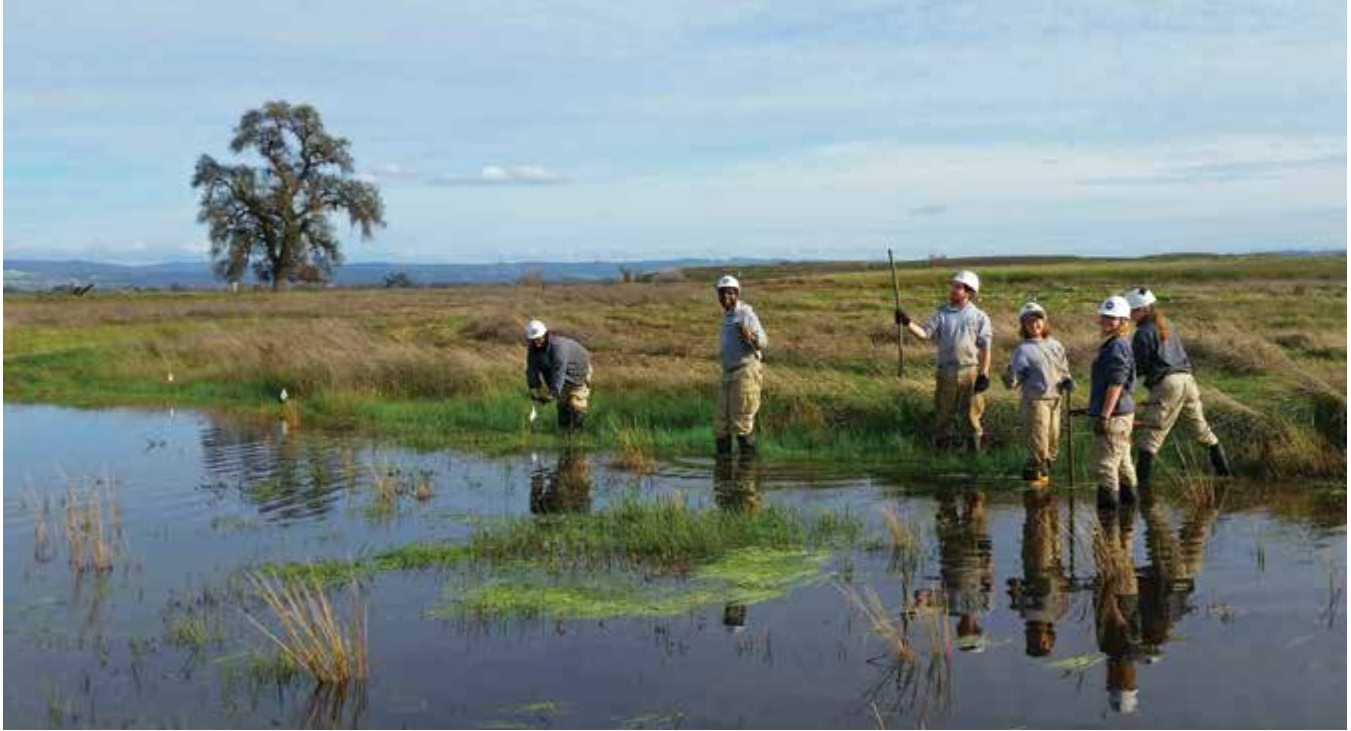
FIGURE 14. b) Work crew planting the stakes along a creek in Placer County.

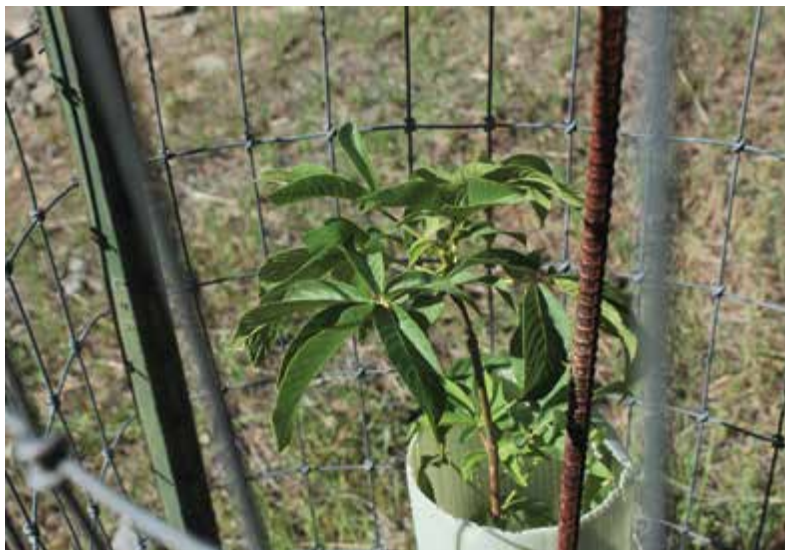
FIGURE 15. TubeX treeshelter around a buckeye (*Aesculus californica*) secured by heavy posts and surrounded by a cage.

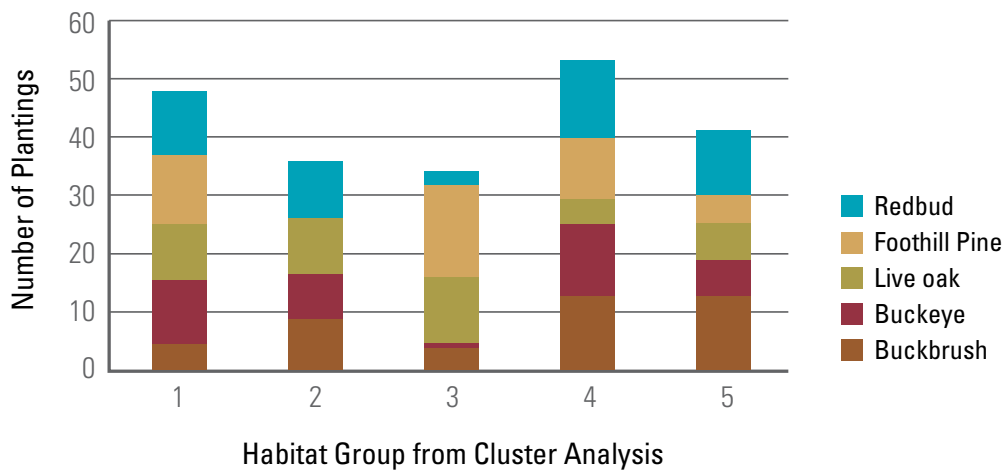
FIGURE 1. The number of restoration plantings in each habitat category identified by cluster analysis at the Audubon Bobcat Ranch in California. Colors correspond to the species composition of plantings assigned to each cluster using Ward’s hierarchical cluster analysis.

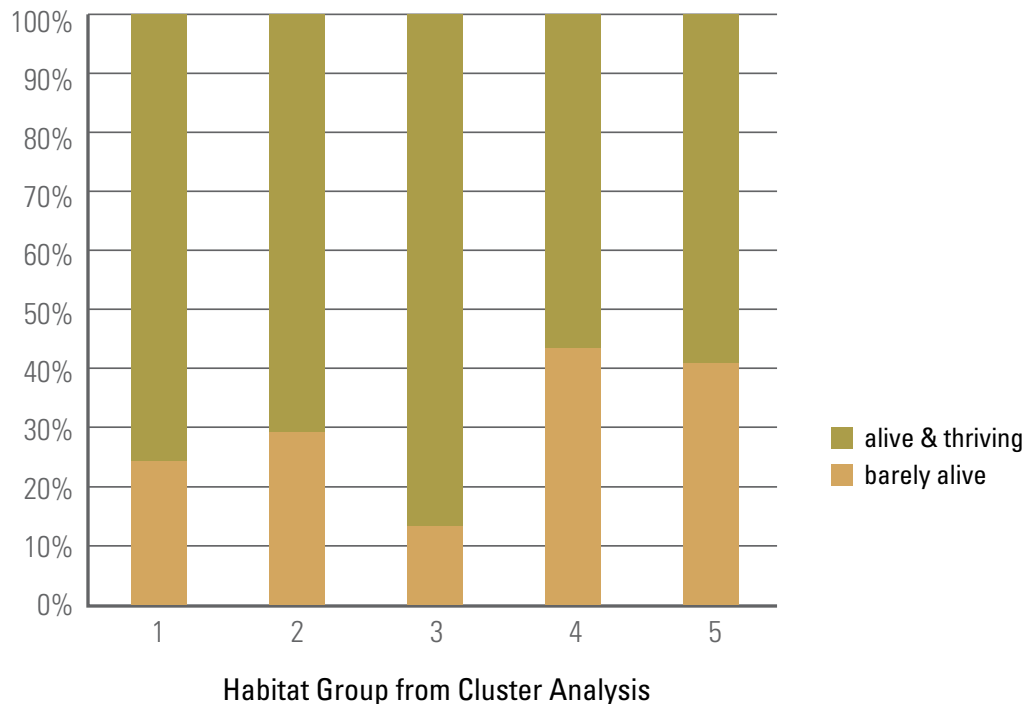
FIGURE 2. Distribution of plant health scores of restoration plantings between habitat group categories identified using Ward’s hierarchical cluster analysis at the Audubon Bobcat Ranch restoration site in California. Plantings were categorized as either ‘barely alive’, ‘alive’ or ‘thriving’. Here the number of ‘alive’ and ‘thriving’ plants have been summed.

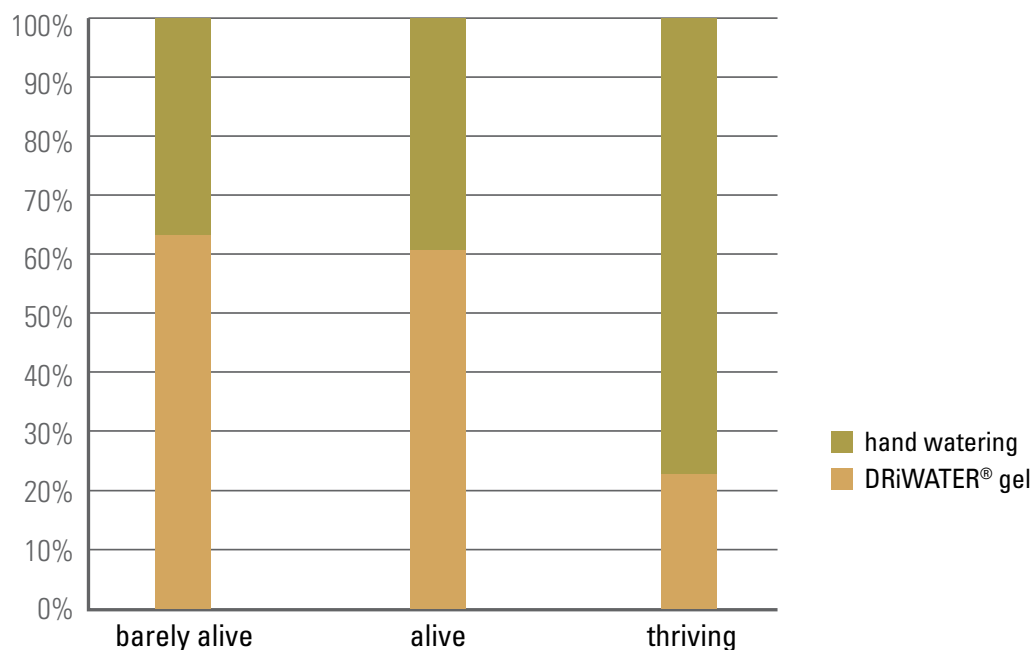
FIGURE 3. The distribution of plant health scores for buckbrush between two management options, DRiWATER® gel or hand watering once a month.

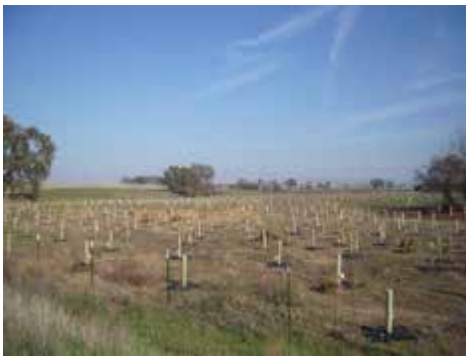
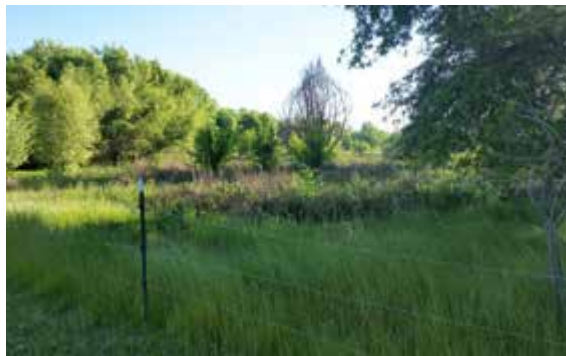
Riparian Floodplain Restoration on Doty Ravine Preserve (2008 California Regional Water Quality Control Board – Supplemental Environmental Project (SEP)). On the left is from the 2006-7 season showing dense thatch of medusahead. The right-hand photo from 2015 shows trees planted in 2008.
