Development of Vegetation and Aquatic Habitat in Restored Riparian Sites of California's North Coast Rangelands

Michael S. Lennox,^{1,2} David J. Lewis,¹ Randall D. Jackson,³ John Harper,⁴ Stephanie Larson,¹ and Kenneth W. Tate⁵

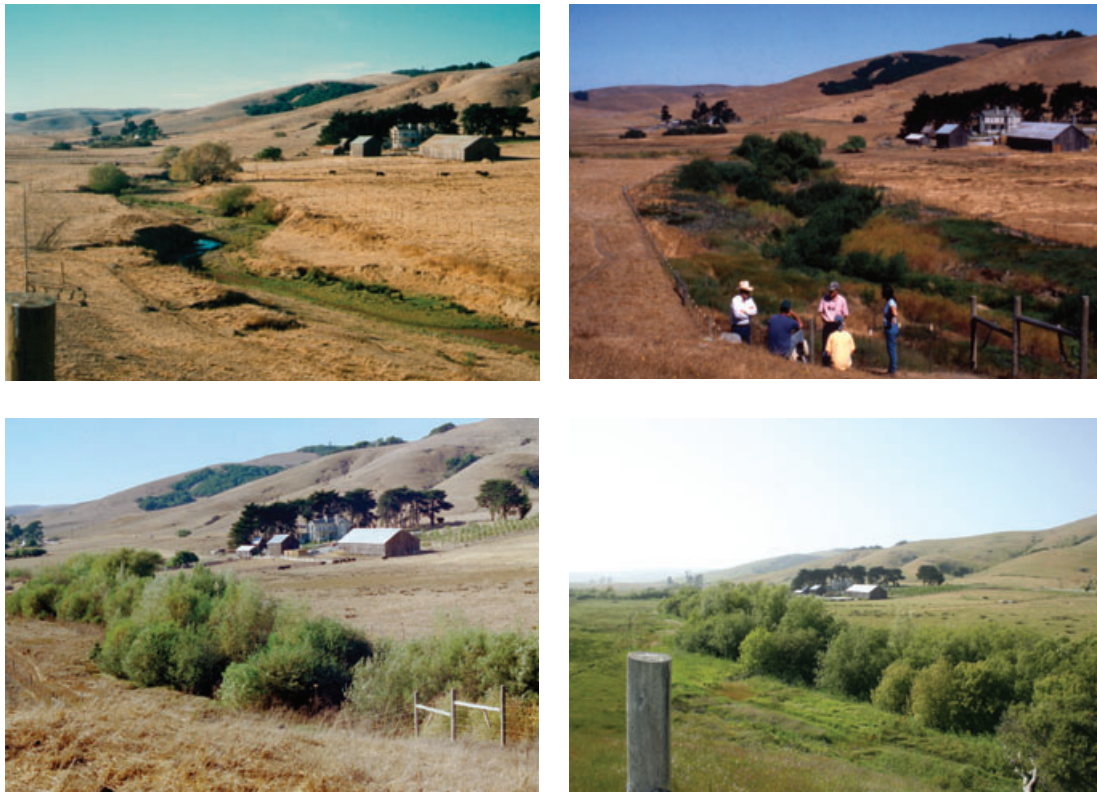
Figure 2. Photographic time-series of an example project site on a tributary to Walker Creek in Marin County, documenting vegetation response at 0 a), 2 b), 8 c), and 12 years d) since restoration occurred (images courtesy of Marin Resource Conservation District).
