RESEARCH ARTICLE

Development of Vegetation and Aquatic Habitat in Restored Riparian Sites of California's North Coast Rangelands

Michael S. Lennox,^{1,2} David J. Lewis,¹ Randall D. Jackson,³ John Harper,⁴ Stephanie Larson,¹ and Kenneth W. Tate⁵

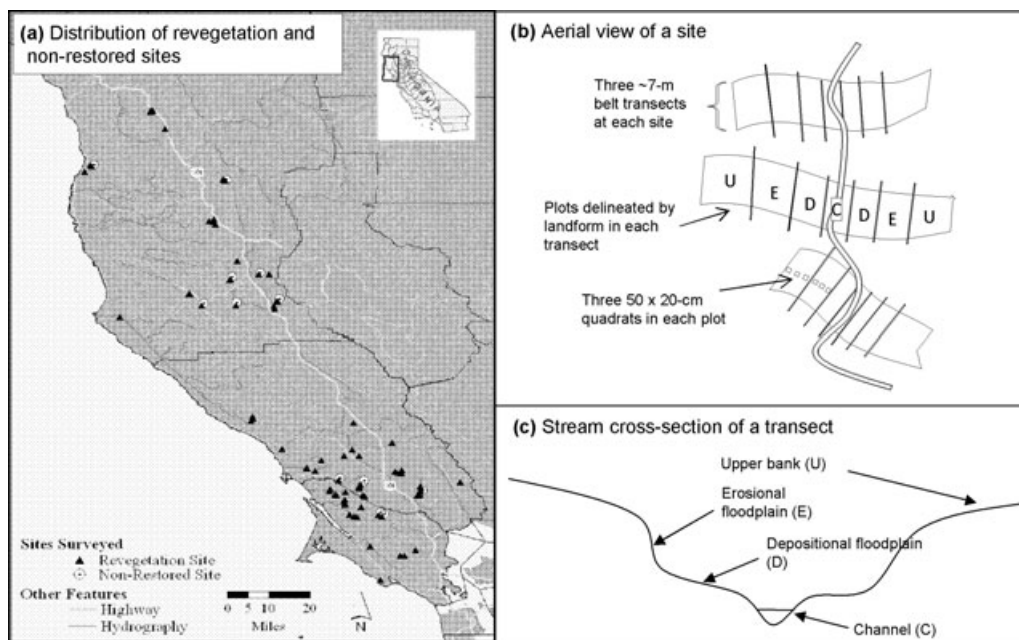
Figure 1. The three county study areas north of San Francisco Bay including locations of restored and nonrestored survey sites (image courtesy of Sonoma County GIS Central) a). Aerial view of an idealized survey site depicting belt transects, plots delineated by landform, and herbaceous quadrats b). Stream channel cross-section showing landforms along a transect c).

We surveyed 102 sites in Marin, Mendocino, and Sonoma Counties (Fig. 1). Sites were selected in collaboration with consultants, agencies, and landowners, whose permission was solicited for access to conduct surveys. Project cooperators identified both "successful" and "unsuccessful" projects to be included in the study. Site selection focused on projects with documented implementation dates in alluvial stream reaches of willow and mixed oak woodland vegetation with few trees present prior to project installation (e.g., Fig. 2a). Surveyed project sites were primarily on second- and third-order streams with a range in project age from 4 to 39 years since restoration.

We characterized riparian forest and aquatic habitats at riparian restoration project sites using 36 ecological attributes collected at 5 nested spatial scales: (1) site ($n = 102$, Fig. 1a), (2) belt transect ($n = 3$ per site, Fig. 1b), (3) landform class ($n = 4$ per transect, Fig. 1c), (4) plot ($n = 2+$ per landform), and (5) quadrat ($n = 3$ per plot, Fig. 1b). Landform classes were delineated by channel morphology and depositional or erosional features adapted from Harris (1987, 1999). Specifically, we used the lowest observed bankfull location and flood-prone elevation ($2 \times$ bankfull depth) described by Rosgen (1996) to delineate plots in the active floodplain. The final plot sampled on each bank extended from the top of the bank to the fence or field edge, and included alluvial

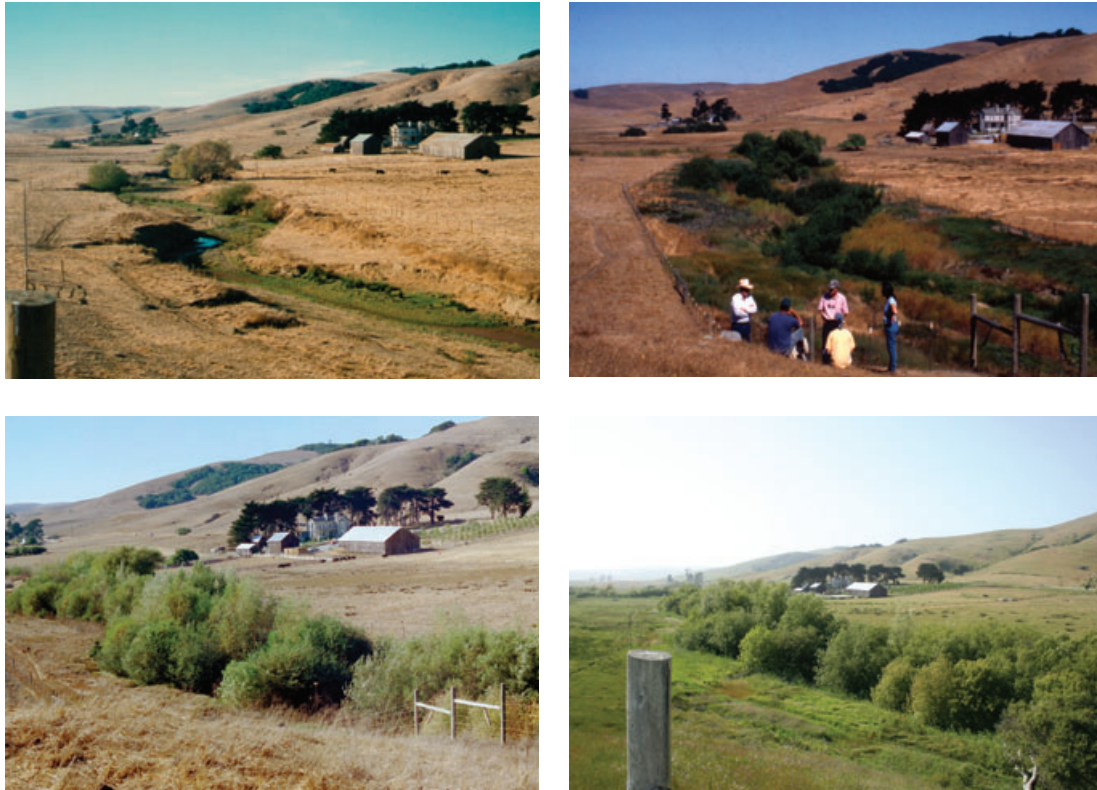
Figure 2. Photographic time-series of an example project site on a tributary to Walker Creek in Marin County, documenting vegetation response at 0 a), 2 b), 8 c), and 12 years d) since restoration occurred (images courtesy of Marin Resource Conservation District).

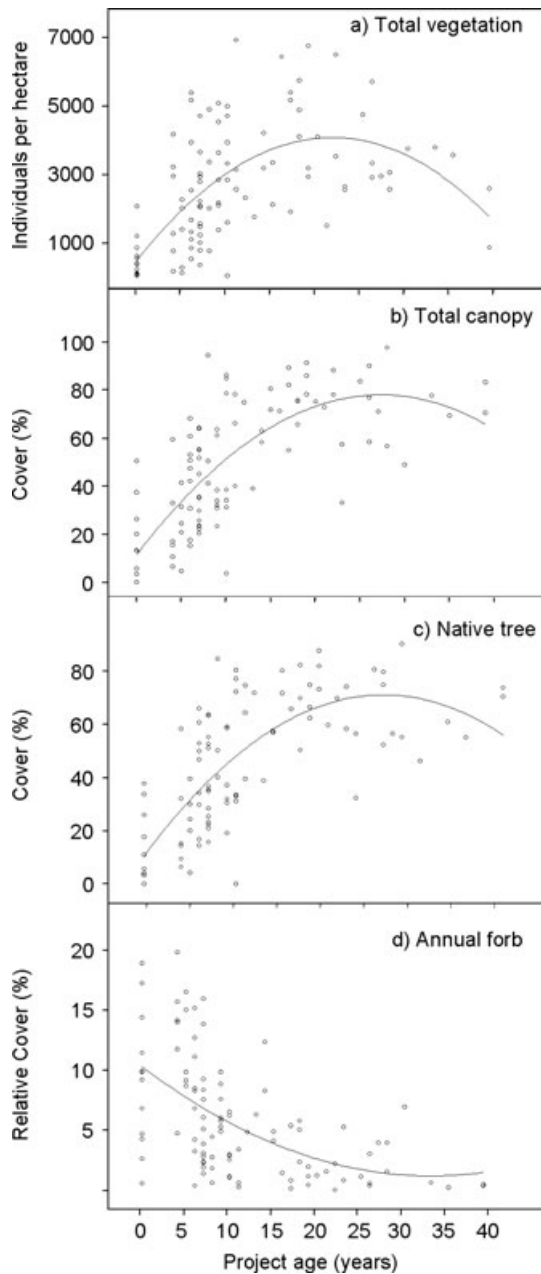
Figure 3. Vegetation attributes as a function of project age ($n = 102$) for total woody density a), total canopy cover b), native tree cover c), and annual forbs relative cover d).

increased. Of all these significant relationships, the best fits were total canopy cover and native tree canopy cover (Fig. 3).

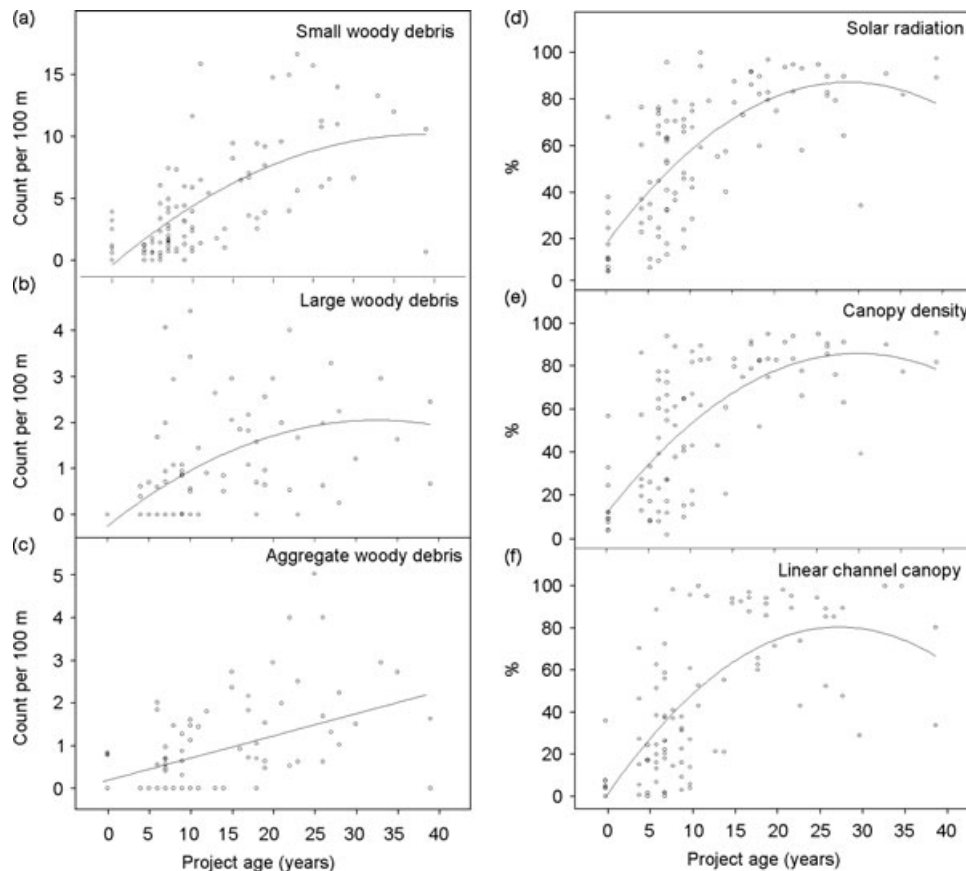
Figure 4. Aquatic habitat attributes as a function of project age ($n = 102$) for small woody debris a), large woody debris b), aggregate woody debris jams c), intercepted solar radiation d), canopy density e), and linear channel canopy f).

Significant relationships with project age were observed for 11 of 15 aquatic habitat metrics, including eight positive and three negative trajectories (Table 2). Stream channel morphology results had significant trajectories for five of the six attributes. The width-to-depth ratio of the bankfull channel had a negative linear relationship with project age. Streambank stability had a positive curvilinear relationship with project age and no relationship was found for bank slope angle. The three woody debris frequency metrics increased over time (Fig. 4). Small and large wood frequencies were best described by curvilinear relationships with project age, while aggregate debris jams of wood were best described by a linear relationship.

Water column attributes had significant trajectories for six of the nine investigated. Stream shade metrics, including intercepted solar radiation, canopy density, and linear channel canopy all increased curvilinearly over time (Fig. 4). Fine sediment and embeddedness showed no significant trajectory. Pool habitat metrics that had curvilinear relationships with project age were maximum and mean pool depth as well as pool habitat type. Pool frequency was not significantly related to project age (Table 2).
