Monitoring Study Group Meeting Minutes

June 24, 2008

South Lake Tahoe—Angora Fire Field Meeting

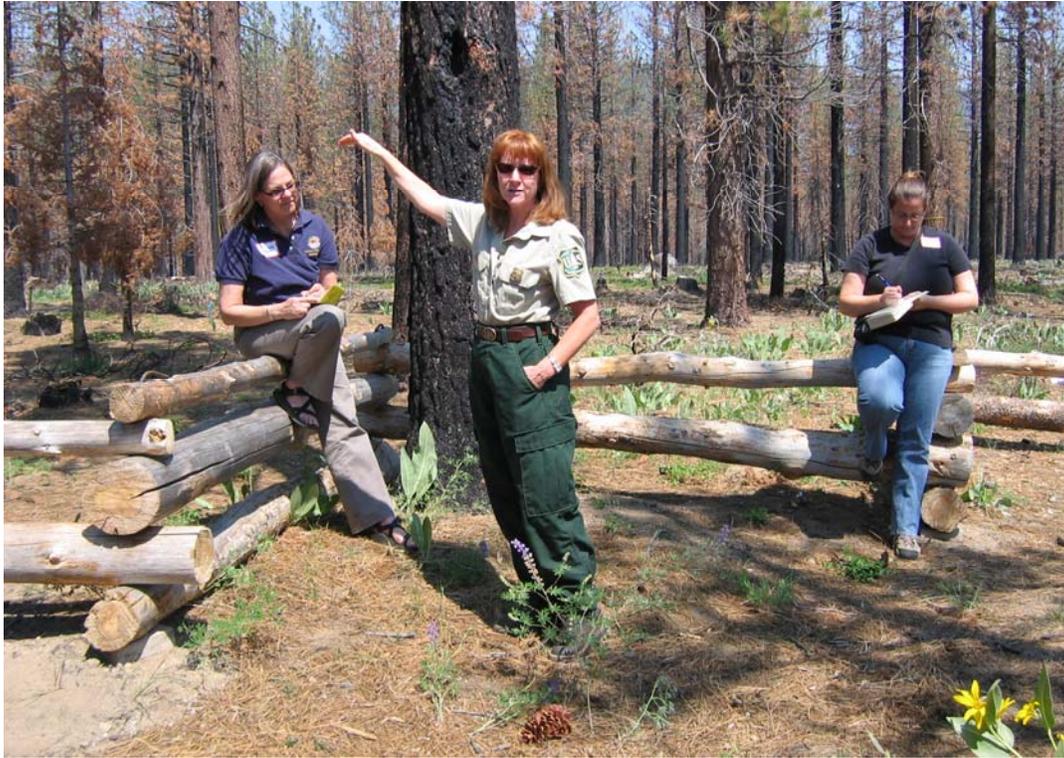
Figure 1. Kathy Murphy, USFS, explaining how fuel treatment areas reduced fire behavior from a crown fire to a surface fire and were effective in reducing fire intensity.

In the field, Kathy showed the group an area where fuel treatment had occurred near a subdivision and was subsequently burned during the Angora Fire (Figure 1). While the pine tree boles were scorched, the majority of the trees have green foliage and survivability appears likely (Figure 2). Hugh Safford, USFS Ecologist, and Doug Cushman, Lahontan RWQCB, provided additional information at this field stop. Hugh informed the group that there is virtually no pine regeneration in the severely burned areas of the fire, since the fire burned before cone drop (only 15 seedlings recorded on 600 plots). Past fire frequency in this area ranged from 5 to 15 years prior to fire suppression efforts. There was considerable discussion regarding why SEZs have not been treated to reduce fire intensity. Doug discussed the complexities involved with proposed management in SEZs, as well as providing a brief overview of Lake Tahoe water quality concerns, congressional designation and funding in the Basin.

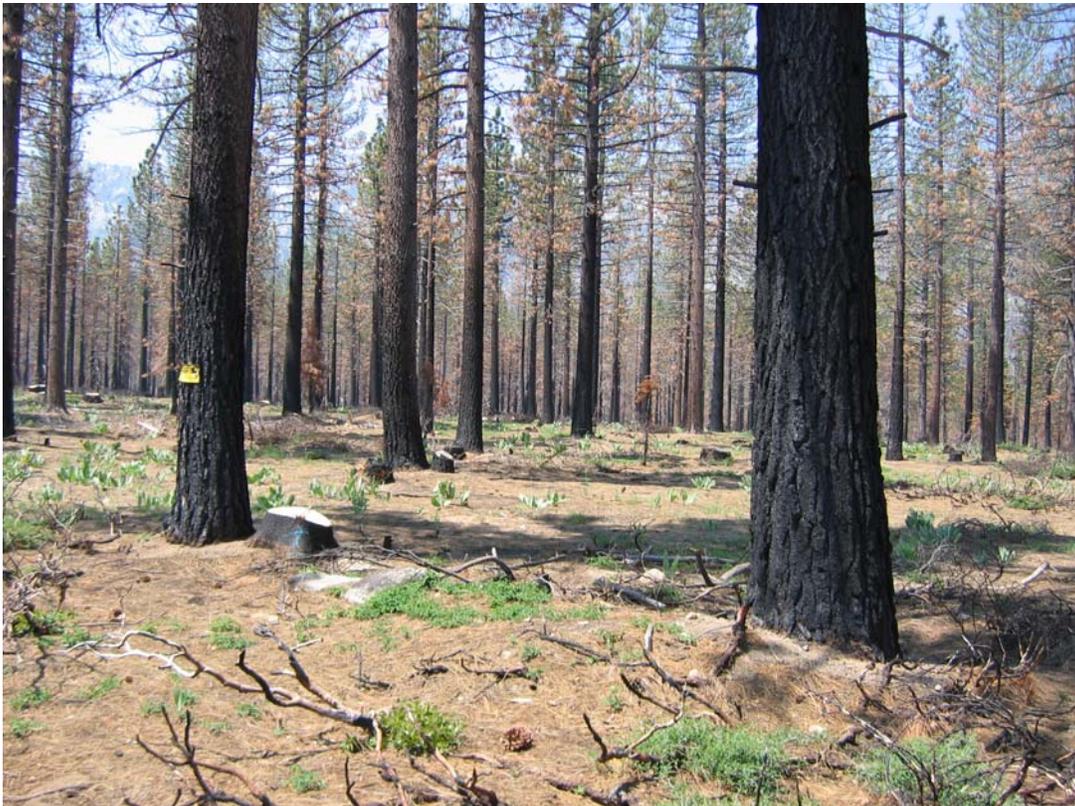
Figure 2. Treated Jeffrey pine stand near a subdivision where fire intensity was reduced.

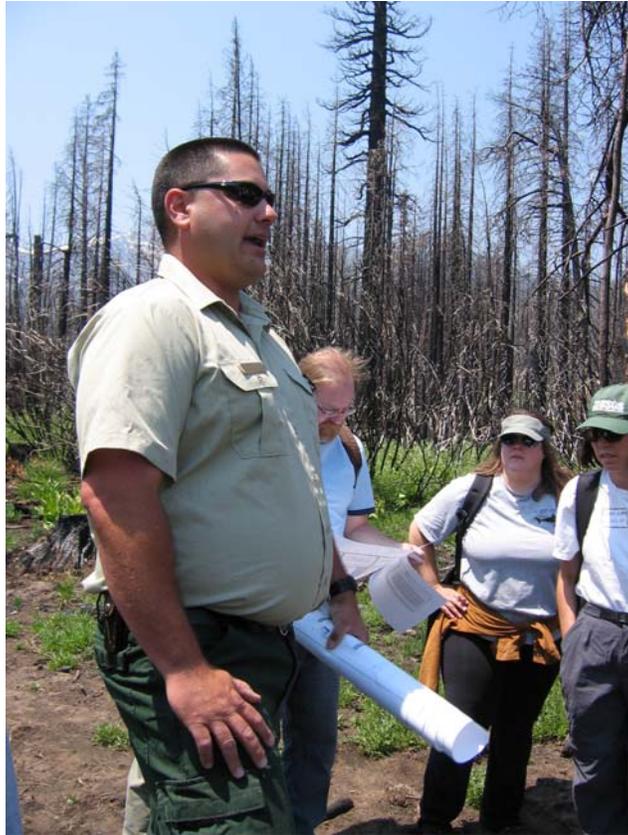
Figure 3. Richard Vacirca, USFS, explaining channel monitoring studies he is conducting in the Angora Creek watershed.

Mr. Richard Vacirca, Aquatic Biologist for the USFS Lake Tahoe Basin Management Unit, explained stream channel condition monitoring work being undertaken to

determine the effects of the fire along Angora Creek, a significant tributary of the Upper Truckee River (Figures 3 and 4). Richard stated that most of the Angora Fire was a stand replacement fire in the upper part of the watershed, with little to no herbaceous vegetation remaining. Due to greatly reduced evapotranspiration (ET), water yield from the upper Angora Creek basin is considerably higher after the fire. The study was instigated to determine if the fire would produce measurable increases in fine sediment storage, lateral channel migration, channel incision, and other changes. Introduced brook trout are the dominant fish species in the channel. Fish population sampling is occurring at three reaches, as well as macroinvertebrate sampling.

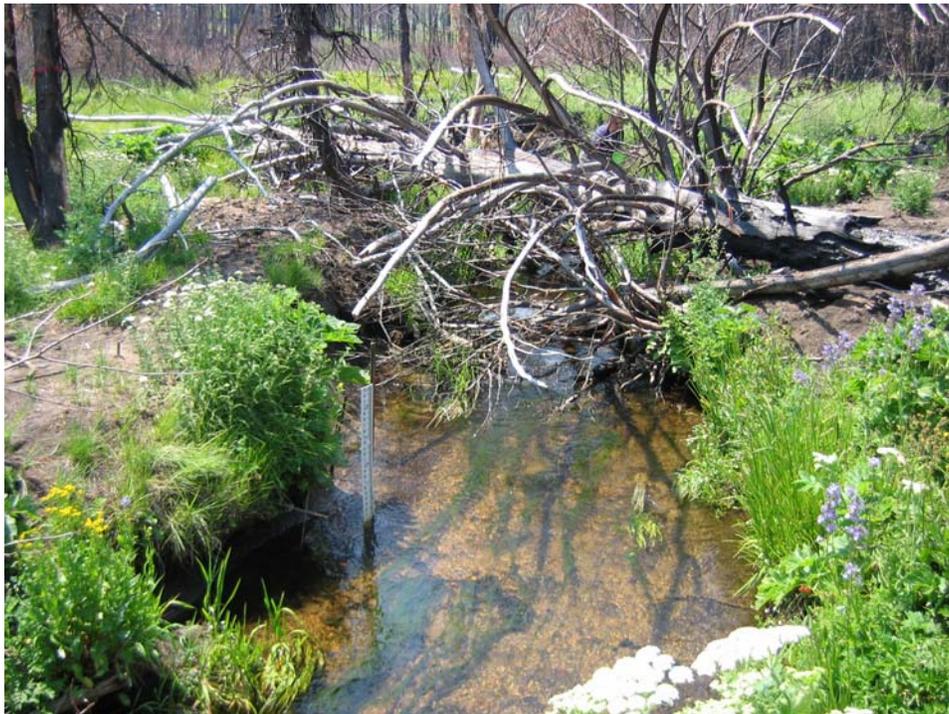
Figure 4. Angora Creek channel monitoring station with staff plate and bank scour pins.

Currently, the Angora Creek channel is incised with limited channel sinuosity, largely related to past management practices in the watershed. Two-year return interval peak flows are estimated to be fully contained in the channel. Channel cross section measurements are being made at three stations that include bank scour pins. A total station survey has been completed for a channel longitudinal survey. Additionally, pebble counts have been completed. Since there were no large flood flows during hydrologic year 2008, very little fine sediment has been deposited in monitored reaches and overall channel impacts have been very minor. The main change has been considerably more water available to the channel from the surrounding wet meadow area. The study is limited by a lack of pre-fire channel data.

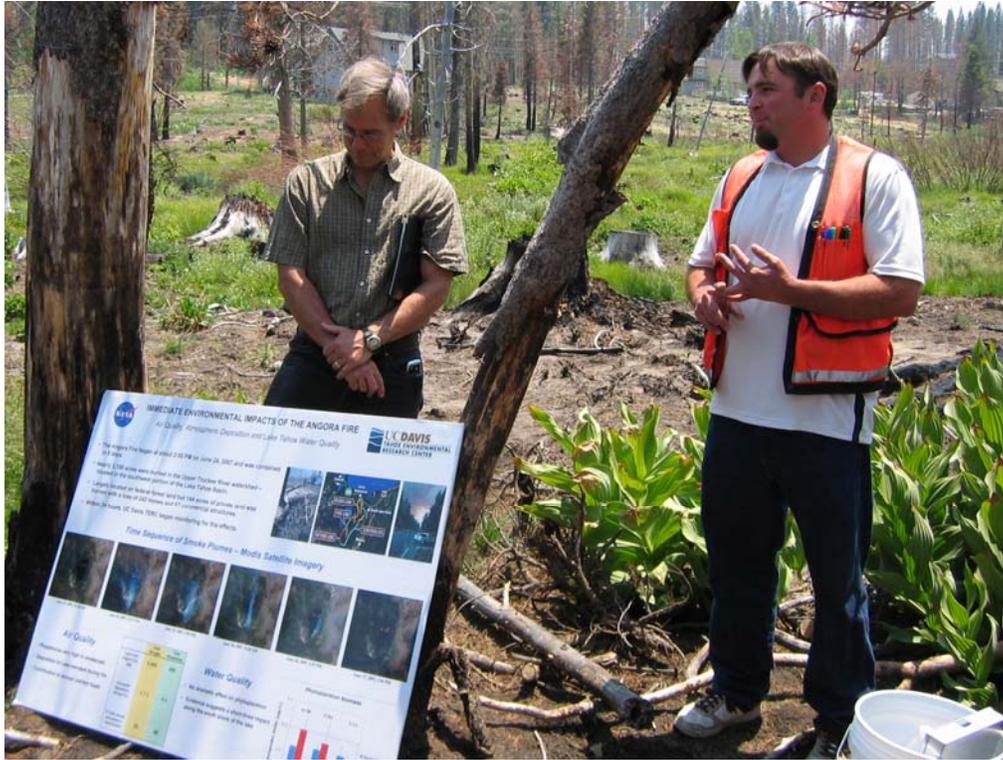
Figure 5. Russ Wigart, El Dorado County, explaining water quality monitoring work being undertaken in Angora Creek. Dr. Alan Heyvaert, DRI, is located to the left of Mr. Wigart.

Following lunch, Dr. Alan Heyvaert, Hydrologist with the Desert Research Institute, Russ Wigart, Monitoring Coordinator for El Dorado County Department of Transportation, and Raph Townsend, Staff Researcher, UC Davis, explained the water quality monitoring they are conducting at three sites along Angora Creek (Figure 5). Alan stressed that this work is a collaborative effort and includes the USGS. Funding was provided by a two year state grant. The upper Angora Creek site (Figure 6) was initially installed in 2002 by Graham Matthews and Associates to monitor turbidity, suspended sediment concentration (SSC) and flow above a meadow restoration project. Following instrumentation improvement, a suite of parameters are currently being monitored, including turbidity, SSC, flow, conductivity, nutrients (total and dissolved nitrogen and phosphorus), pH, dissolved oxygen, and temperature. Both day-to-day and storm event sampling is occurring. Raph explained how the various monitoring equipment operates at this site. Turbidity is recorded with a recording turbidimeter operating without the turbidity threshold sampling (TTS) program (a predetermined “trigger” is used to document SSC and turbidity during the entire storm hydrograph). Turbidity and SSC have been found to be highly correlated ($r^2 = 0.94$).

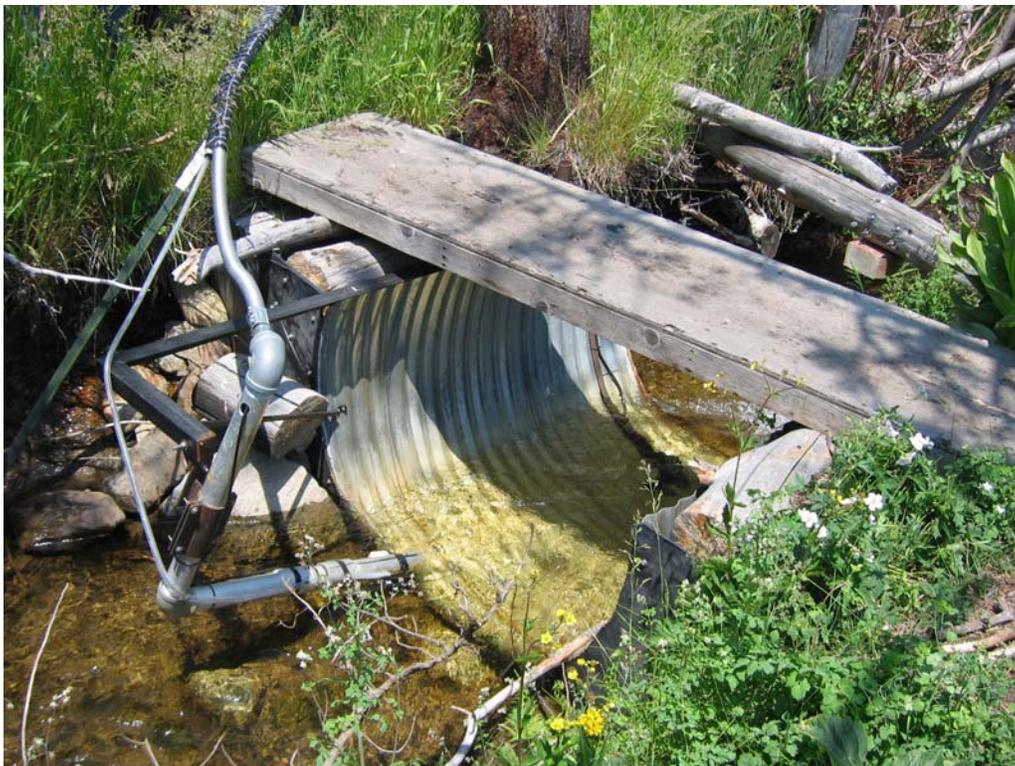
Figure 6. Water quality monitoring station on upper Angora Creek, including boom with recording turbidimeter and a half-round culvert used as a rated section for flow measurement.

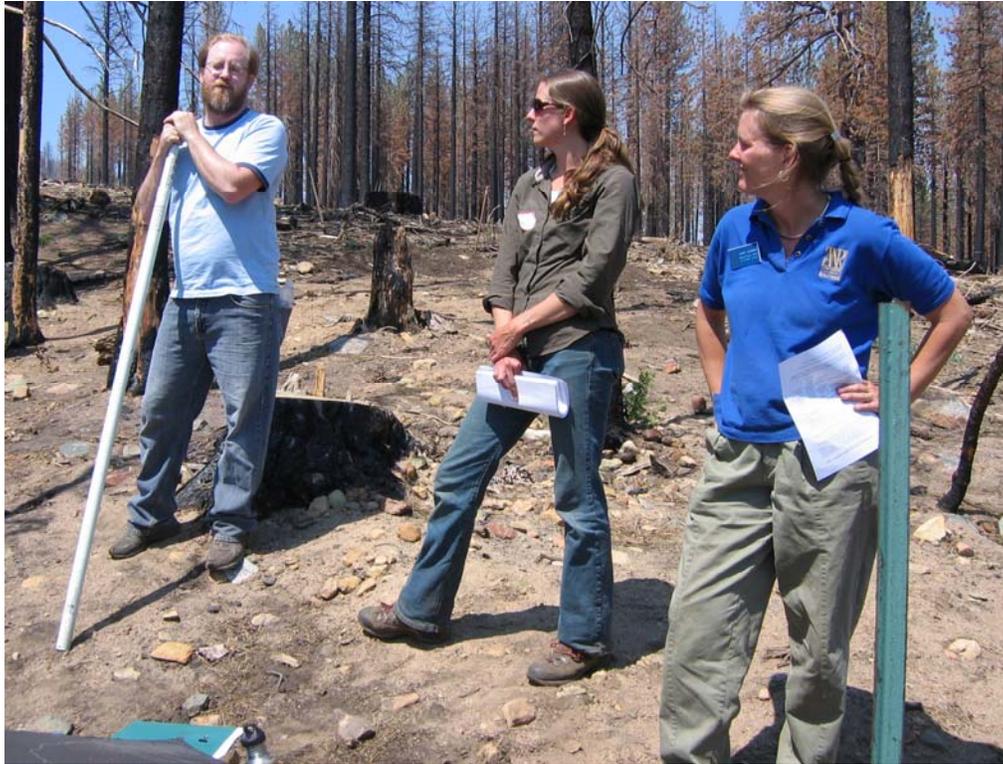
Figure 7. Scott Carroll, CTC, Daylin Wade, CTC, and Susie Kocher, UCCE, explaining hillslope monitoring studies being conducted in the 30 acre “Mule Deer” CTC parcel.

The final field trip stop was the 30 acre “Mule Deer” CTC parcel that was clearcut following the Angora Fire (Figure 7). SPI completed the salvage logging with rubber tired skidders under an emergency contract with the CTC. Logging slash and small dead trees were masticated, with the ground up material spread over the hillslope. Jeffrey pine seedlings were planted at a rate of 200-300/acre and the slopes were reseeded with native forb species. Contour felled logs were also placed on the hillslope to reduce surface erosion. Susie Kocher, UCCE, explained that a suite of monitoring projects are taking place on this parcel, including soil strength measurement (an index of soil compaction) made with a recording cone penetrometer, silt fences, erosion pins, channel longitudinal profiles, and vegetation plots.² The goal of the monitoring work is to evaluate the effectiveness of post-fire restoration treatments completed by the CTC. Objectives of the practices were to reduce soil erosion, accelerate forest recovery, and reduce fuel loading.

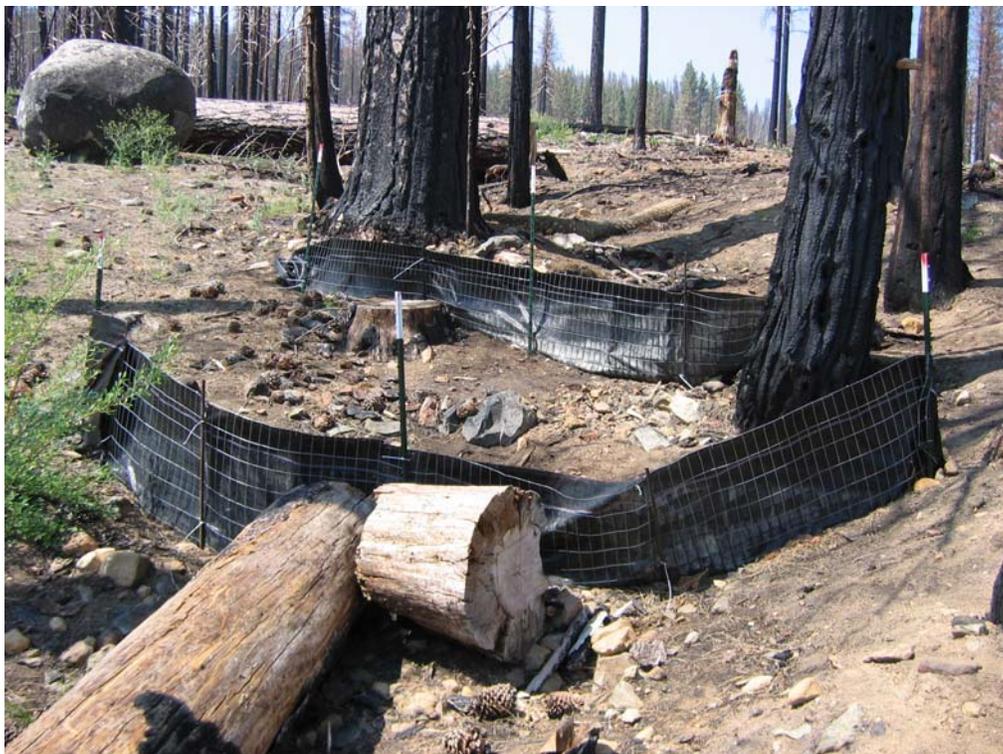
Figure 8. Silt fences installed in an ephemeral tributary channel of Angora Creek to measure sediment contribution from the treated hillslopes.

Daylin Wade, Forestry Program Assistant with the CTC, explained how the silt fences were constructed last fall along a small ephemeral tributary of Angora Creek located within the 30 acre parcel. Three sets of fences were installed, each with two fences located about four feet apart to increase trapping efficiency (Figure 8). Following the spring of 2008, accumulated sediment was removed from all but one of the fences. Overall, 65 five gallon buckets of wet sediment was removed and weighed. Samples were taken to determine moisture content, which will allow the dry weight of the material removed to be determined. A unit area sediment production rate will be calculated and compared to estimates produced from the WEPP model (no control conditions were available within the burn area). Scott Carroll, CTC, covered the longitudinal profile survey work that has been conducted along the channel. The profile was shot last fall prior to winter storms and again this spring. The only small change noted to date has been where sediment has filled in behind coir logs that were installed in the channel after the original survey. A net filling of approximately 3.5 cubic yards has been recorded. No significant channel changes have occurred and filling behind the logs is likely natural erosion. Susie Kocher explained how the Rimik CP40 cone penetrometer operates to record soil strength. Measurements were taken at 39 plots after the fire, following treatment, and again in May/June 2008. Soil moisture content is also measured, since soil strength is related to moisture. Soil strength data will be analyzed to determine if there was a significant increase in soil compaction following treatment. Measurements will continue for five years.
