# Post-Fire Erosion Control

## Mitigating Hillslope Erosion Following a Wildfire

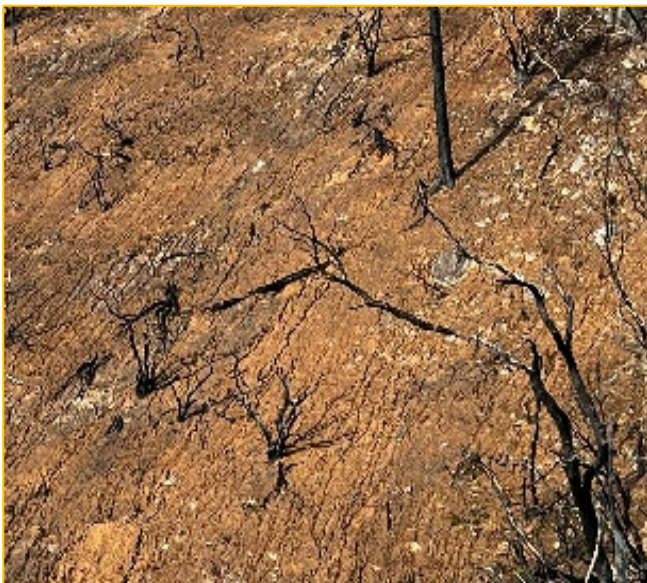
Image 1. Formation of rills following the 2022 Oak Fire  
[Credit: Alison Deak]

Hillslope erosion occurs through three processes: (1) rainsplash when raindrops hit bare soil and detach soil particles; (2) sheeting from water flowing over weakened soils and carrying soil particles along with it; and (3) rilling, the process of water becoming concentrated in incisions on the landscape and developing into larger flow paths if not mitigated (Image 1).

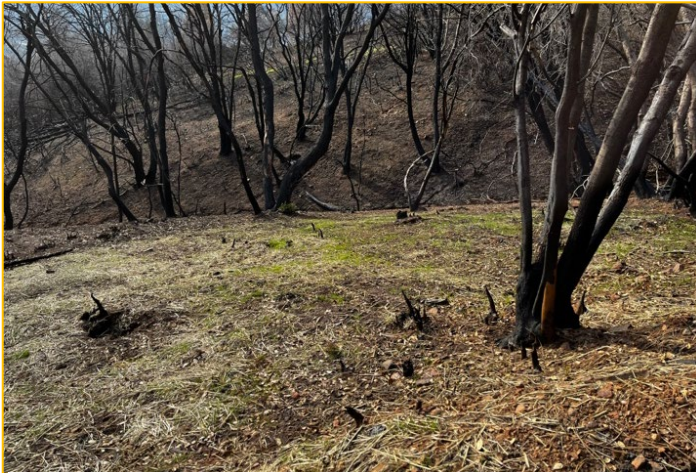
Image 3. A successful straw mulching treatment  
[Credit: Alison Deak]

**Agricultural straw mulching** is a low-cost and effective erosion control strategy, but it may be less effective during high-intensity rainfall events than wood mulch and has the potential to be transported off hillslopes by wind (Image 2). Straw mulches also come with the risk of introducing non-native species that could compete with regenerating native vegetation, even if certified weed-free (Shive et al. 2017).

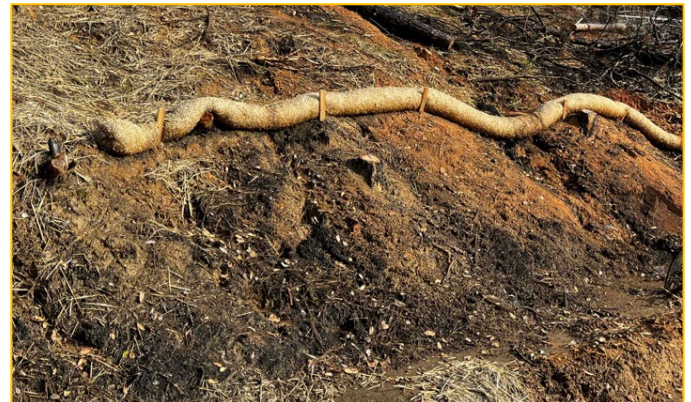
Image 2. A failed erosion barrier that led to channelized flow during a high-intensity rain event [Credit: Alison Deak]

they may be expensive to install if using off-site materials and are likely to fail during short-duration high intensity rainfall events because they do not provide ground cover and can channelize flow if installed incorrectly (Image 3; Robichaud et al 2008). Erosion barriers can be constructed using either contour log felling or straw wattles.
