**ENVIRONMENTAL CONSULTING SERVICES
UC-ANR INTERMOUNTAIN RESEARCH AND EXTENSION CENTER
TULELAKE, CA 96134**

**08/24/2021
Millennium Project No.: 21015.2001**

Millennium Consulting Associates (Millennium) performed a campus-wide hazardous materials survey at Intermountain Research Center for the University of California Agriculture & Natural Resources (UC ANR in accordance with the scope of work determined by UC ANR to include the investigation, assessment and testing of materials in facilities that are known to have asbestos and lead paint, as well as other aged facilities that may have residual hazardous materials. The project is being conducted to determine the existence of Asbestos Containing Materials (ACM) in specified buildings. The lead and polychlorinated biphenyl (PCB) component of the survey are for hazardous communication notification, waste profiling, and disposal purposes for contractors and subcontractors as needed for planned future projects. In addition, a quantification was conducted of other regulated materials (fluorescent light tubes, potential PCB-containing light ballasts, exit signs, etc.) within interior and exterior areas of the buildings surveyed. Millen

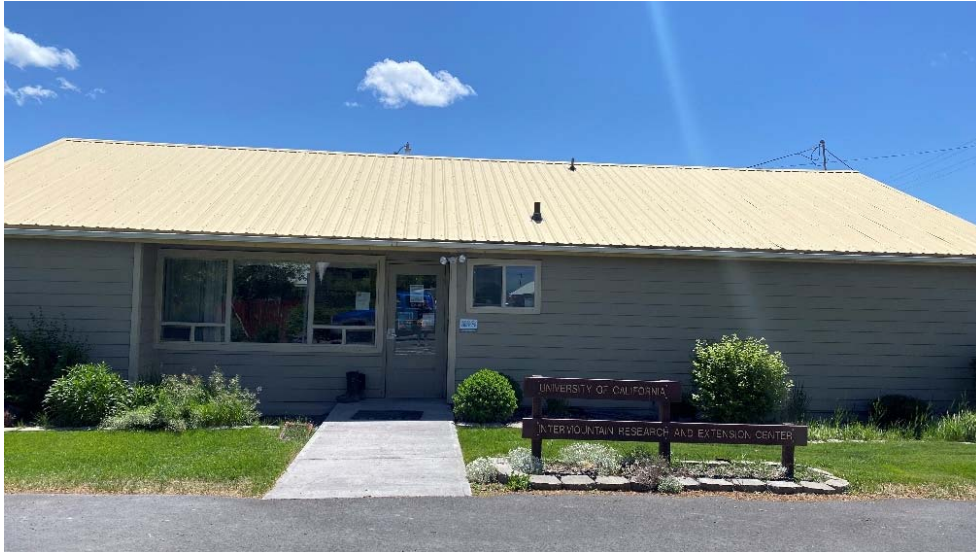
Building 101 is referenced as the office & laboratory building and is located in the center of the Intermountain Research & Extension Center (IREC) campus. It is an office building that occupies approximately 1,674 gross square feet. The building consists of a laboratory space, dining room, storage and mostly office spaces for administrative activities. The flooring consists of a mix of vinyl flooring and laminate flooring throughout. The walls consist of drywall systems within the building along with acoustical ceiling tiles. The exterior walls are comprised of metal siding on a cement foundation, and a pitched metal roof.

According to the IREC Asbestos Inventory updated in January 2020 and confirmed by the onsite representative, building 101 has ACM flooring residing under newly installed laminate flooring, and should be considered present throughout the structure. The materials sampled in this building include:

ORMs observed within building 101 were limited to forty (40) fluorescent light tubes and twenty (20) light ballasts.

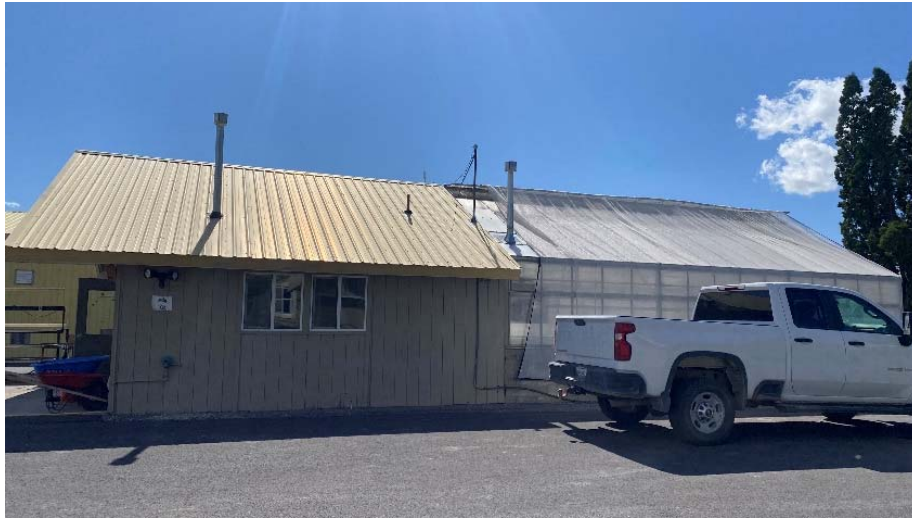
Building 102 is referenced as the potting shed and greenhouse in the center of the Intermountain Research & Extension Center campus, and totals 1,277 square feet. The structure has concrete walking areas within the greenhouse while the potting shed consists of metal siding and a pitched metal roof.

According to the IREC Asbestos Inventory updated in January 2020, building 102 has ACM pipe lagging in the walls of the potting shed; Millennium inspectors could not locate any pipe lagging from accessible locations within the potting shed, and it should be considered present within the walls of the structure. The materials sampled in this building include:

ORMs observed within building 102 were limited to nine (9) fluorescent light tubes and six (6) light ballasts.

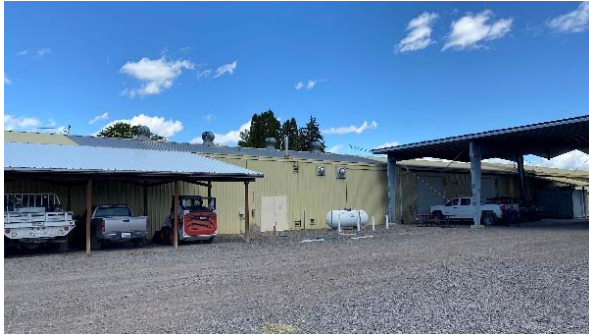
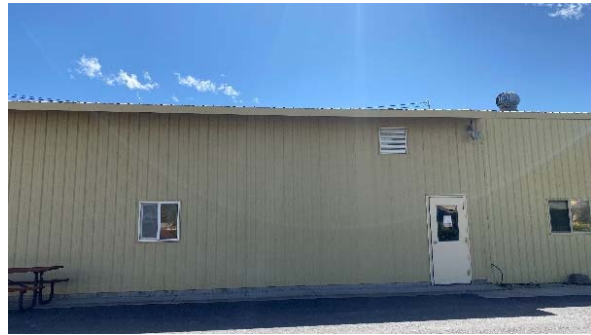
Buildings 103 & 104

Building 103 is a large multipurpose building referenced as the potato research facility, and totals approximately 1,440 gross square feet. The building materials consist of metal roofing and siding, and cement floor.

In addition, building 104 is an addition to building 103 on the south side and consists of metal roofing and siding. The materials sampled in this building include

ORMs observed within building 103 were limited to ten (10) fluorescent light tubes and five (5) light ballasts.

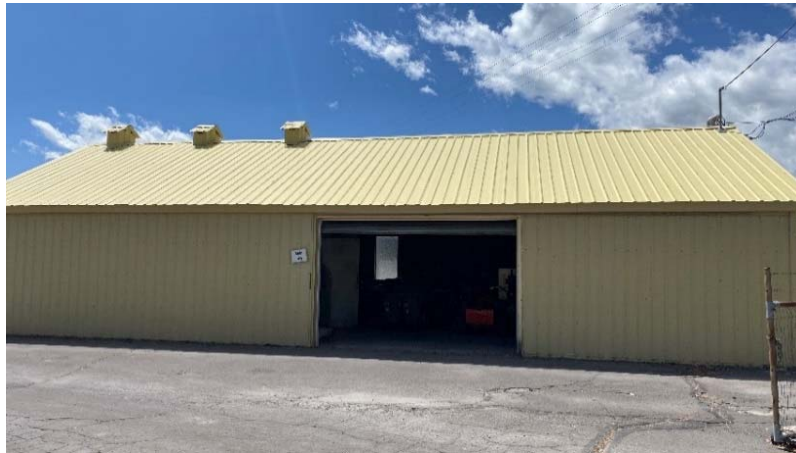
Building 202 is referenced as the potato cellar & glass house and totals 1,200 square feet. The building consists of the metal siding and a pitched metal roof. The materials sampled in this building include:

ORMs observed within building 202 were limited to twelve (12) fluorescent light tubes and nine (9) light ballasts.

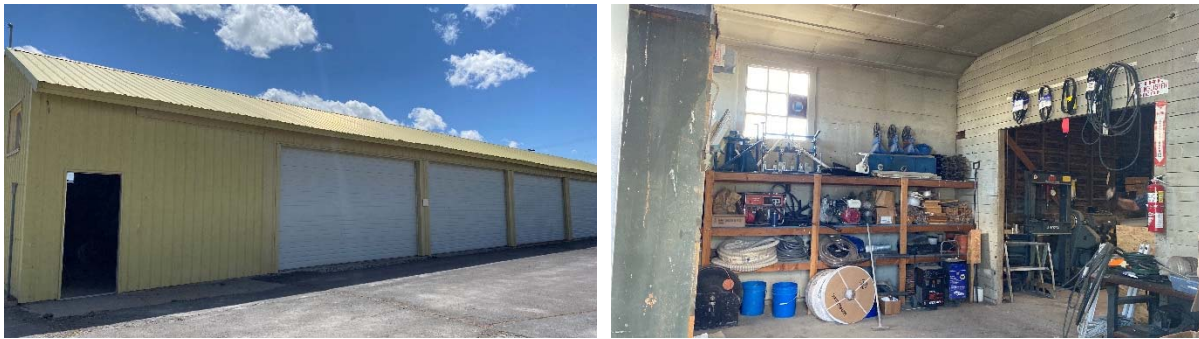
Building 203 is referenced as the shop and machinery storage and is located in the center of the Intermountain Research & Extension Center campus and totals 2,313 square feet. The building consists of the metal roof and siding, interior wood construction and a cement pad.

According to the IREC Asbestos Inventory updated in January 2020 and confirmed by the onsite representative, building 203 has ACM transite wall panels; these panels were observed to not have warning labels, and were sampled to confirm asbestos-content. The materials sampled in this building include:

ORMs observed within building 203 were limited to sixteen (16) fluorescent light tubes and eight (8) light ballasts.

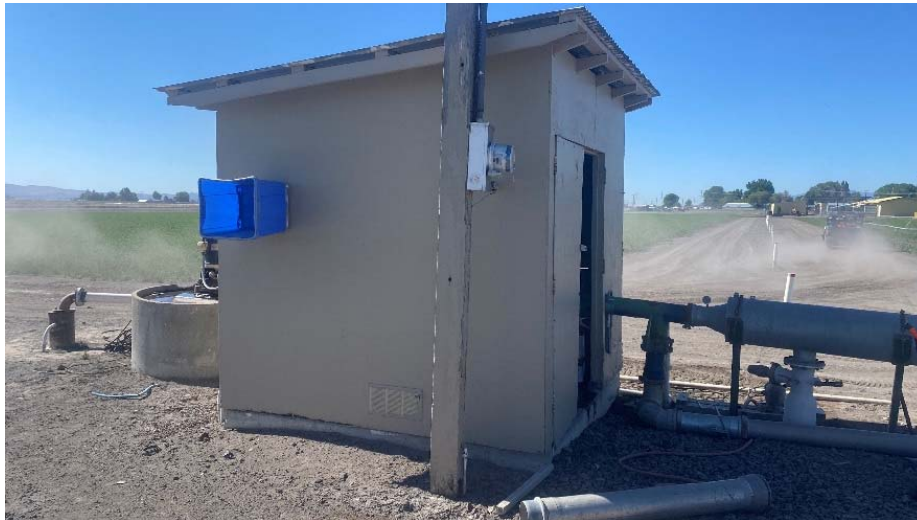
Building 204 is referenced as the pump house and is located on the north side of the Intermountain Research & Extension Center campus and totals 64 square feet. The building consists of wood construction with a metal roof and a cement pad. The materials sampled in this building include:

No ORMs were observed within building 204.

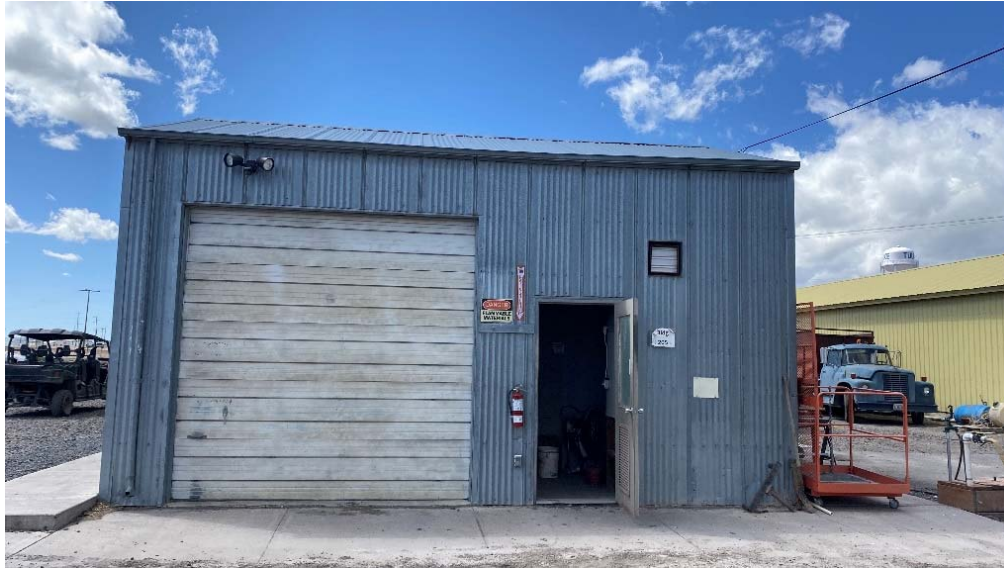
Building 205 is referenced as the pesticide storage and is located in the center of the Intermountain Research & Extension Center campus and is approximately 800 square feet. It is a small square-shaped building and consists of steel walls and roof, with concrete flooring.

ORMs observed within building 205 were limited to two (2) fluorescent light tubes and one (1) light ballast.

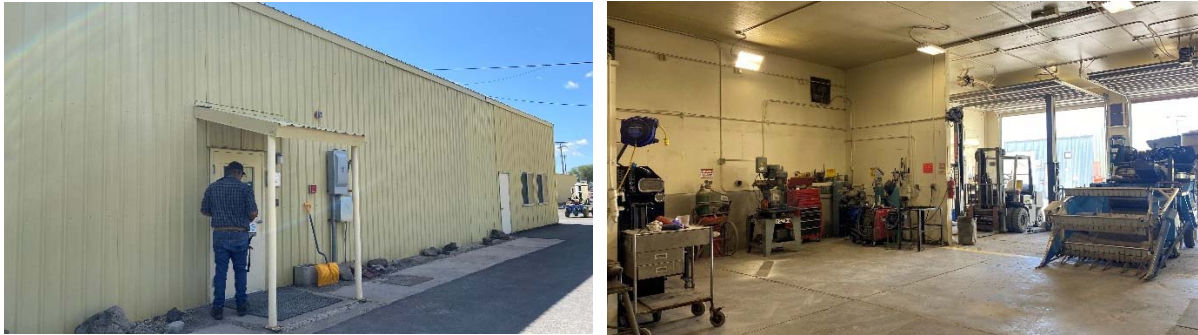
Building 206 is referenced as the seed-repair shop and is attached to the south side of building 104 and totals 2,304 square feet. The building consists of corrugated metal walls and roofing with concrete flooring.

According to the IREC Asbestos Inventory updated in January 2020 and confirmed by the onsite representative, building 206 has ACM transite wall panels at the base of most walls. These were observed to have warning labels, and were not sampled. The materials sampled in this building include:

ORMs observed within building 206 were limited to forty (40) fluorescent light tubes and twenty-one (21) light ballasts.

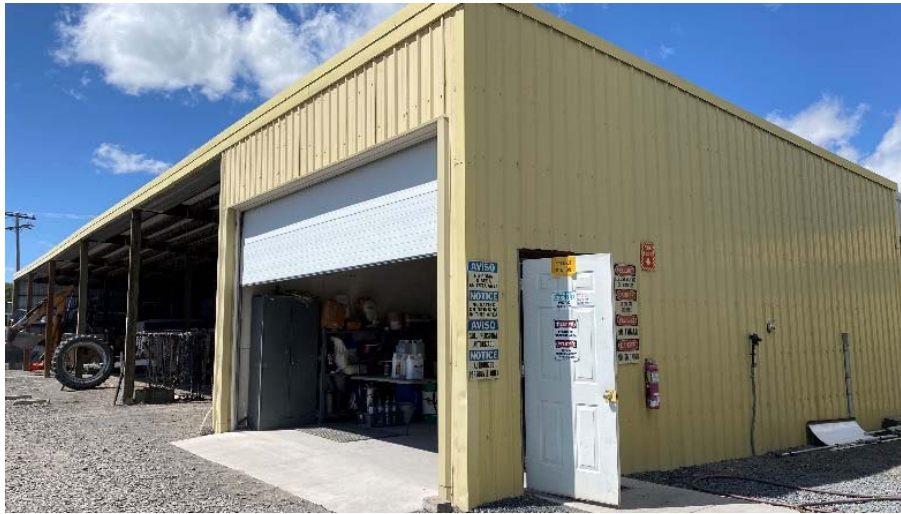
Building 207 is referenced as the equipment storage and is located in the center of the Intermountain Research & Extension Center campus. It is a rectangular shaped building that occupies approximately 3,600 gross square feet. The building consists of open-bay warehouse storage areas. The exterior walls are corrugated metal, and the roof is corrugated metal roofing. The materials sampled in this building include:

ORMs observed within building 207 were limited to eight (8) fluorescent light tubes and four (4) light ballasts.

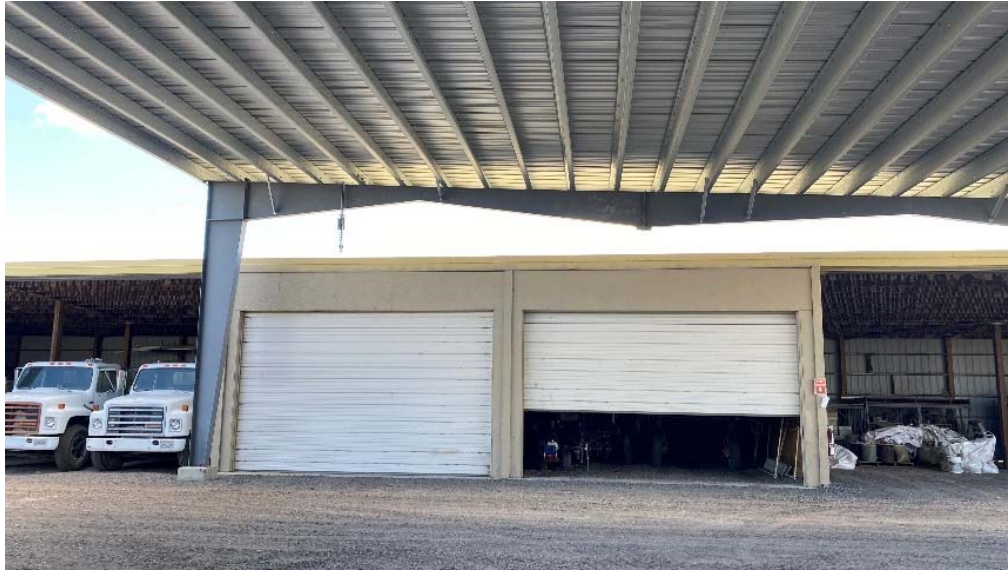
Building 208 is referenced as equipment shed 2 and is located in the center of Intermountain Research & Extension Center campus. It is a large rectangular-shaped storage facility that occupies approximately 3,600 gross square feet. The building consists of a free standing metal structure with metal roofing. The materials sampled in this building include:

ORMs observed within building 208 were limited to eight (8) fluorescent light tubes and six (6) light ballasts.

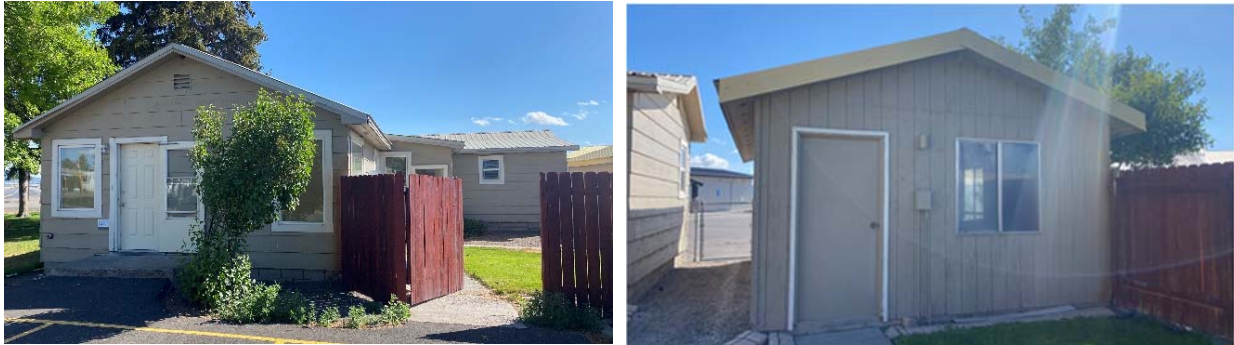
Buildings 301 & 302

Building 301 is a single-family residence located on next to the administrative building at the Intermountain Research & Extension Center campus totaling 1,394 square feet. There are plaster wall and drywall systems within the building, much of which is covered by wood paneling, along with multiple vinyl flooring systems. The exterior walls are comprised of wood panels with a pitched metal roof. There is also building 302 onsite, a 330 square foot detached wood-constructed garage with a pitched metal roof on the north side of the property. The materials sampled in this building include:

ORMs observed within building 301 & 301 were limited to one (1) mercury-containing thermostat.

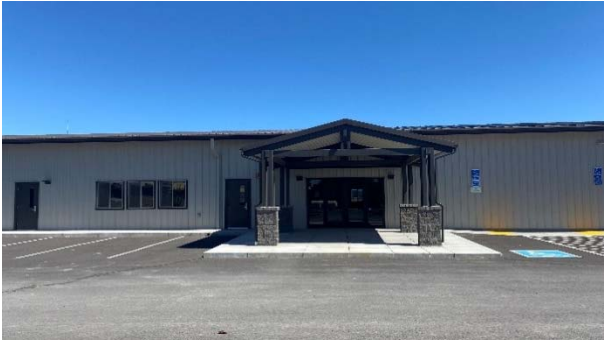
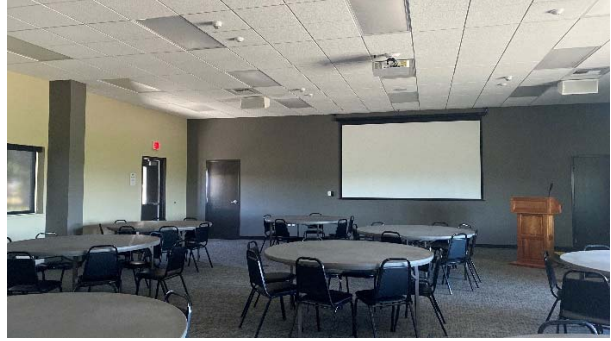
Building 307 is referenced as the multipurpose building and is a newly built facility located on the south side of the Intermountain Research & Extension Center campus. The onsite representative stated the building was built within the past 5 years and requested Millennium not conduct sampling within the structure.

Millennium conducted a visual assessment and observed all building materials were intact with no damage.

ORMs observed within building 307 were limited to sixty-four (64) fluorescent light tubes and thirty-two (32) light ballasts.

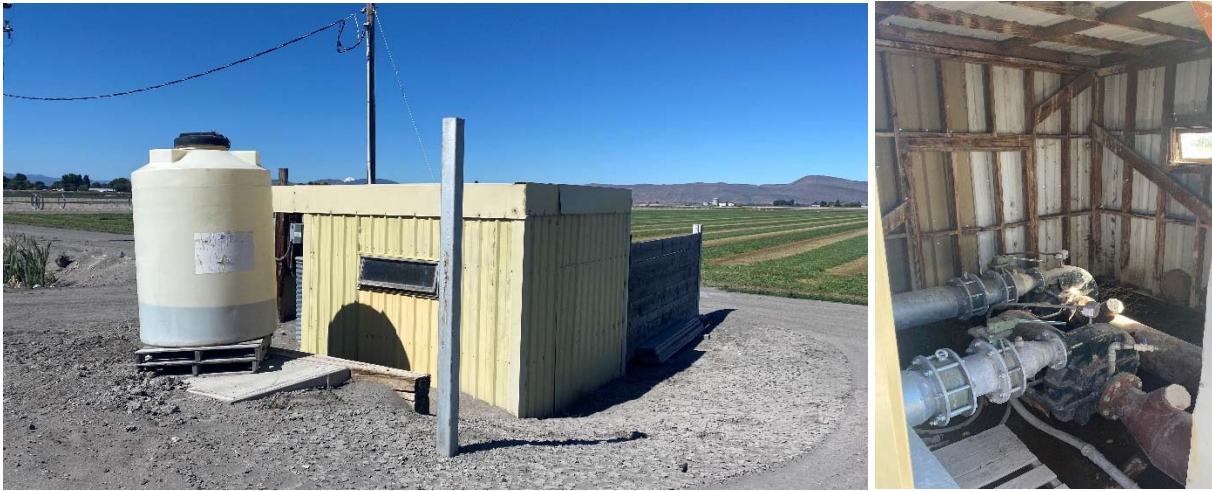
The Kenyon Pump House was located on the east side of the campus at Intermountain Research & Extension Center campus, and consists of a metal and wood shed structure. No suspect materials or ORMs were observed; no samples collected.

With regard to the yellow paint on the metal paneling, the paint was a powder coat on the metal and the collection of paint chips was not possible. The painted metal was similar to metal paneling throughout the campus buildings. A representative sample of the actual painted metal was submitted for analysis (T203-Pb3) with a lead concentration of <80 ppm. The painted metal siding is not considered to be LCP nor LBP.

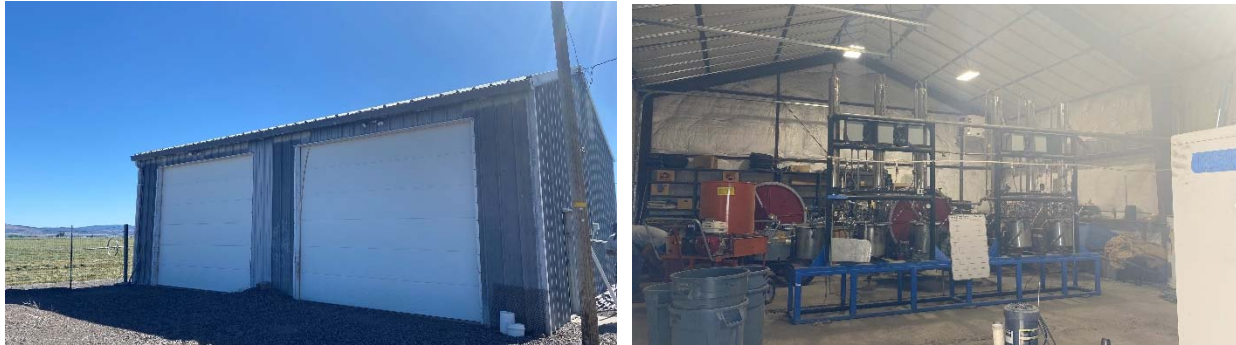
The Mint Still Building is a metal warehouse structure on the far north side of the Intermountain Research & Extension Center campus. The building has insulation panels on the interior with cement flooring. There are above-ground fuel storage tanks on the east side of the building. The materials sampled in this buildings include:

ORMs observed within the Mint Still building were limited to eight (8) fluorescent light tubes and four (4) light ballasts.

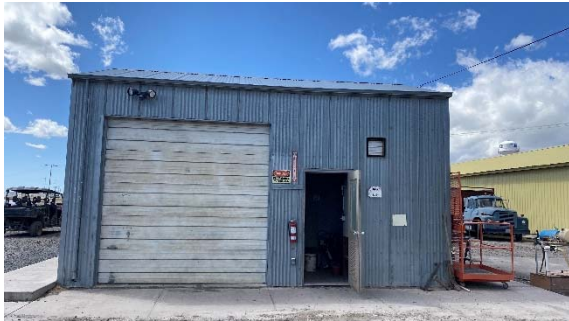
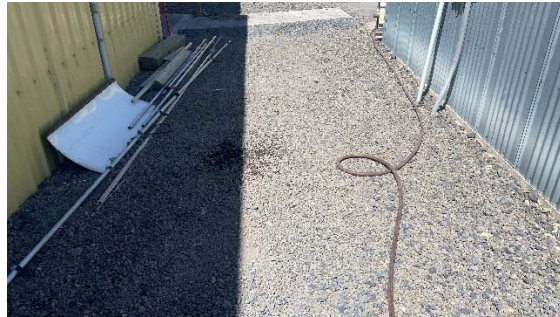
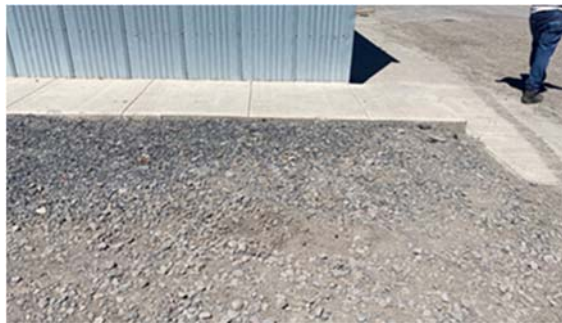
Building 205 are currently in use as a pesticide storage shed. A total of four (4) grab soil samples were collected from around the exterior of the building with the following details:

- S-02: a discrete soil sample was collected at east perimeter of pesticide building, where a volume of foot traffic and/or equipment traffic occurs,
- S-03: a discrete soil sample was collected at north perimeter of pesticide building, where a volume of foot traffic and/or equipment traffic occurs-in and out of building,
- S-04: a discrete soil sample was collected at west perimeter of pesticide building, between building 207 and 205, where a volume of foot traffic and storage may occurs, and
- S-05: a discrete soil sample was collected at south perimeter of pesticide building, additional sampling around perimeter of pesticides storage building.

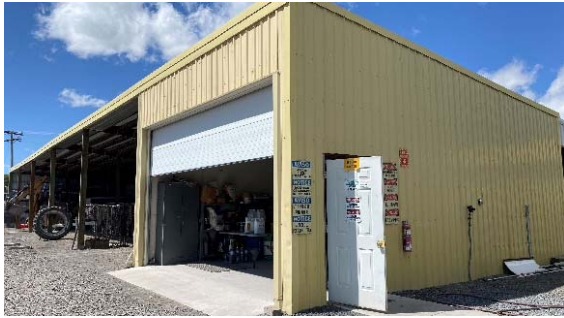
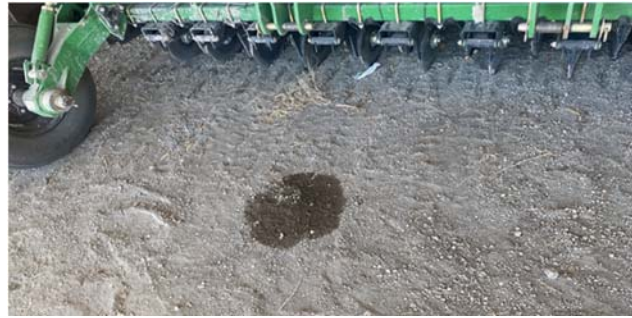
Building 207 was used as a equipment storage containing various and heavy machinery and trucks. One discrete soil sample was collected from inside the building where maintenance trucks were parked and analyzed for TPHg, TPHd, TPHmo, organochlorine pesticides, organophosphorus pesticides, and herbicides. The sample was collected from worst case scenario. It is expected the rest of the area within the 207 building contains less contamination.
