Pasadena Windstorm Tree Failure Analysis

July 2012

Davey Resource Group

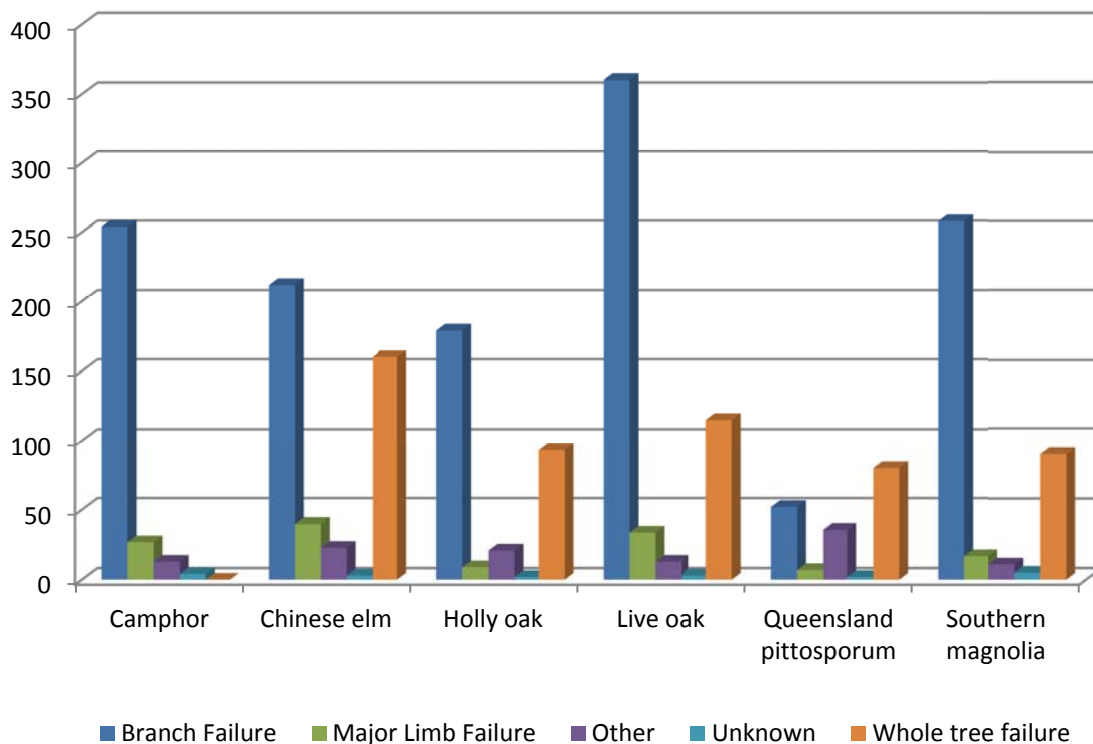
Chart 2. Failure Type of Top Six Species

- Live oak, Chinese elm, southern magnolia, camphor, Queensland pittosporum and holly oak were the top six species with the most damage.
- Queensland pittosporum was the poorest performing species with over 50% of its population suffering damage.

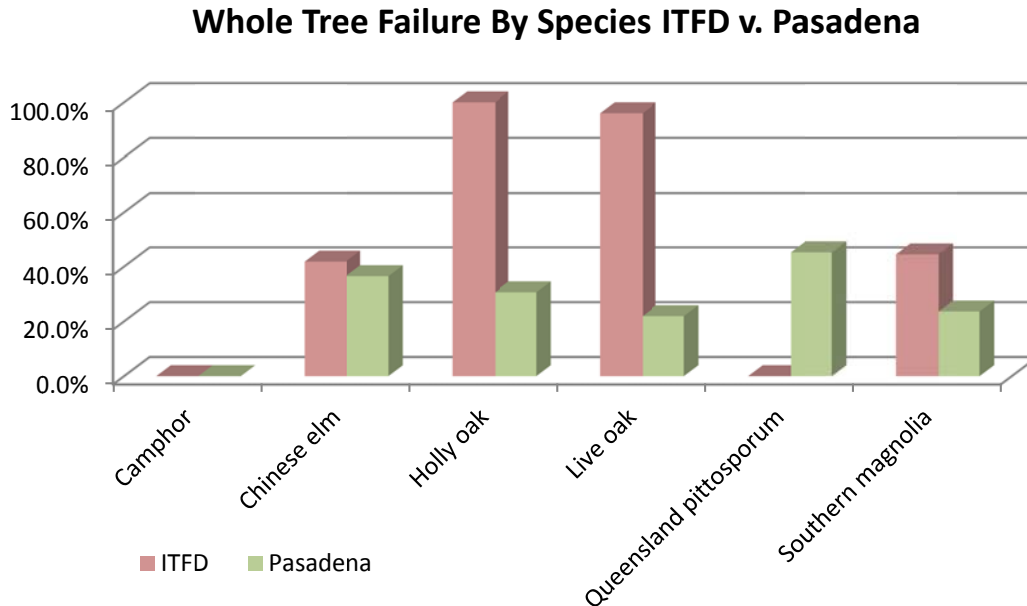
Chart 4. Whole Tree Failure Percentage by Species, ITFD versus Pasadena

Whole tree failure comparisons demonstrated less consistency. Only Chinese elm failures in Pasadena closely mirrored ITFD statistics. Holly oak, live oak and Southern magnolia all experienced a much lower percentage of whole tree failures in Pasadena than represented in data from the ITFD. Camphor and Queensland pittosporum all experienced a higher degree of whole tree failure in Pasadena than in the ITFD. These discrepancies might be related to the single, historic wind event that occurred in Pasadena versus the year-round data collection as gathered by the ITFD during a variety of conditions independent of specific weather events.
