## *chapter 11.* EXPOSED HEAVY TIMBER

### 11.1 THE PROBLEM

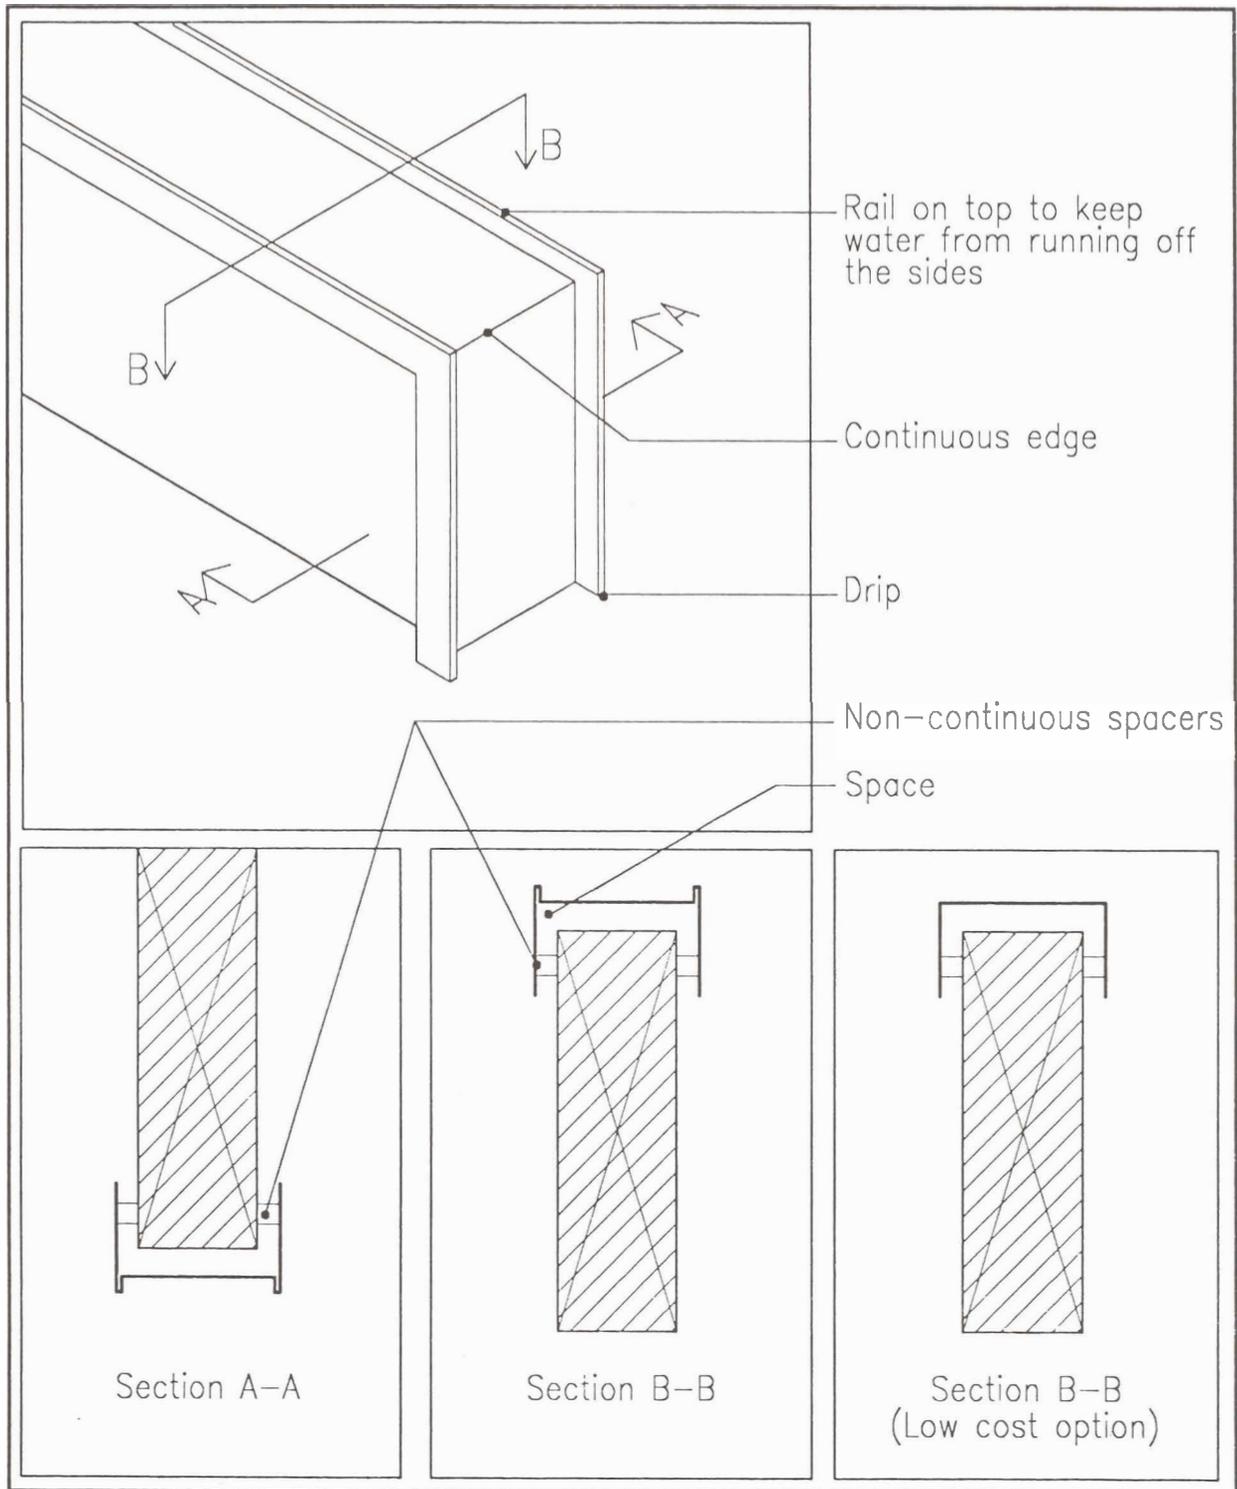
Figure 11-1

# EXPOSED BEAM END FLASHING DETAIL

Flashing and covers can provide local protection from sun and water. Again, the most critical areas are the end-grain and top surfaces. Metal flashing over exposed beam ends is a common and relatively effective protection (see **Figure 11-1**). Note that a ventilation space is necessary between the wood and metal to prevent condensation wetting. Moisture in sun-heated beams will continue to move to the surface when shaded or at nightfall, condensing on the inside surface of the flashing if airflow is restricted. Wood covers shown in **Figure 11-2** are a simpler alternative method, which may be appropriate for less severe conditions. Neither of the methods shown protects the side of the member, where the checks may collect water. For complete protection, treated millwork can be used to cover exposed structural members.

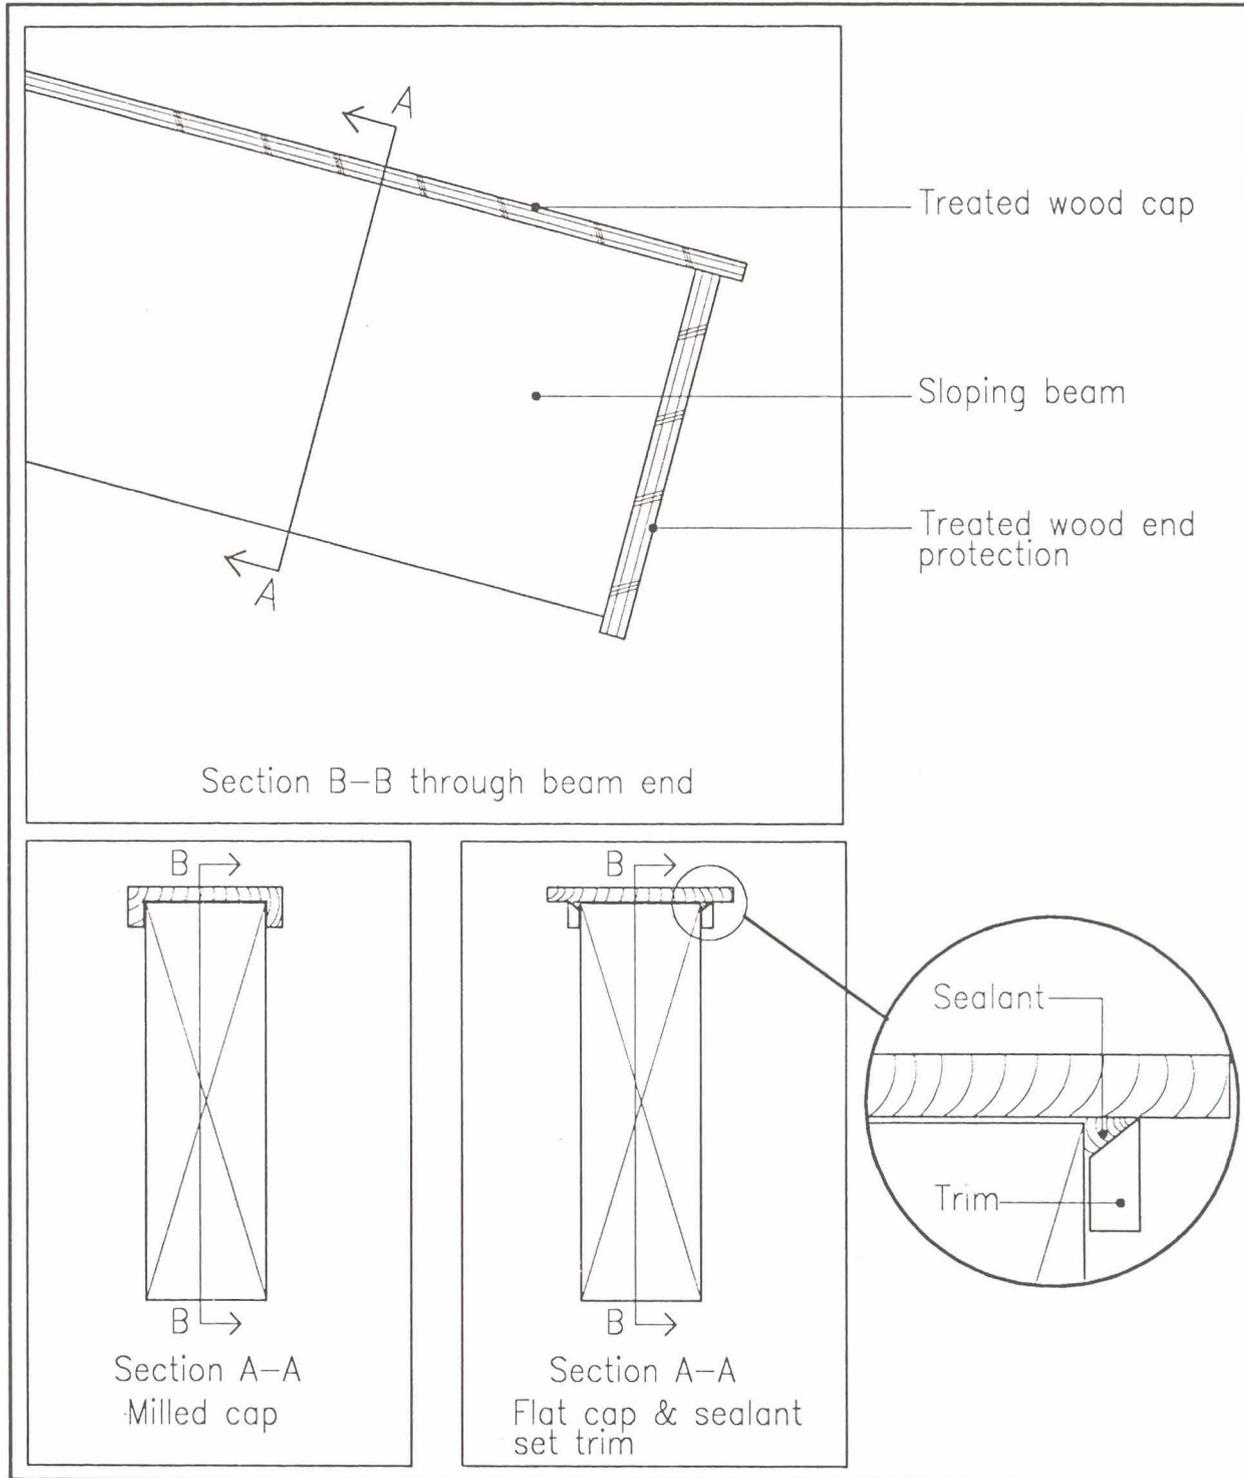
Figure 11-2

# EXPOSED BEAM END PLYWOOD COVER DETAIL

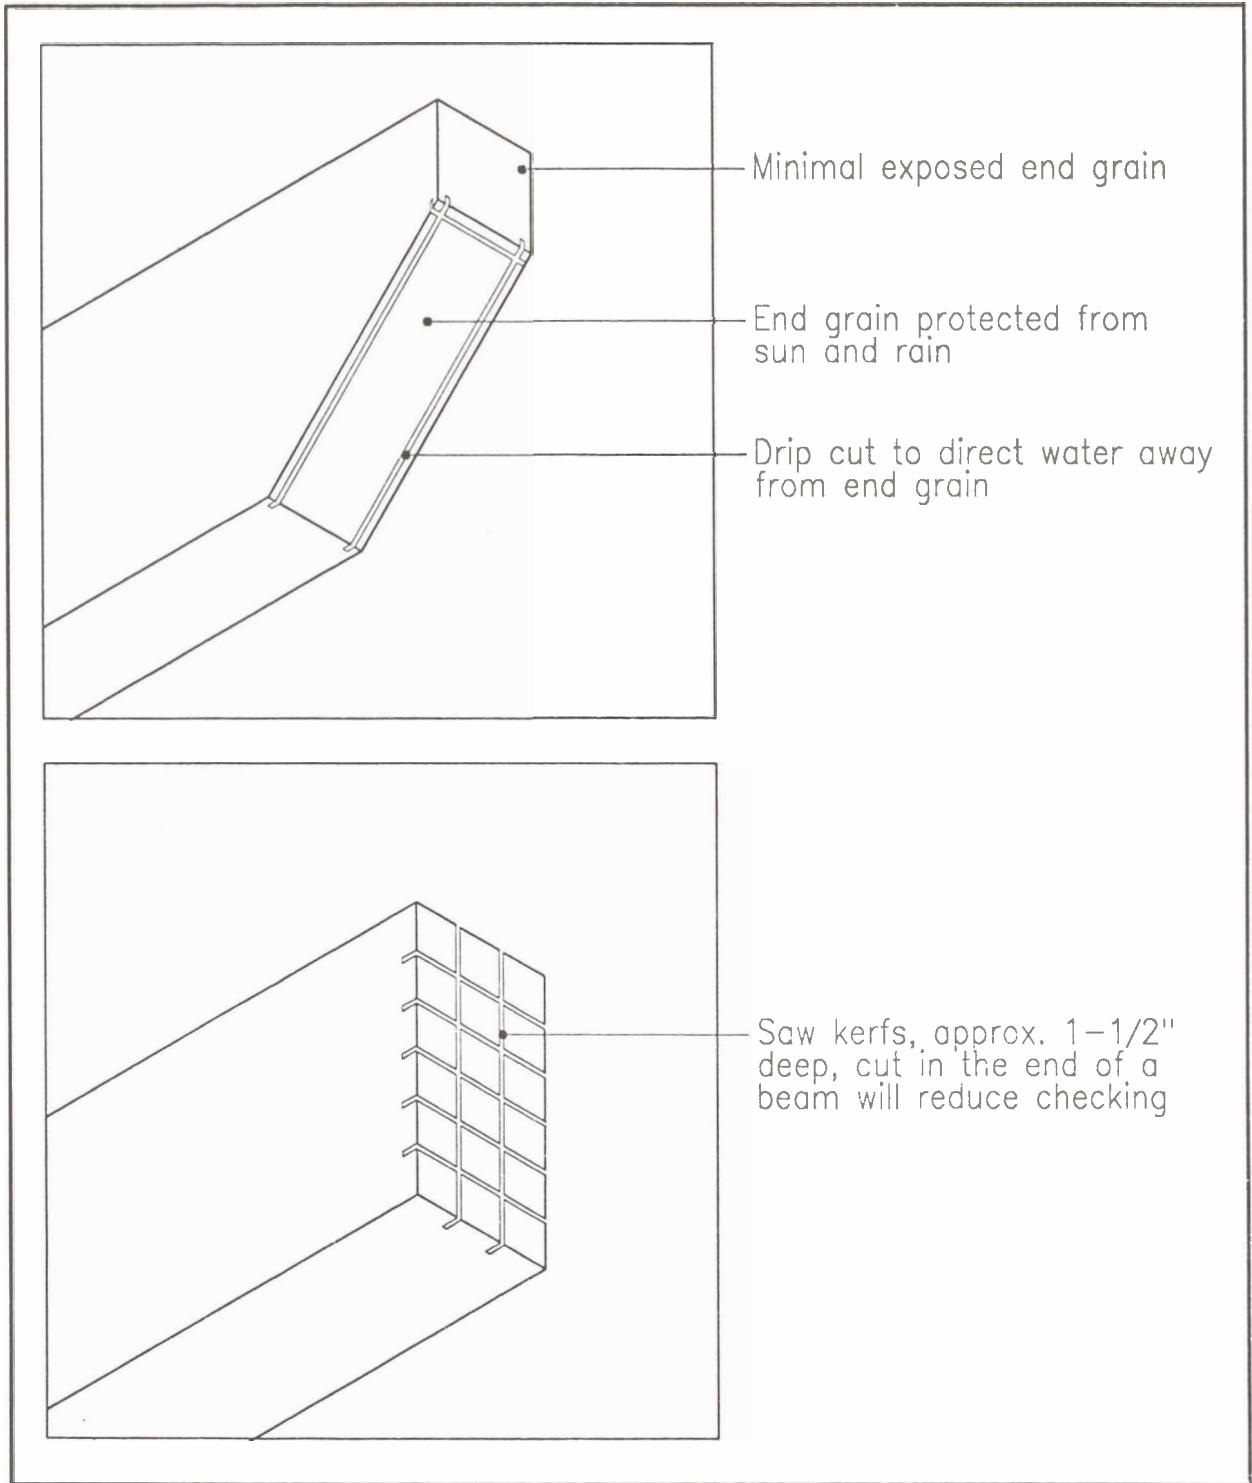
Figure 11-3

## EXPOSED BEAM END PROTECTION BY CUTS AND KERFS

In exposed horizontal members, the kerf must be located on the bottom, so as not to trap moisture; it is generally located on the least noticeable face or on a covered face in columns. Kerfed members should be treated after sawing or placed in the structure where the cut surface cannot be wetted.

Shaping a member or introducing saw kerfs can improve performance by reducing the stresses that cause checking (see **Figure 11-3**). The bevel cut receding from top to bottom at the end of the beam minimizes the unshaded exposed end grain area and thus reduces checking. Cutting saw kerfs in wood members can control checking by dividing the end into sections of effectively smaller dimensions so that stresses are kept below the tensile strength perpendicular to the grain. A deep longitudinal saw kerf may greatly reduce checking, it is equally effective in round or sawn timbers. The principle involved is the same as with kerfs on beam ends and the relief patterns often included on the back of millwork patterns, such as door casing, and on strip flooring.

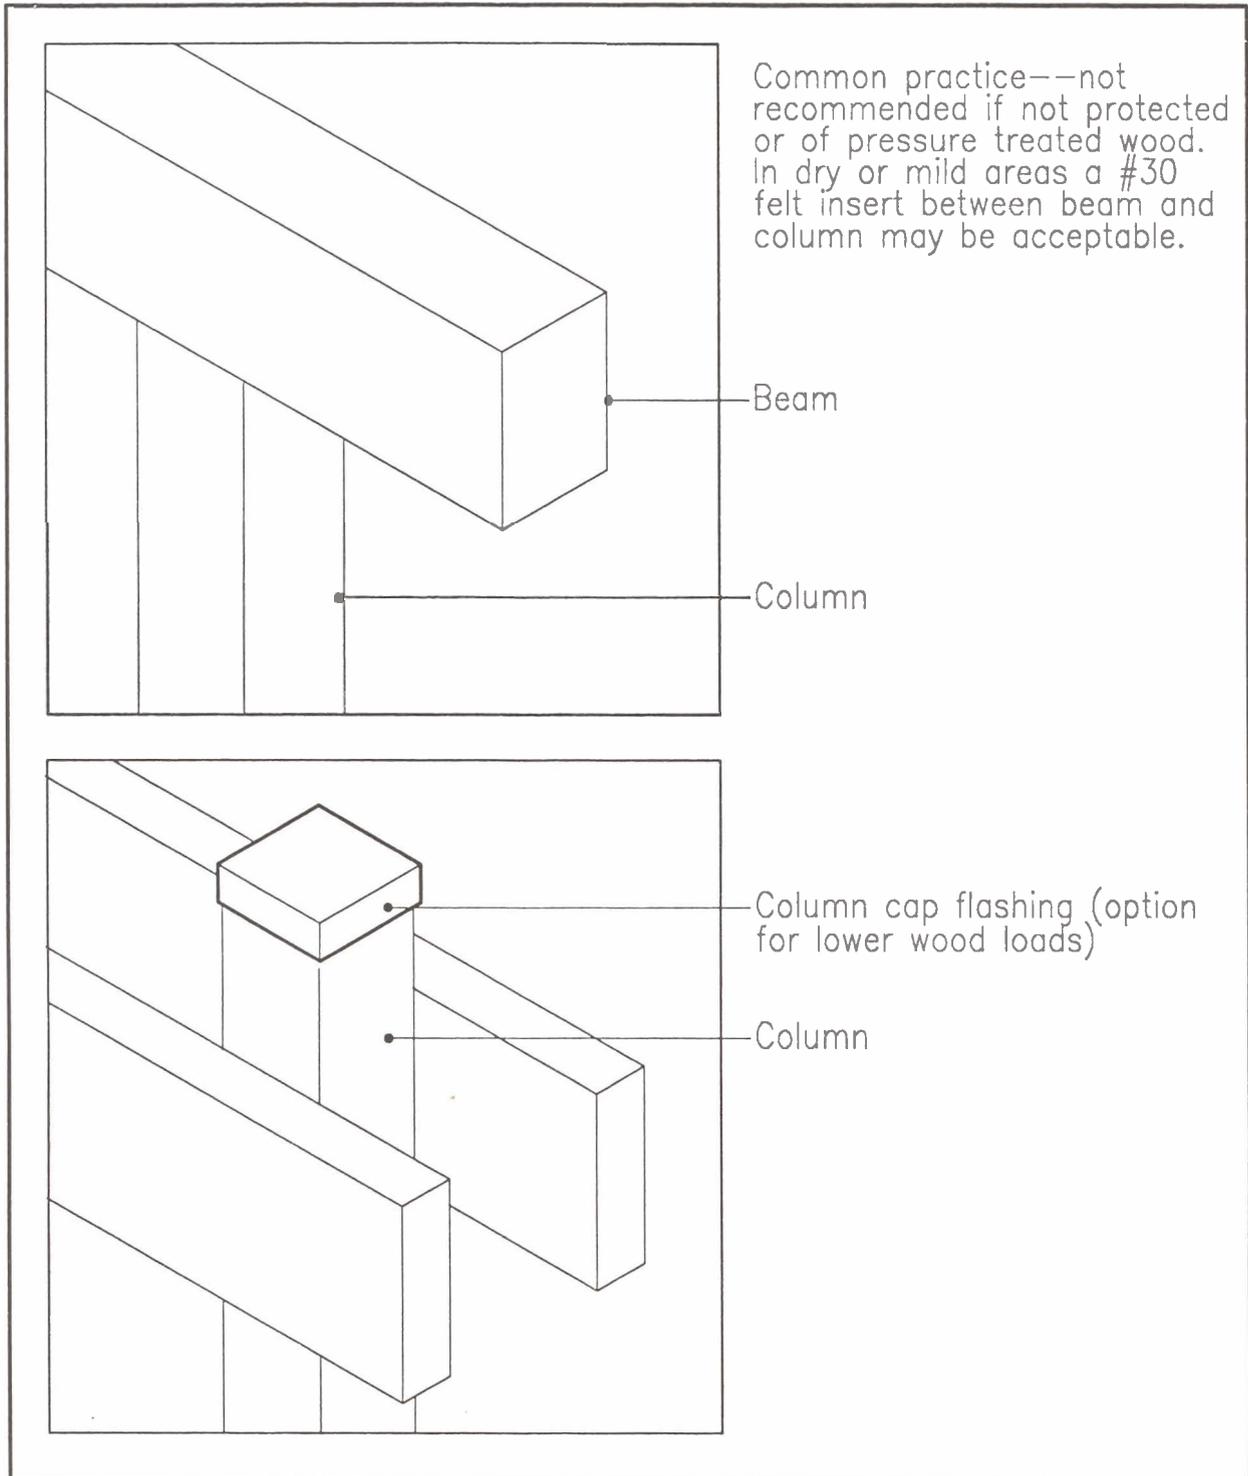
Figure 11-4

## EXPOSED CONNECTION BEAM COLUMN JOINT

When possible, it is better to use many smaller members rather than a few large members to satisfy the same structural requirement, provided they are spaced or the joints between them can be protected (see **Figure 11-4**). The latter may be extremely difficult. The reduced minimum dimension of smaller members substantially decreases the drying time, because the drying time is approximately proportional to the square of the thickness. The column top surface in **Figure 11-4** is vulnerable to capillary water. Preservative treatments are not dependable or effective for the exposed tops of these large members unless the top is the uncut and undamaged treated end of the piece as shipped from the treating plant.

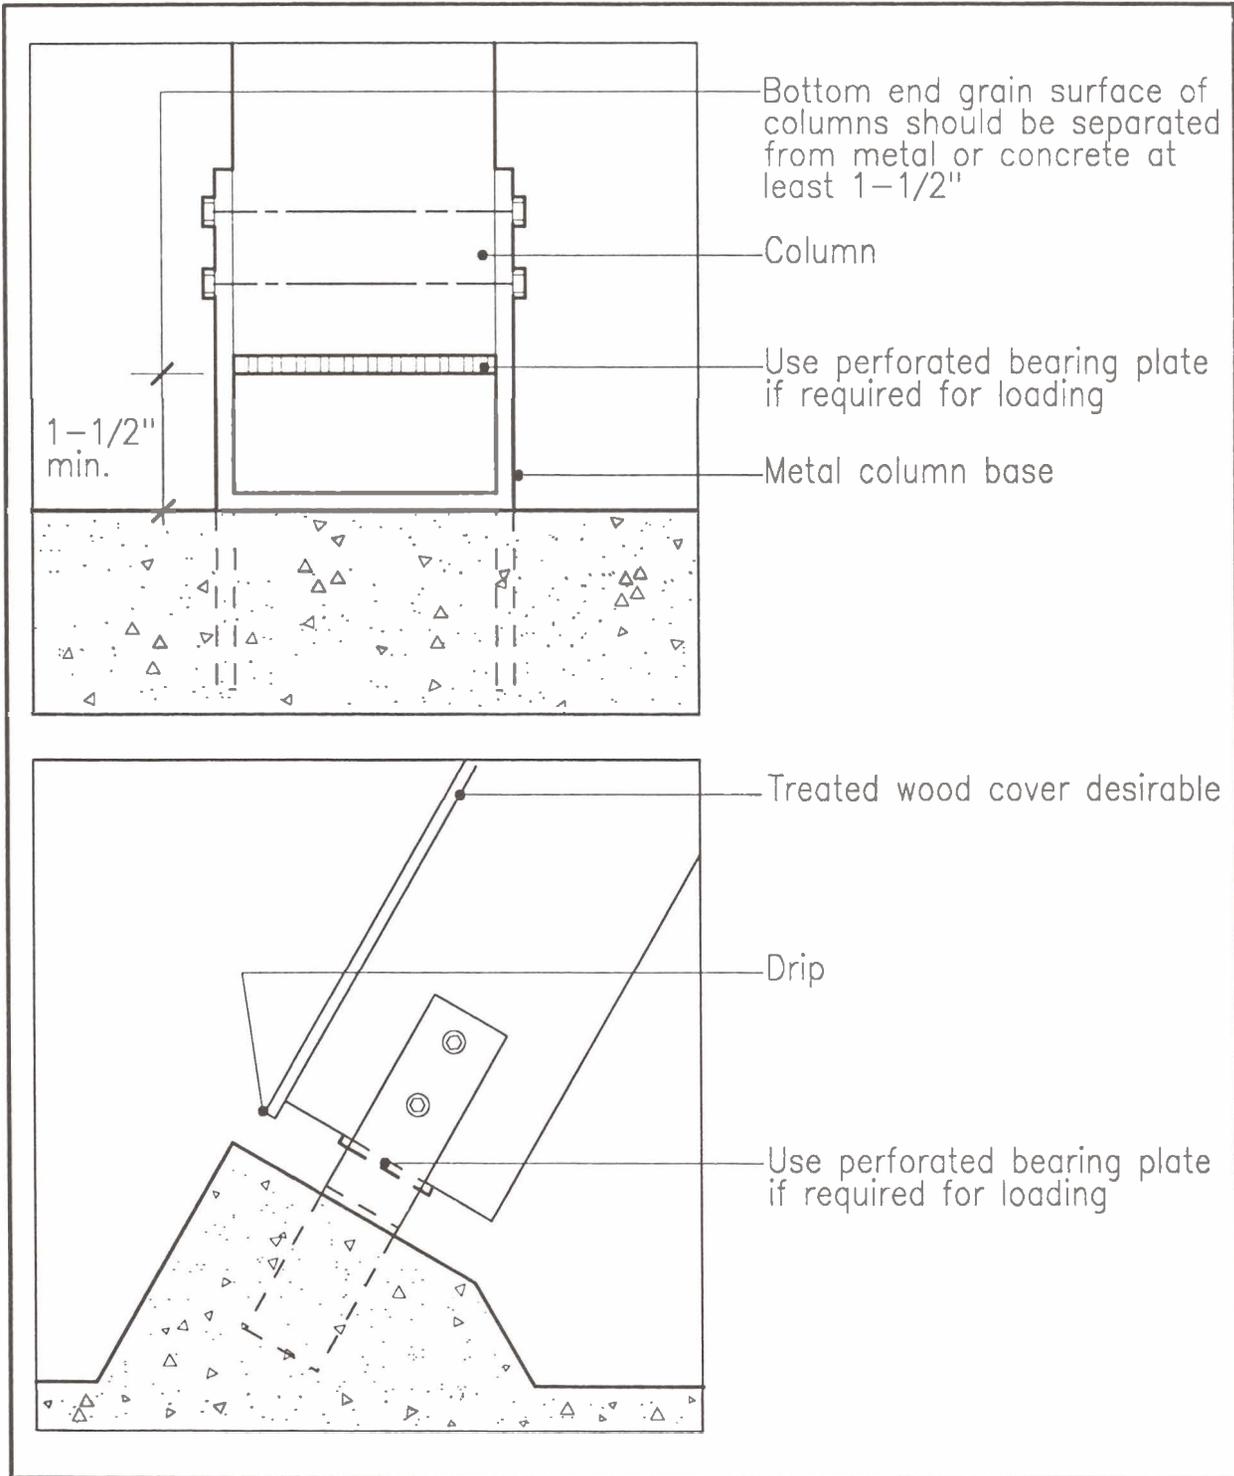
Figure 11-5A

# EXPOSED CONNECTION COLUMN BASE JOINT

At the base of a column or arch, enough space should be provided so the member does not contact water sitting on the ground, concrete, or a metal column base. The weep holes and other drainage features now common in the shoes and other column supports must not be compromised during installation (see **Figure 11-5A** and **11-5B**). When bearing cannot be carried by bolts, design must provide for deflection of moisture away from base.

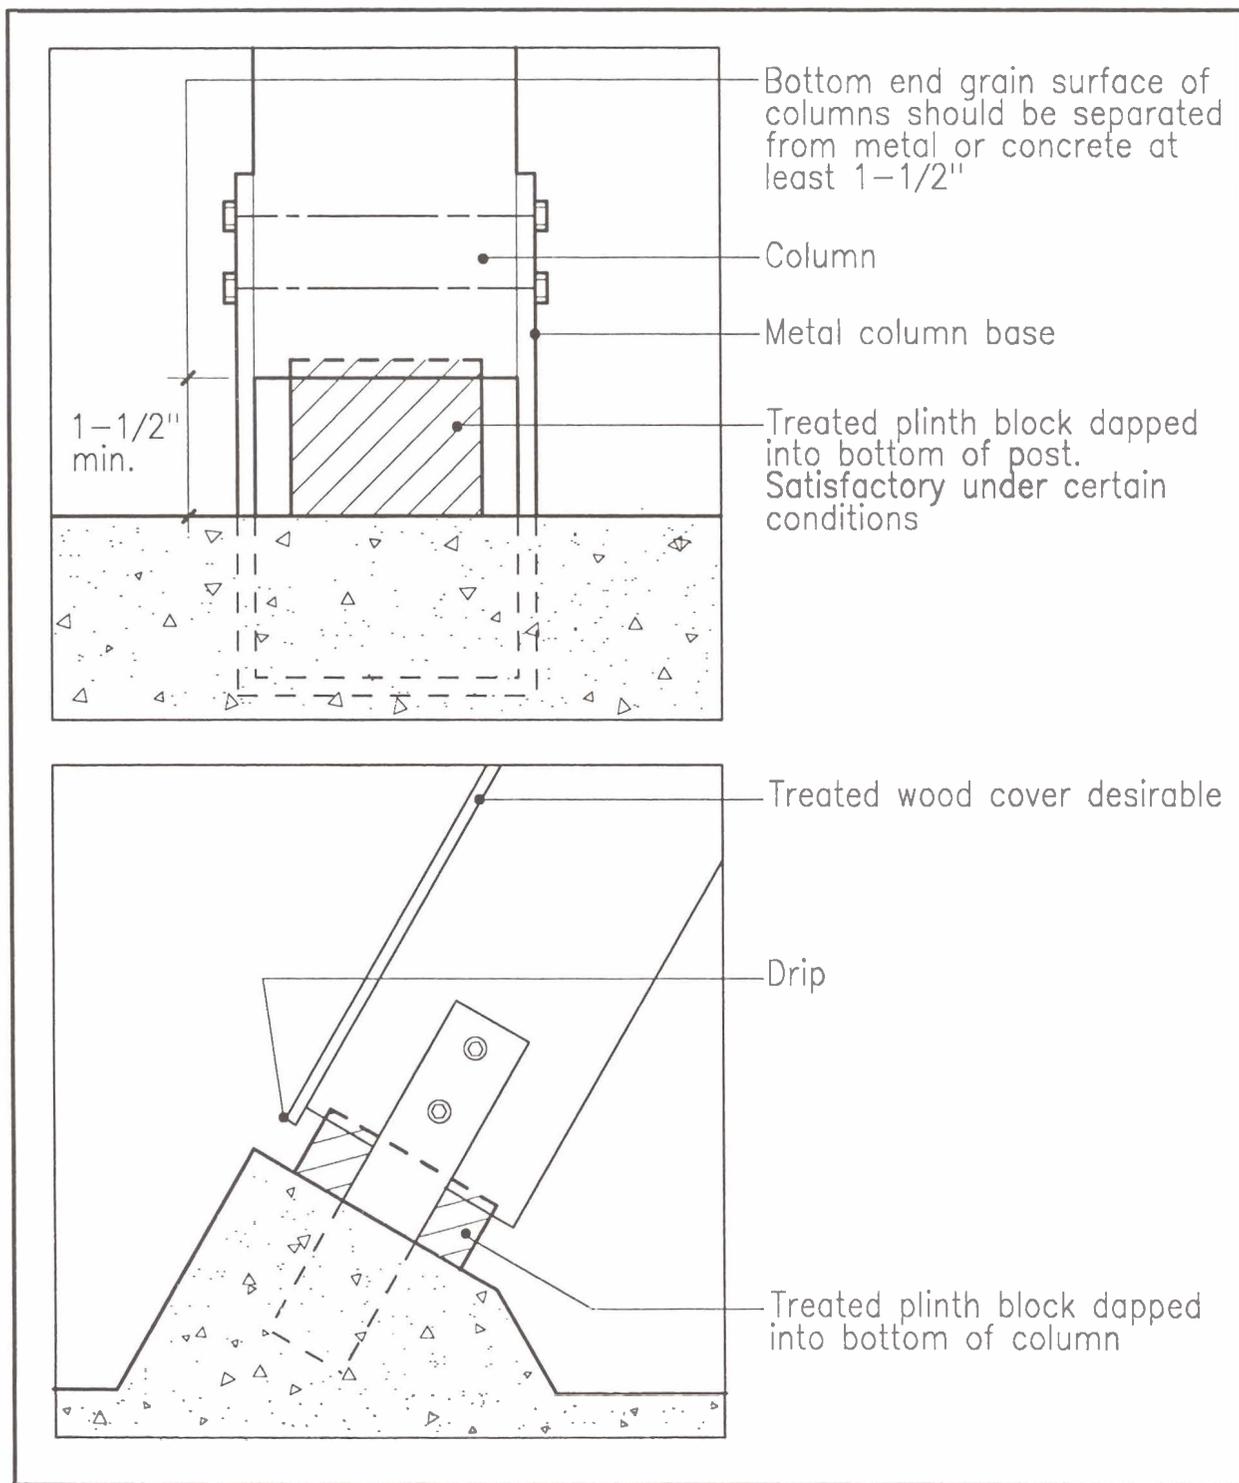
Figure 11-5B

# EXPOSED CONNECTION COLUMN BASE JOINT
