Stream Crossing Alternatives

Pete Cafferata

California Department of Forestry
and Fire Protection

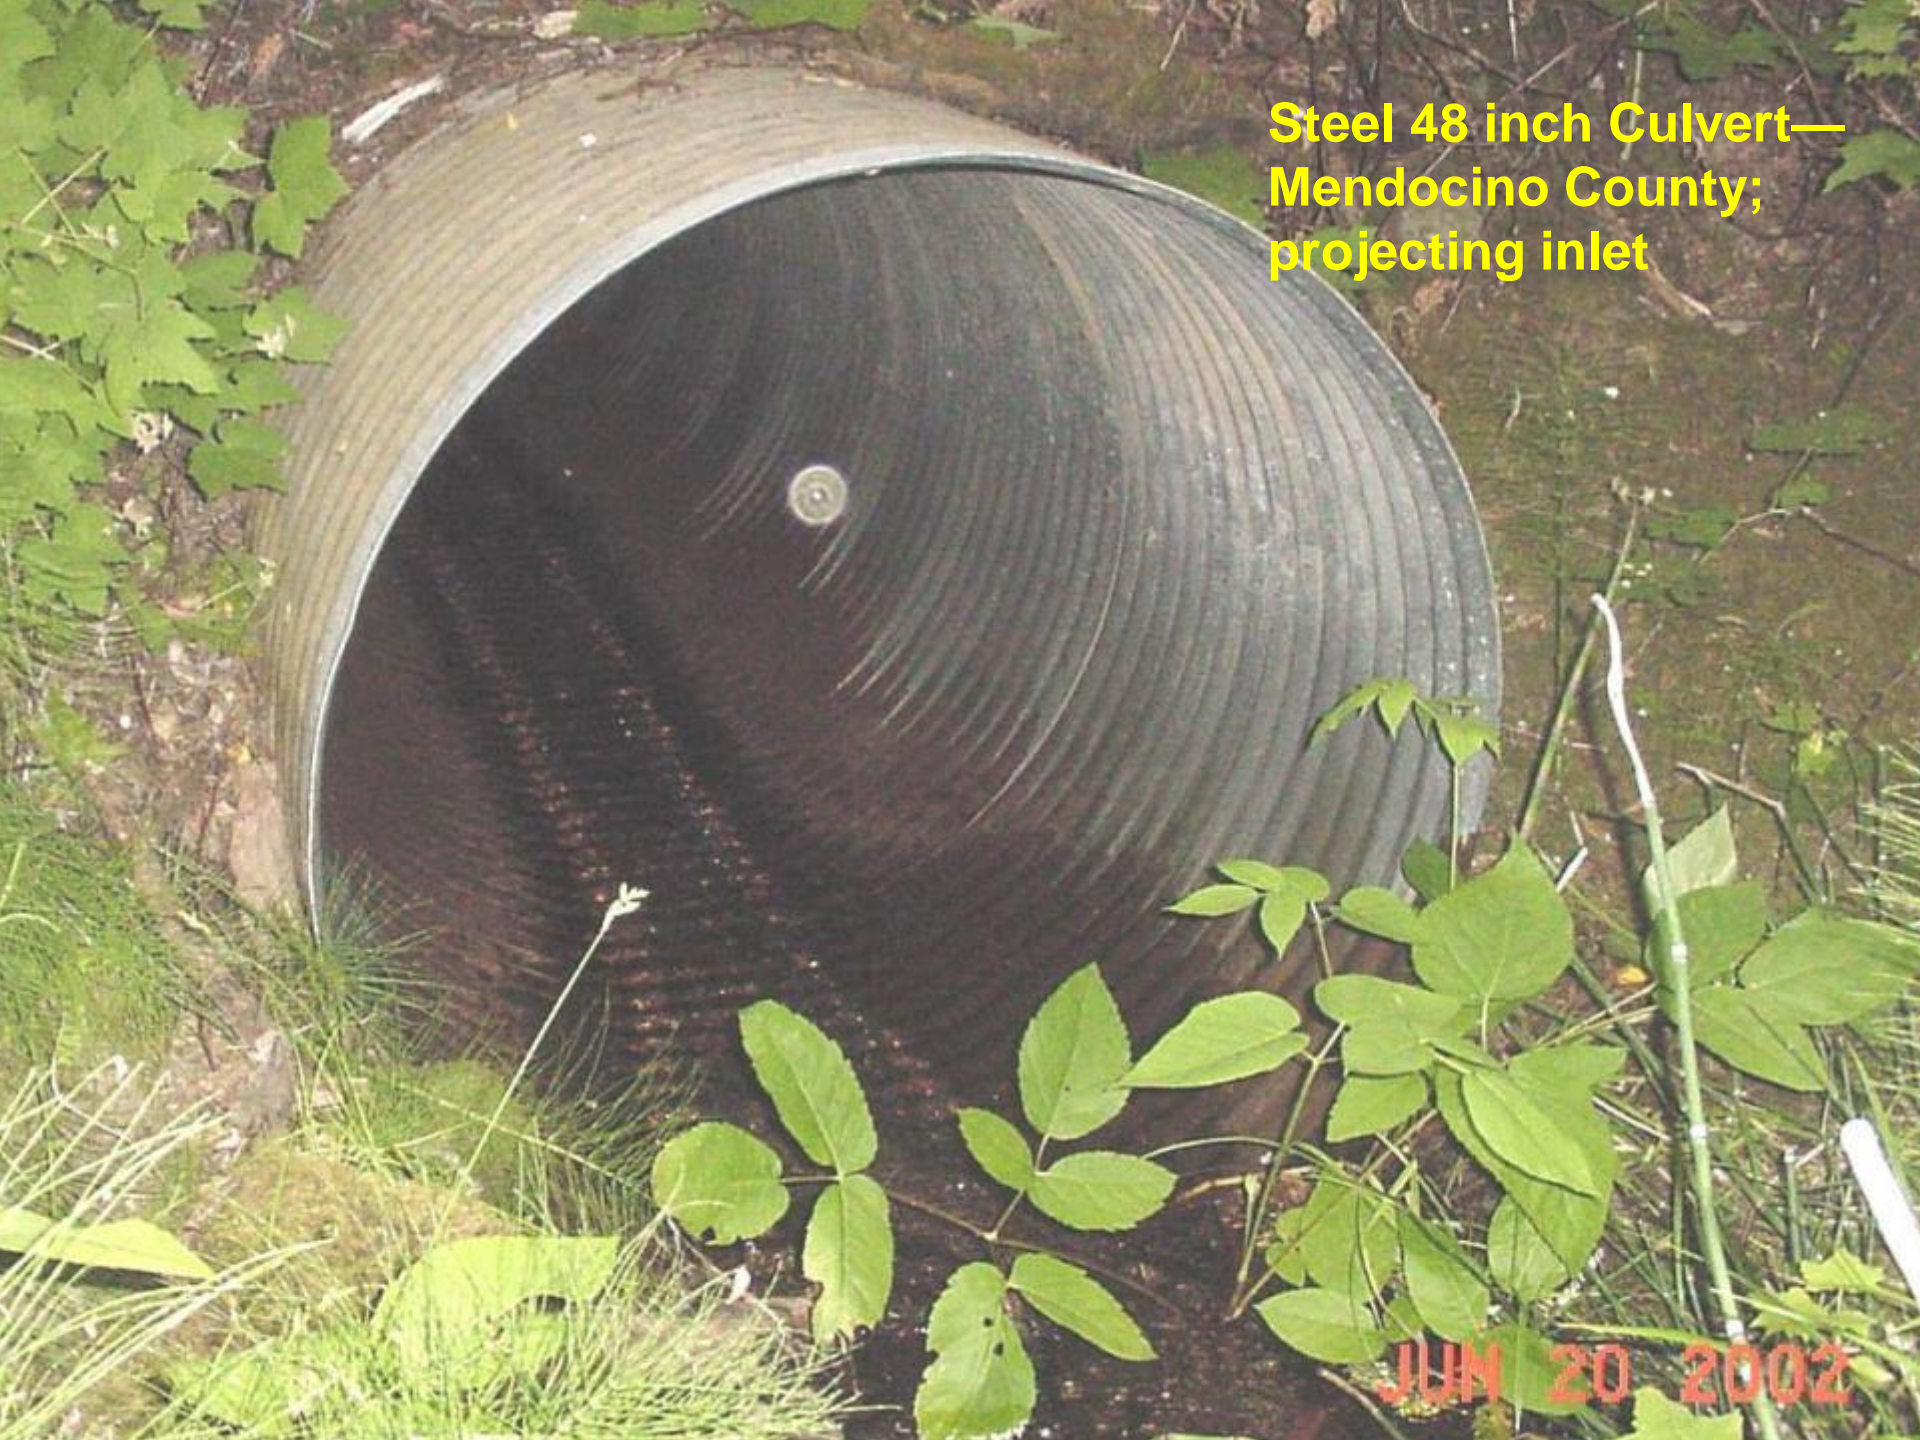
**Steel 48 inch Culvert—
Mendocino County;
projecting inlet**

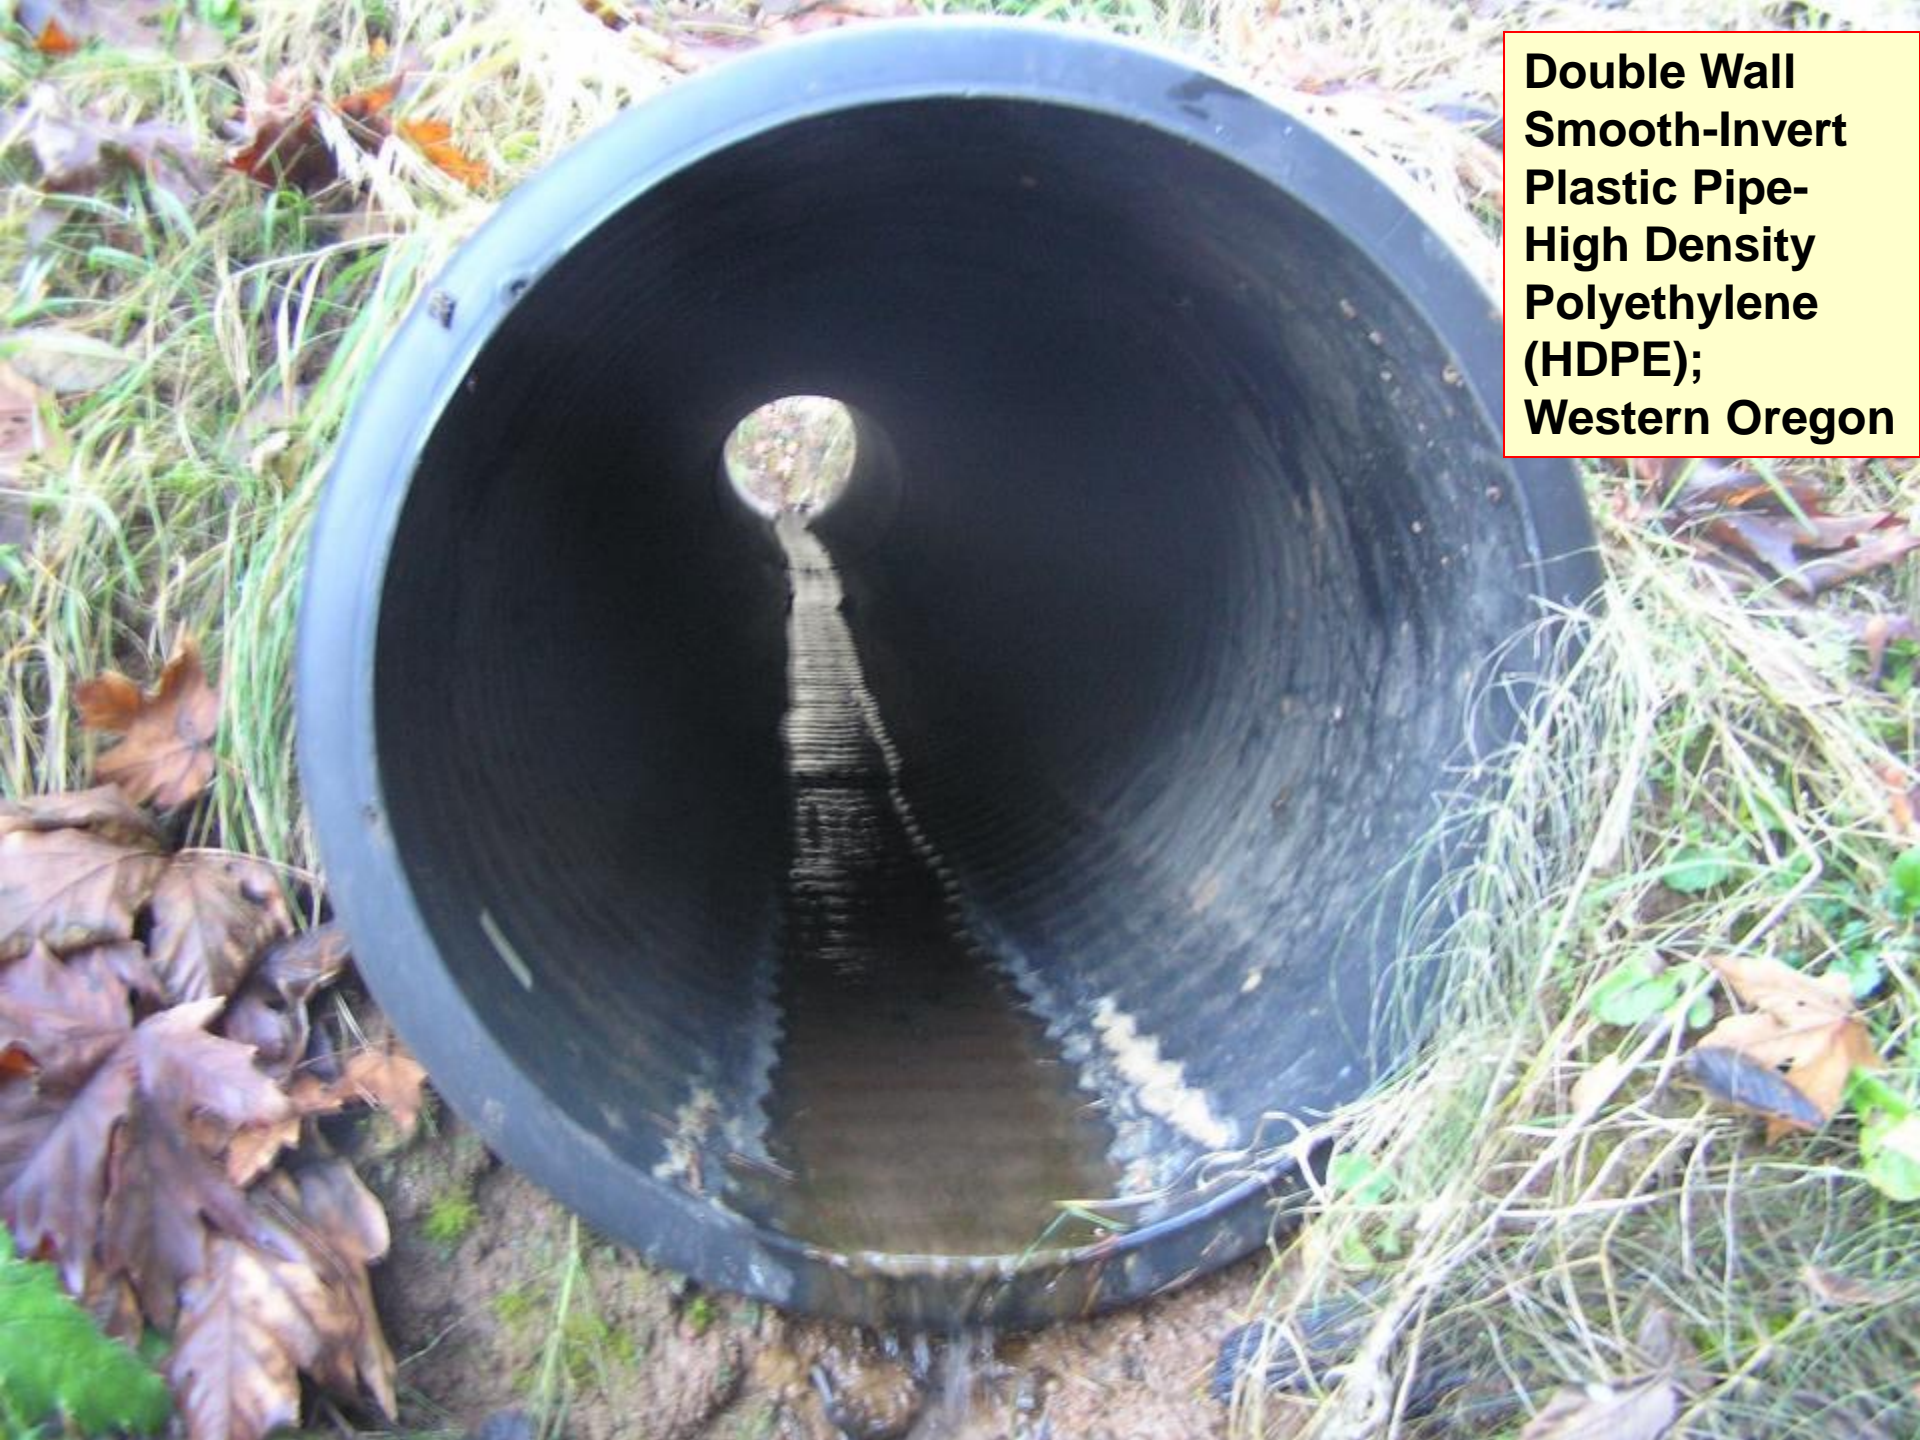
**Double Wall
Smooth-Invert
Plastic Pipe-
High Density
Polyethylene
(HDPE);
Western Oregon**

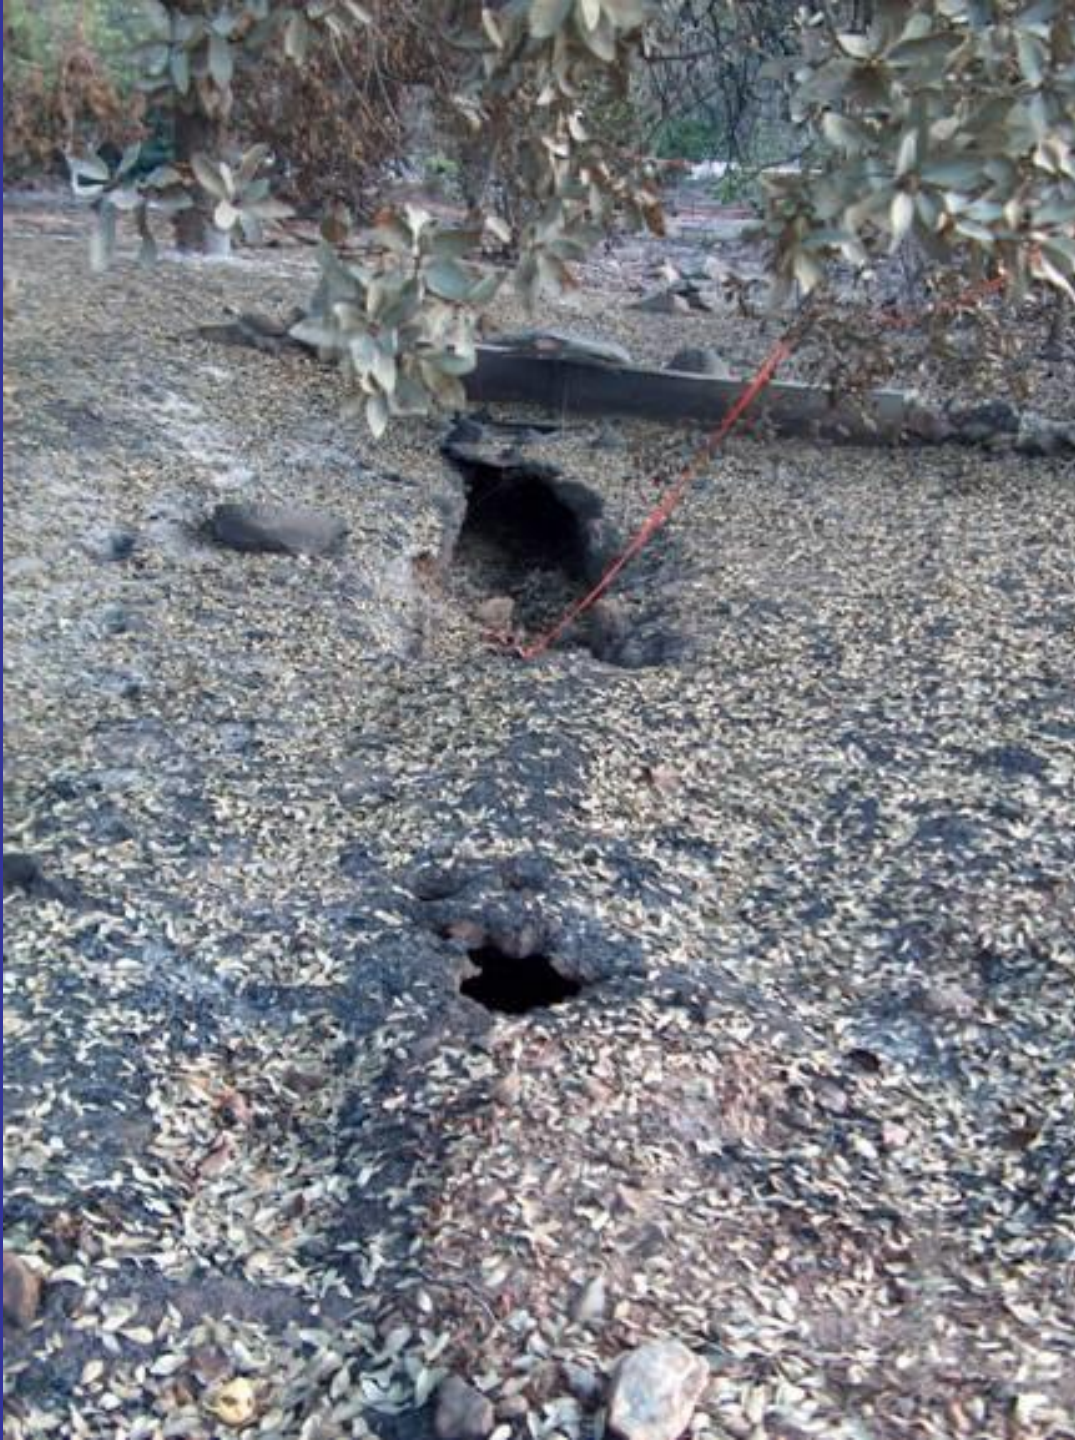
**Holes left where
plastic culvert
burned in small
drainages**

**Roca/Rosa 2007
Fires**

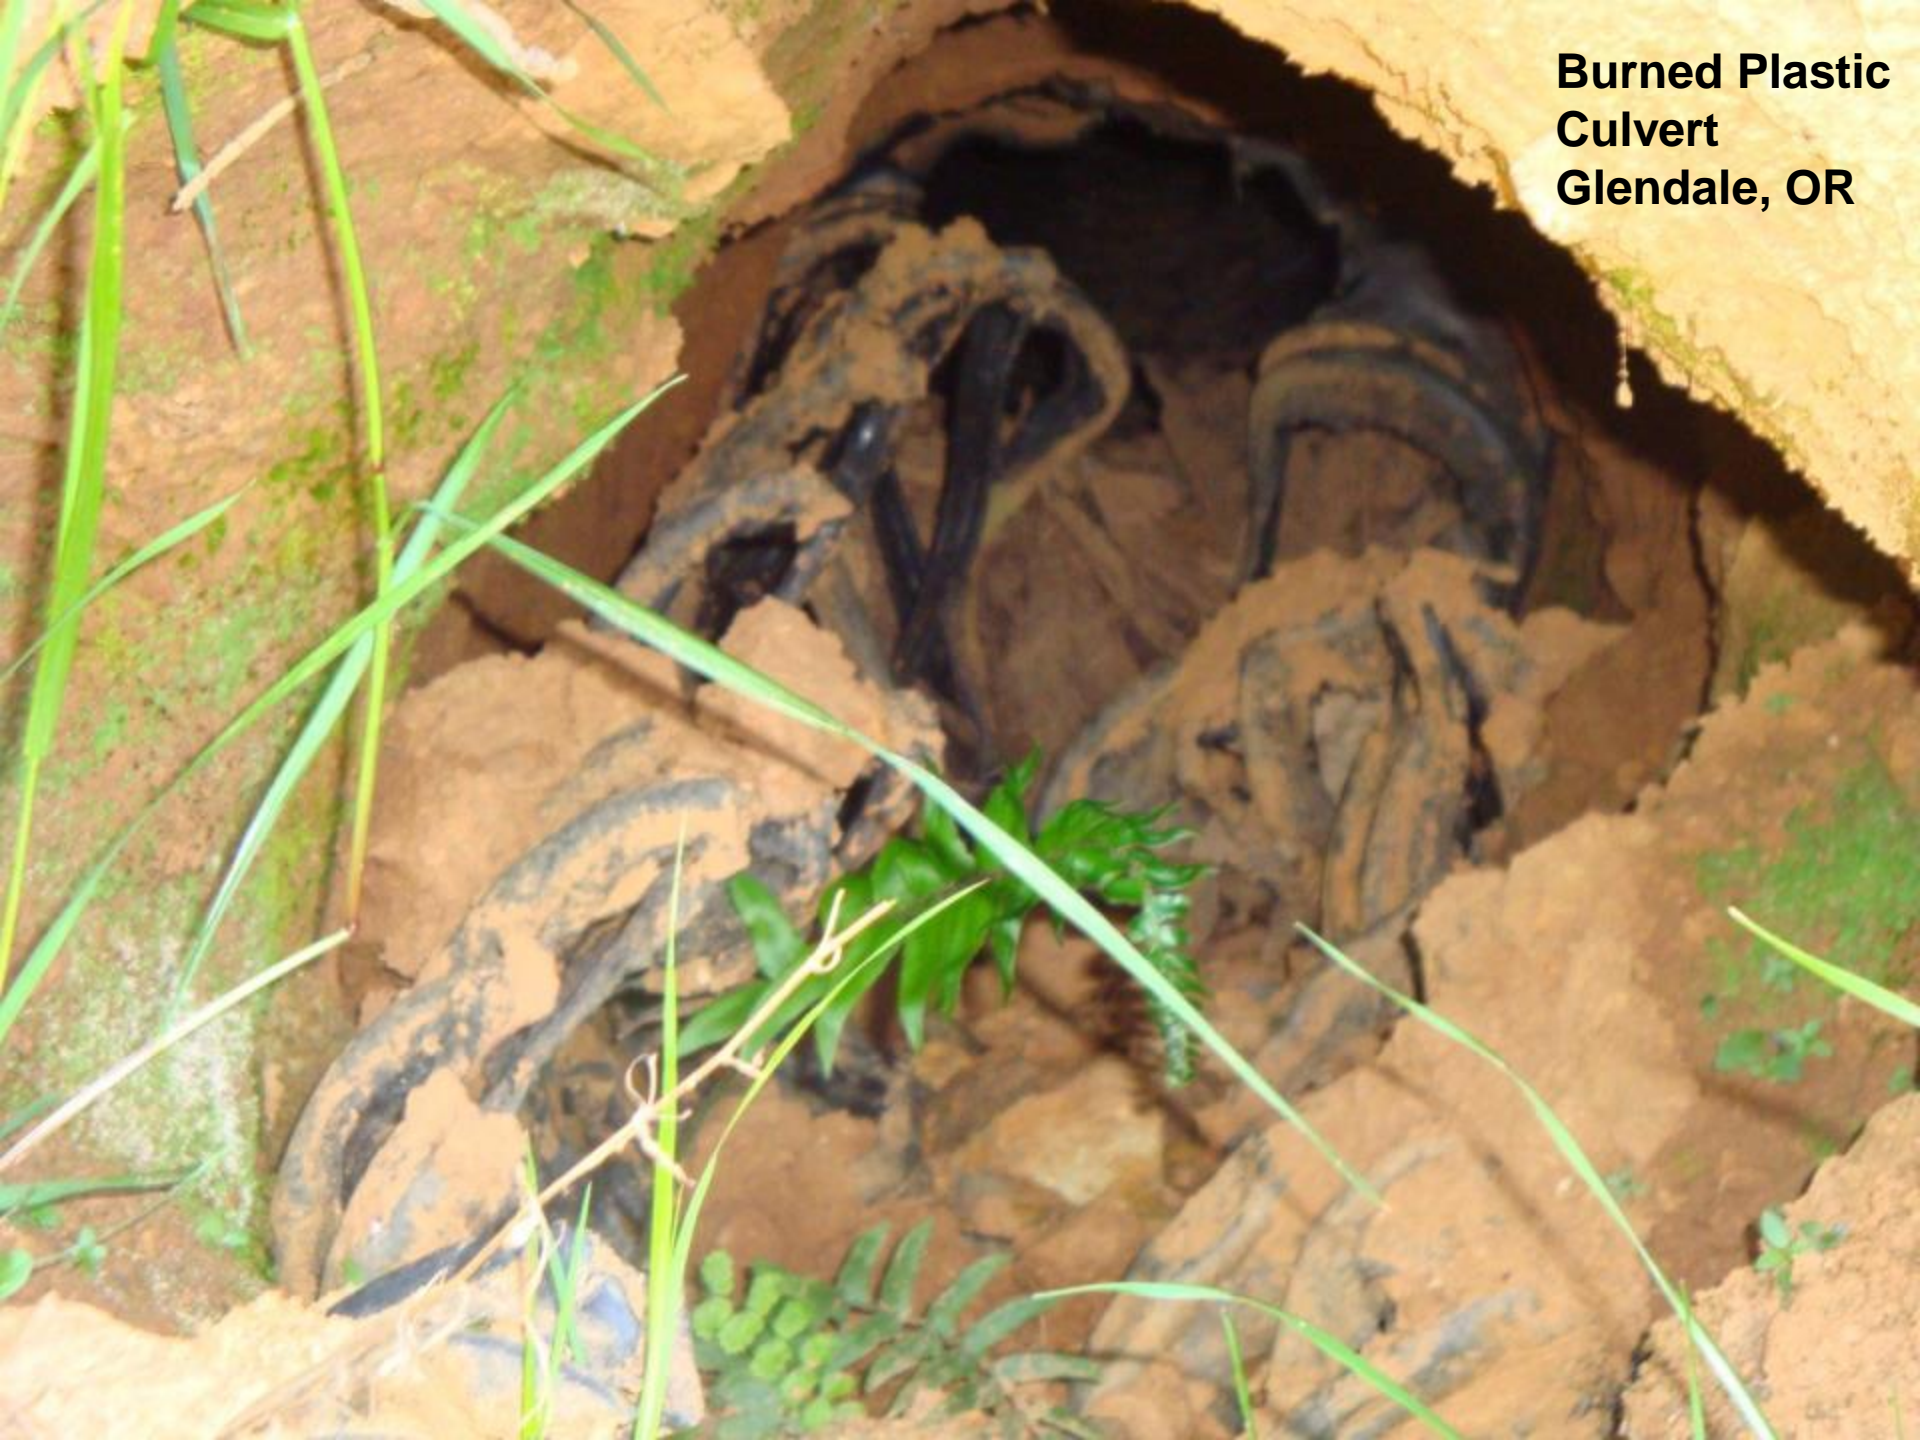
**Burned Plastic
Culvert
Glendale, OR**

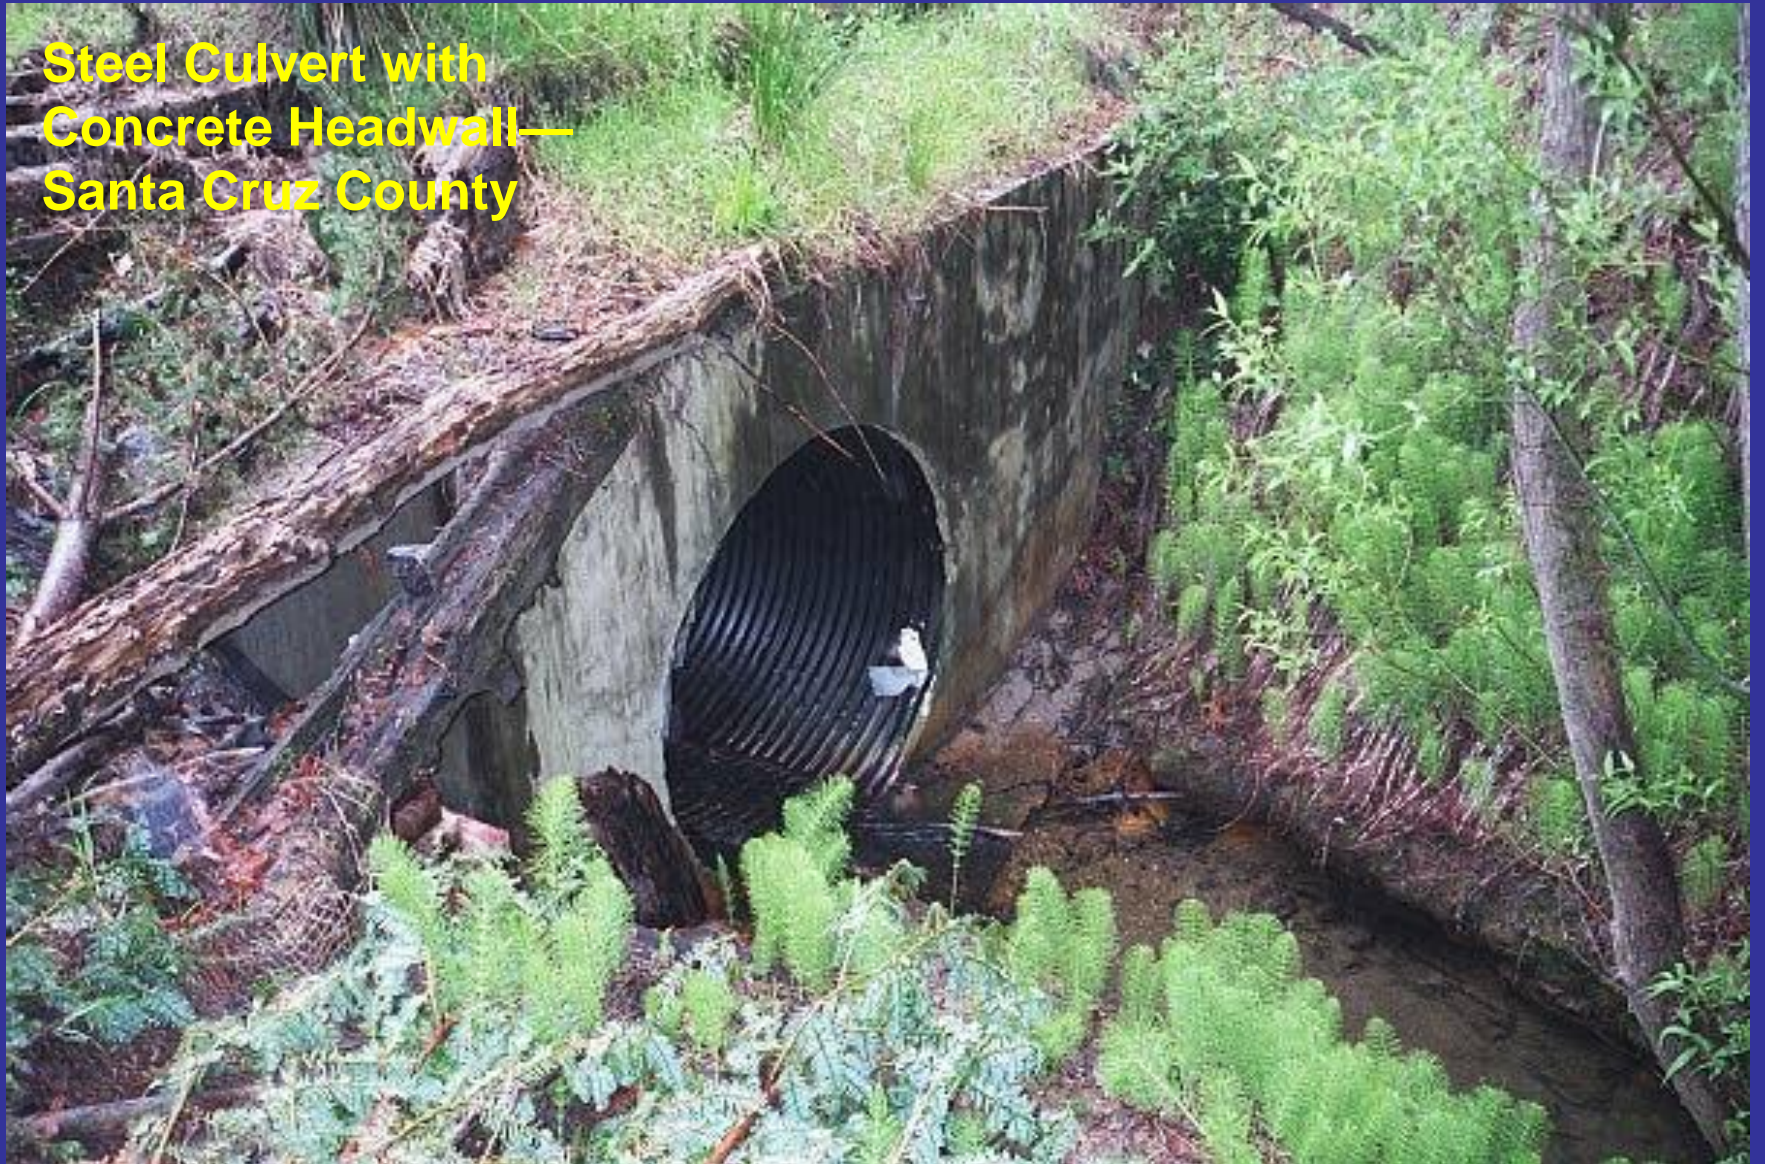
**Steel Culvert with
Concrete Headwall—
Santa Cruz County**

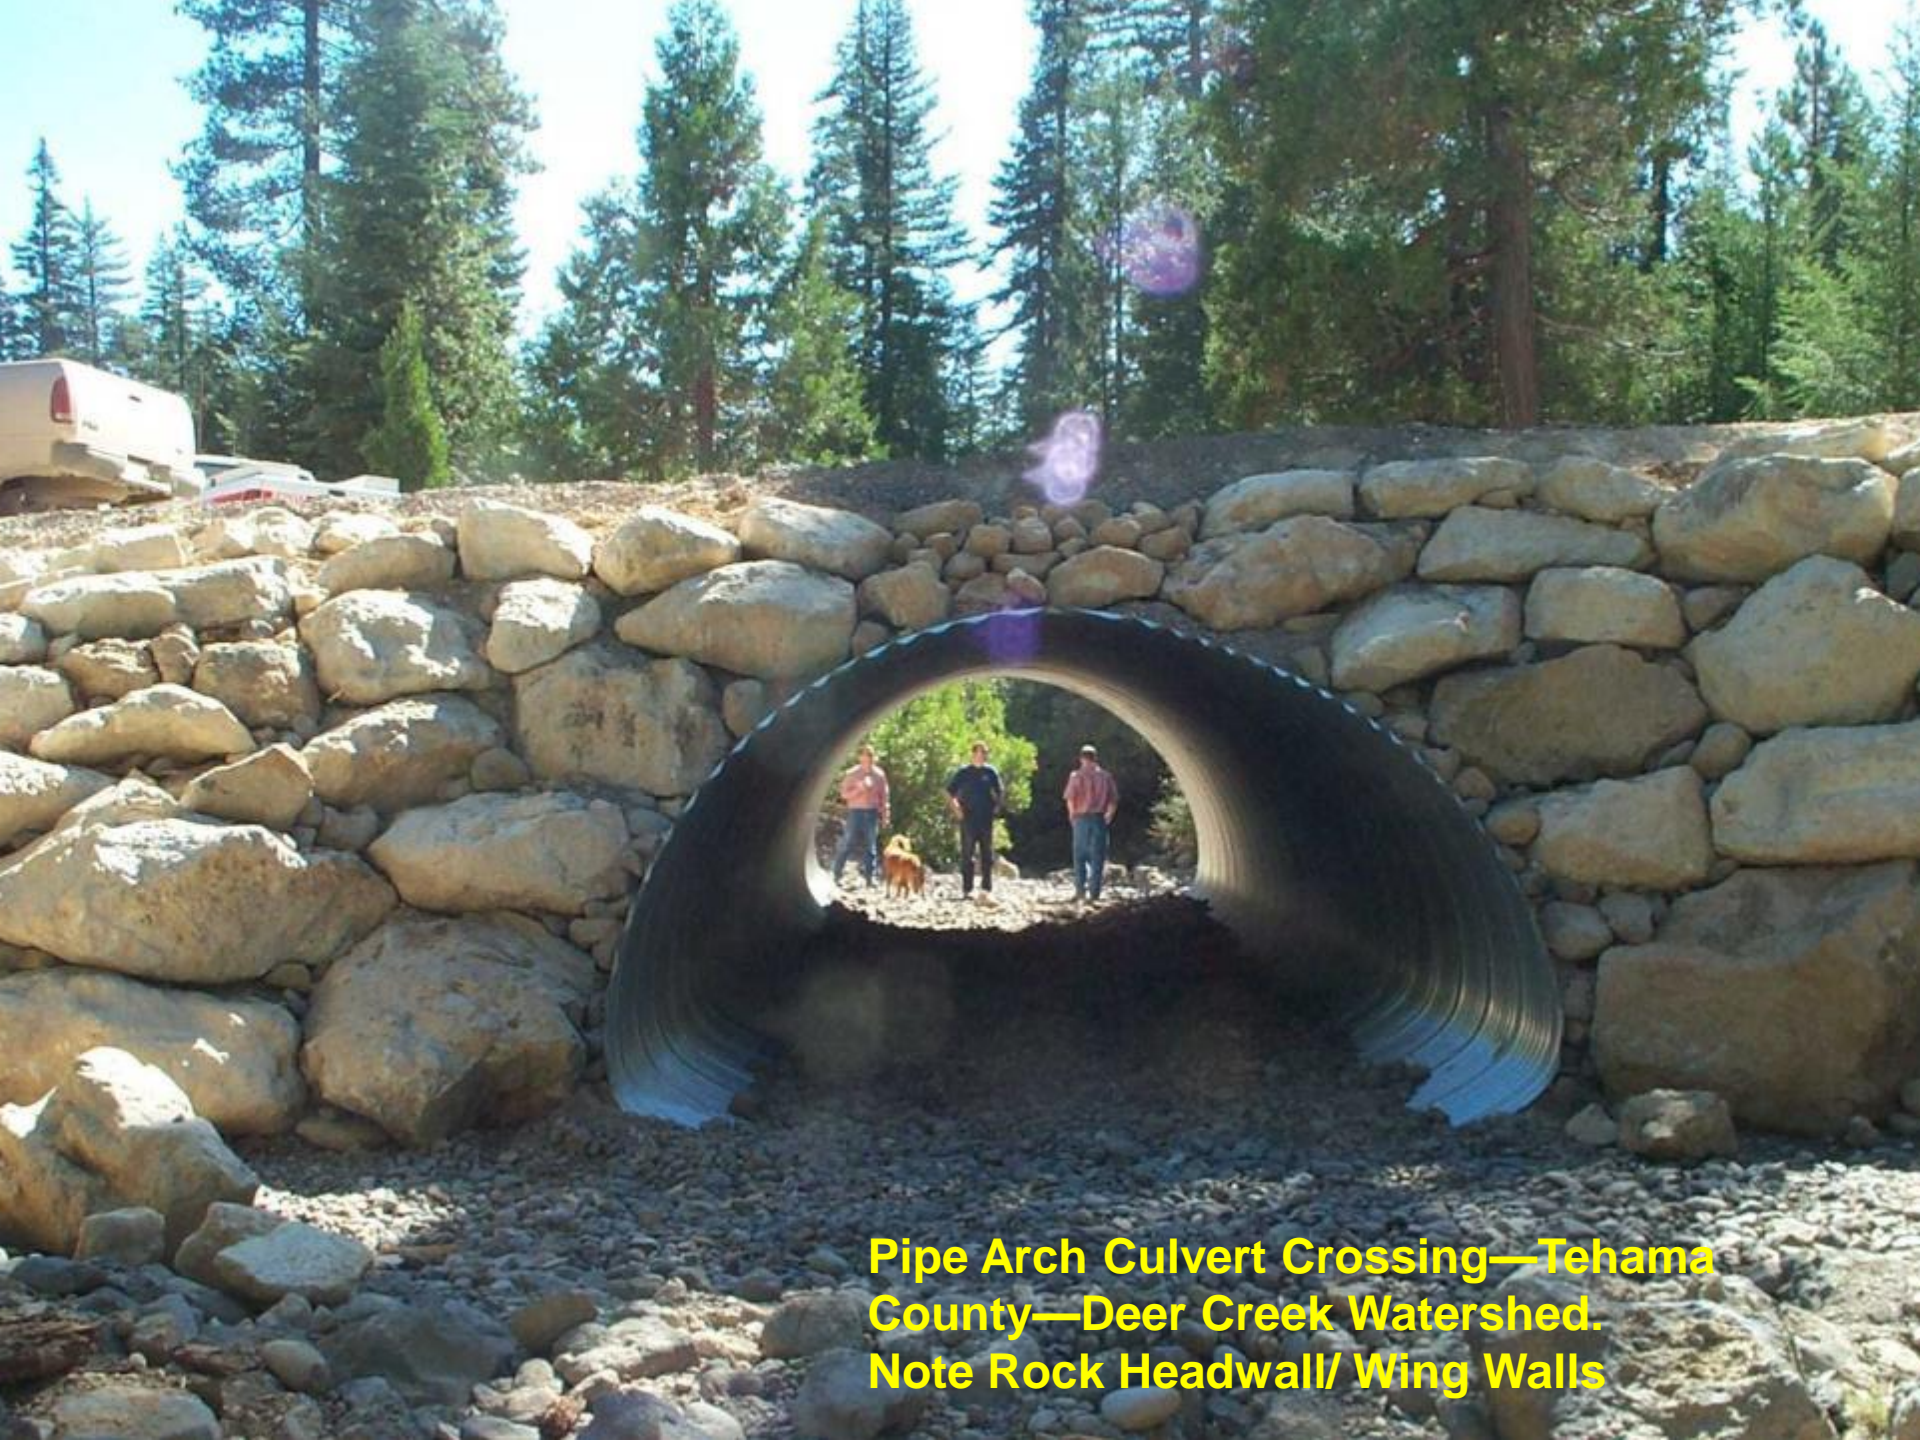
Pipe Arch Culvert Crossing—Tehama County—Deer Creek Watershed. Note Rock Headwall/ Wing Walls

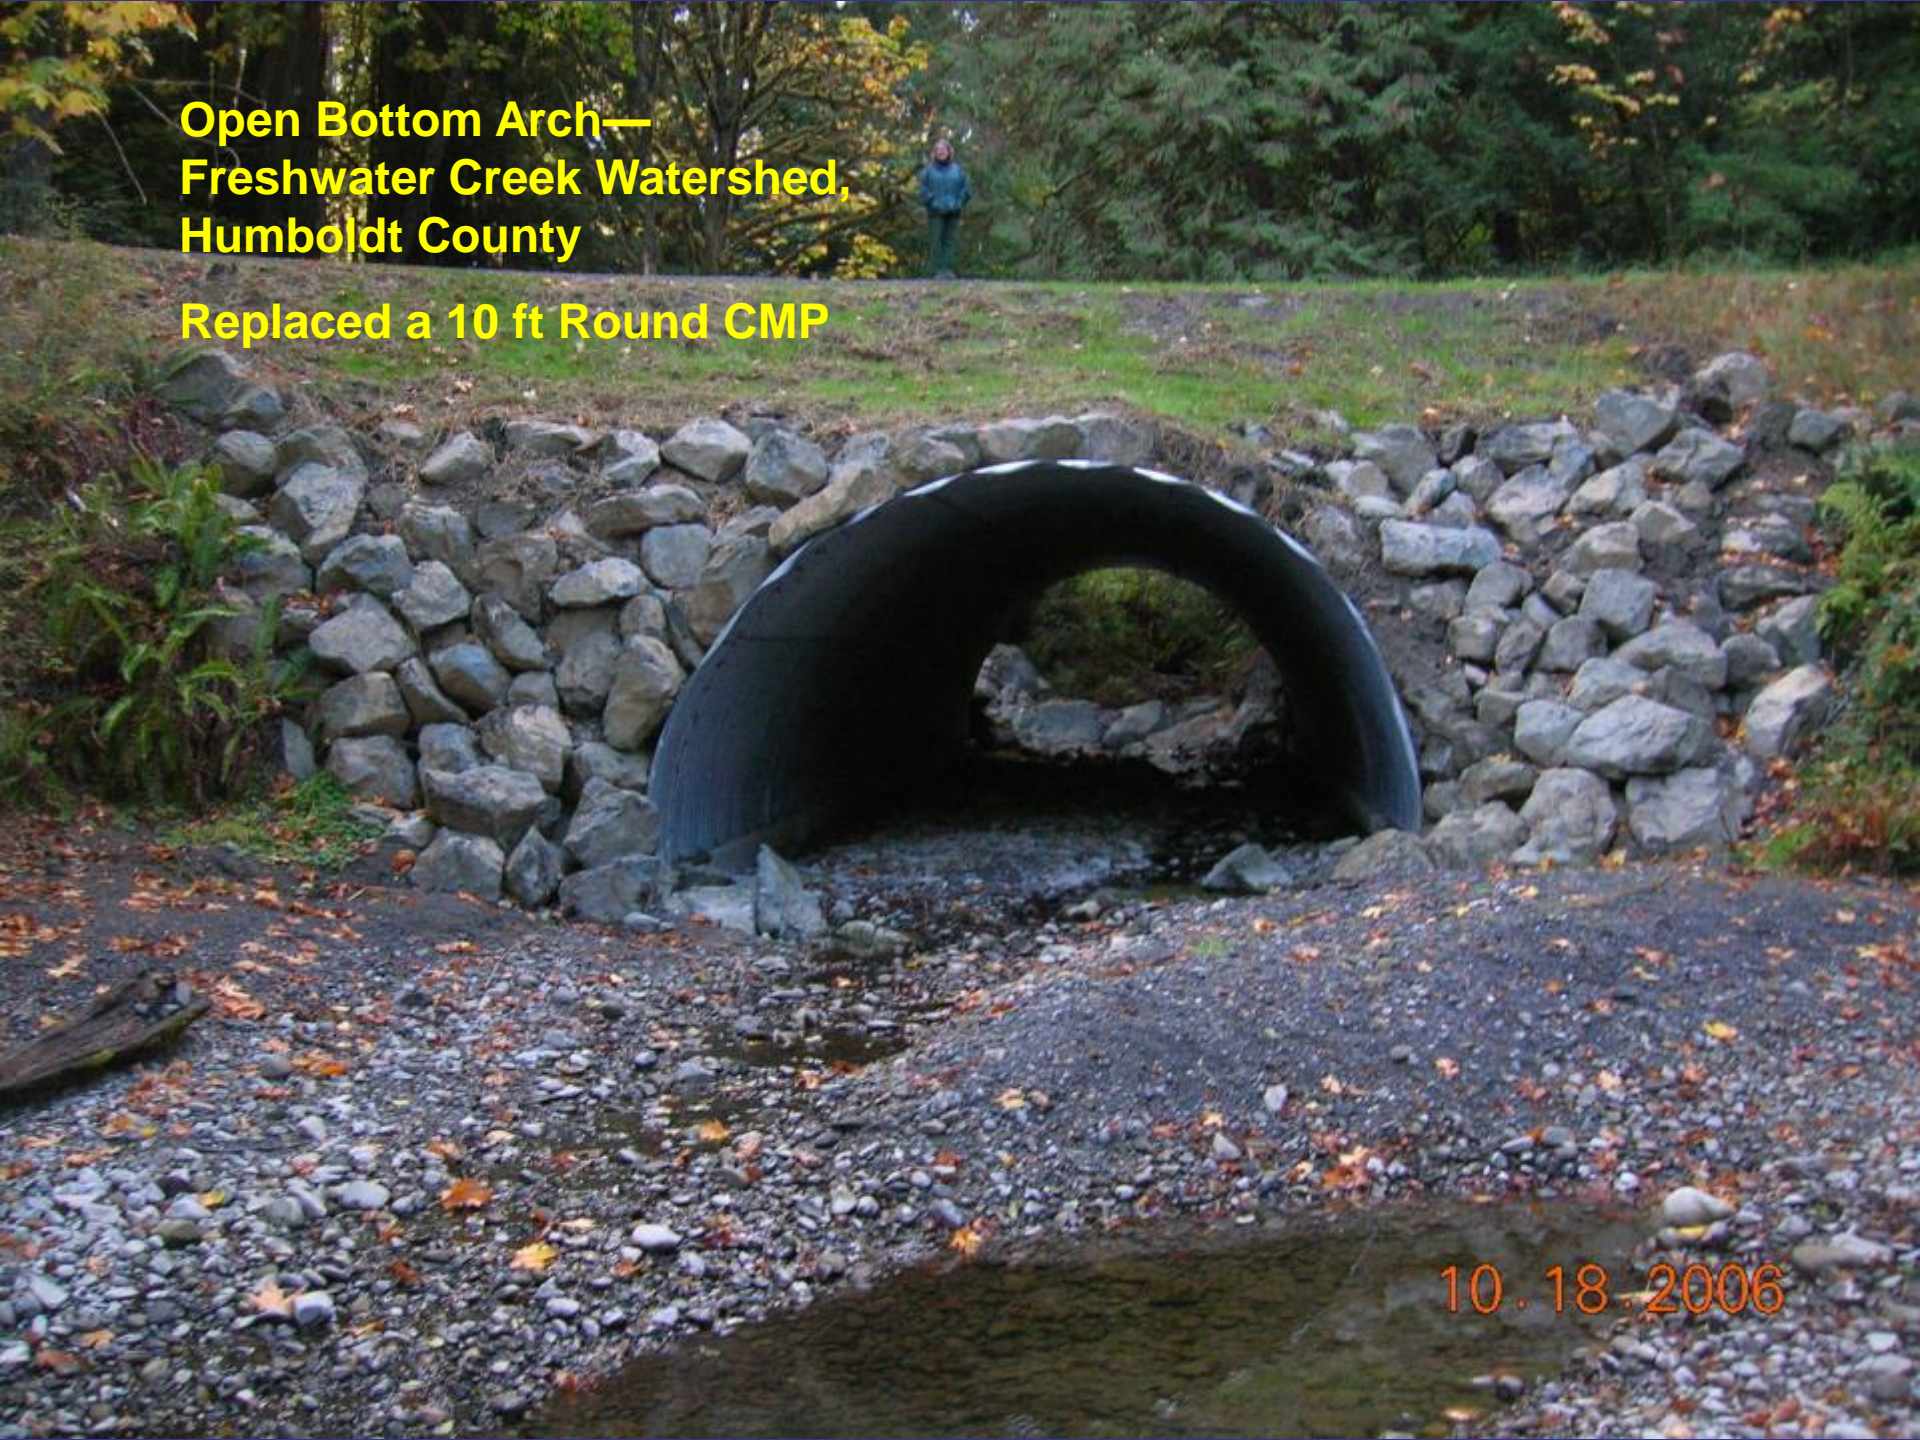
**Open Bottom Arch—
Freshwater Creek Watershed,
Humboldt County**

Replaced a 10 ft Round CMP

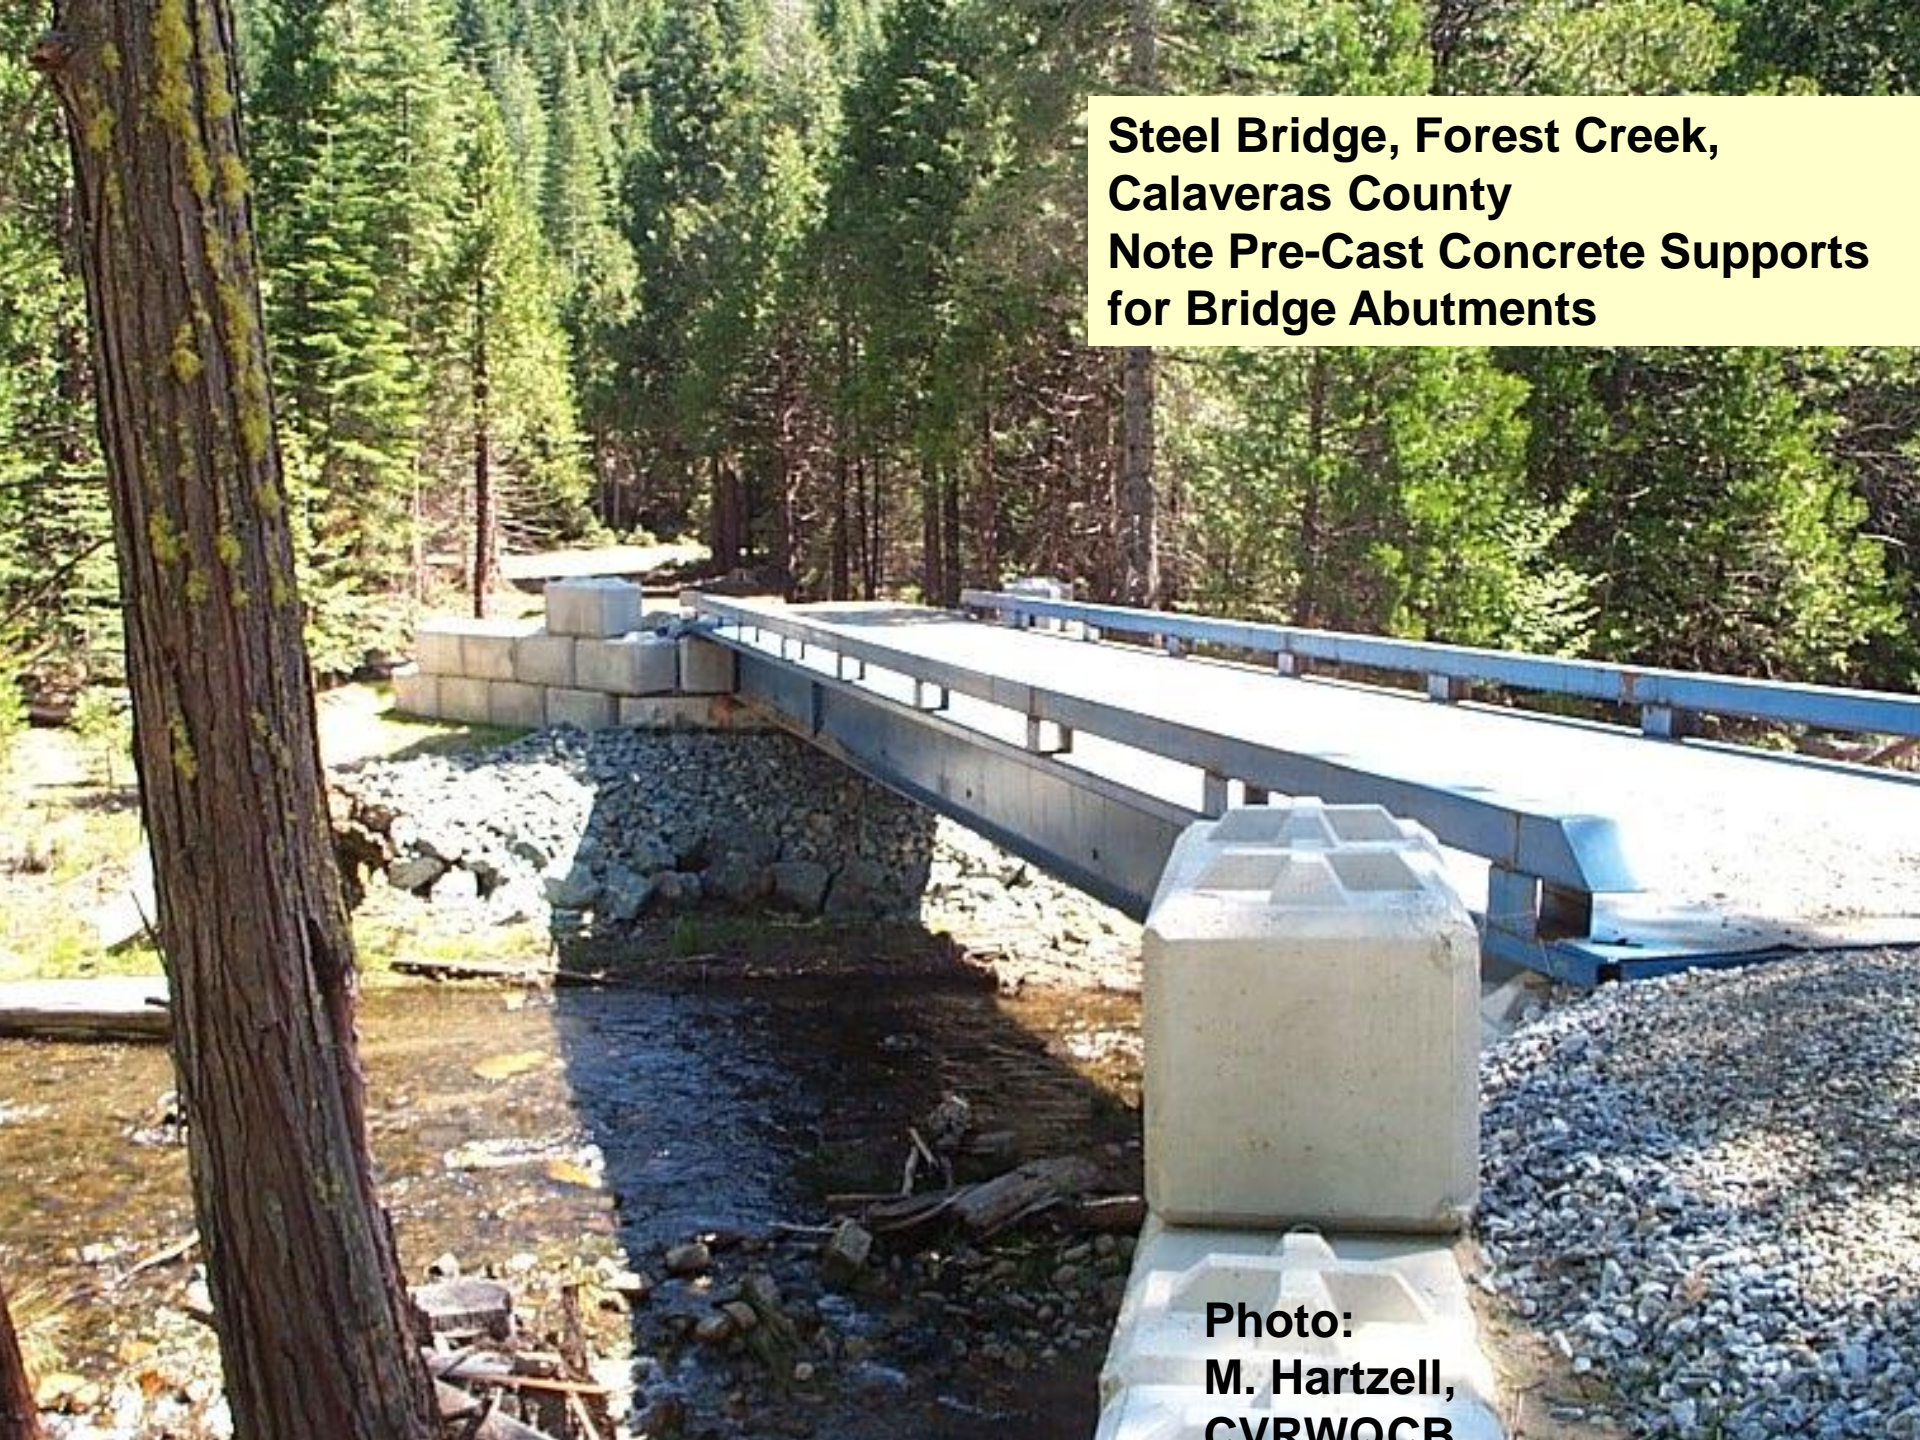
A photograph of a steel bridge crossing a creek in a forest. The bridge is supported by pre-cast concrete abutments. The surrounding area is densely wooded with tall evergreen trees. The water in the creek is clear and flows over a rocky bed. A large tree trunk is visible on the left side of the frame.

**Steel Bridge, Forest Creek,
Calaveras County
Note Pre-Cast Concrete Supports
for Bridge Abutments**

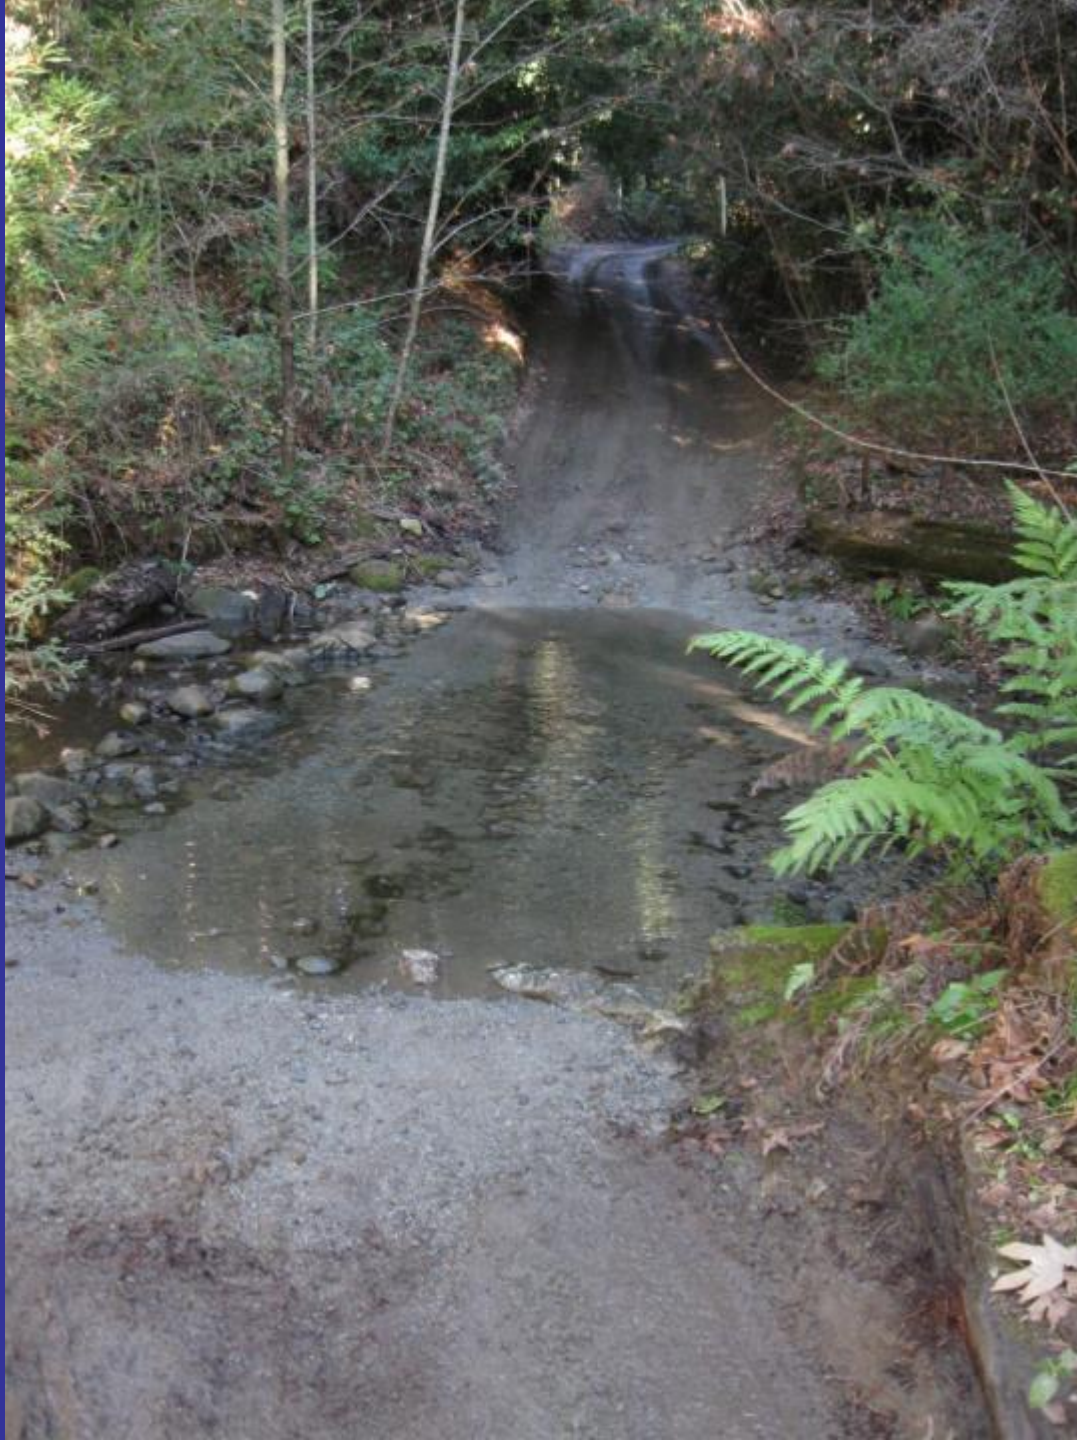
**Unimproved Wet
Ford Crossing
with Chronic
Sediment Entry
into Hinckley
Creek**

**Santa Cruz
County**

**NOT
DESIRABLE**
