Stream Crossing Alternatives

Pete Cafferata

California Department of Forestry
and Fire Protection

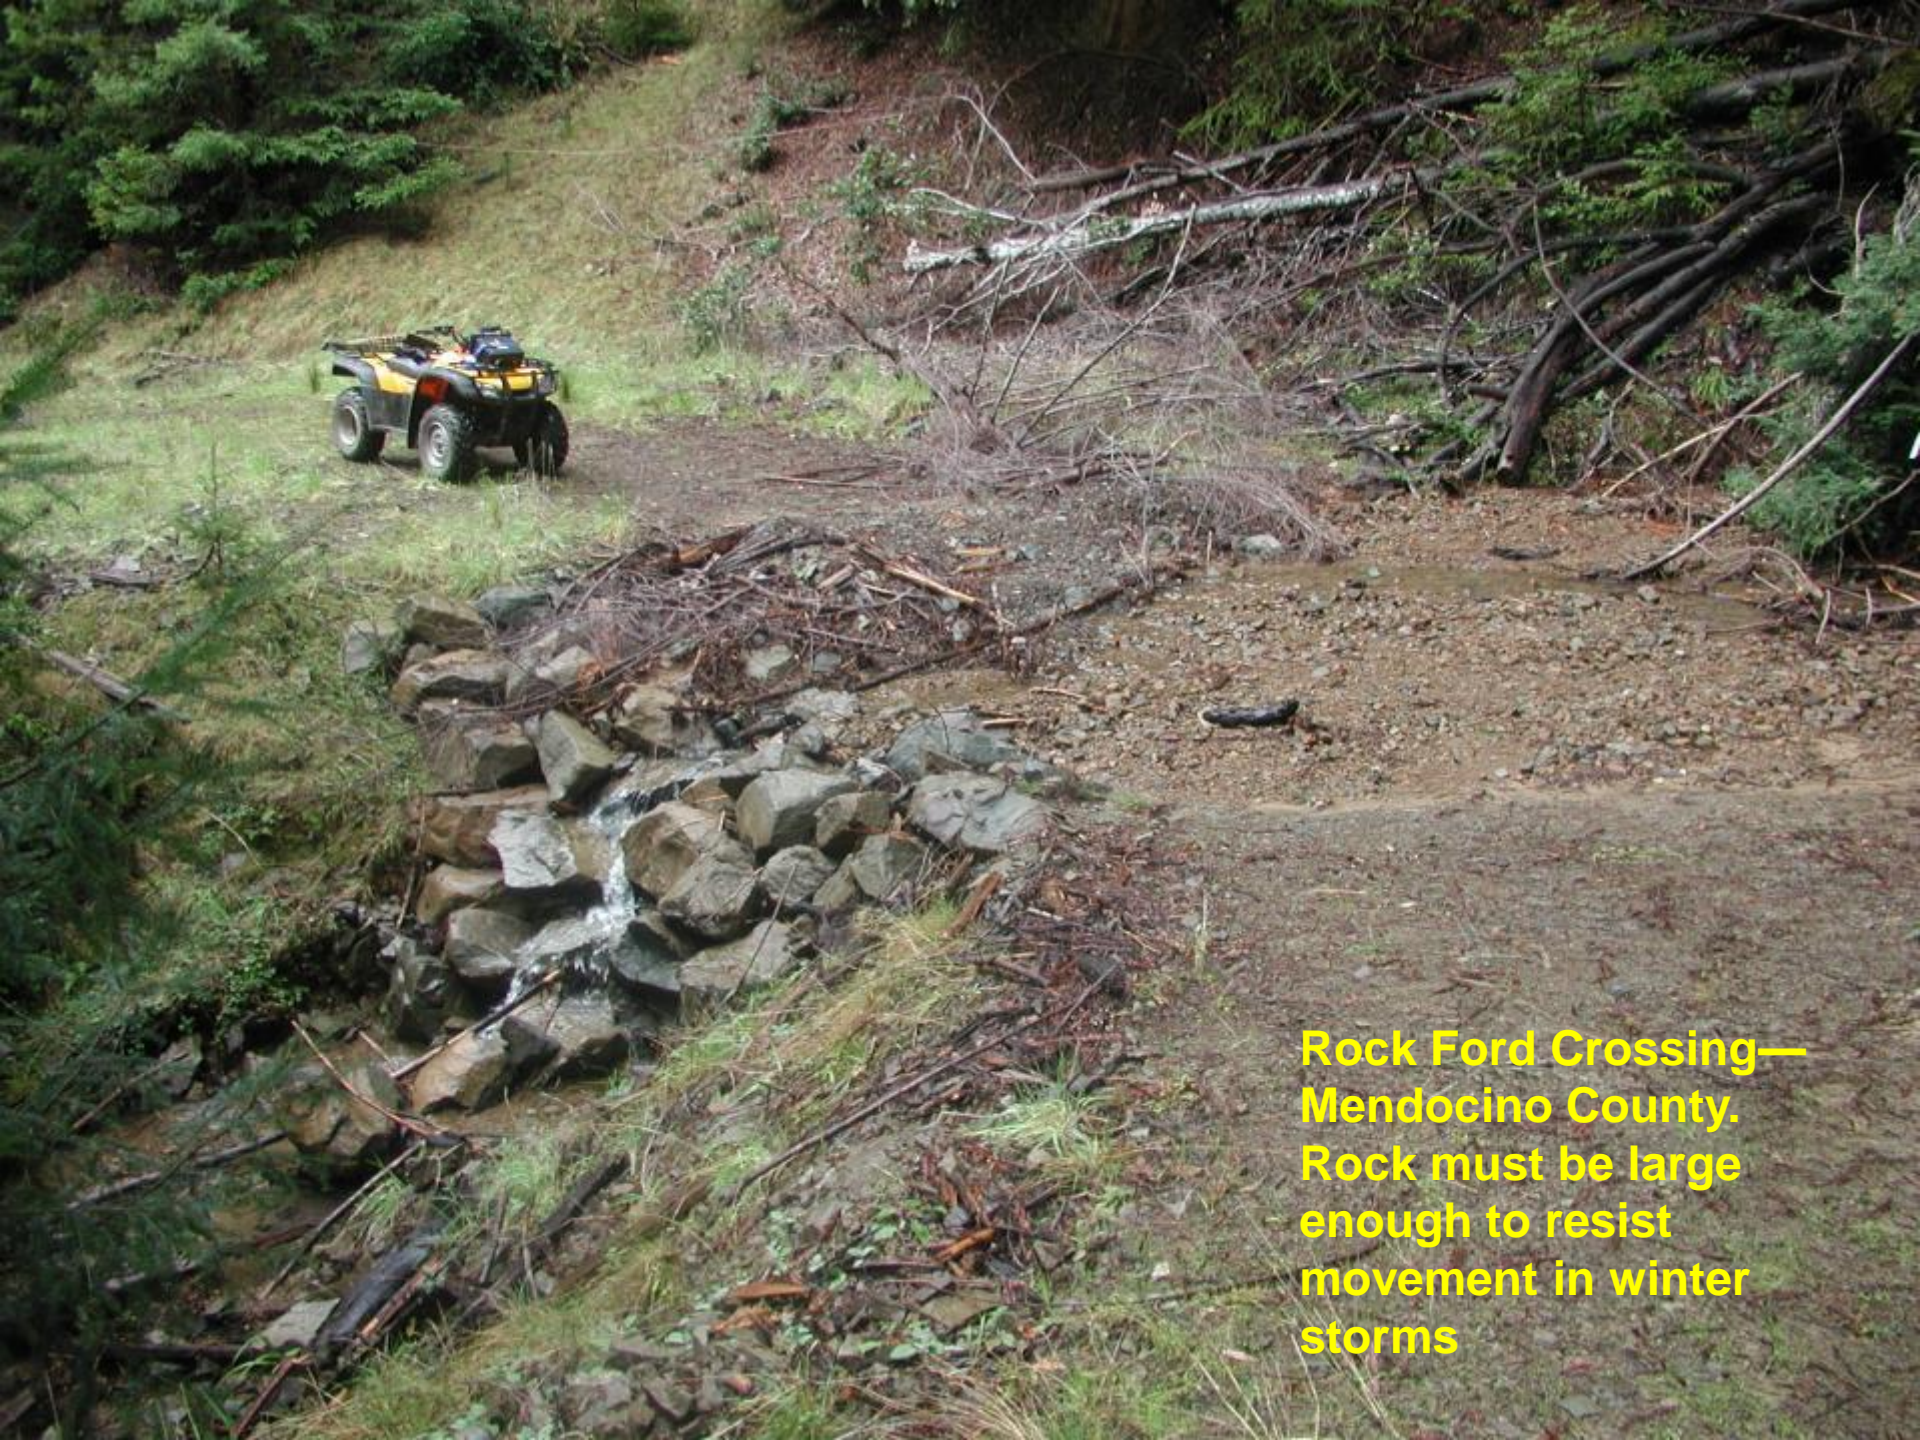
**Rock Ford Crossing—
Mendocino County.
Rock must be large
enough to resist
movement in winter
storms**

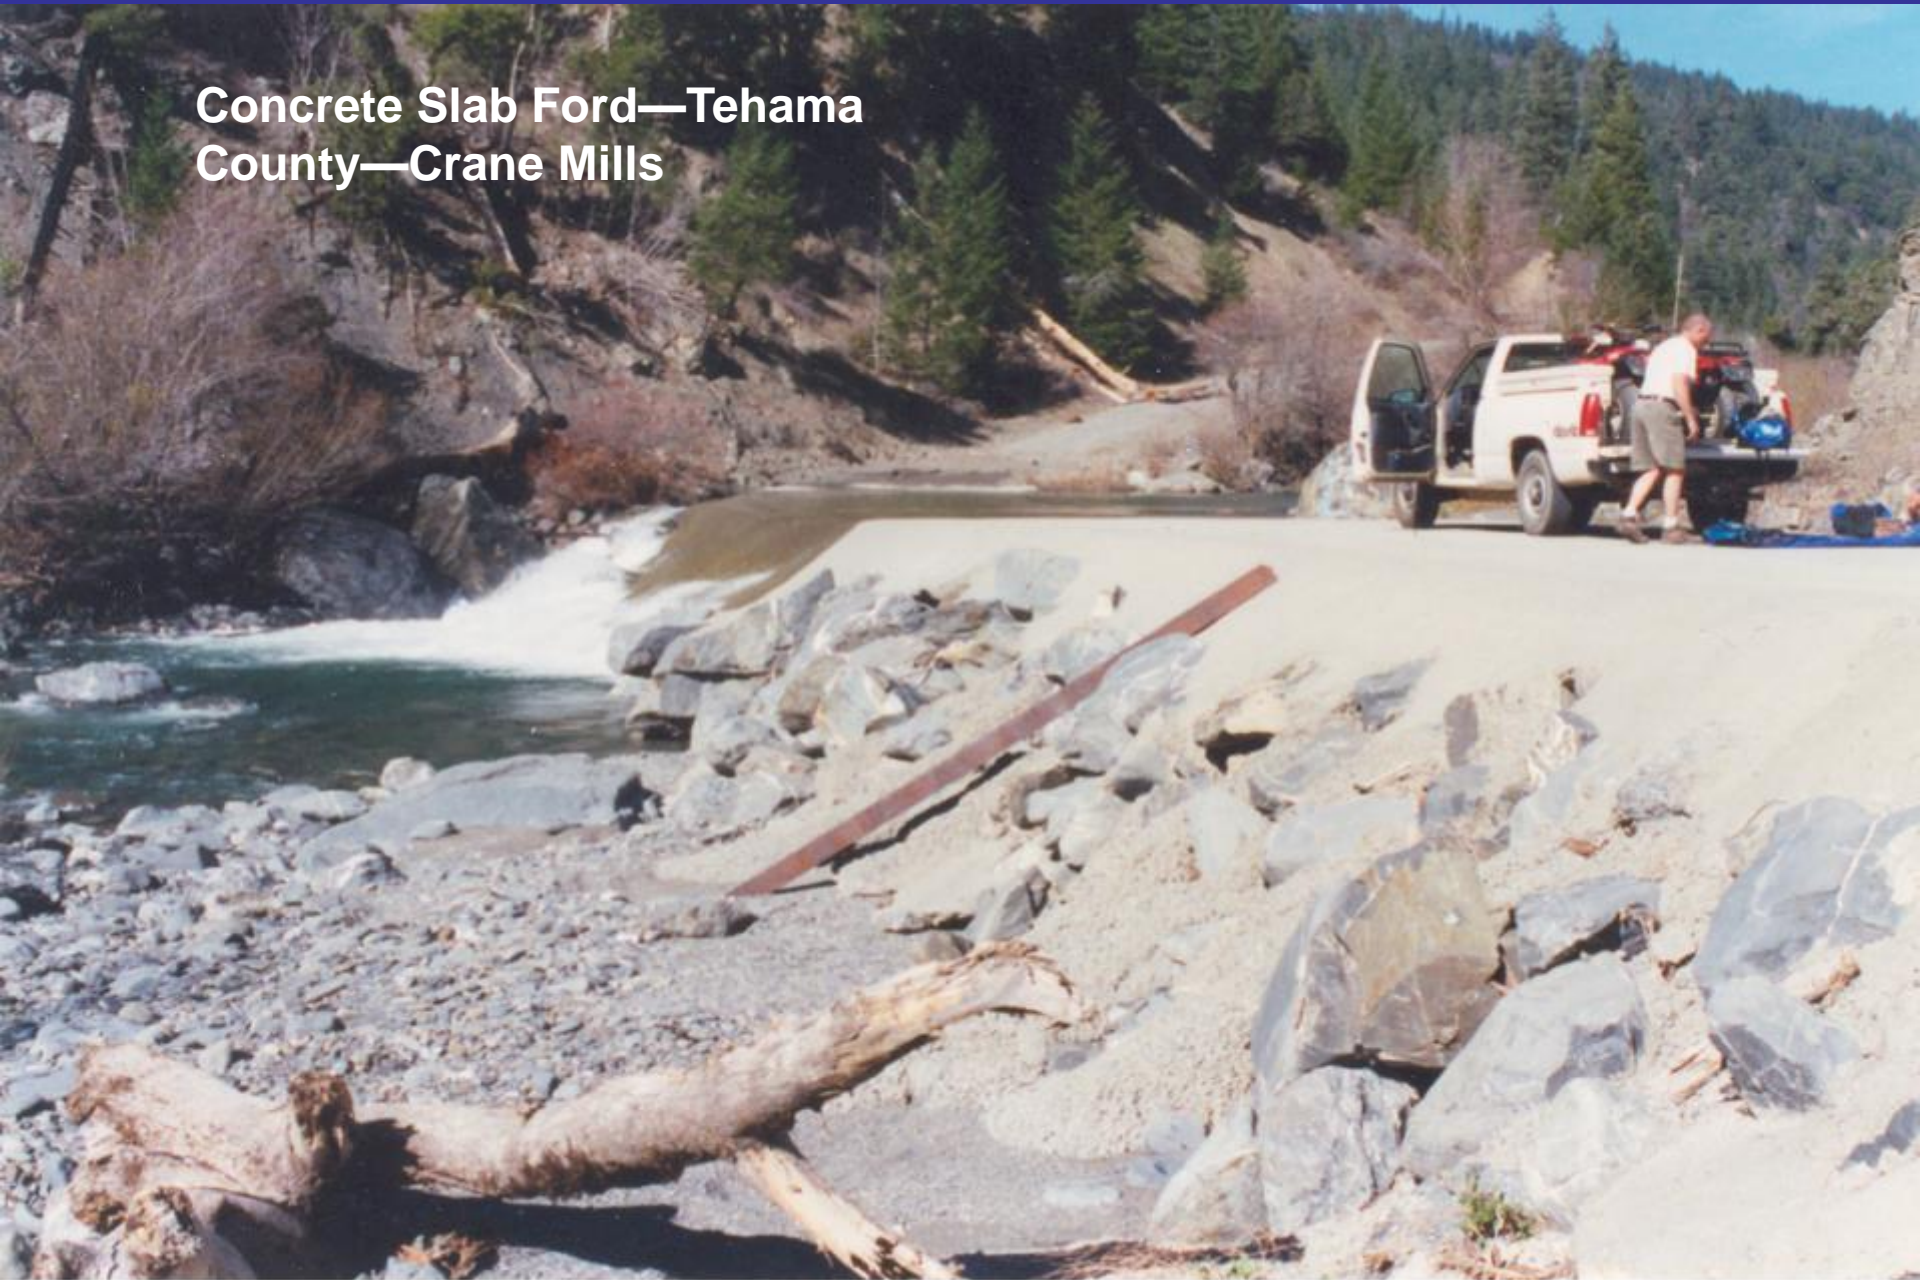
**Concrete Slab Ford—Tehama
County—Crane Mills**

Thomes Creek "The Slab."

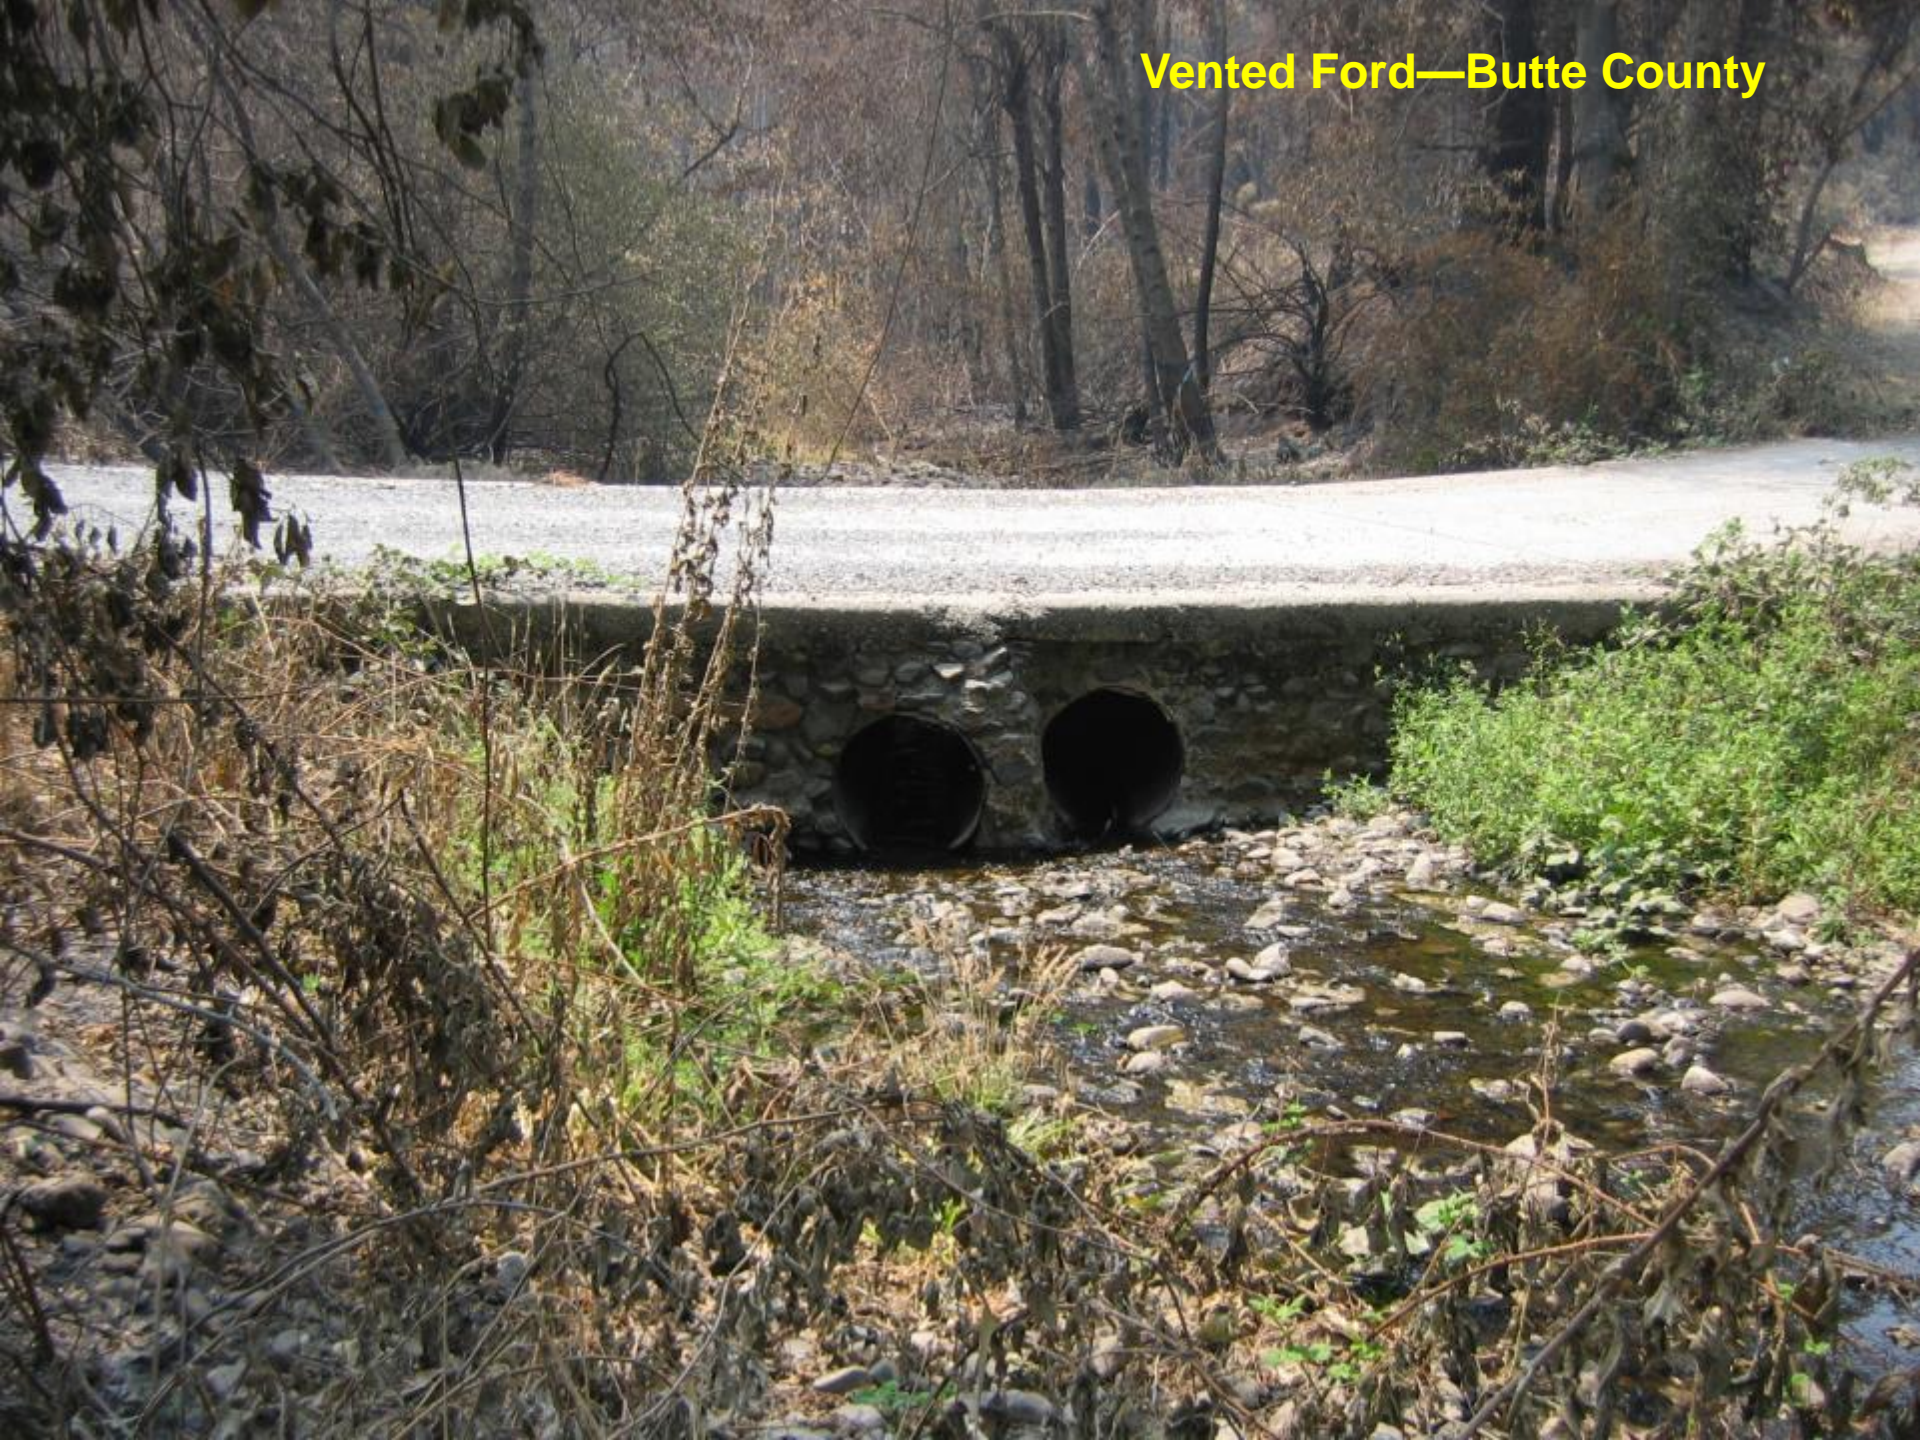
Vented Ford—Butte County

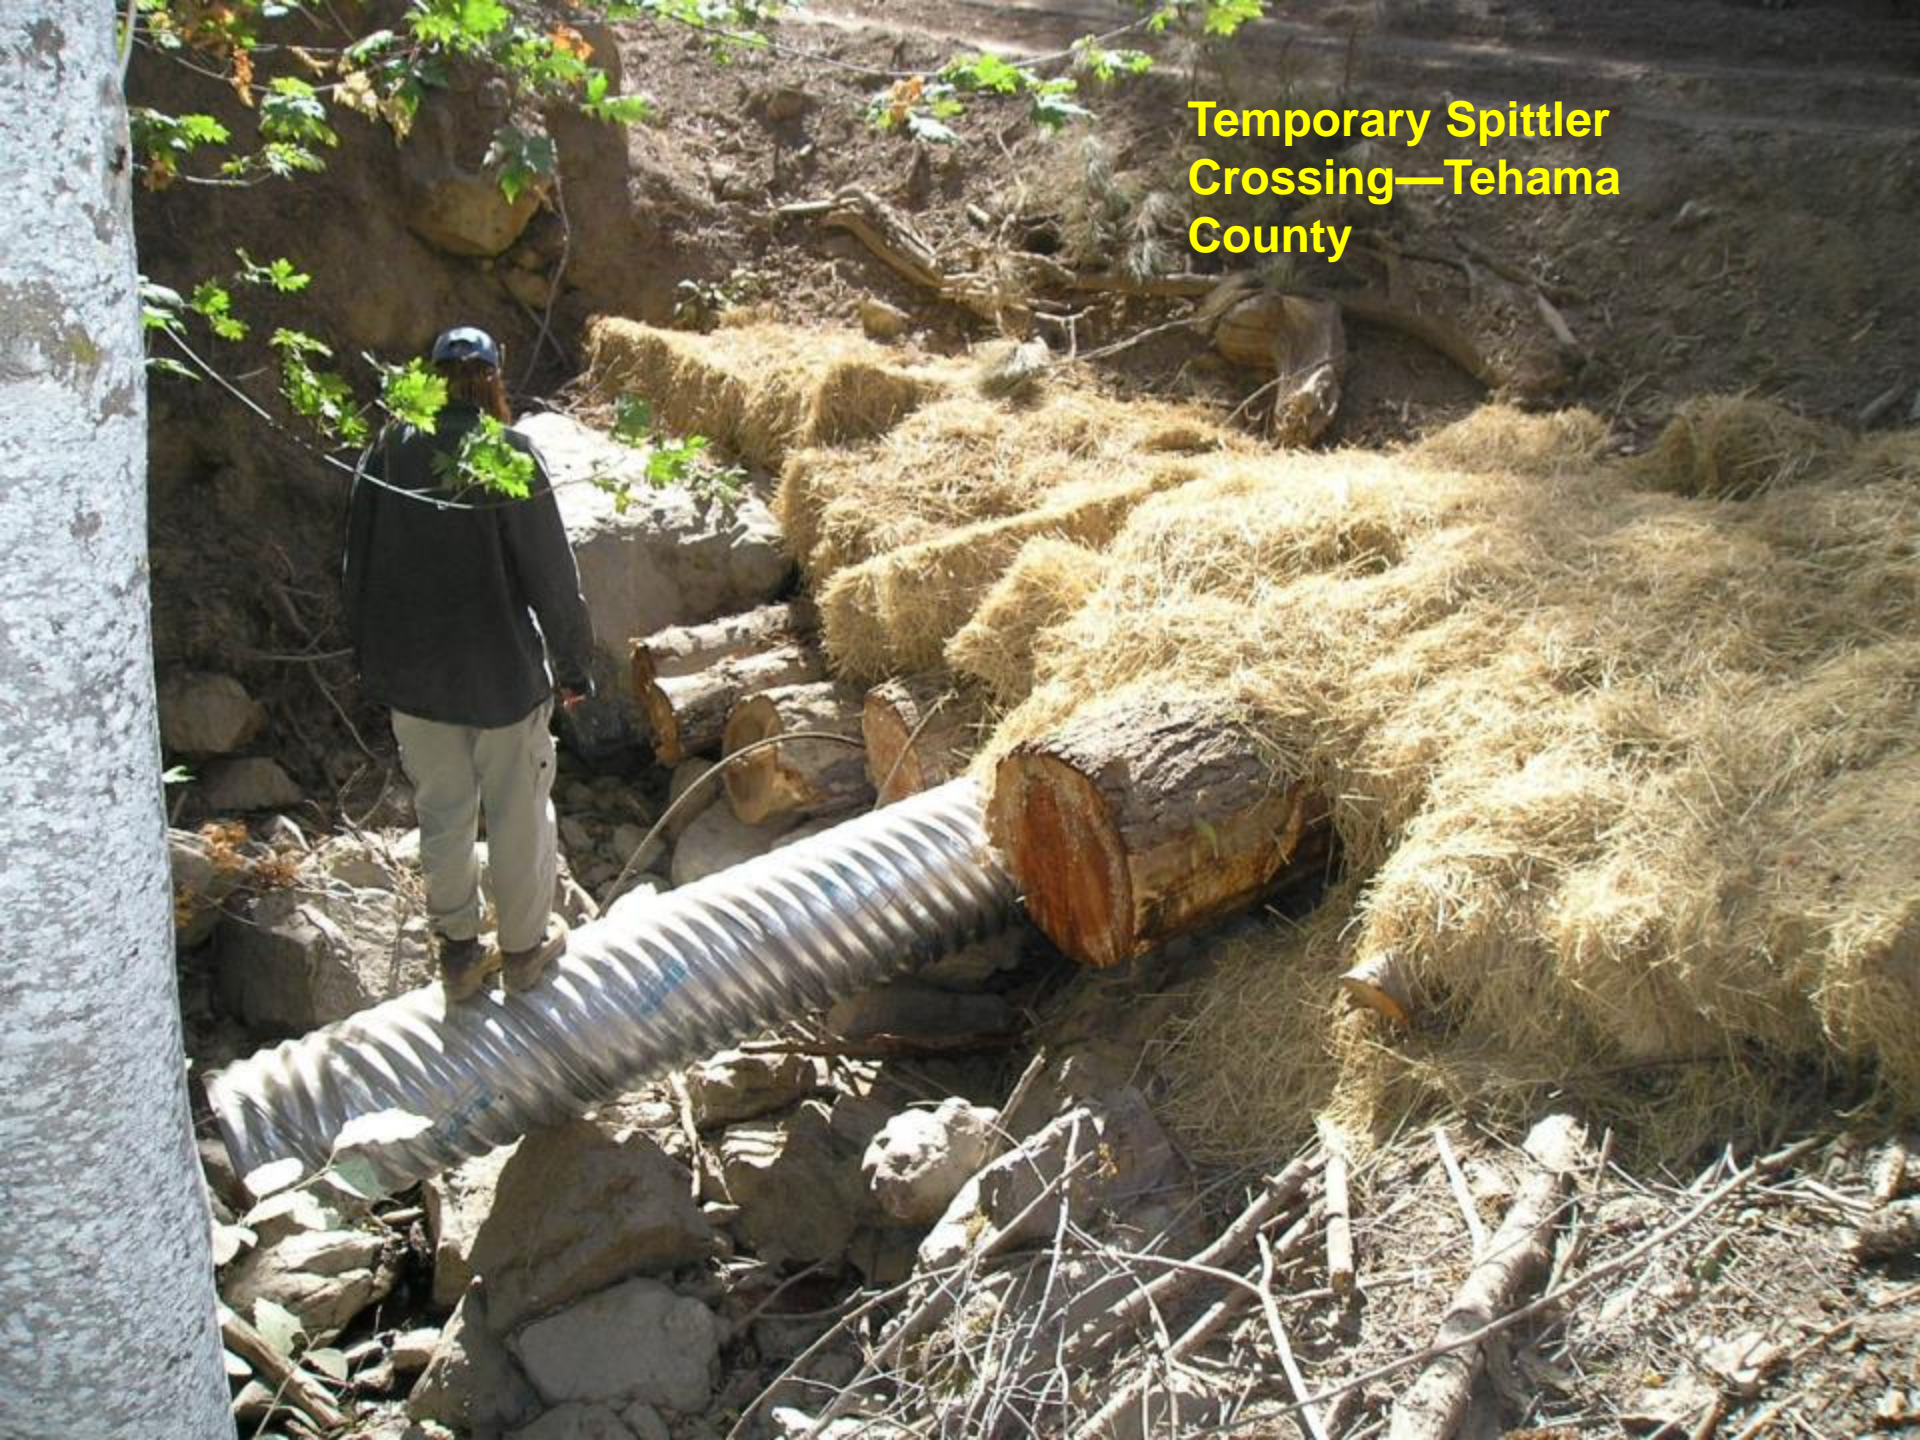
**Temporary Spittler
Crossing—Tehama
County**

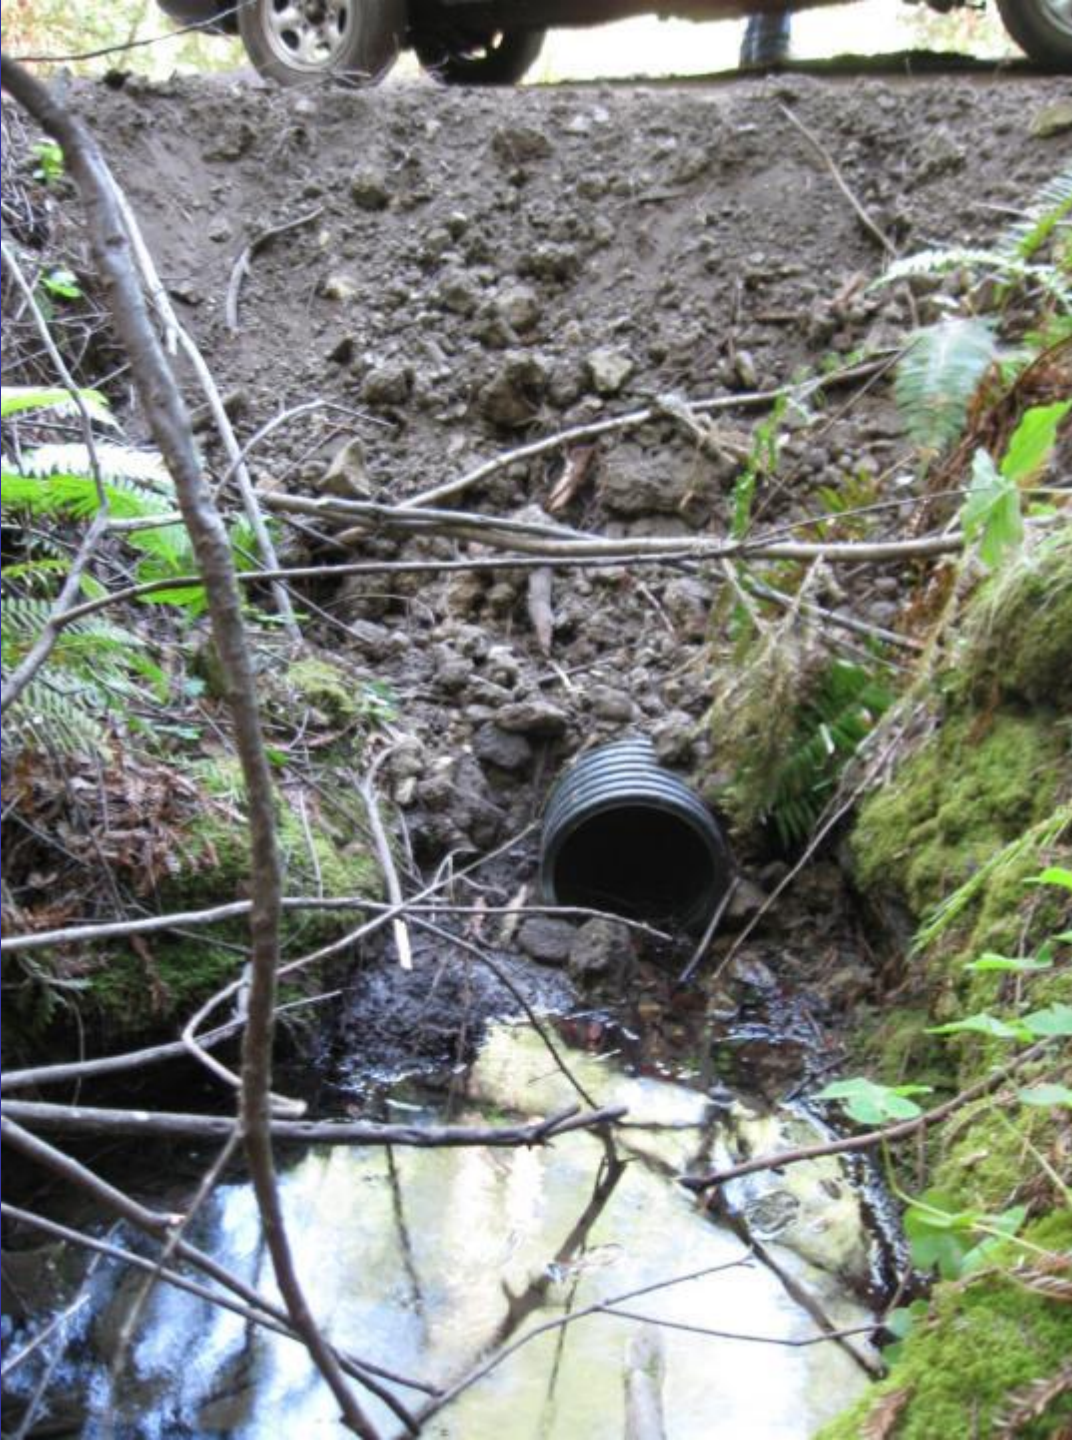
**Temporary 12
inch plastic
pipe**

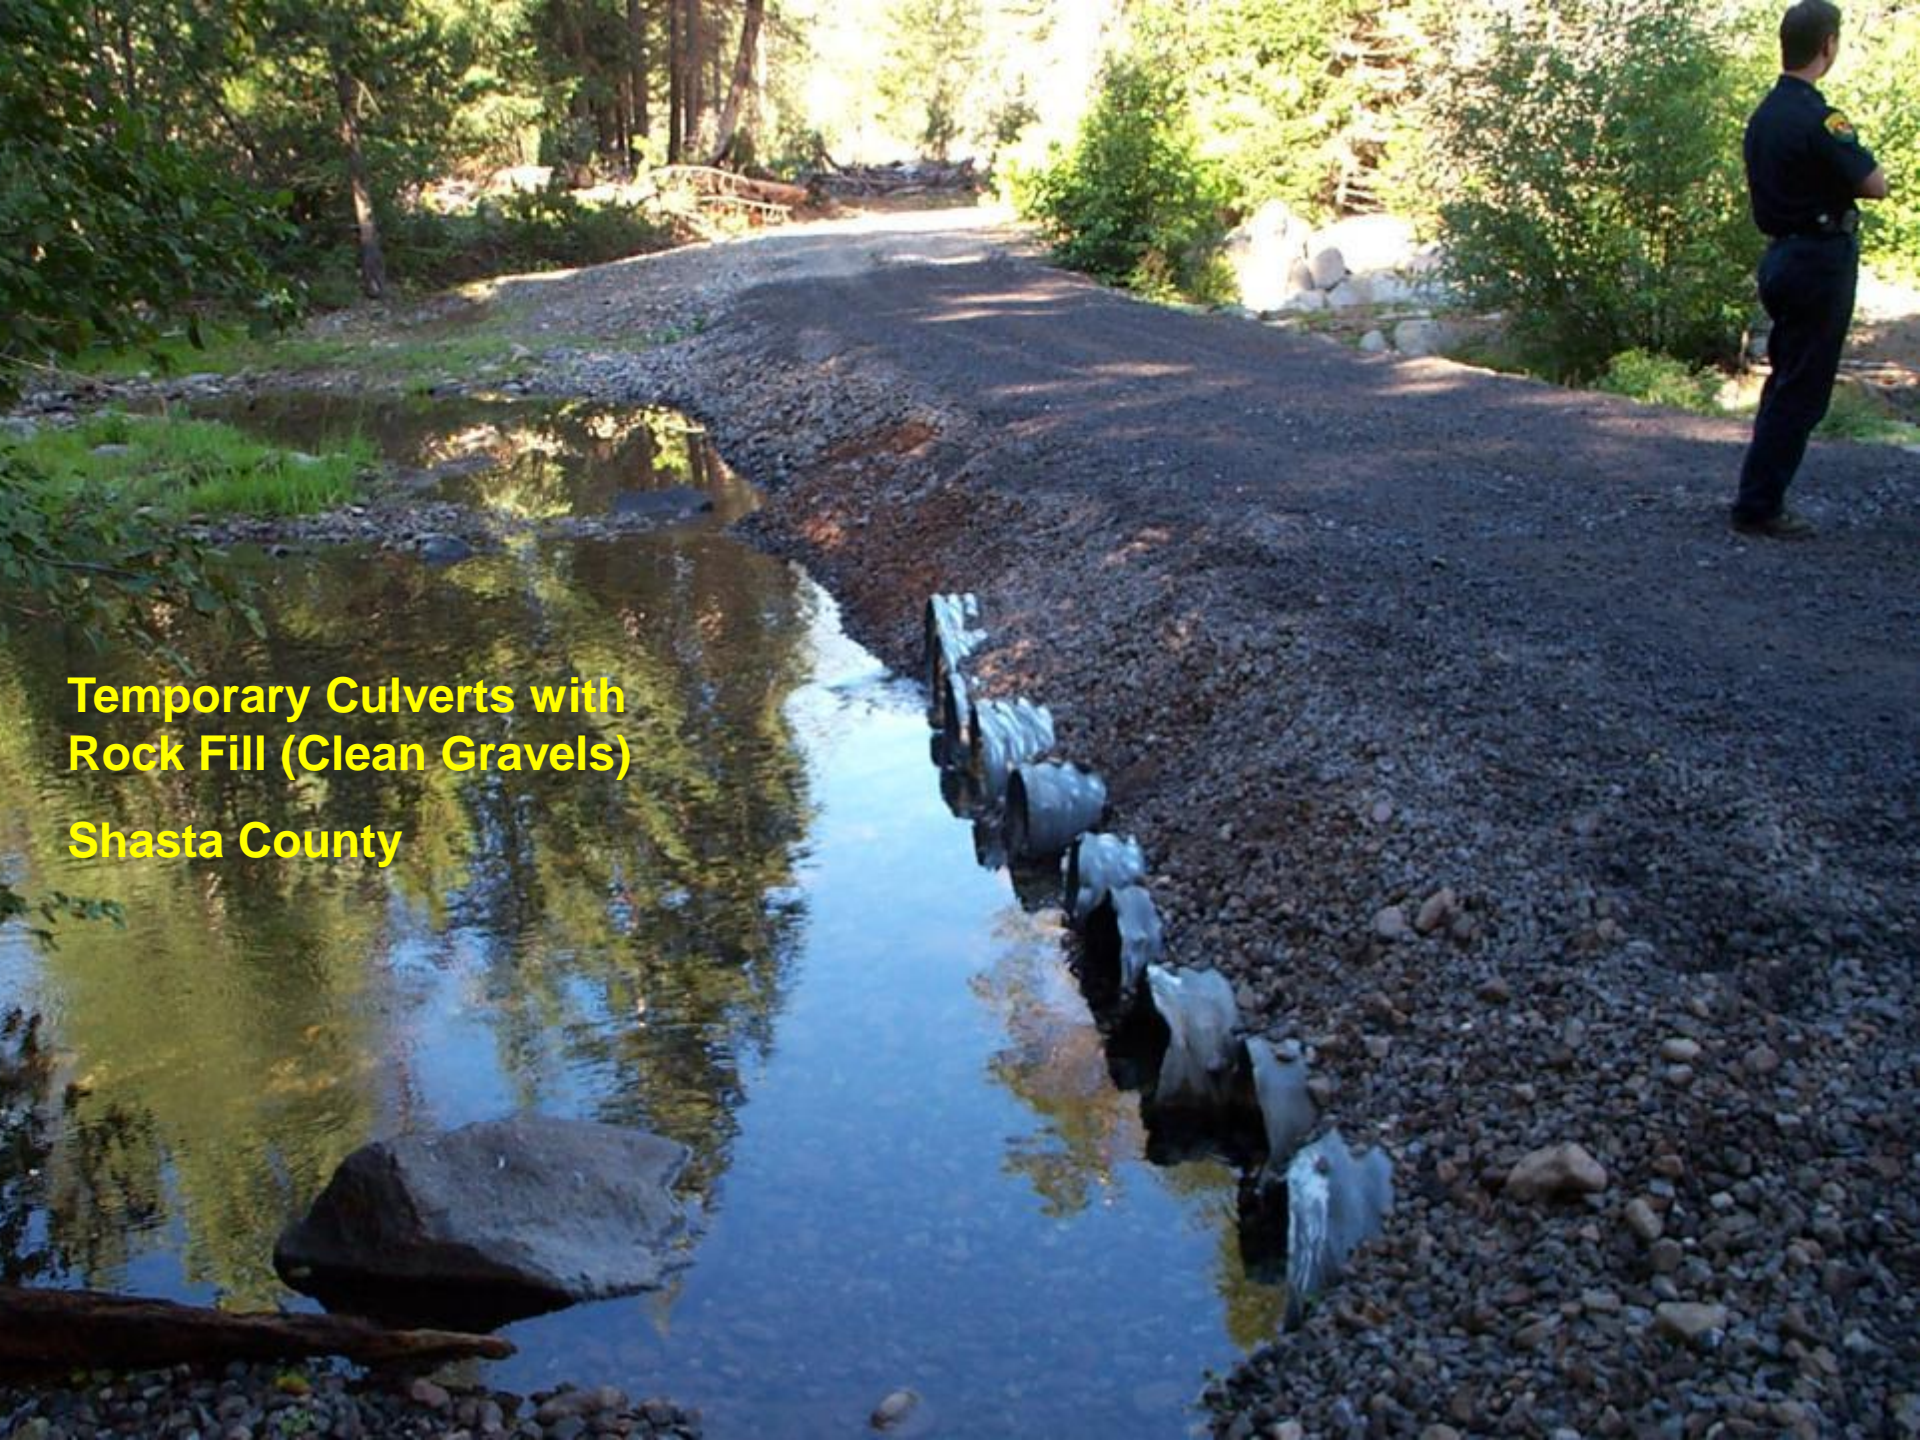
A gravel road crosses a stream. The road is made of dark gravel and is supported by a series of temporary culverts made of corrugated metal sheets. The culverts are supported by a bed of clean, light-colored gravel. The stream is shallow and reflects the surrounding trees. A person in a dark uniform stands on the right side of the road, looking towards the stream. The background shows a dense forest of tall trees.

**Temporary Culverts with
Rock Fill (Clean Gravels)
Shasta County**

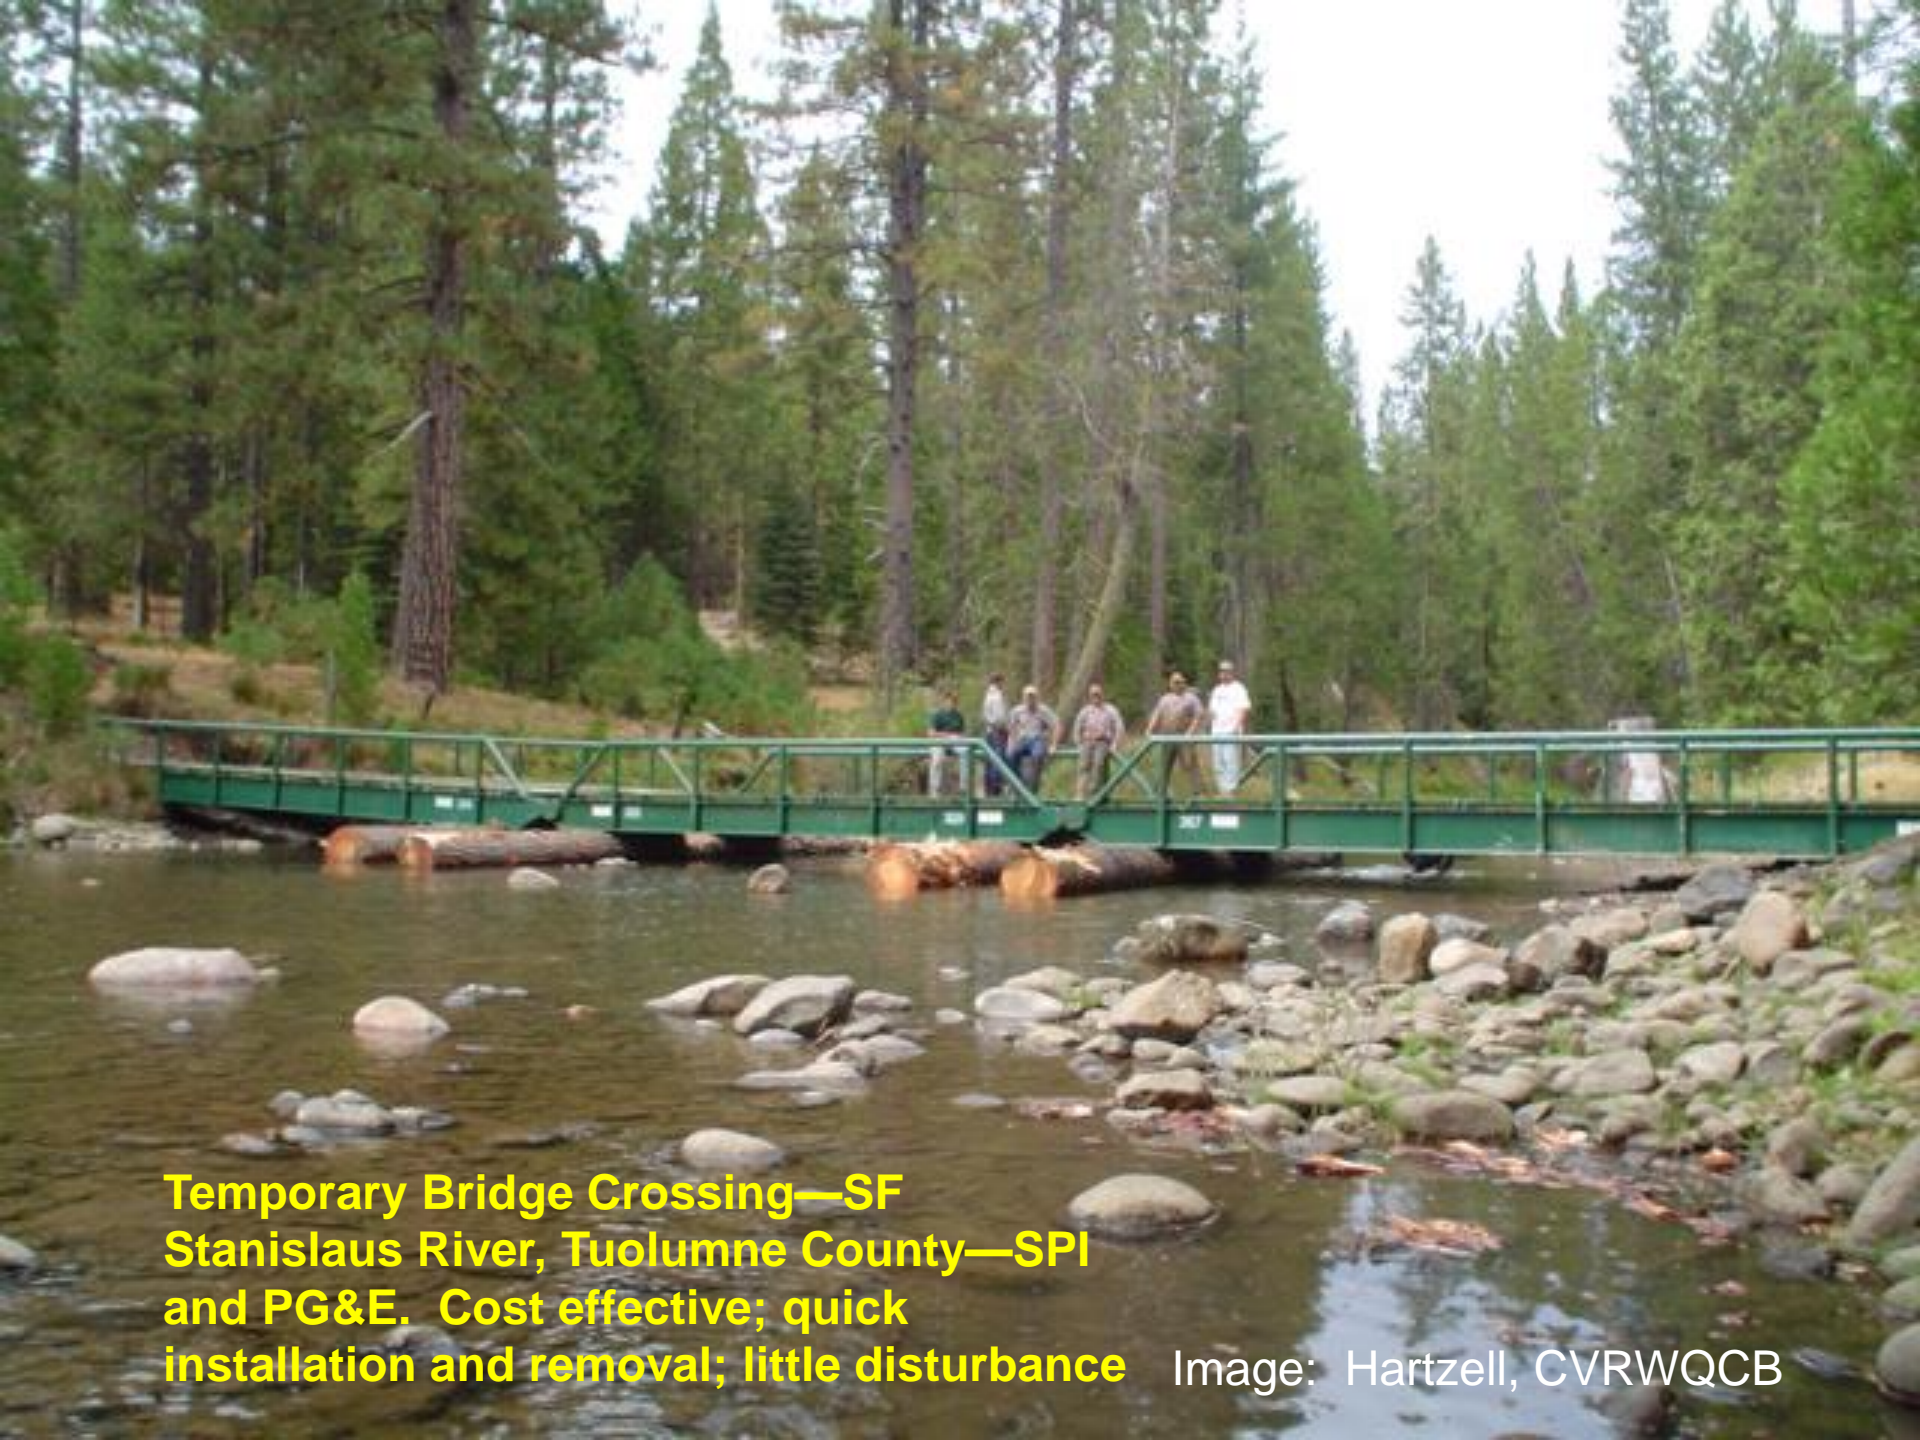
**Temporary Bridge Crossing—SF
Stanislaus River, Tuolumne County—SPI
and PG&E. Cost effective; quick
installation and removal; little disturbance**

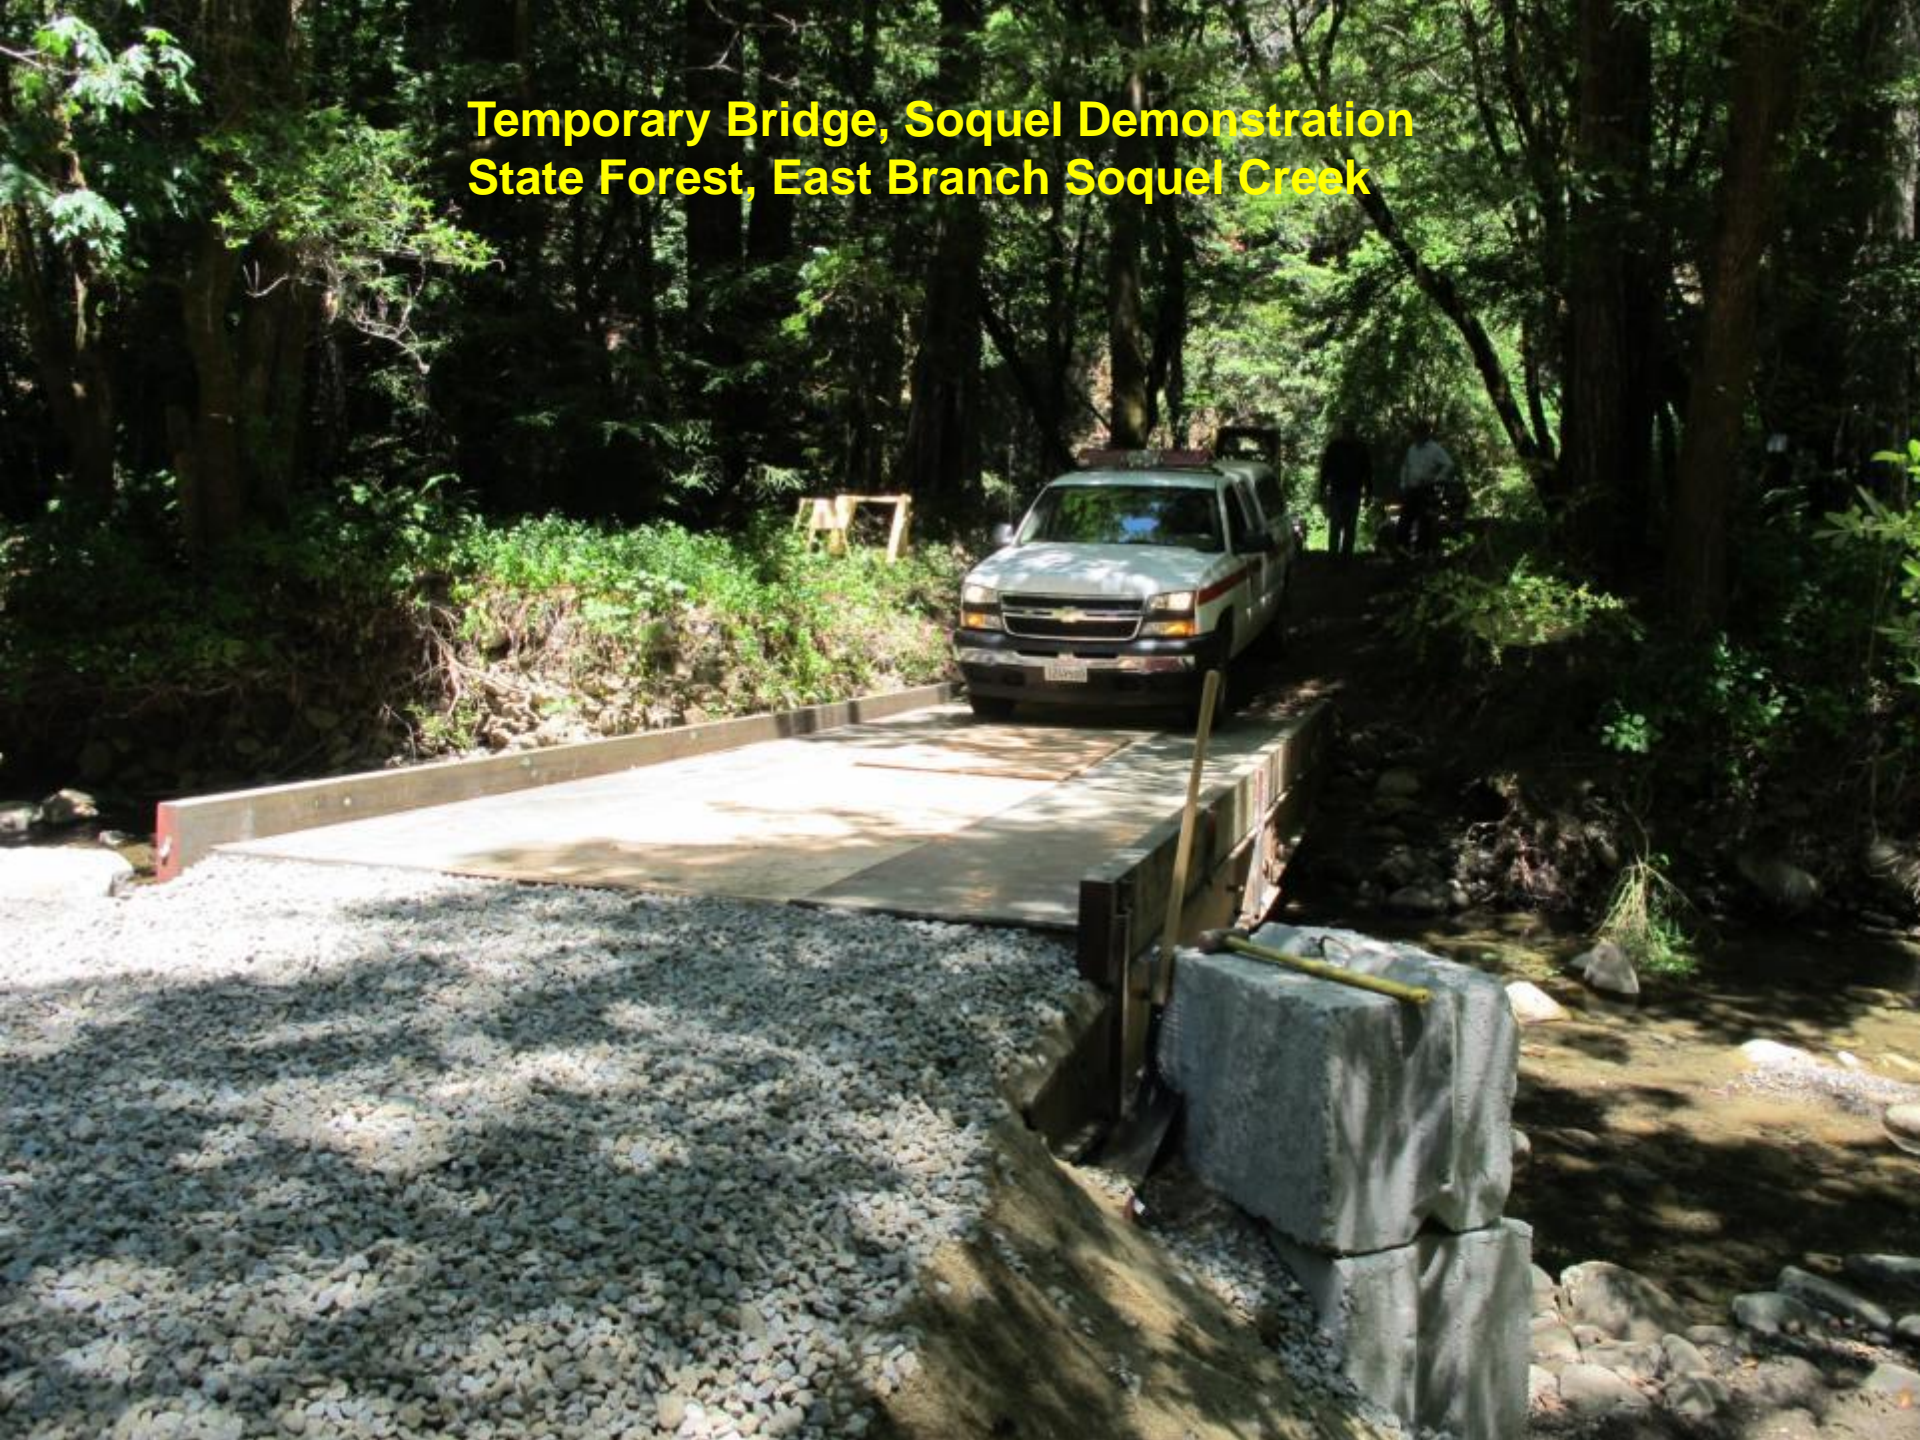
**Temporary Bridge, Soquel Demonstration
State Forest, East Branch Soquel Creek**
