Stream Crossing Alternatives

Pete Cafferata

California Department of Forestry
and Fire Protection

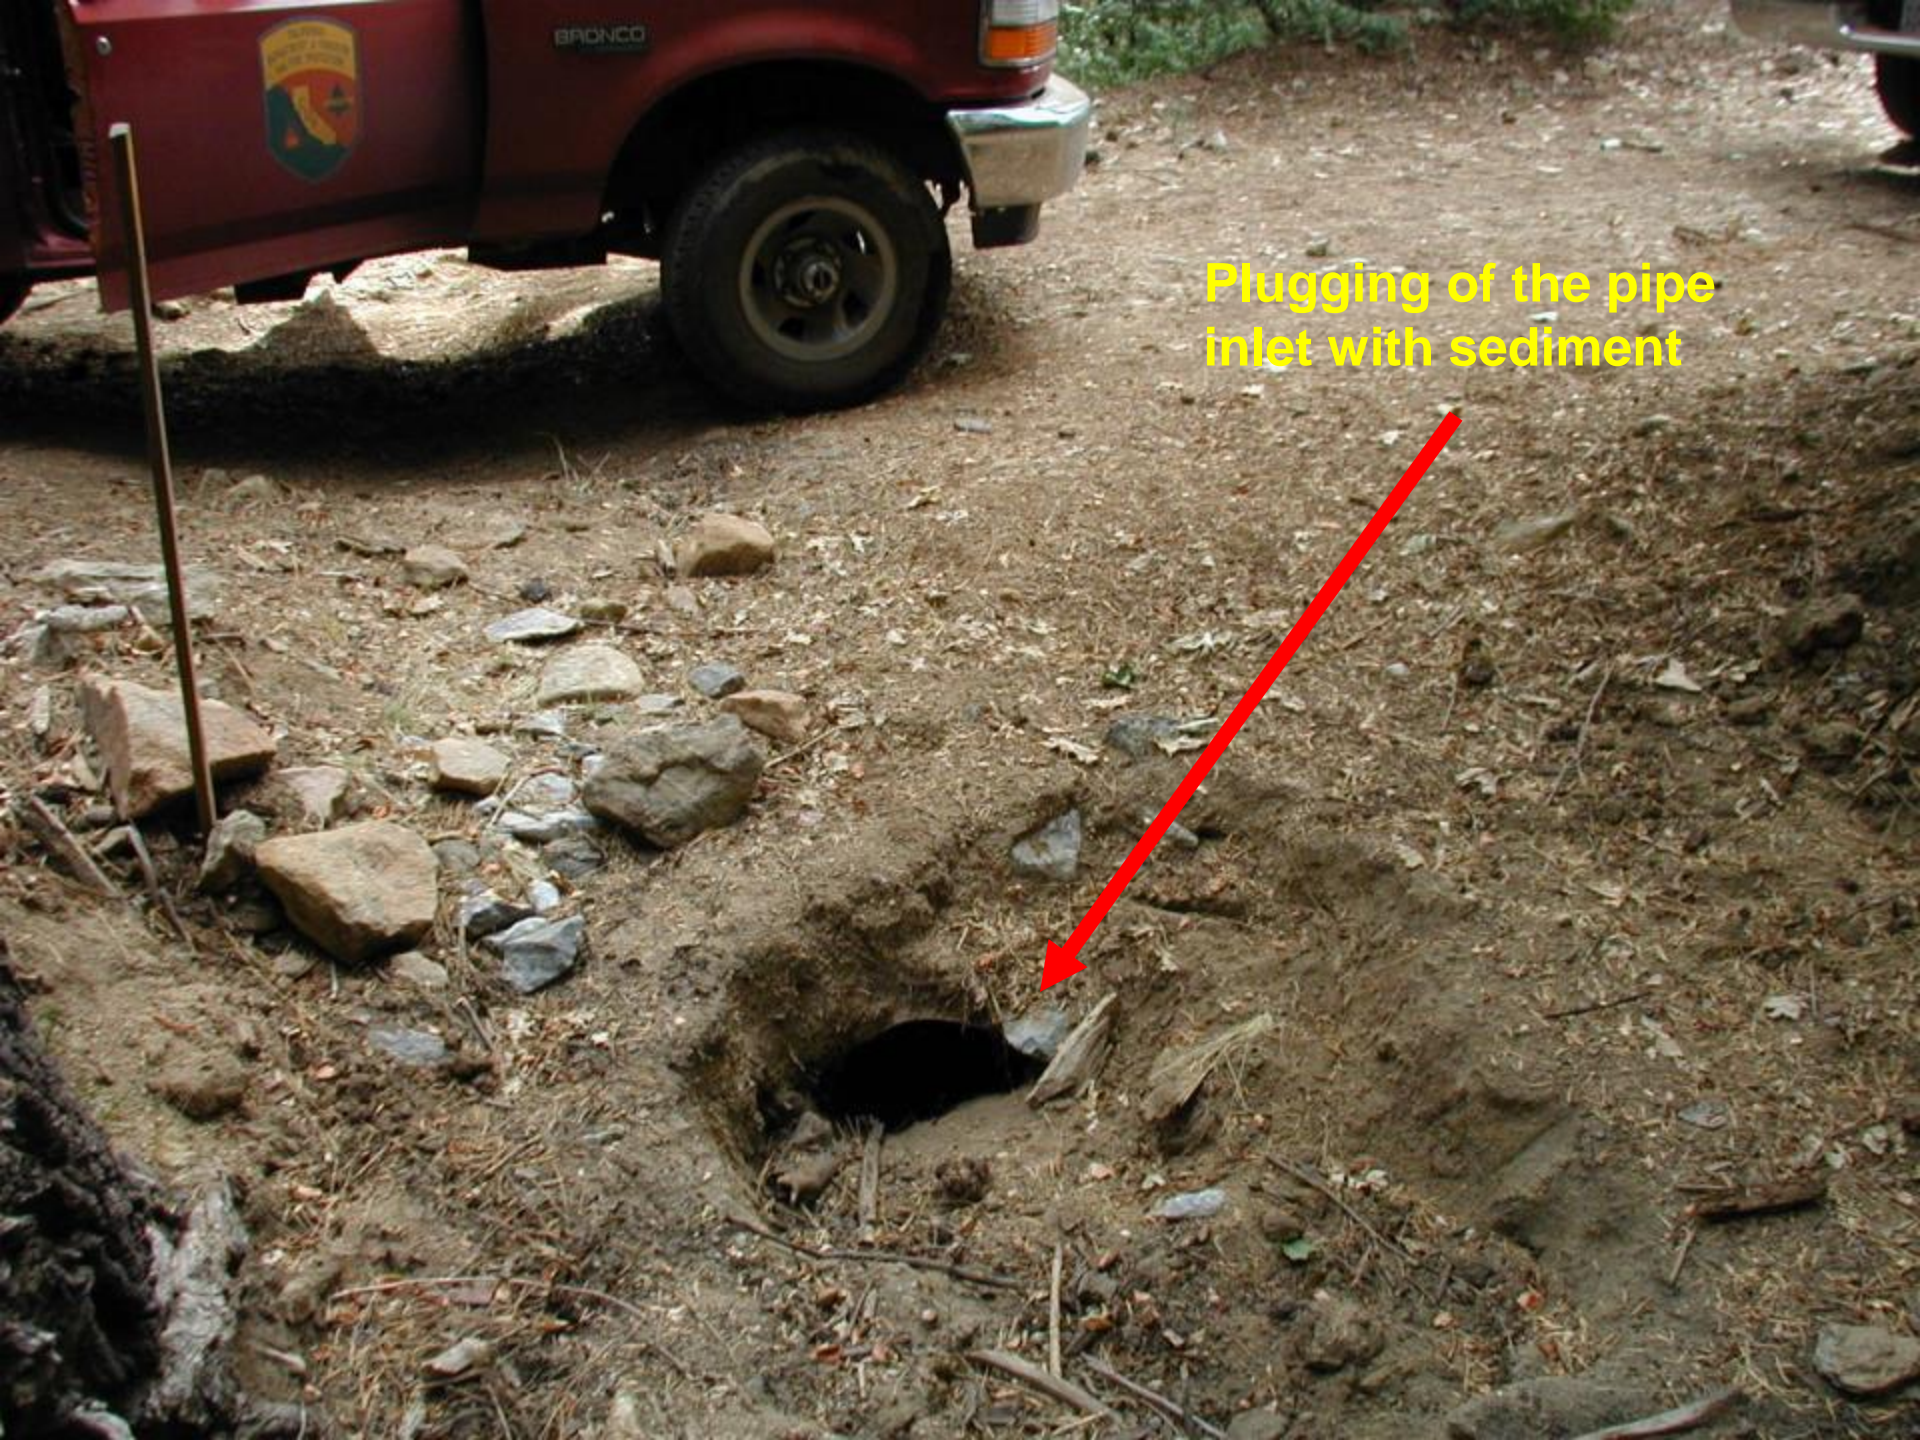
48" CMP water subs under

Fish travel through pipe in high water flows.

Stream re-surfaces within 100' of pipe. 18 adult salmon were located
200-800 feet upstream of structure.

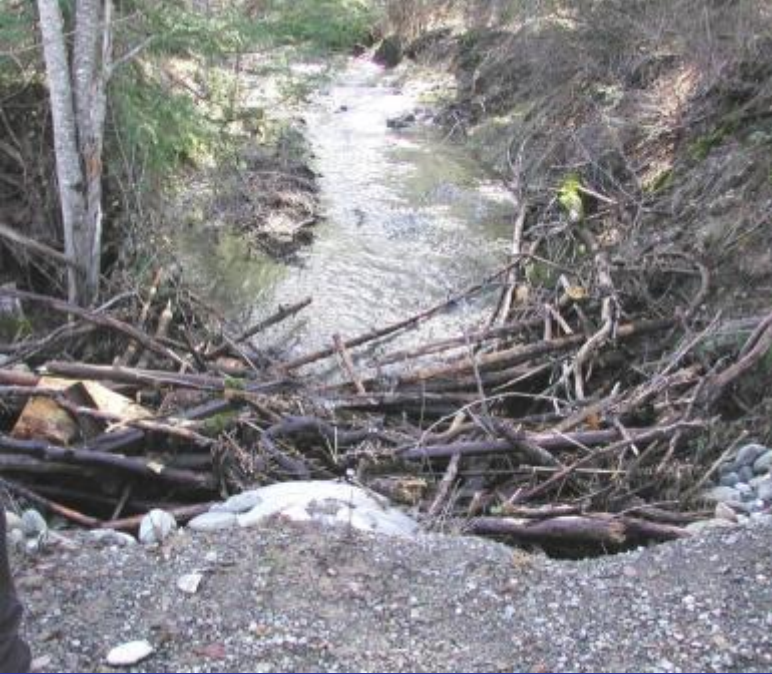
Crossings with terraces or sediment wedges above the inlet often have insufficient capacity to pass flood flows.

Terraces upstream of the culvert inlet indicate past ponded conditions.

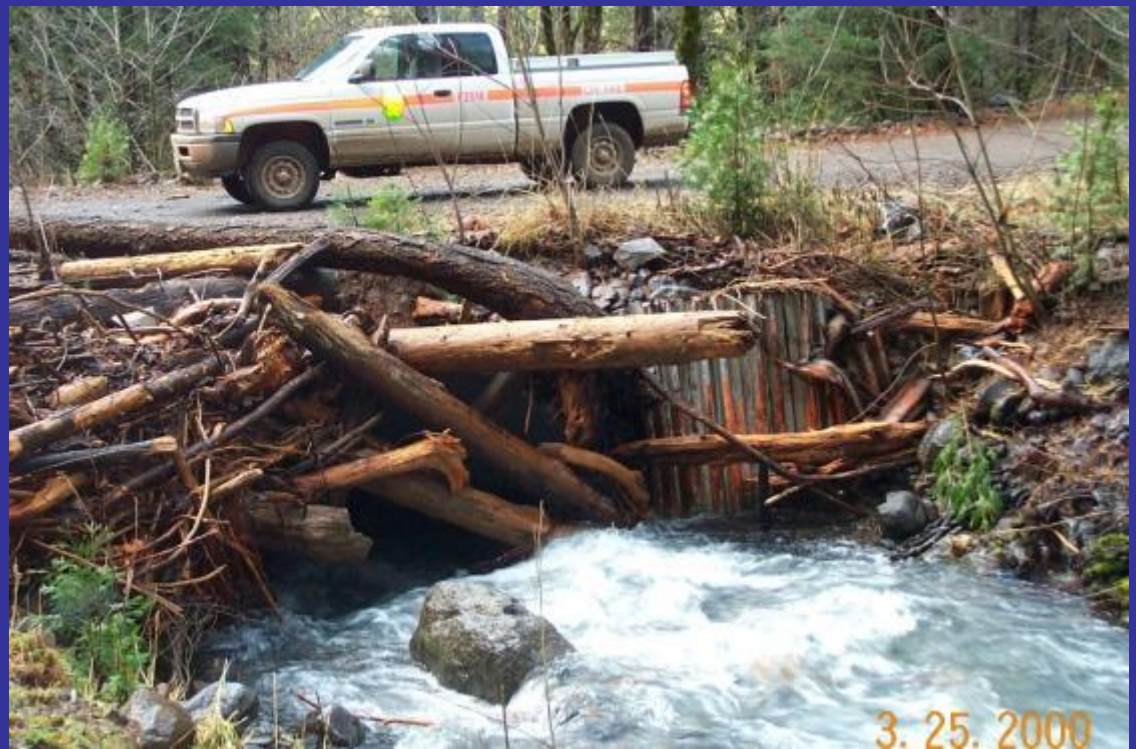
Culverts Blocked by Woody Debris

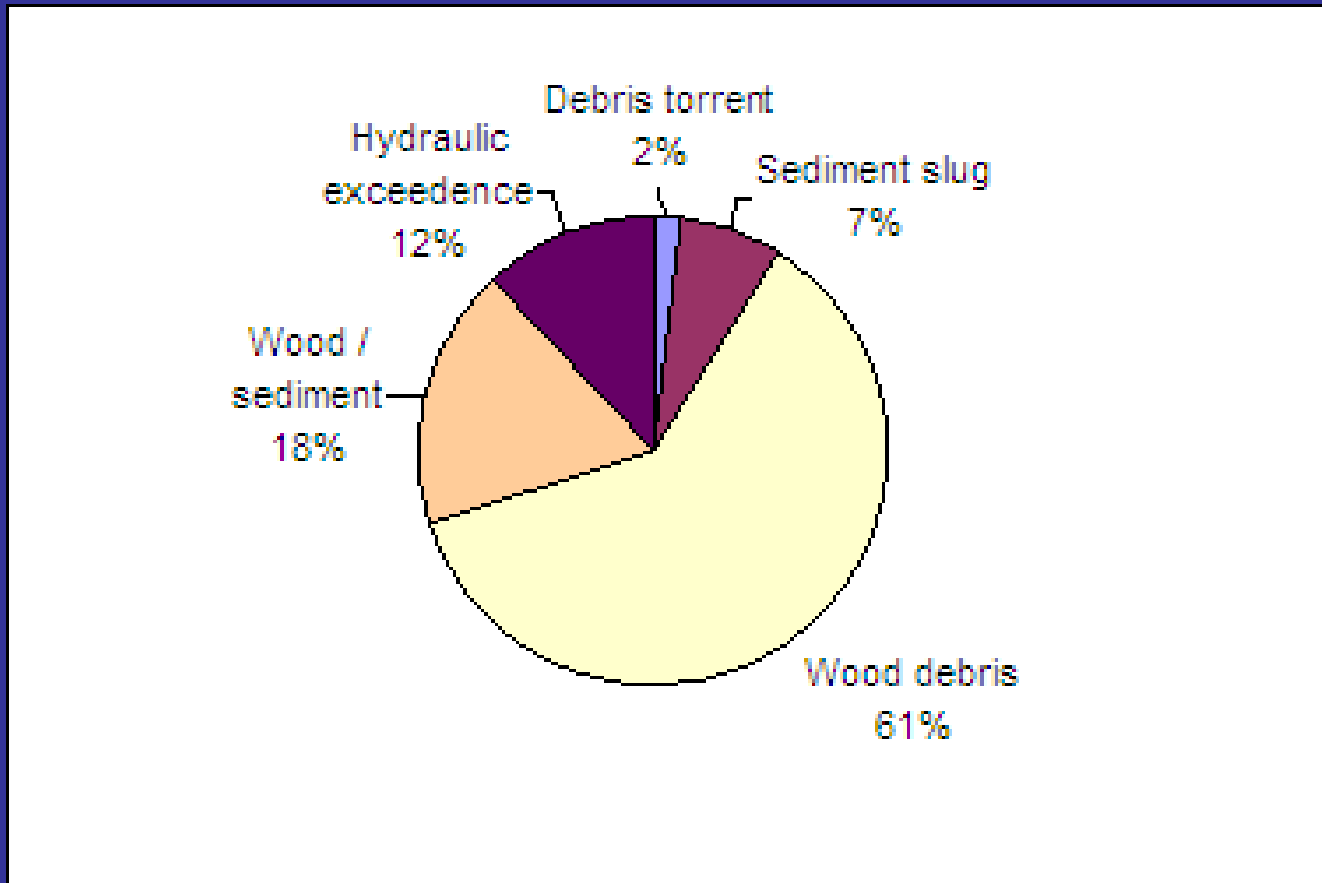
Failure Mechanisms for Culverts Along Forest Roads in Northwest CA Associated with Storms < 12 RI (Flanagan 2004)

n = 57

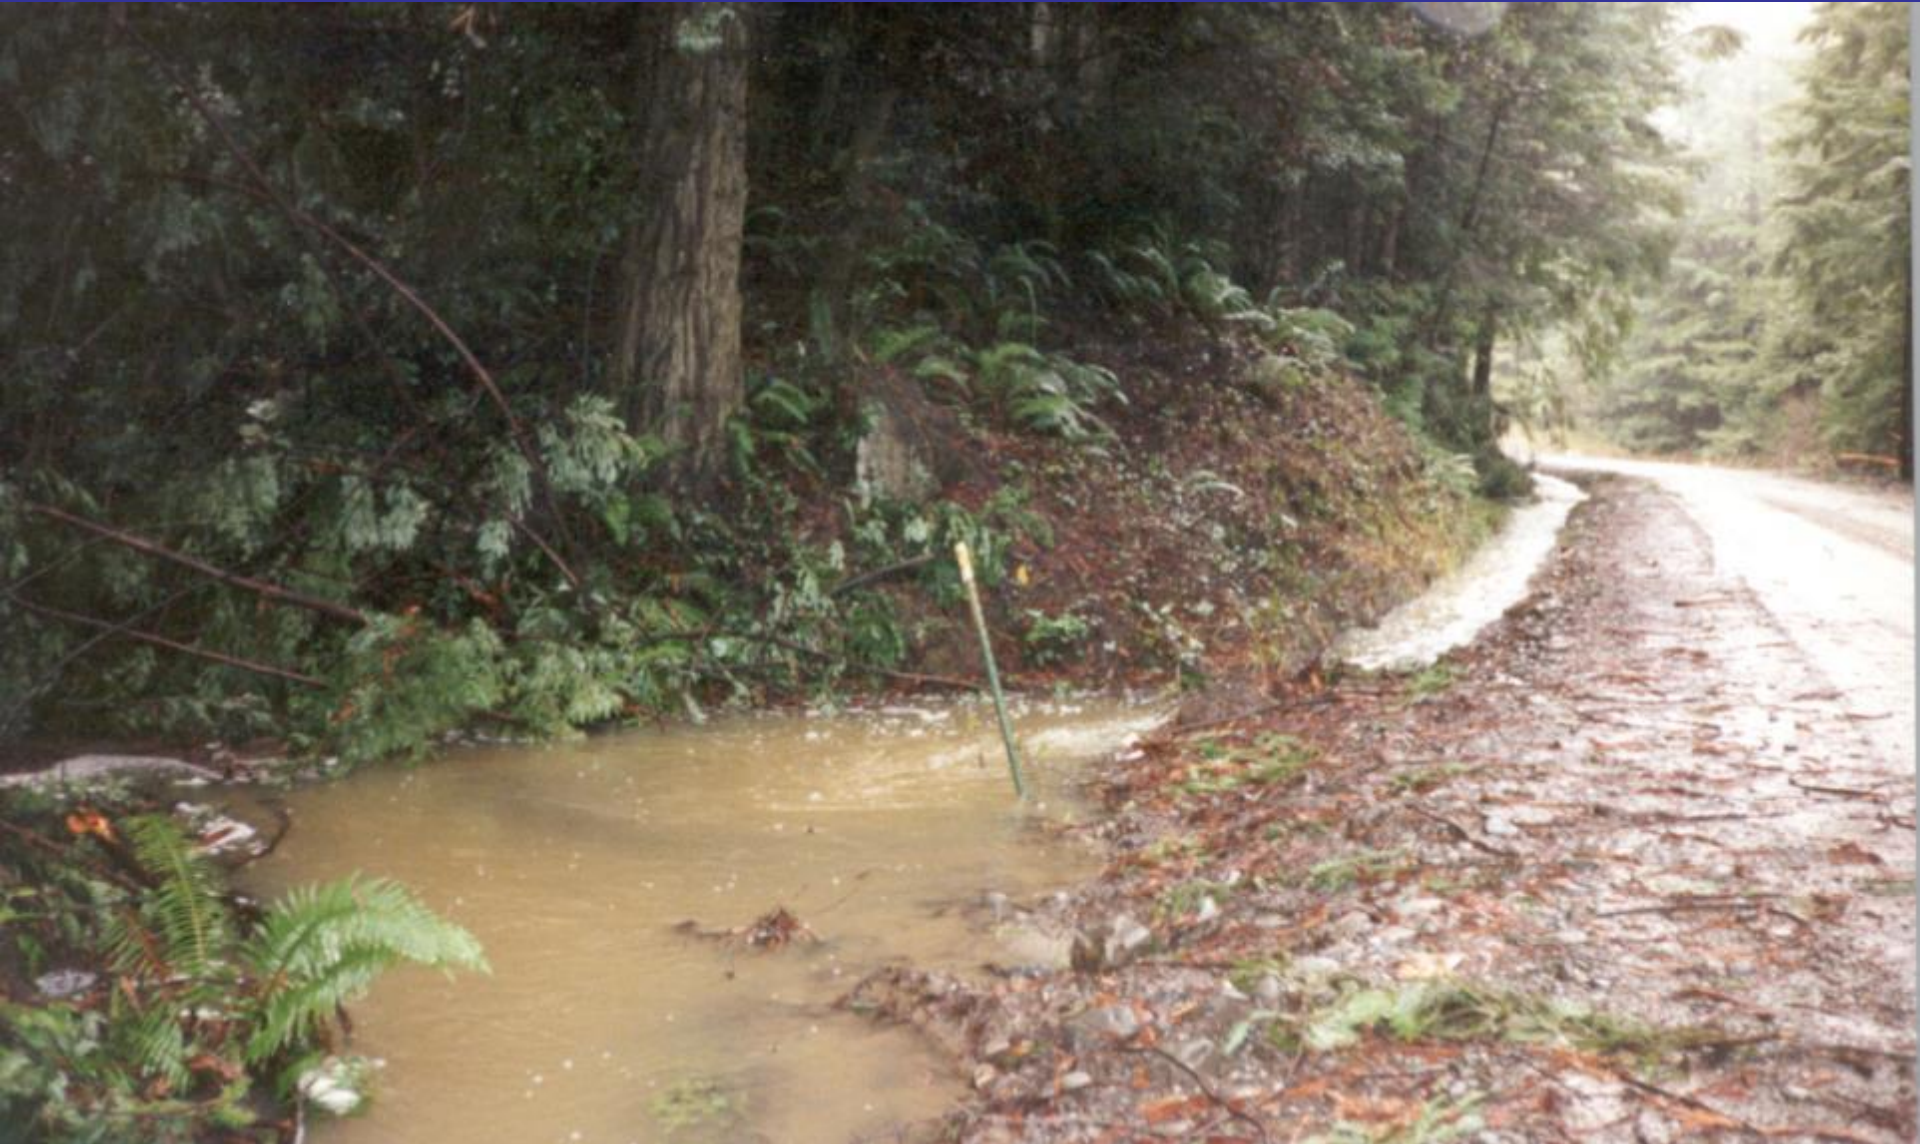
Humboldt County Crossing—Inlet Blocked

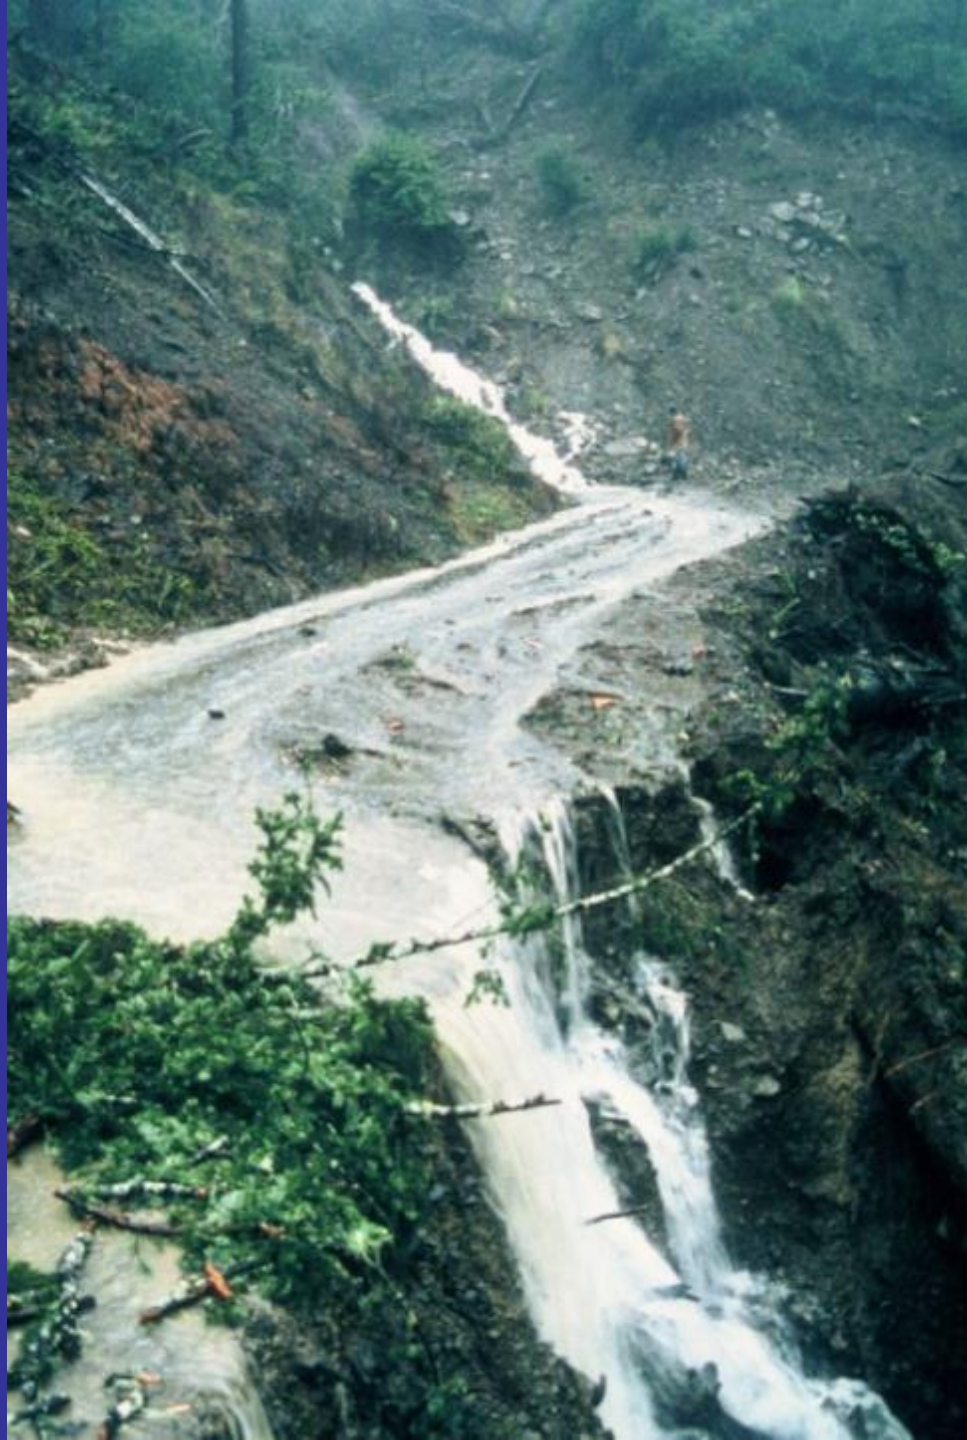
**Stream
Diversion
from
Blocked
Culvert Inlet**

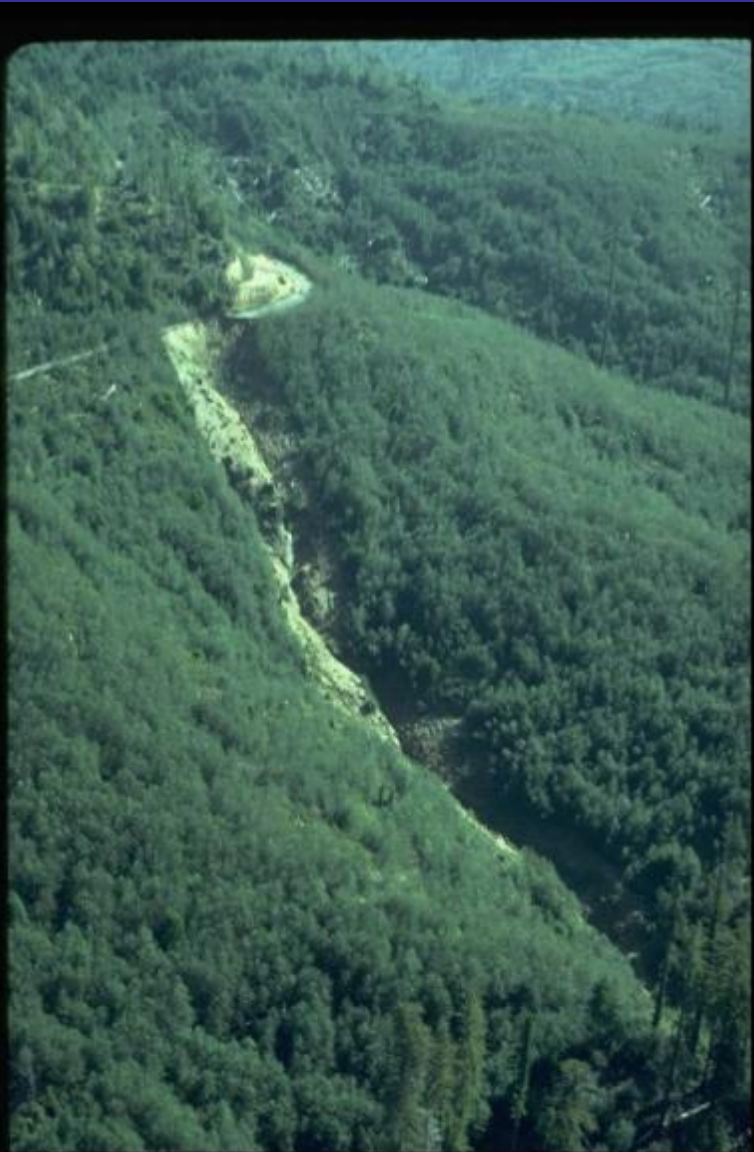
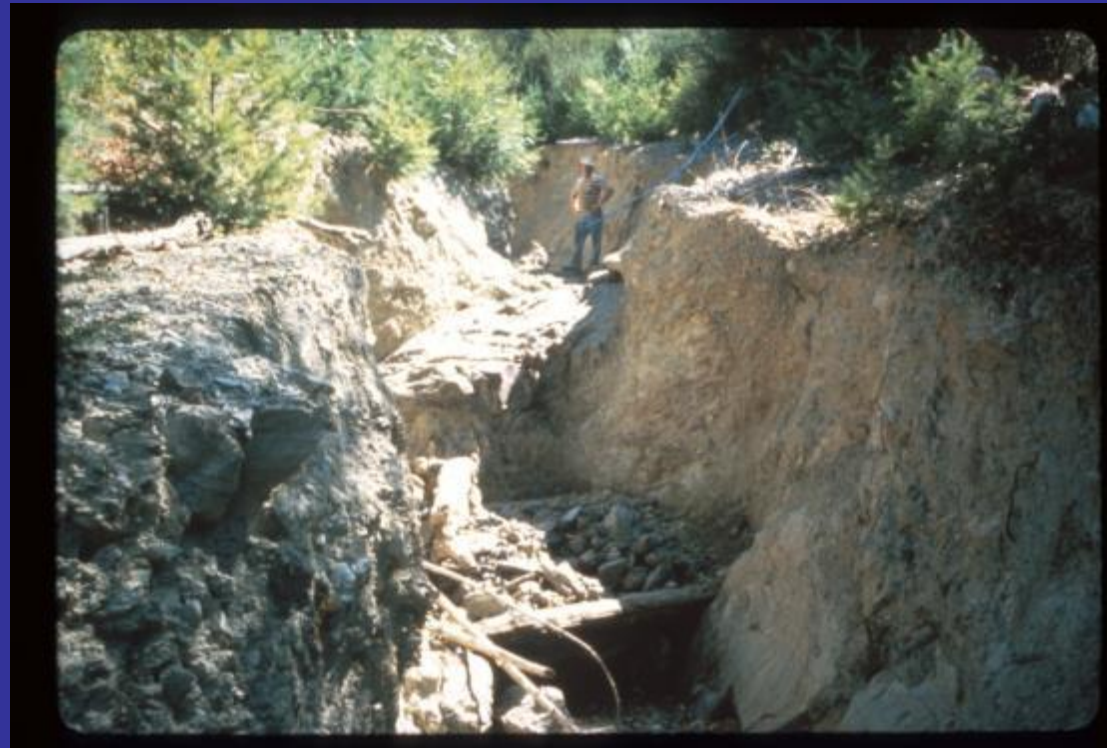
Example of Stream Diversion Gullies — Redwood Creek Watershed

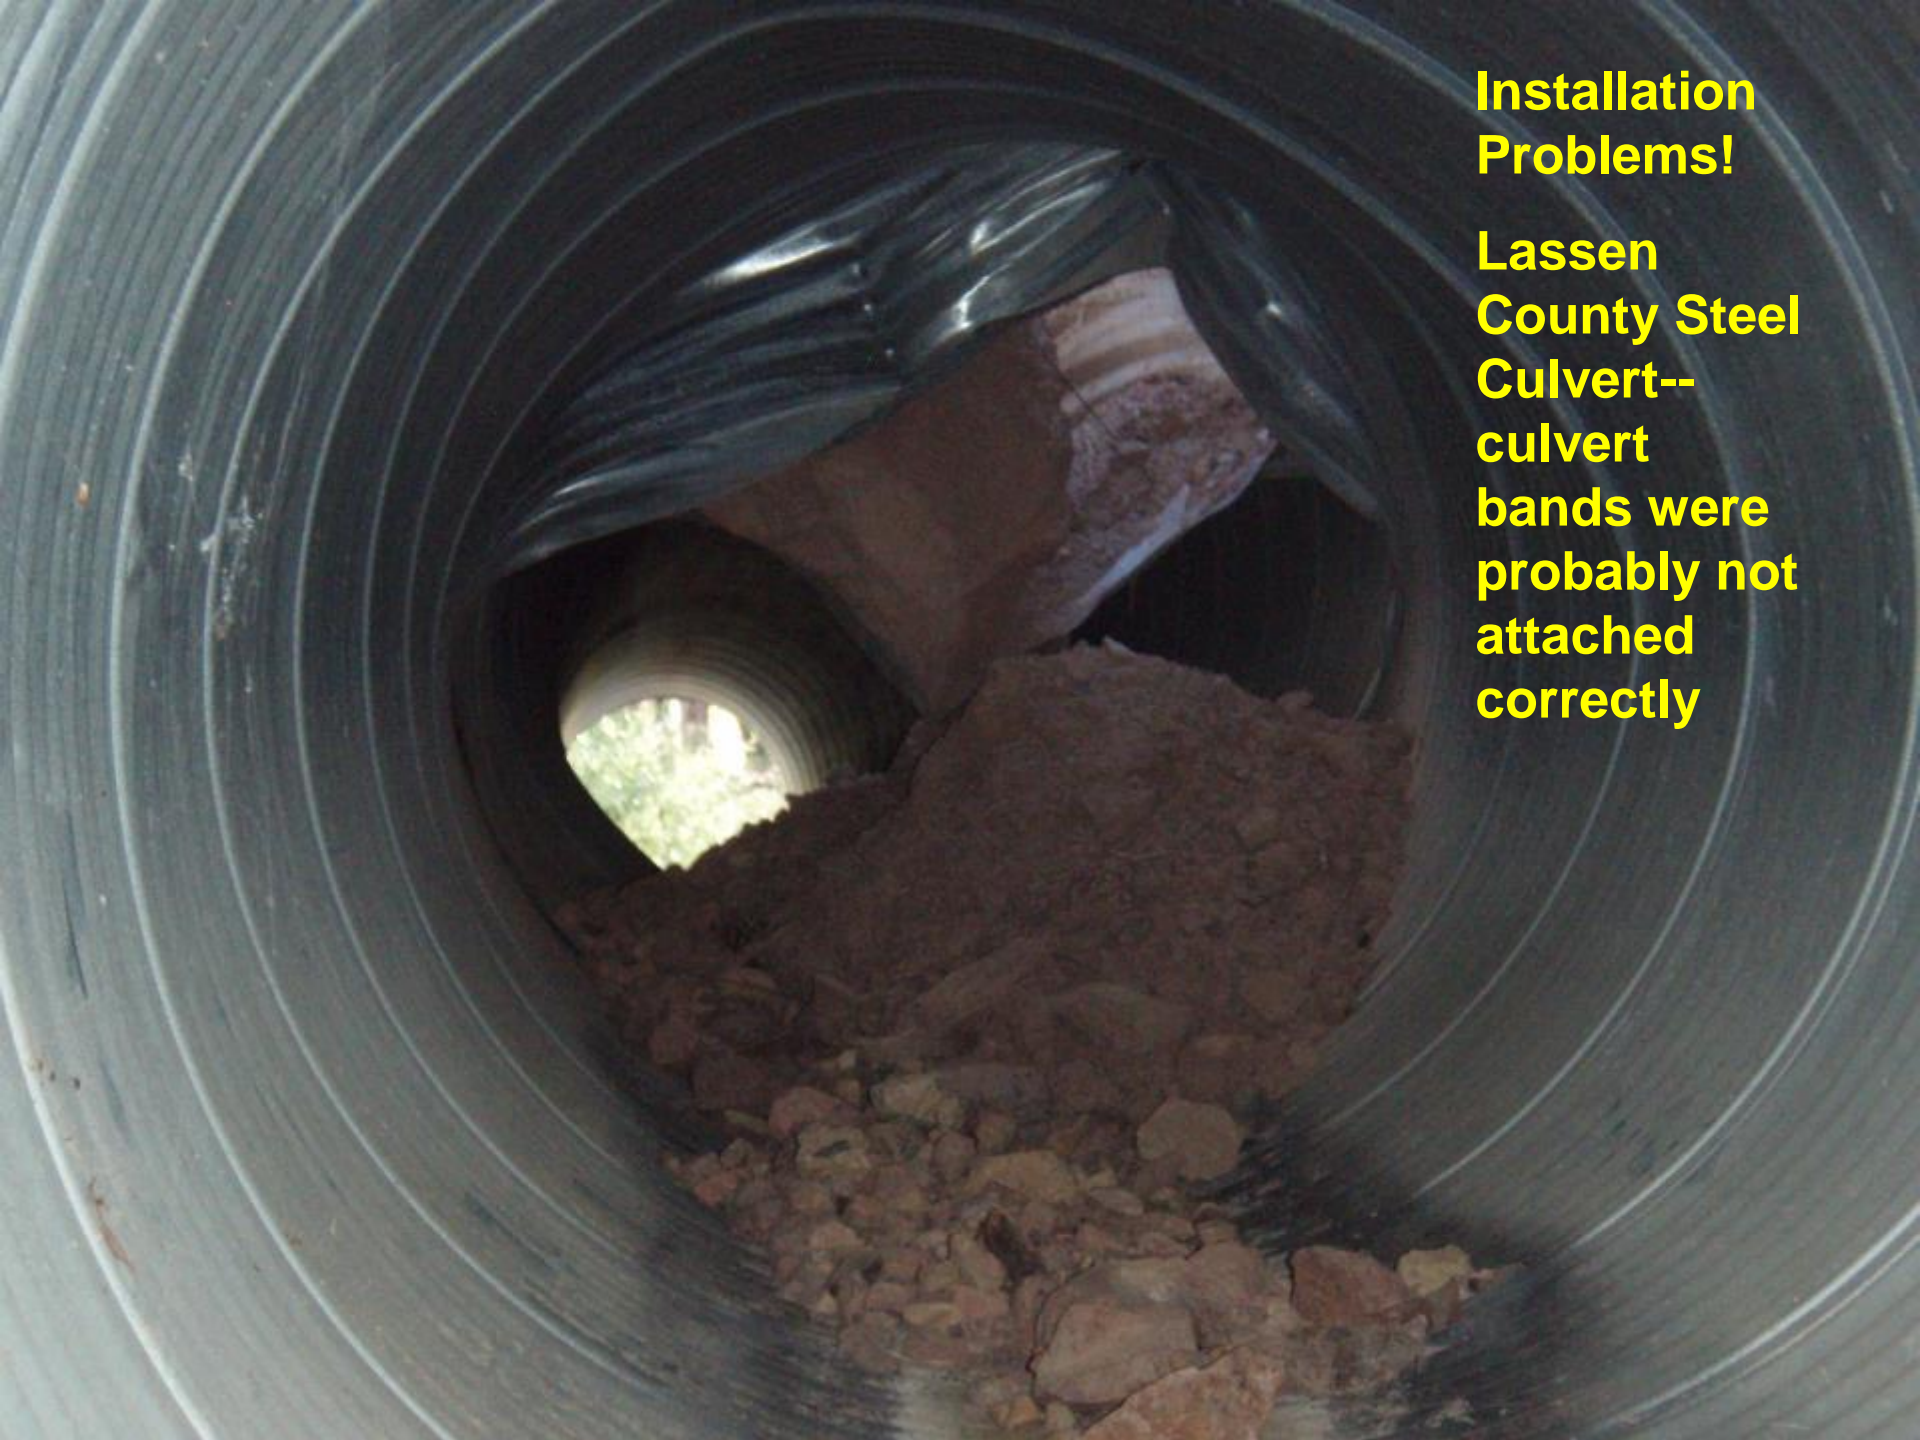
**Installation
Problems!**

**Lassen
County Steel
Culvert--
culvert
bands were
probably not
attached
correctly**

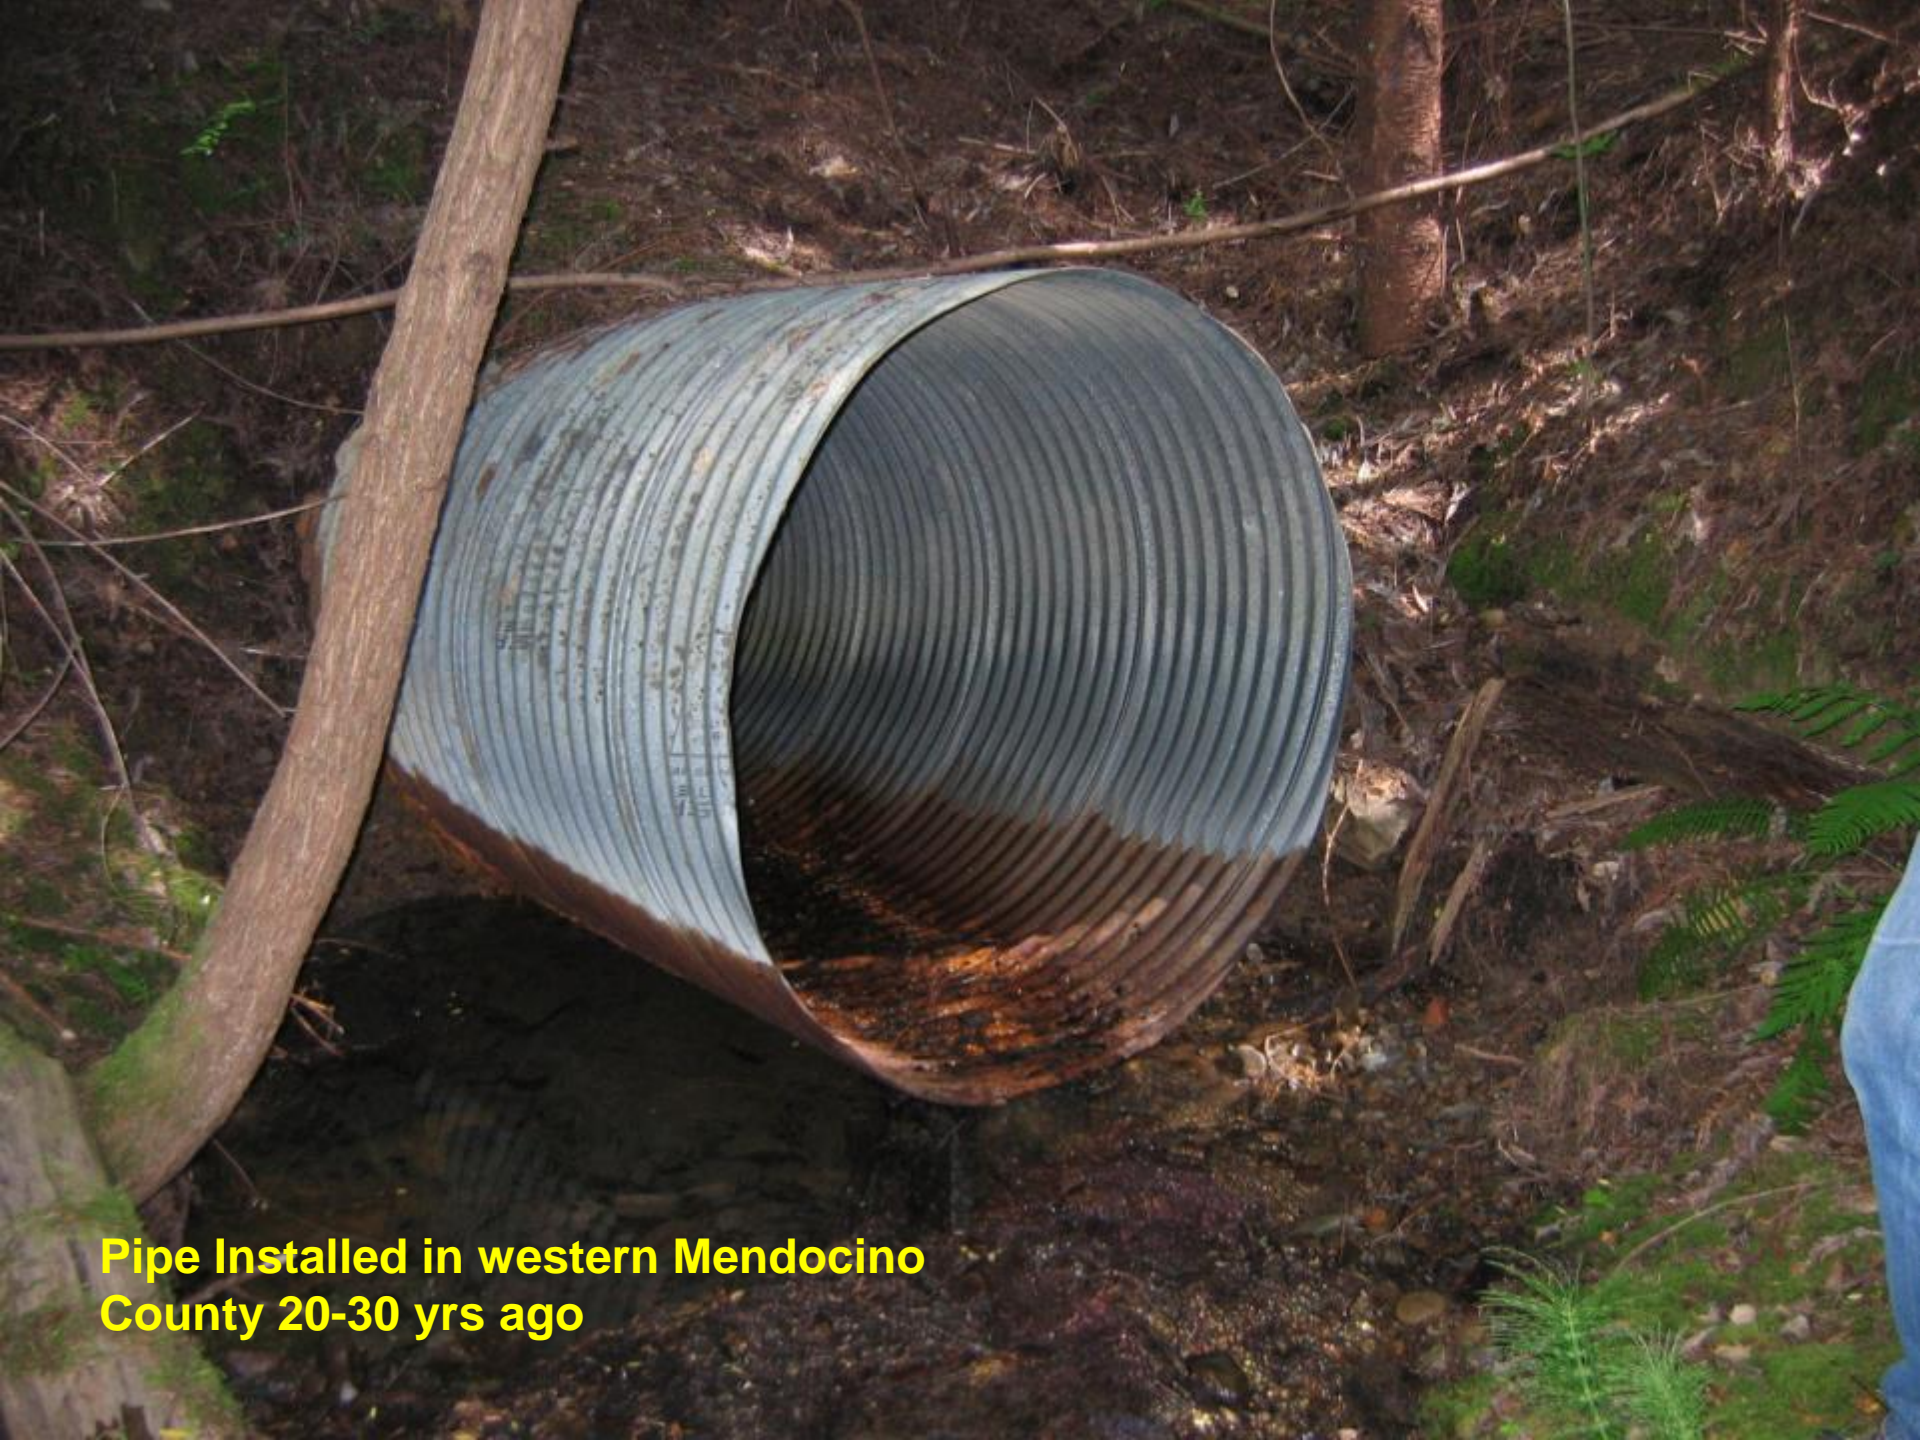
**Pipe Installed in western Mendocino
County 20-30 yrs ago**

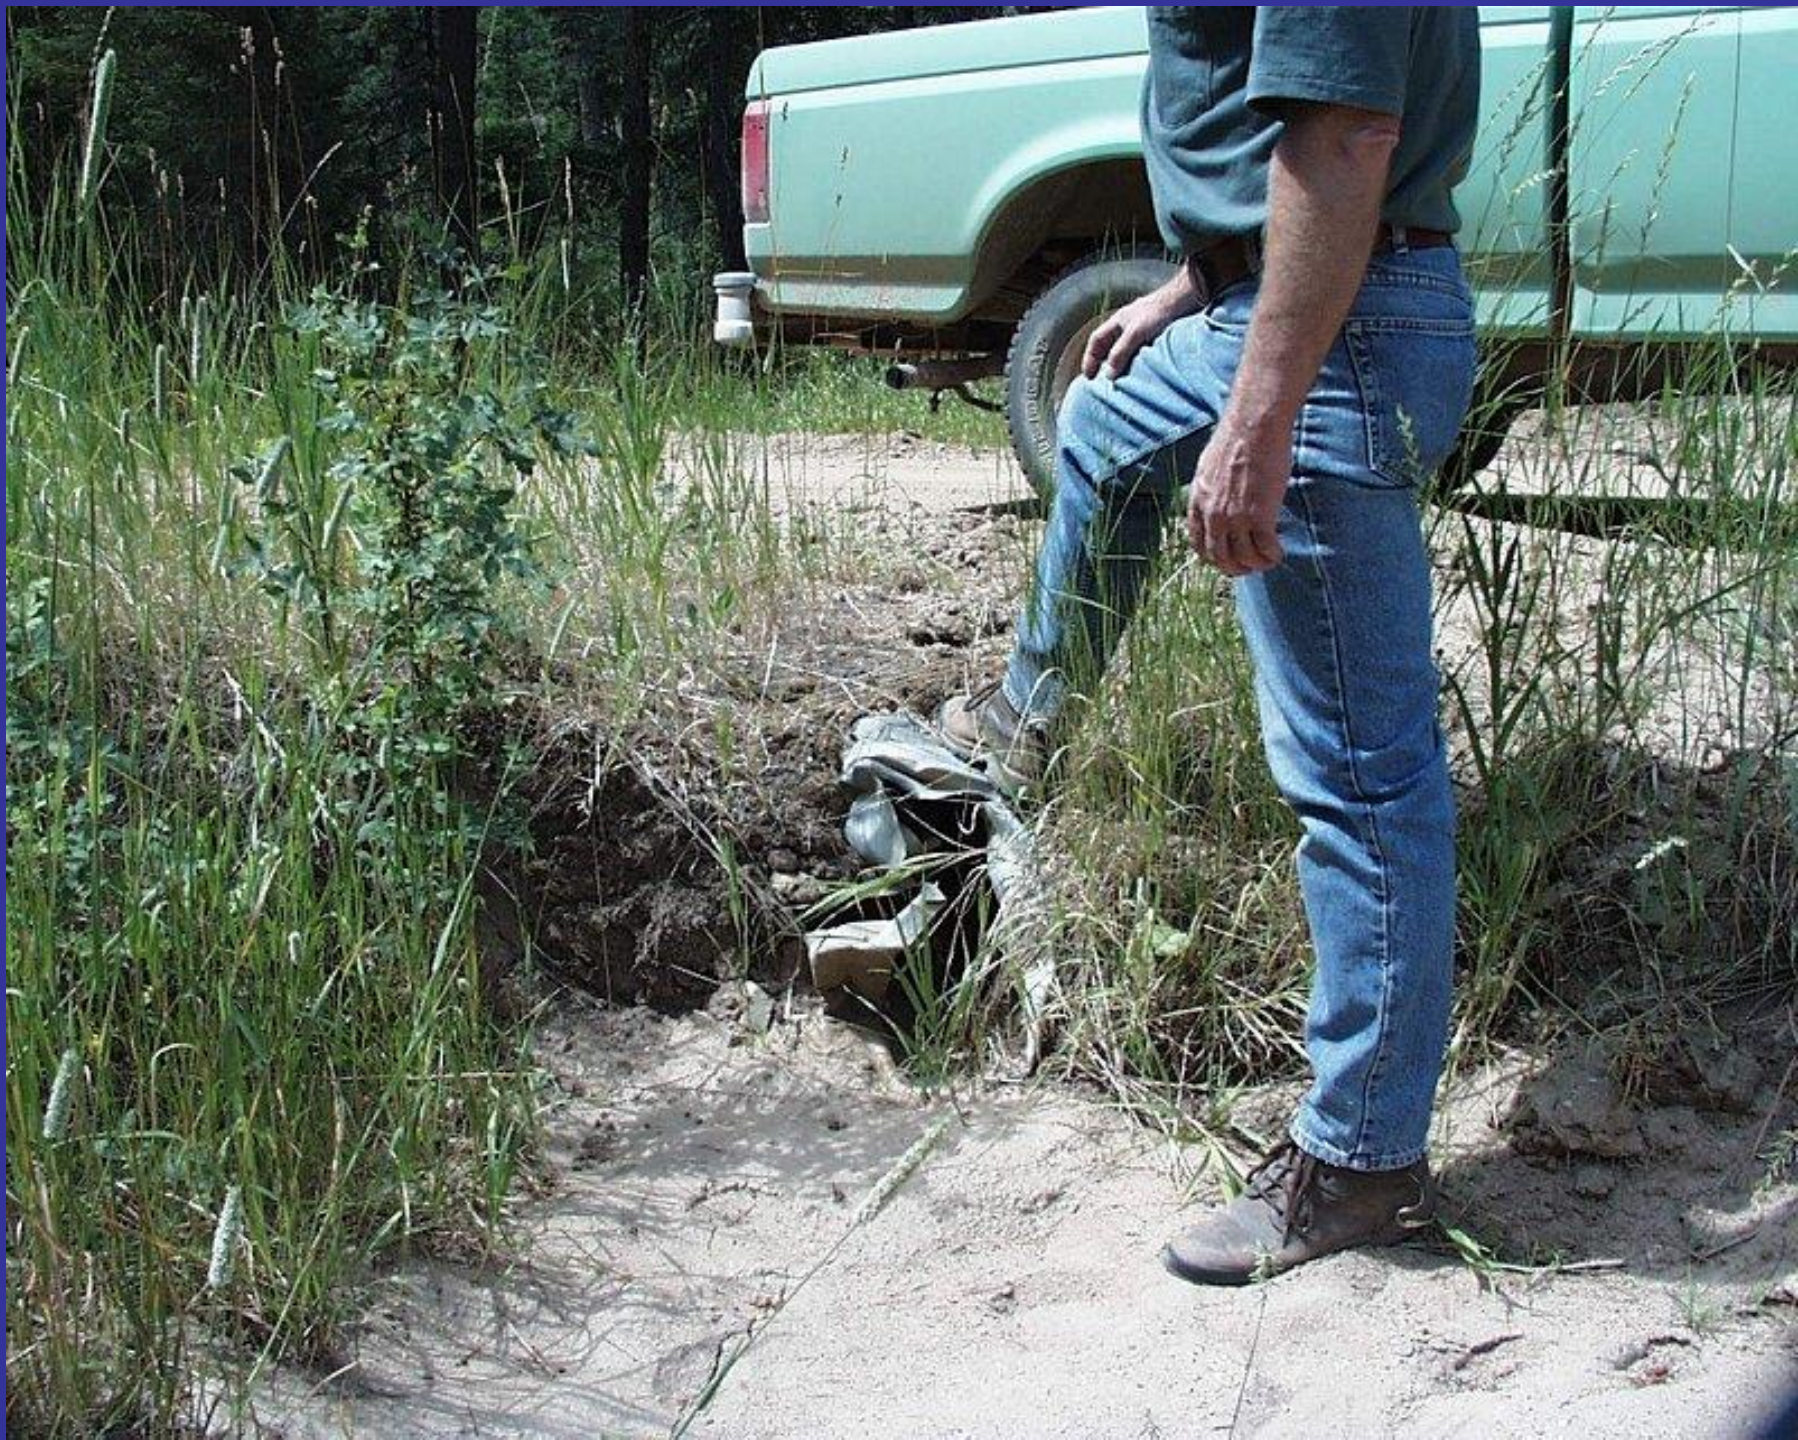
Elevated Outlet in Fish Stream

Cottaneva Creek, western
Mendocino County
Pipe replaced with a bridge by
MRC

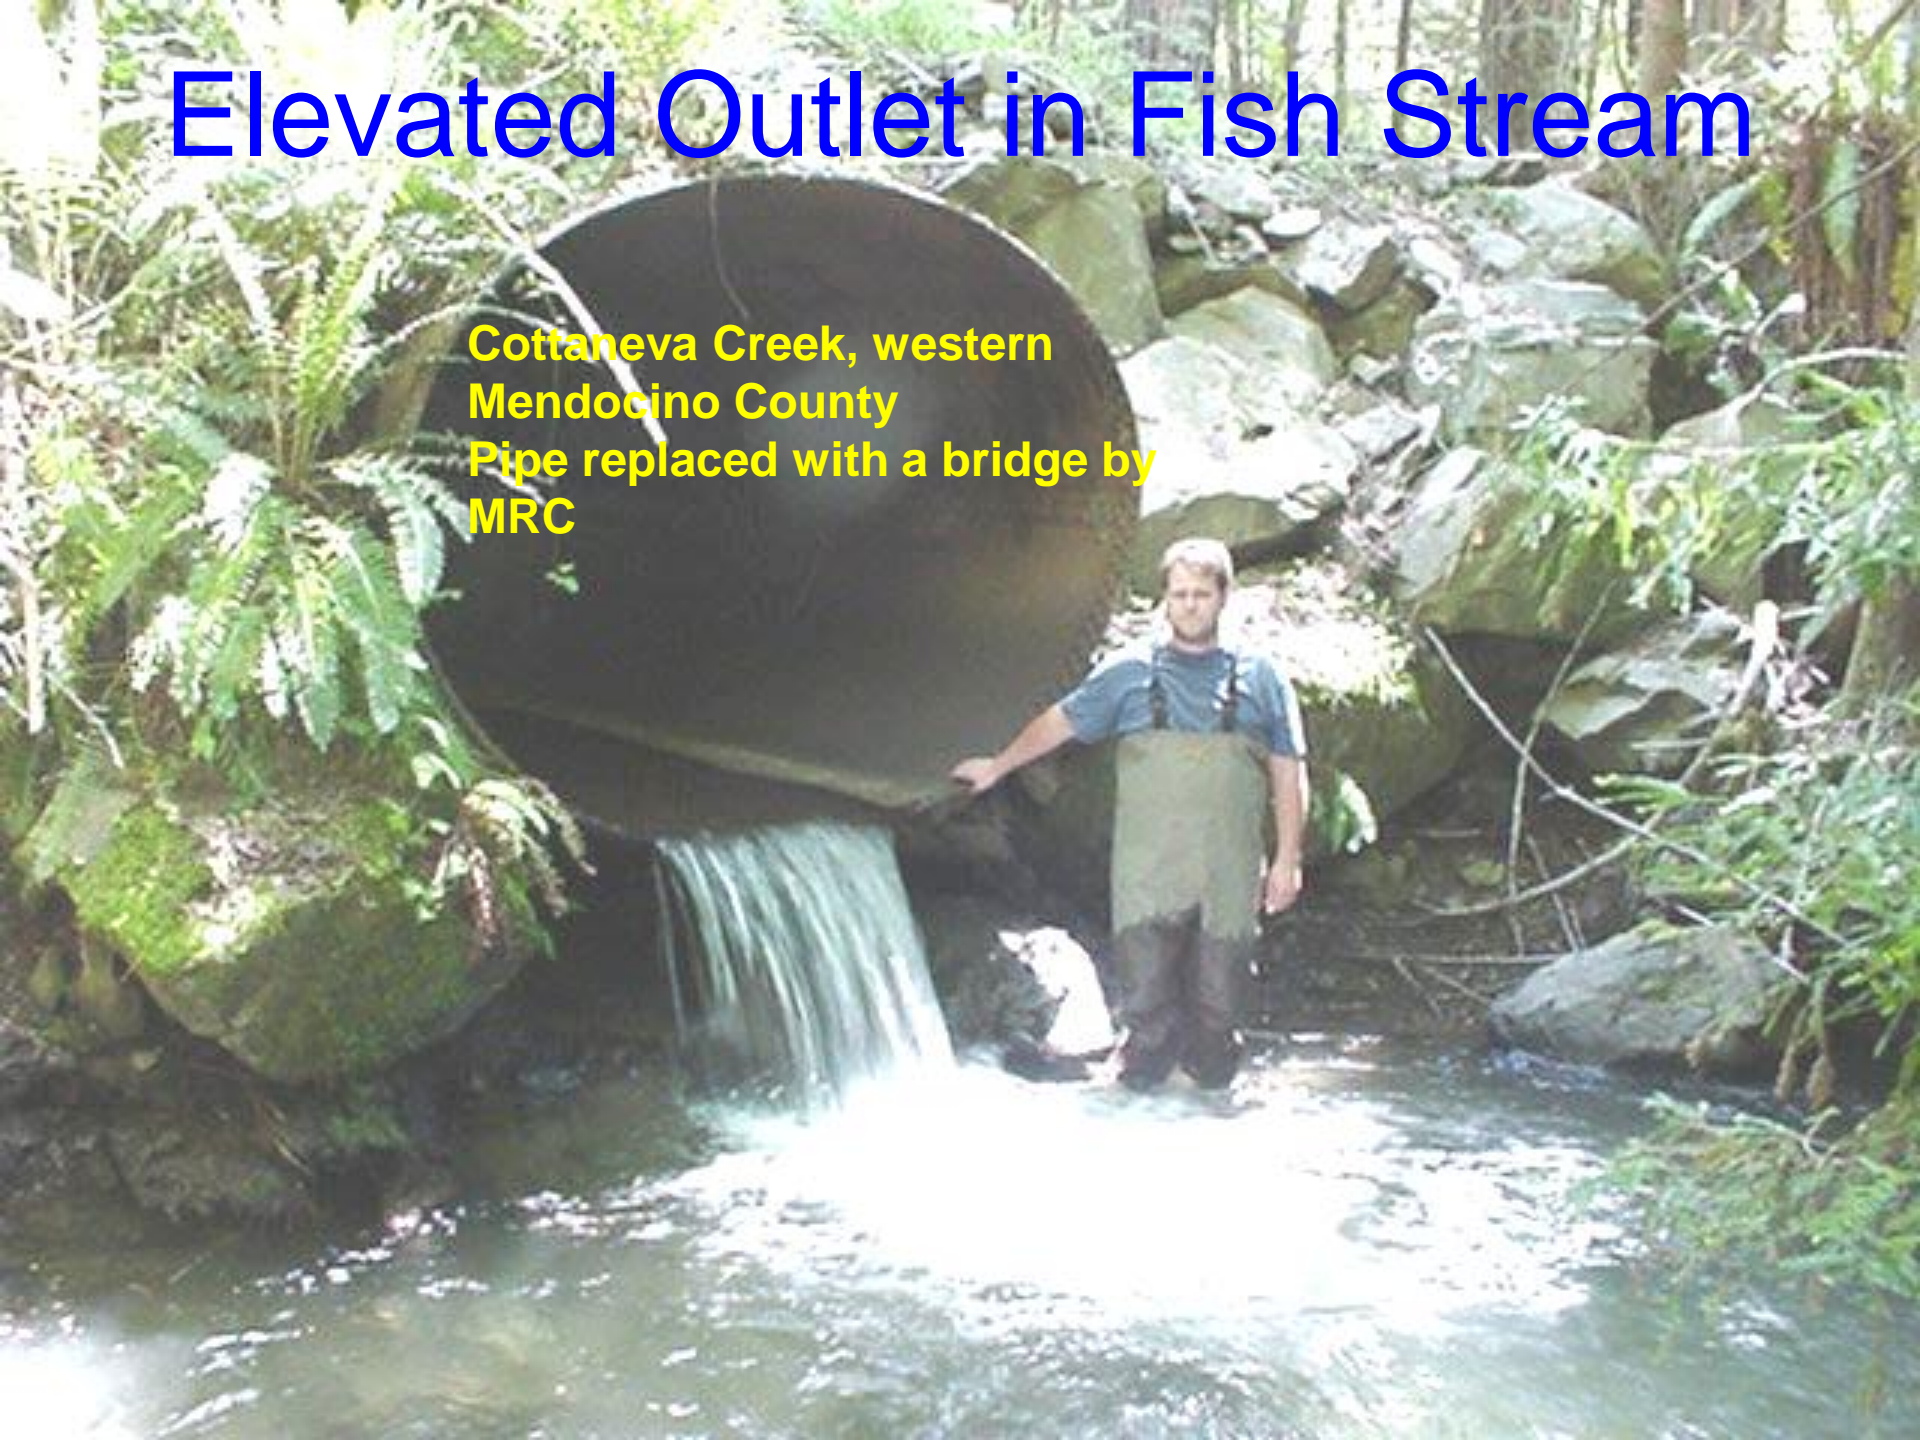
Failed Open Bottom Arch Crossing—Tehama County

After first winter, 5
feet of scour at
inlet, undermining
footings by 2 feet
