Stream Crossing Alternatives

Pete Cafferata

California Department of Forestry
and Fire Protection

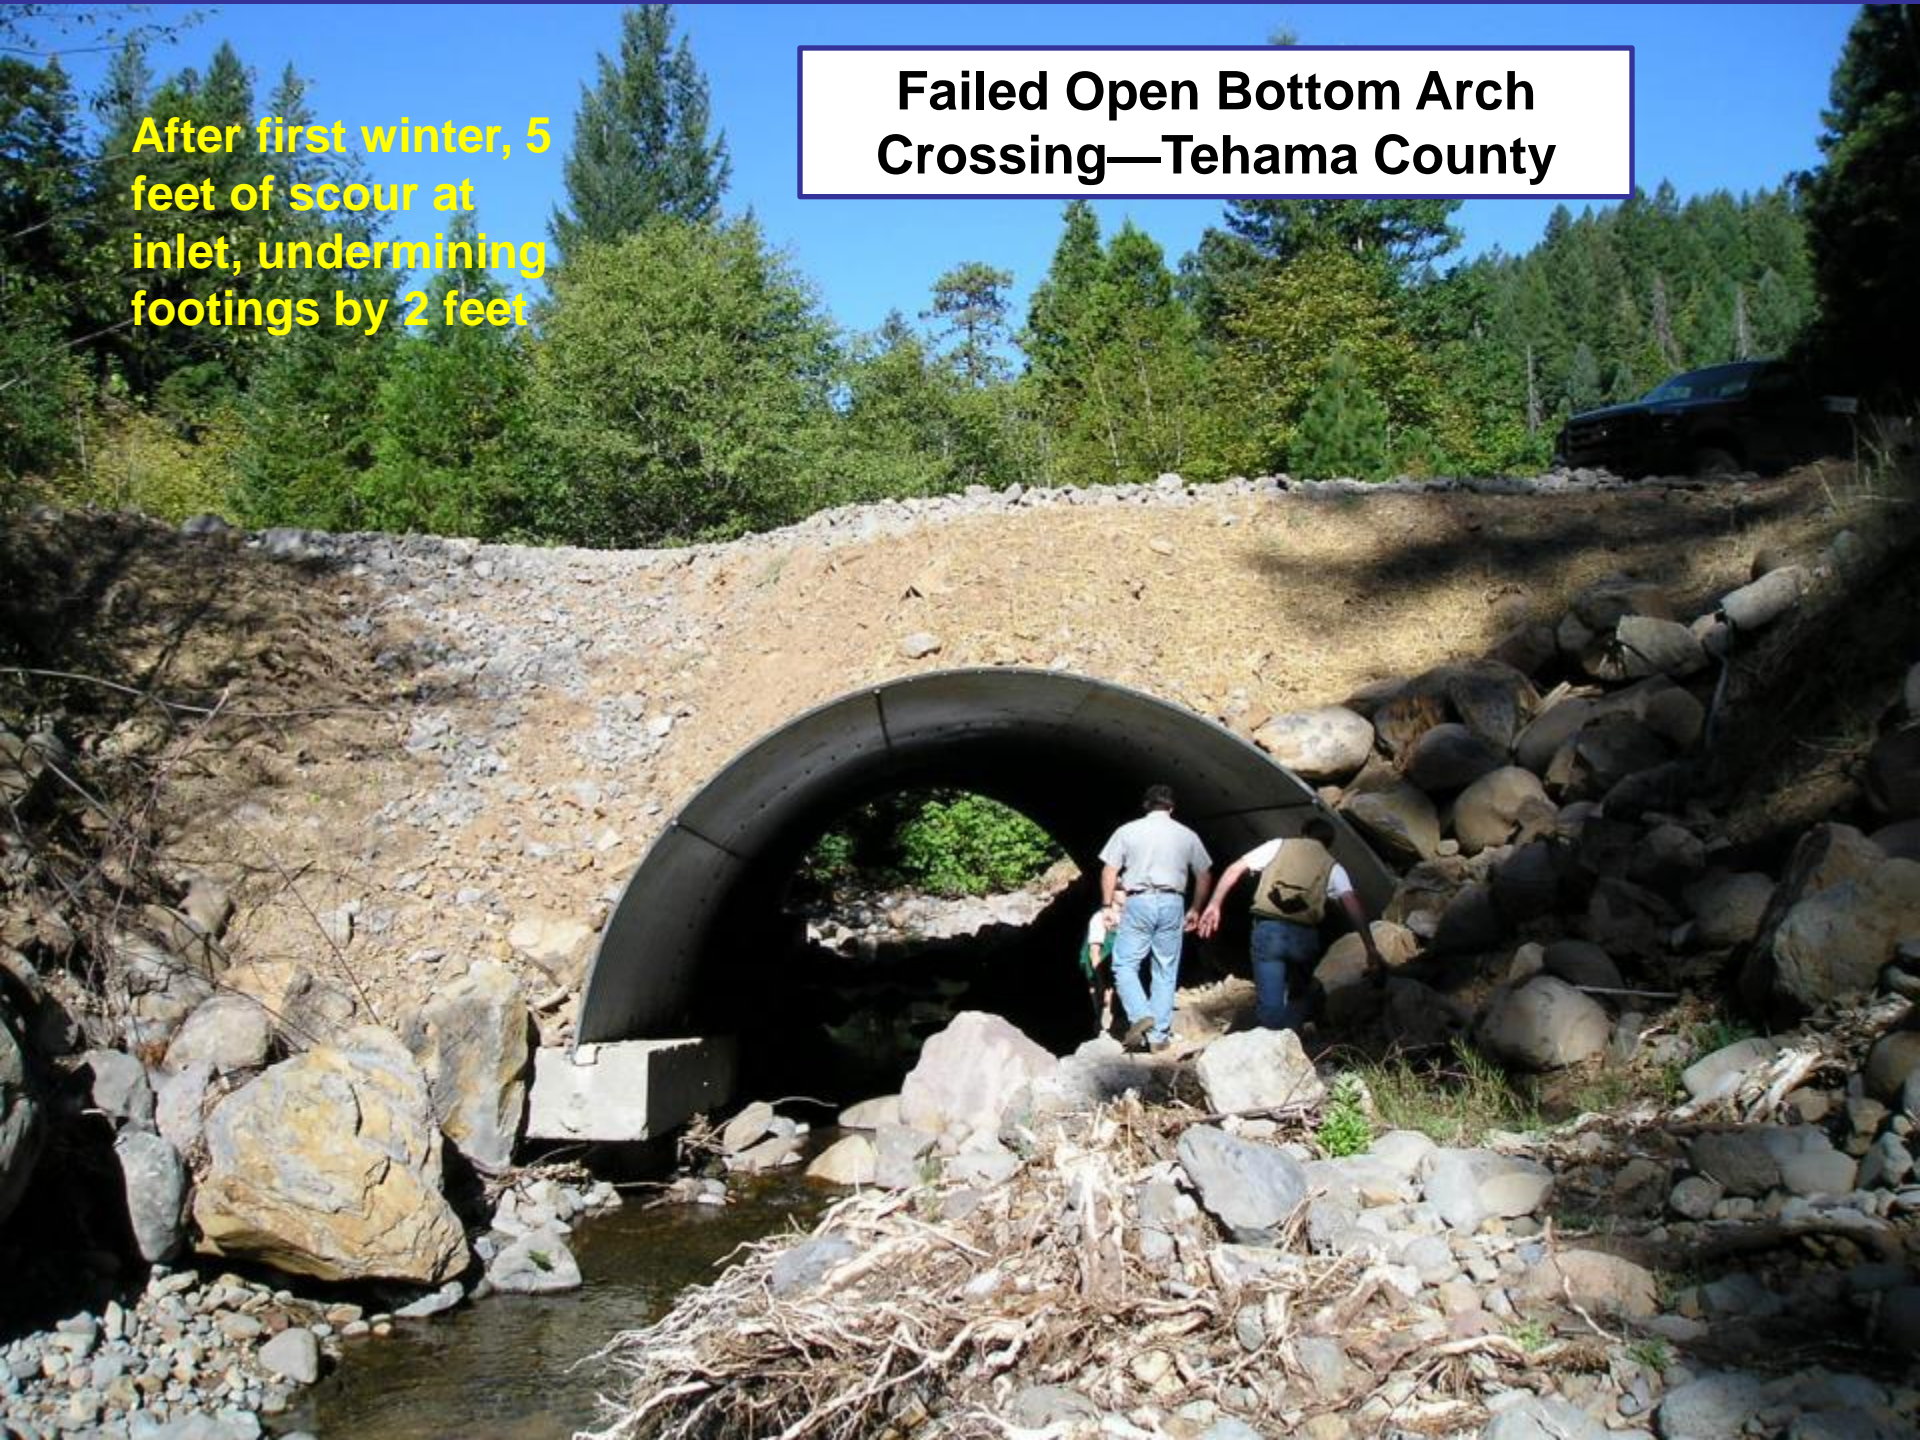
Failed Rock Ford Crossing—Undersized Rock

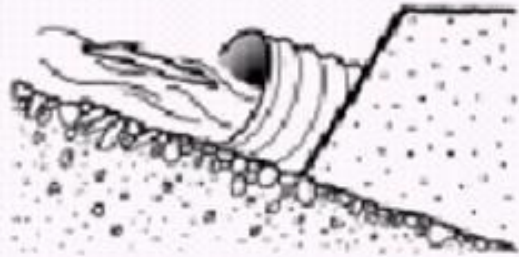
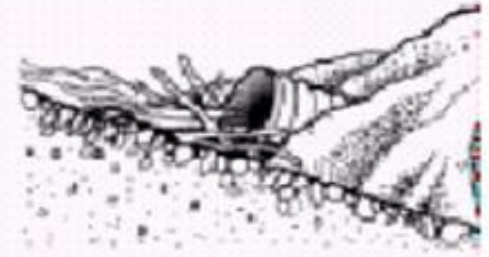
1. Culverts Should Not Pond Water

$HW/D < 1.0$
(suggest 0.67)

GOOD

Reduced Plugging
Hazard

$HW/D > 1.0$

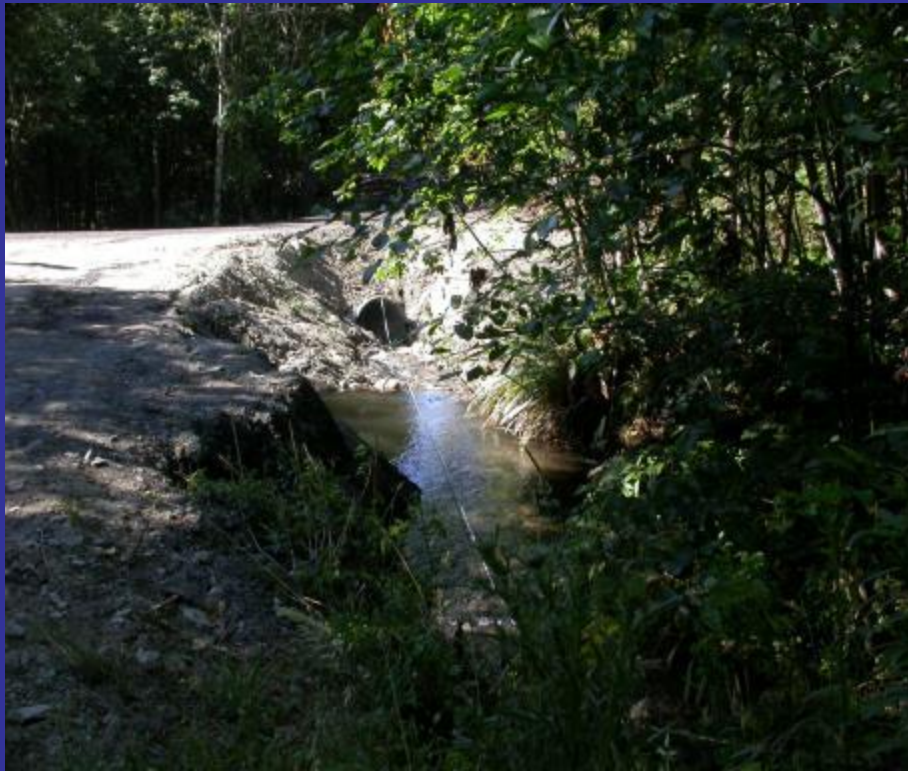
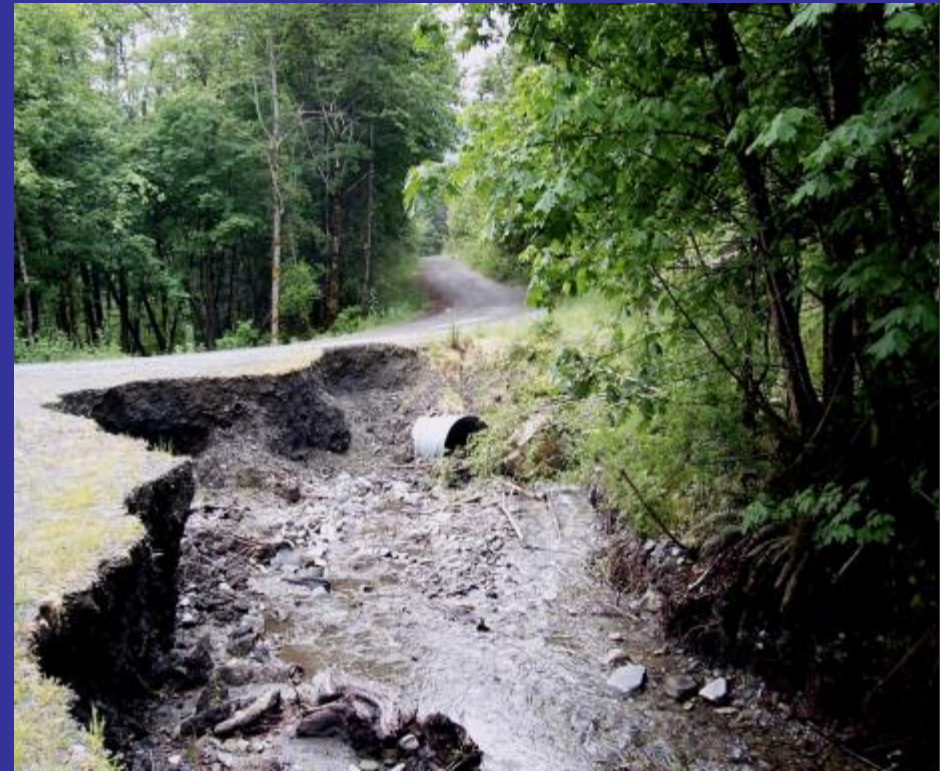
Misaligned Crossing

After Construction

Misalignment can result in
Road Fill/ Bank Erosion!

After One Winter

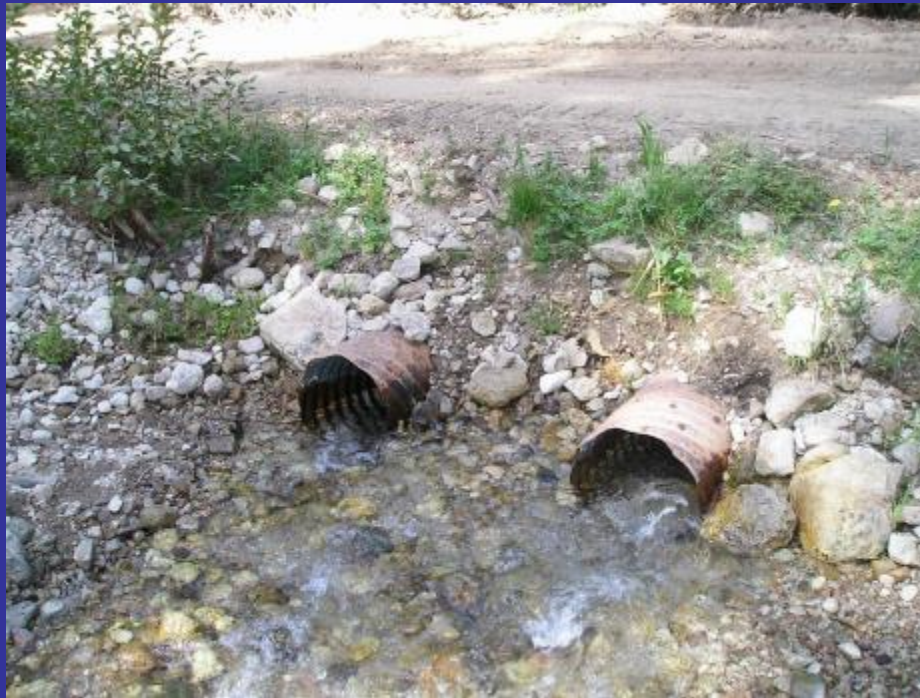
6. Single Large Pipe—Not Multiple Pipe Barrels

- Installing multiple pipes is a bad strategy for passing woody debris.

Use Single
Large Pipe to
Minimize
Plugging
Potential!

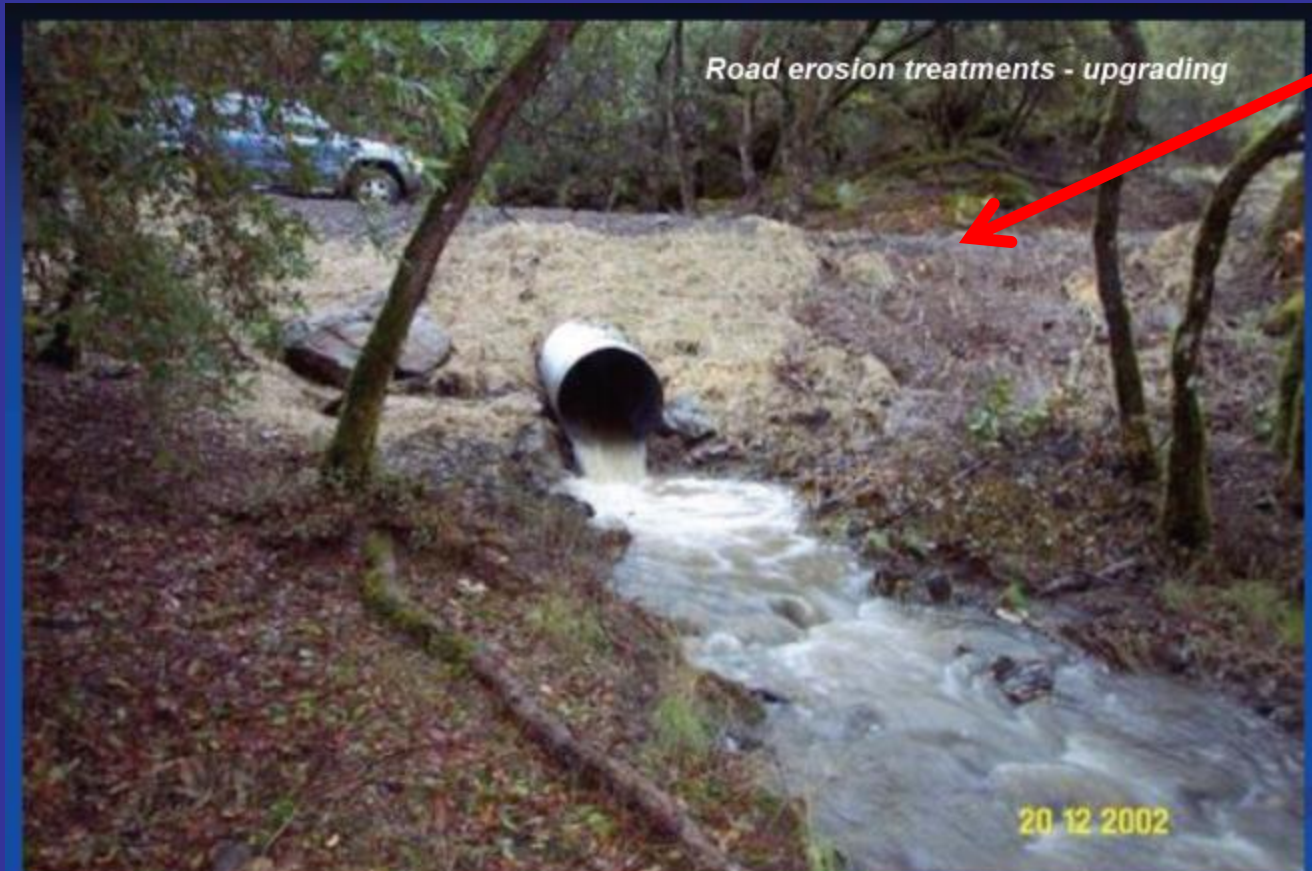
Functioning Critical Dip

After upgrading (and overtopping)

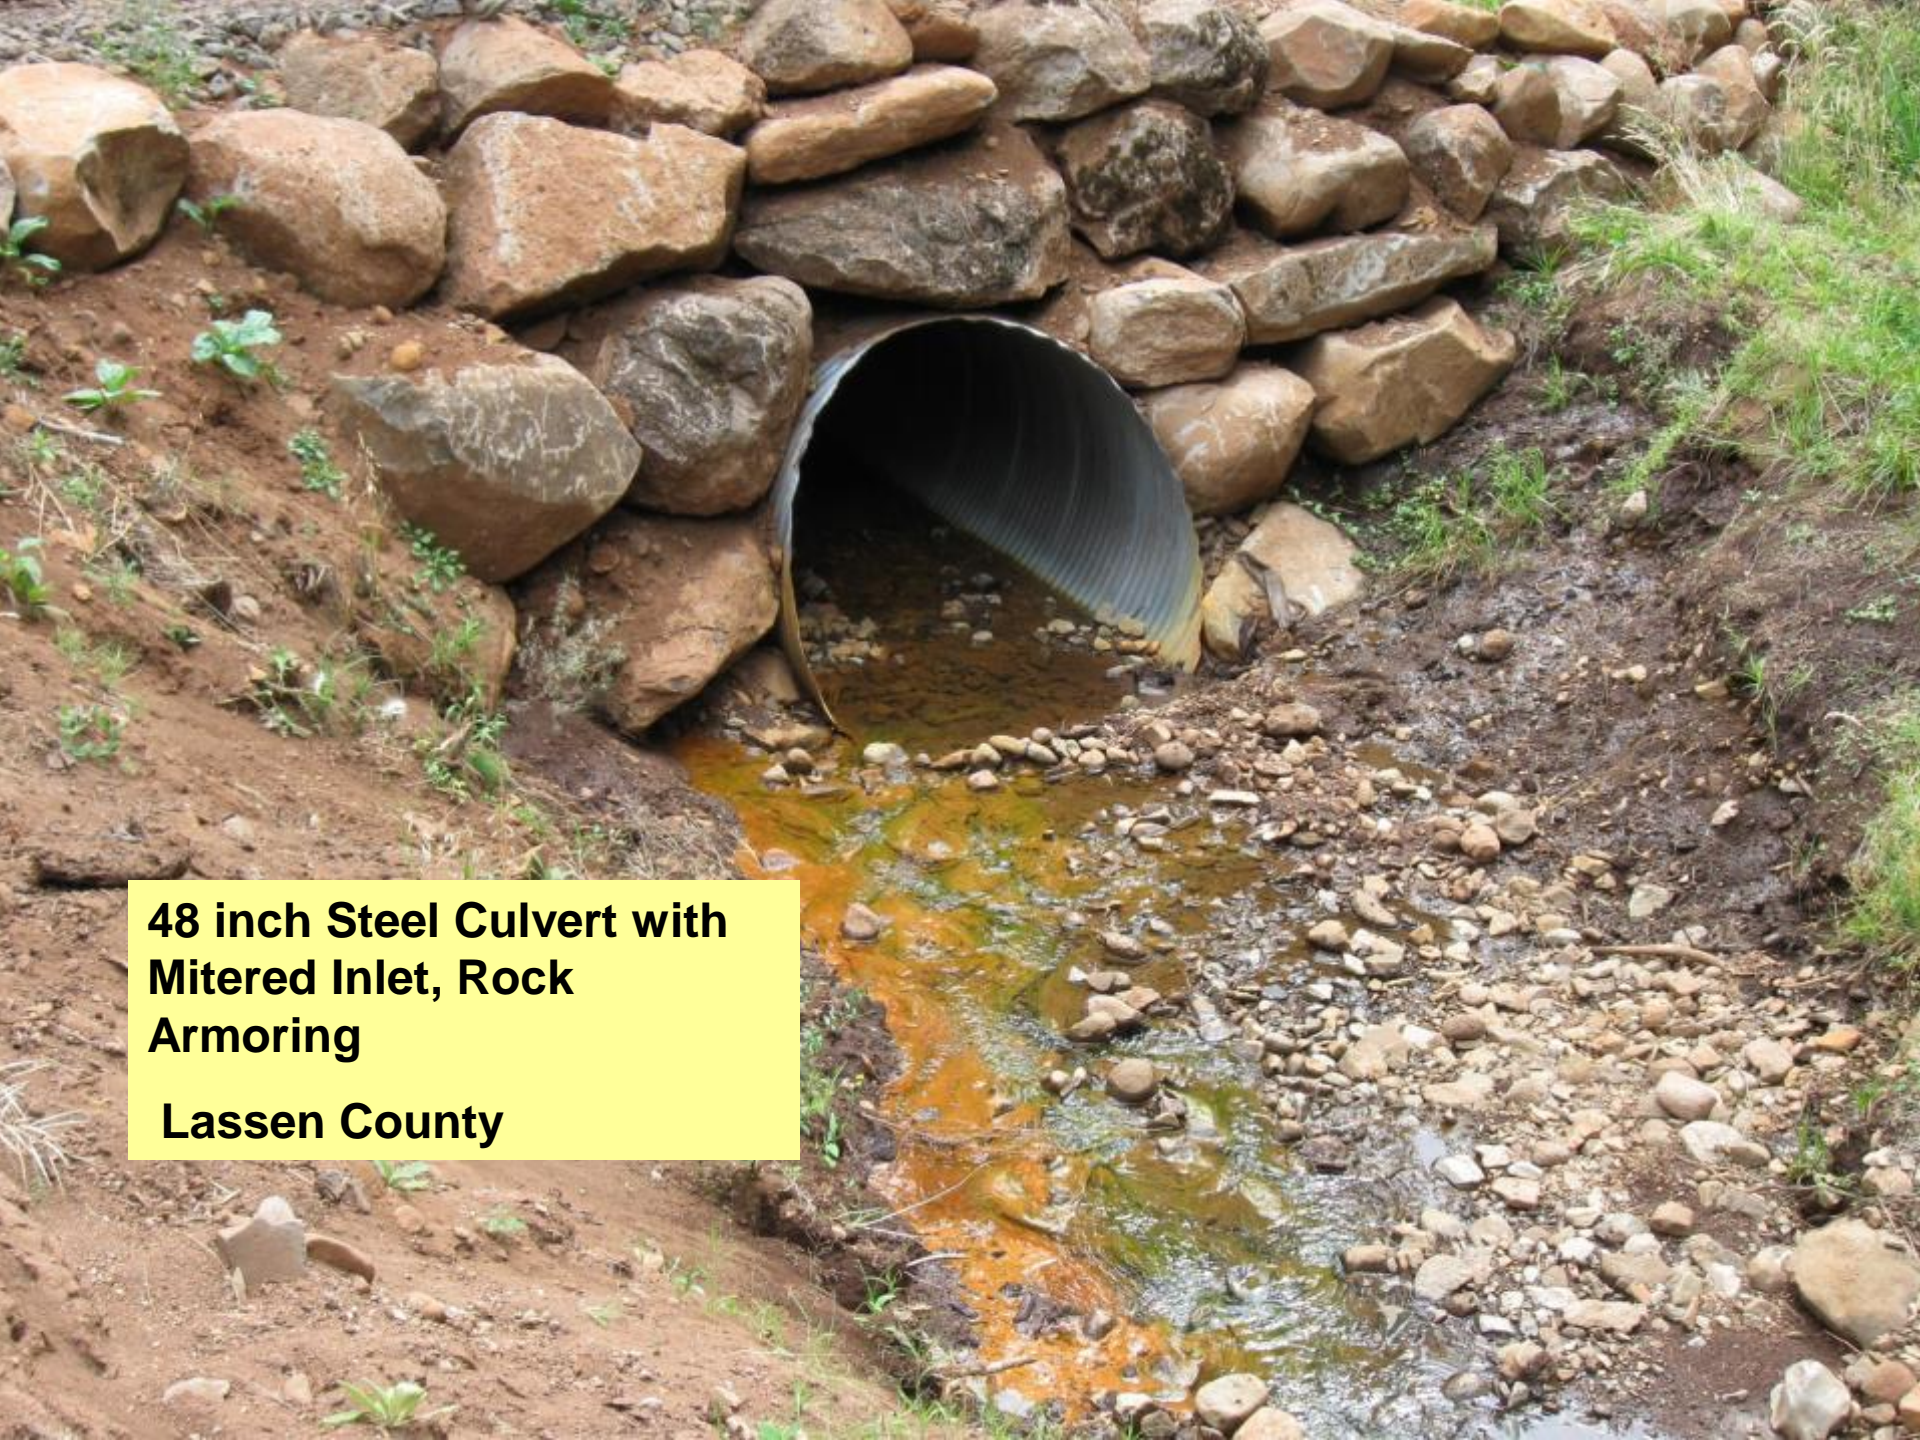
**48 inch Steel Culvert with
Mitered Inlet, Rock
Armoring**

Lassen County

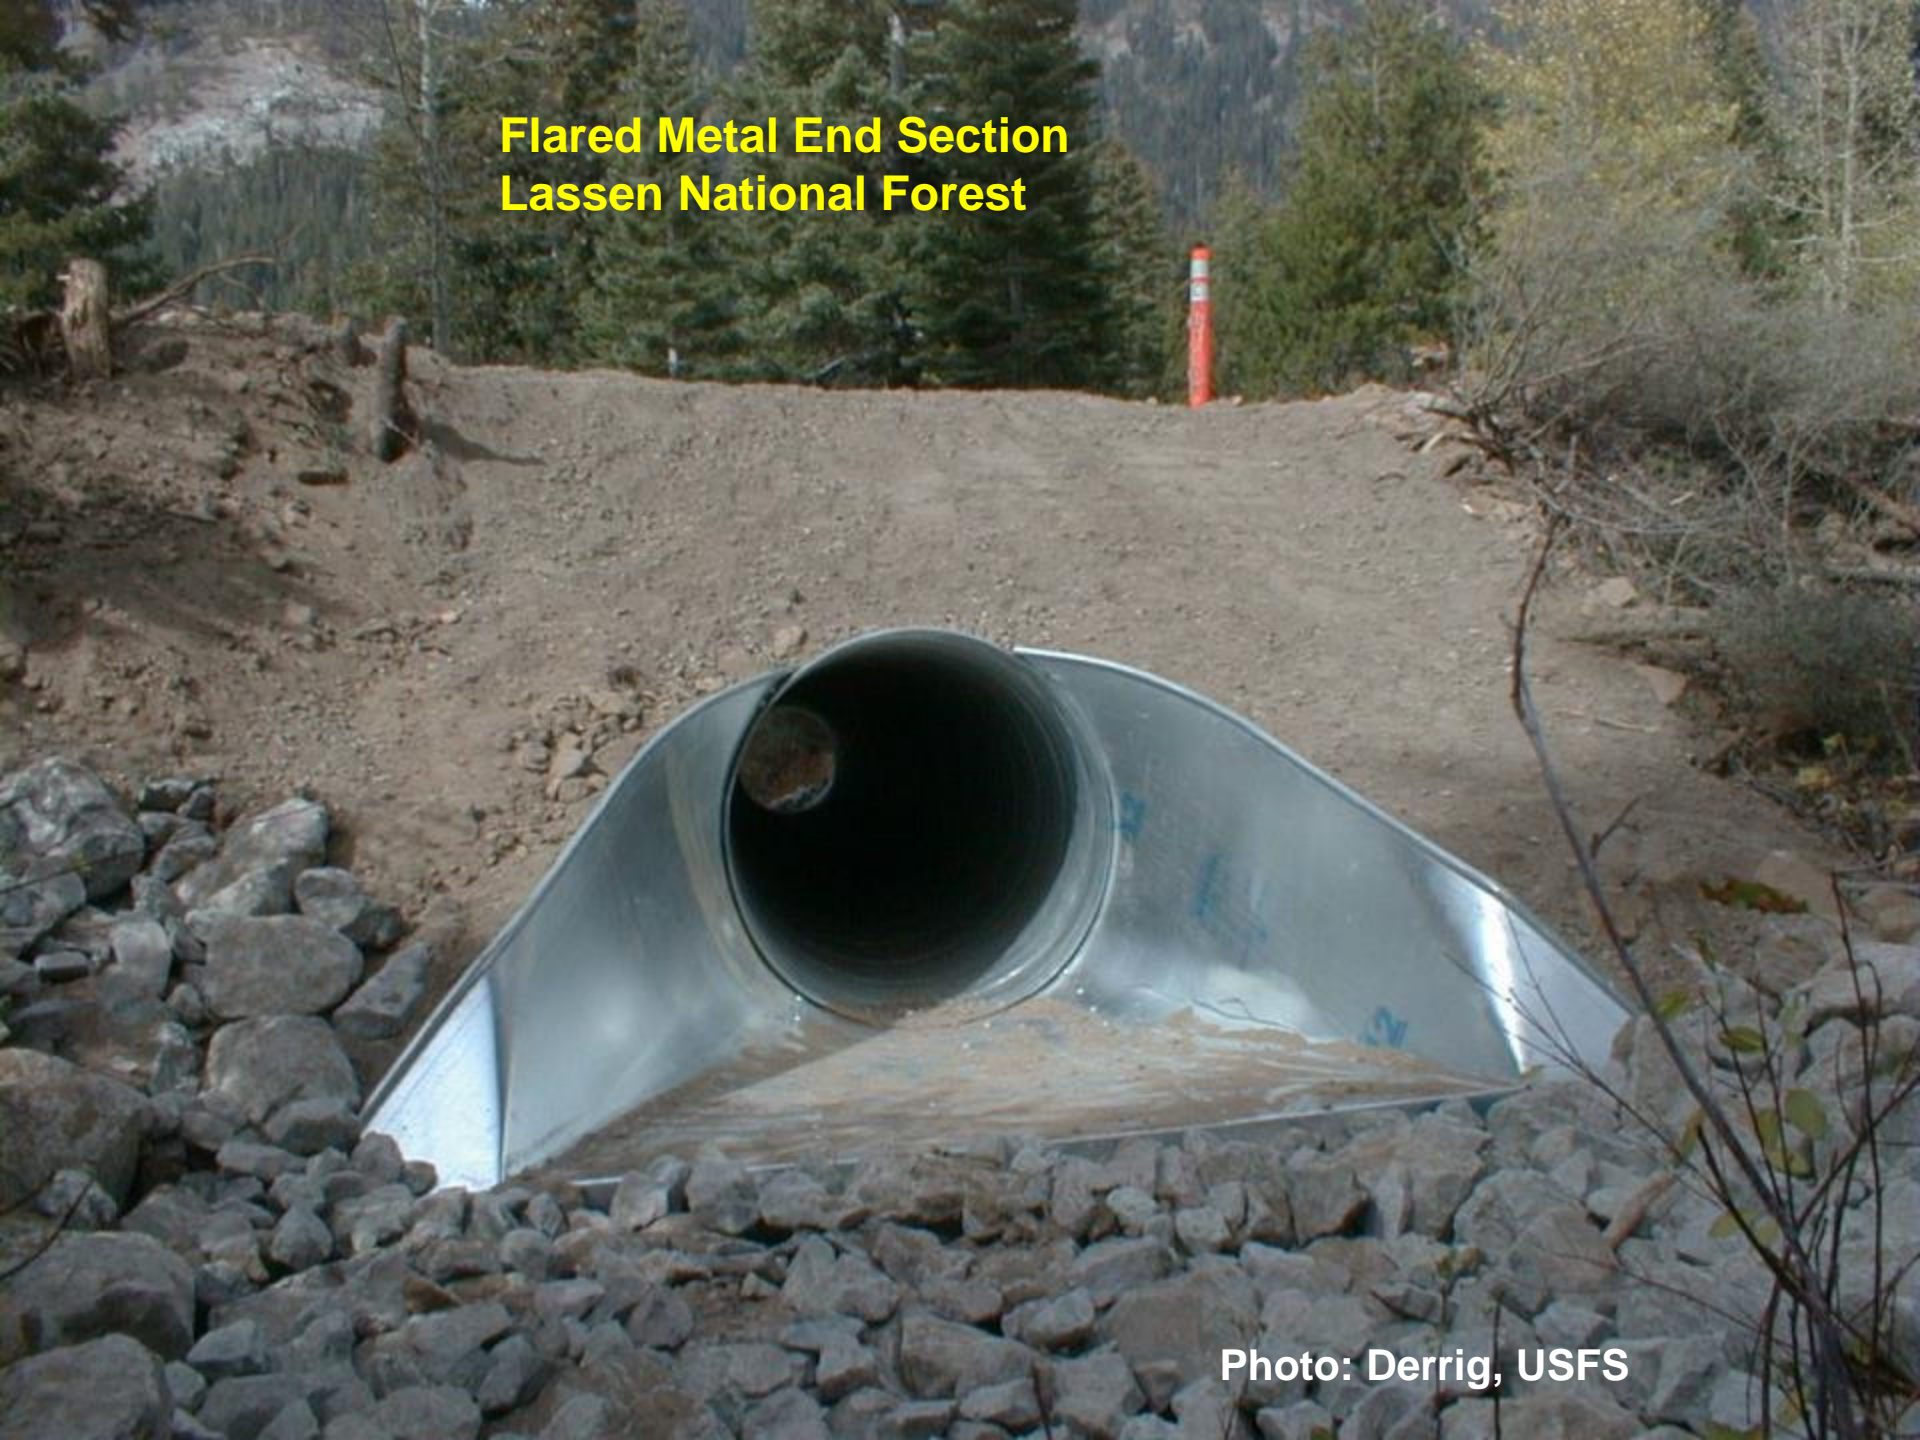
**Flared Metal End Section
Lassen National Forest**

- **Simple Trash Rack (Fence Posts)**
 - <\$50 (but requires abundant maintenance!)
- **Bevel (Mitered) End Section**
 - ~\$50 - \$100
- **Flared Metal End Section**
 - 36 inch pipe -- ~\$500
 - 48 inch pipe -- ~\$1,100
 - 60 inch pipe -- ~\$2,000

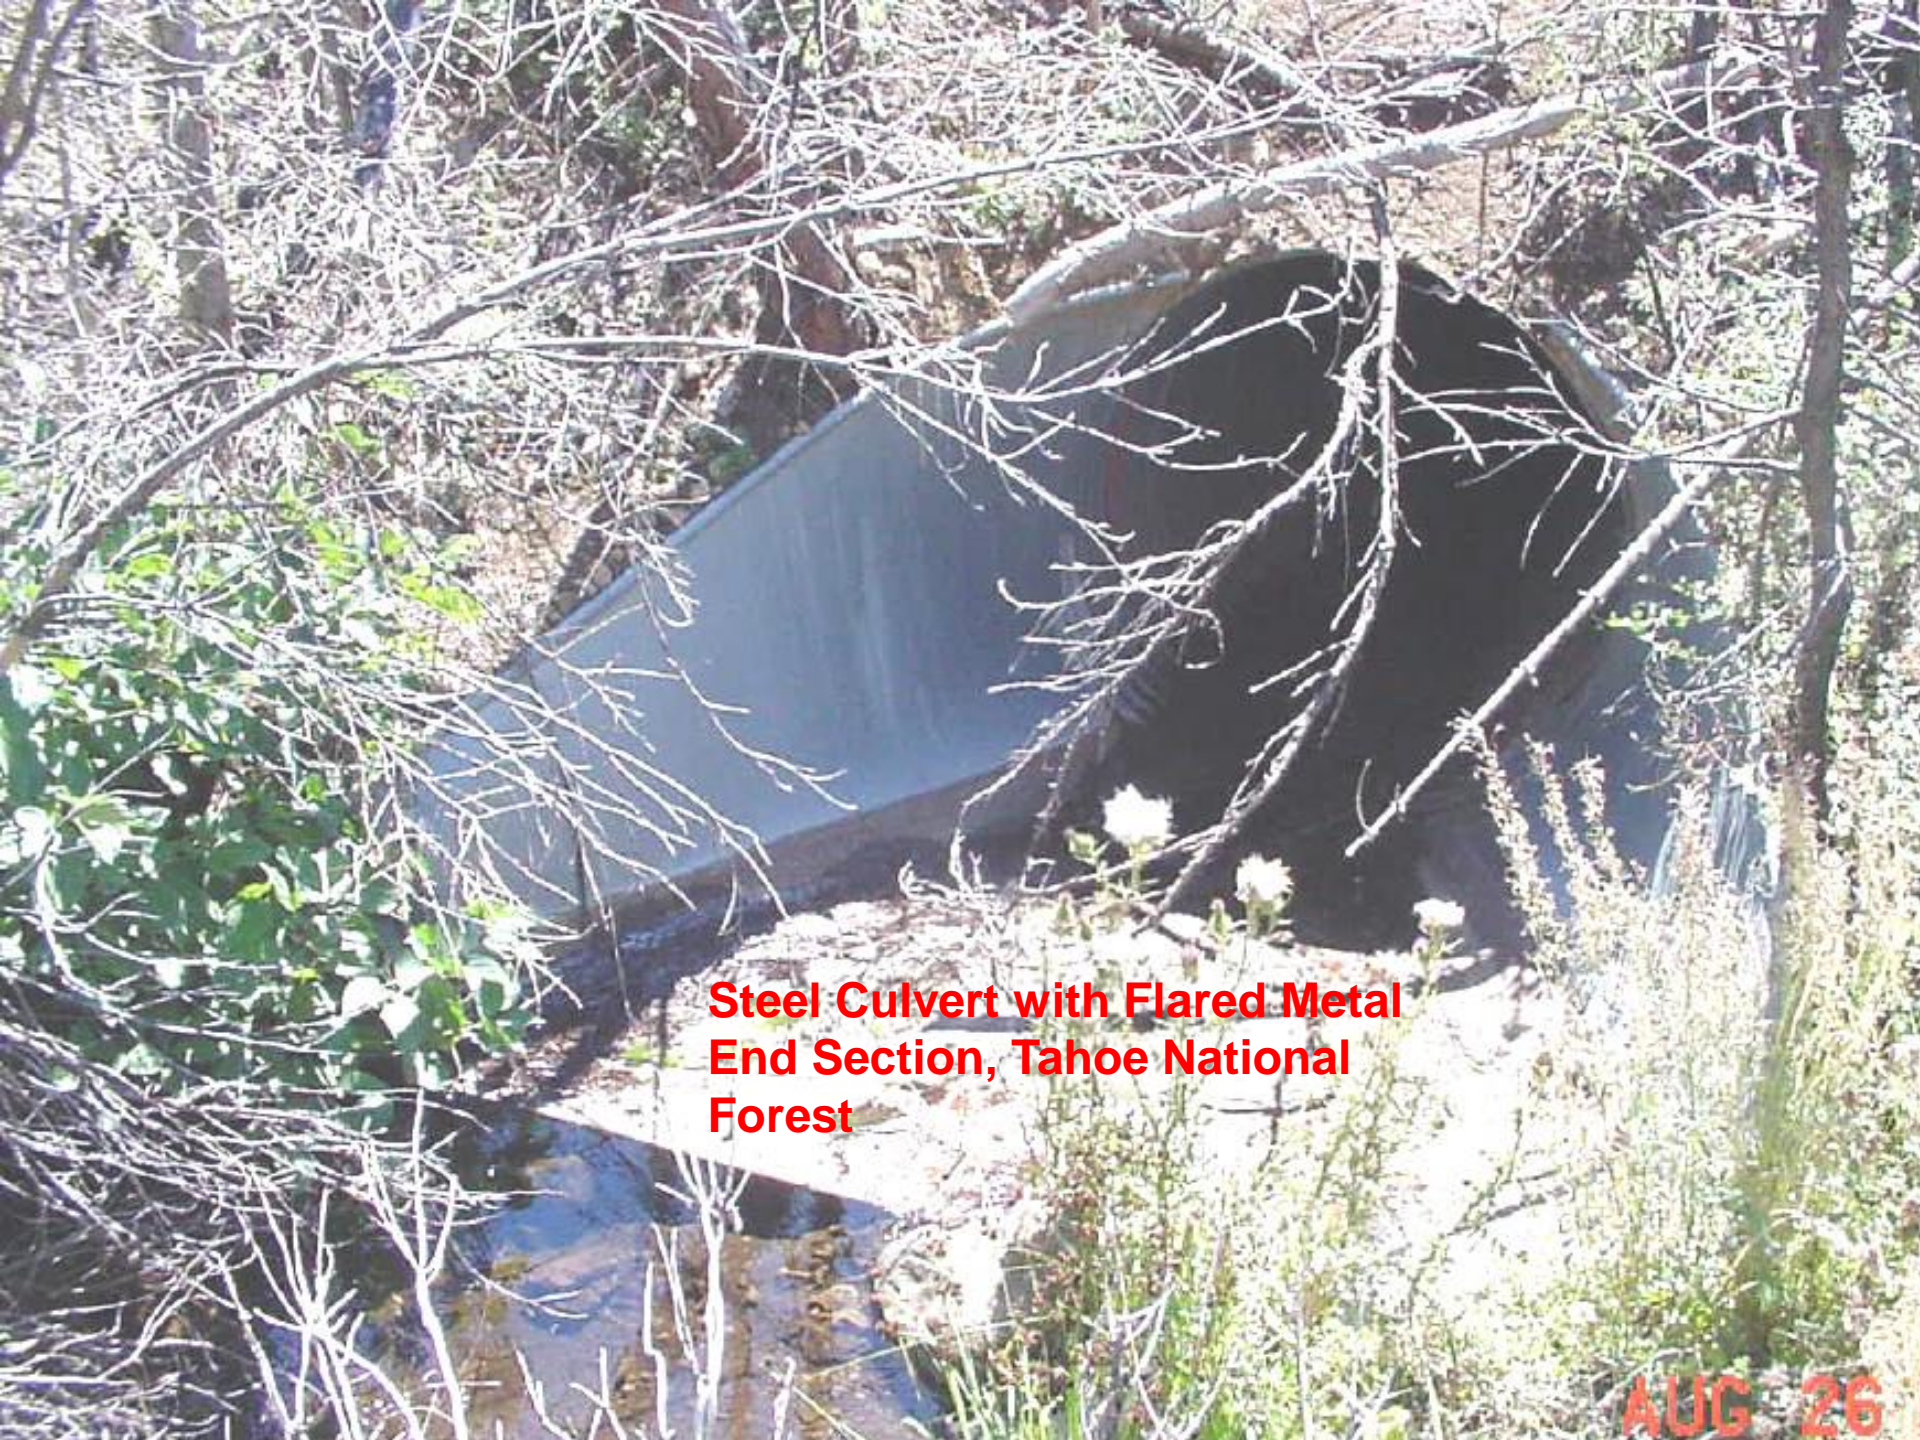
**Steel Culvert with Flared Metal
End Section, Tahoe National
Forest**

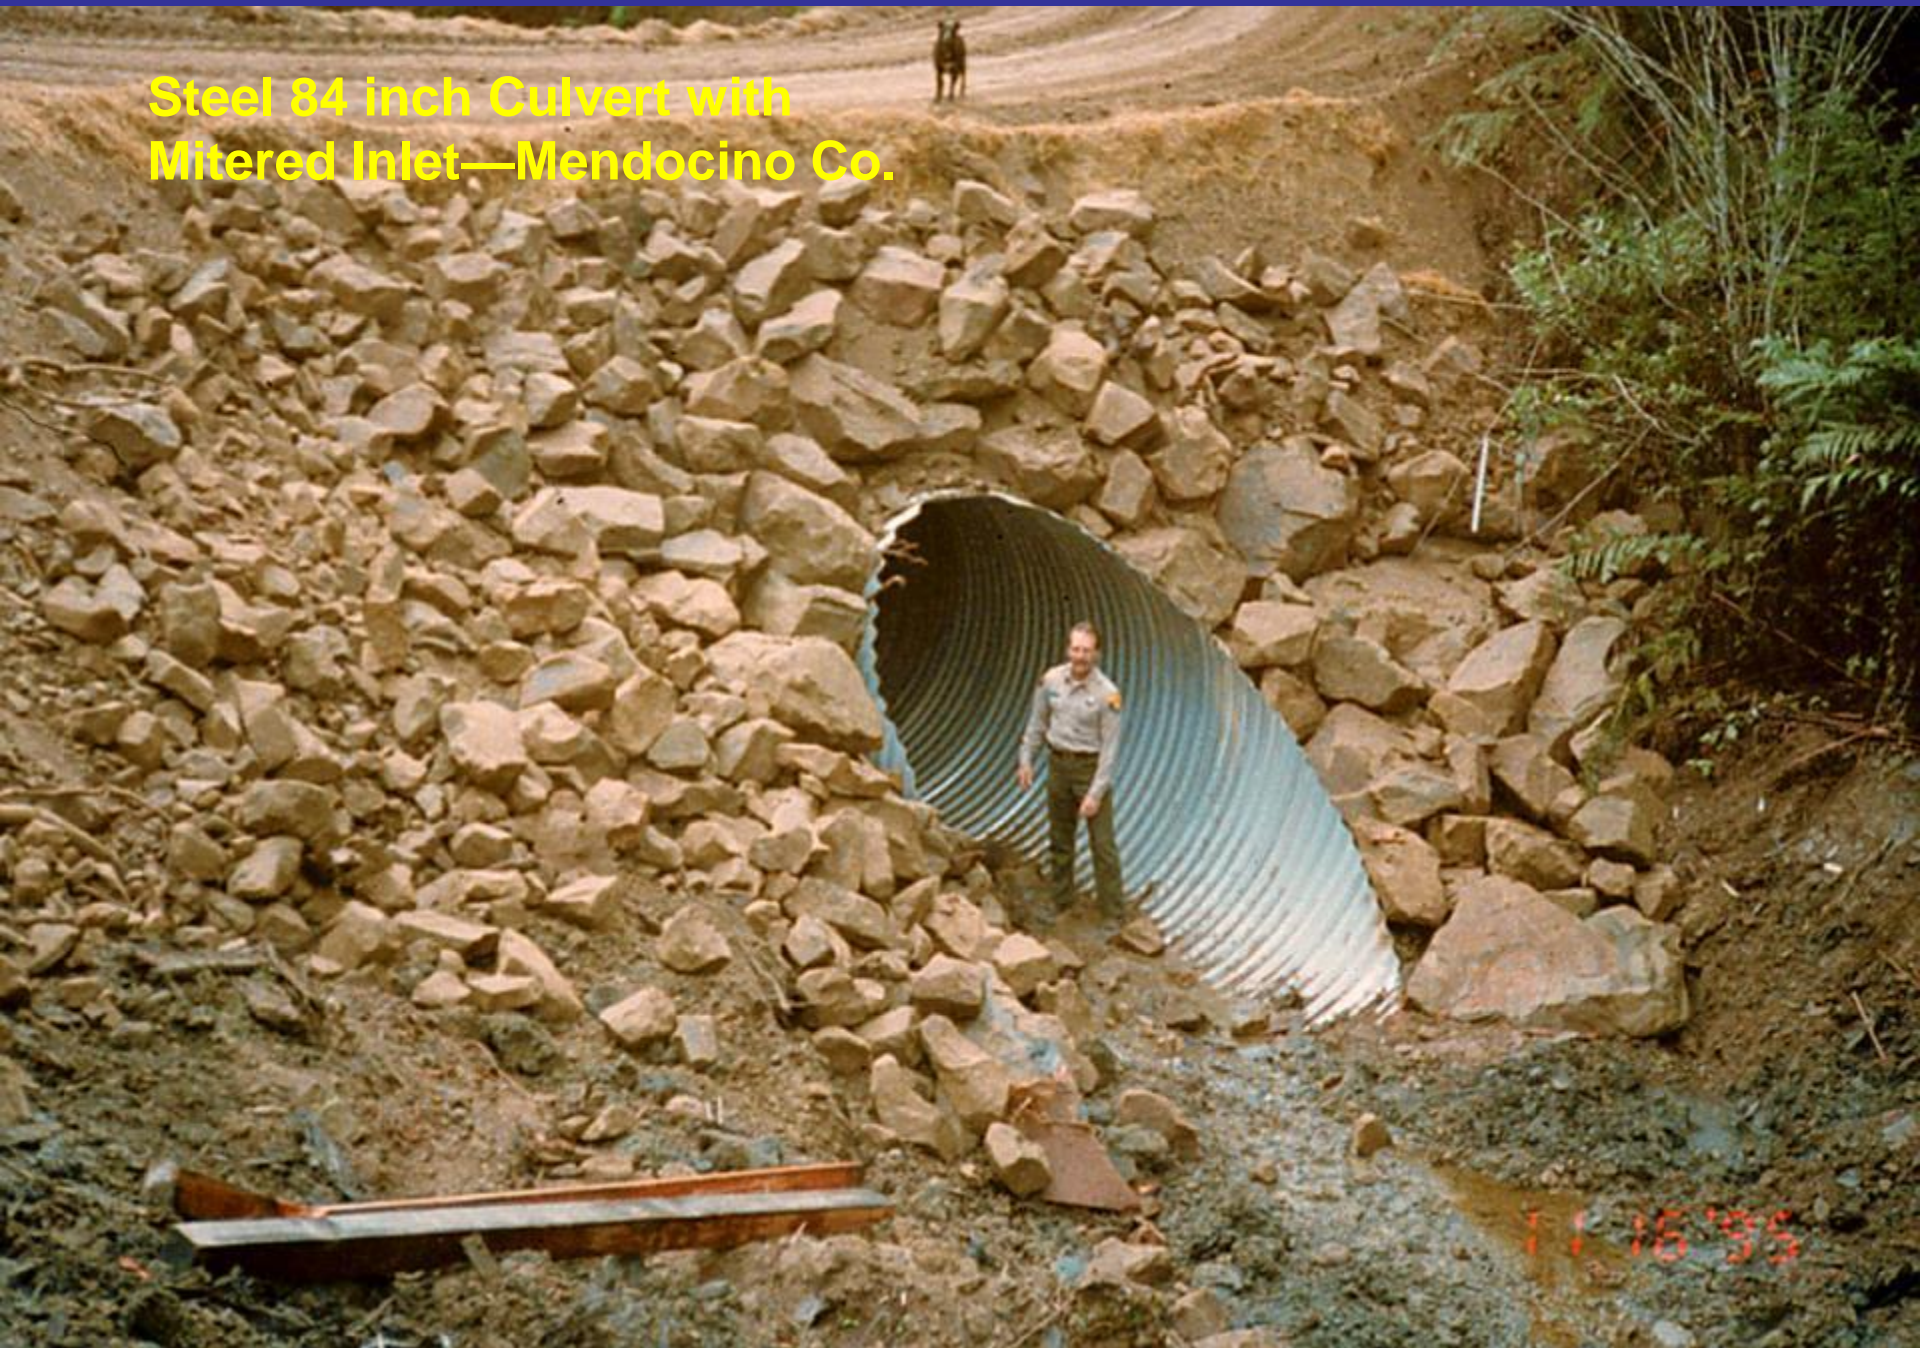
Steel 84 inch Culvert with
Mitered Inlet—Mendocino Co.

- A mitered culvert is formed when the culvert is cut to conform with the plane of the embankment slope.
- Beveled inlets reduce wood blockage and plugging.
- Bevel the inlet edge to increase flow efficiency and reduce pipe size by <10%.
- “Mitered ends are much less likely to be plugged by ice, debris, or beaver” (*Wisconsin Transportation Bulletin*).

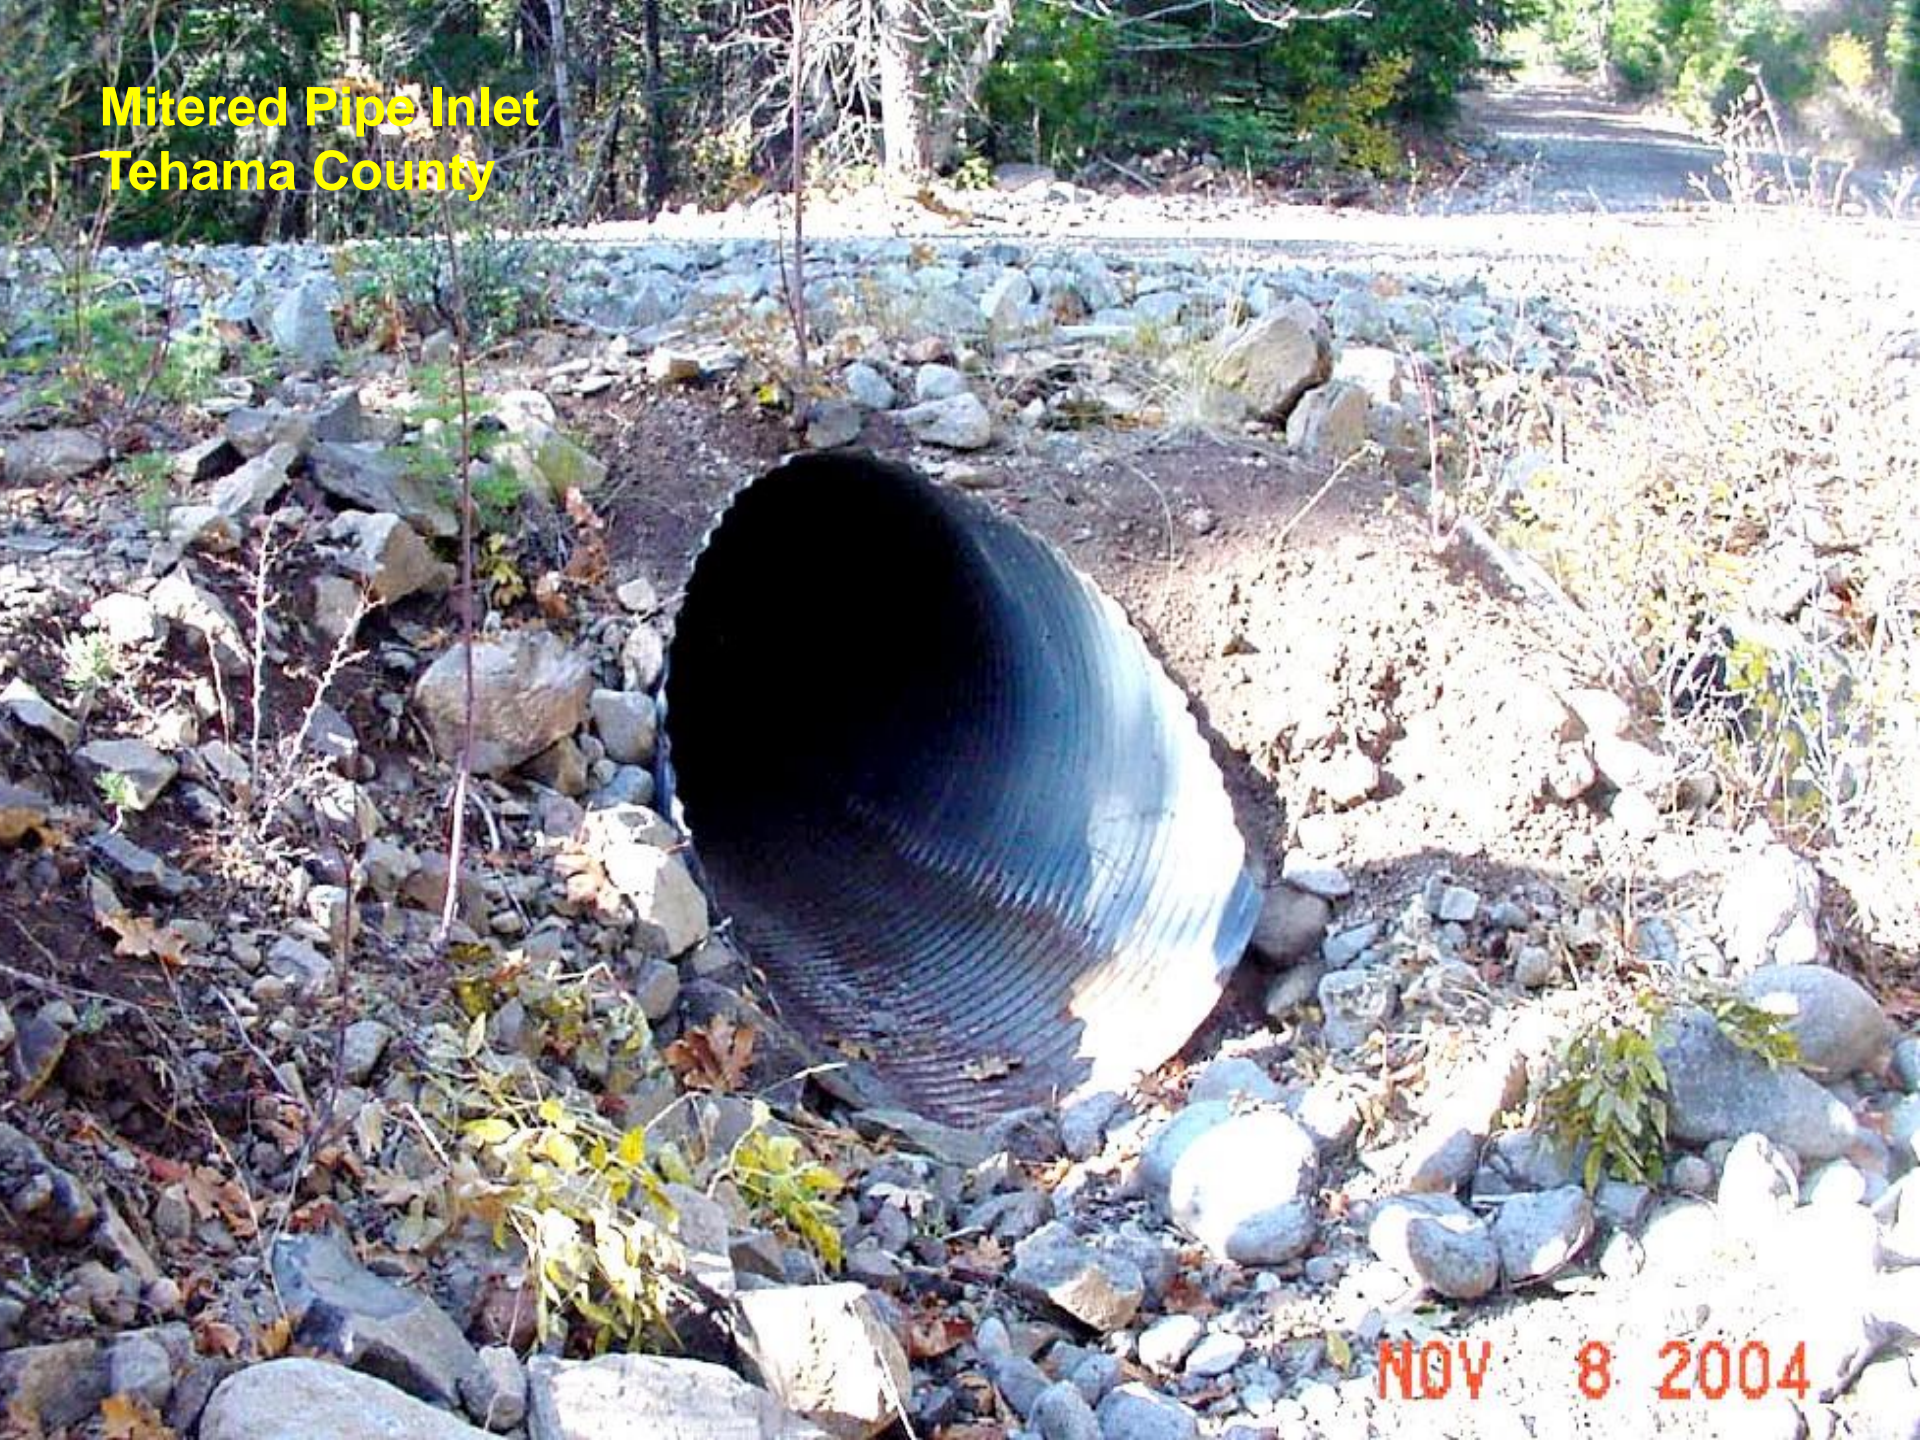
Mitered Pipe Inlet
Tehama County

**Miter too far away from fillslope;
should be maximum of 6
inches—not 1-2 feet**

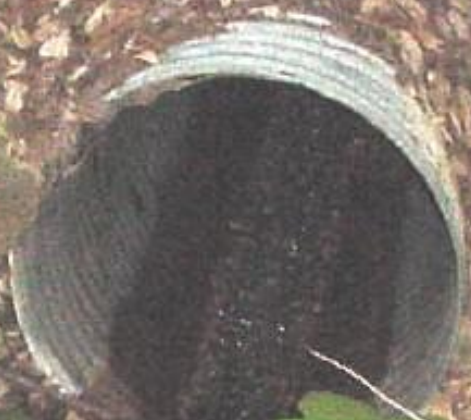
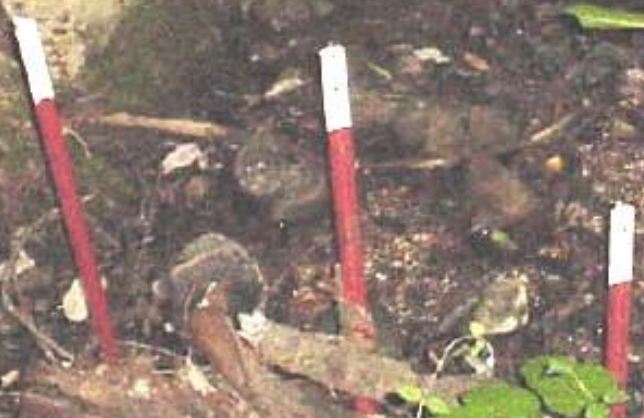
Simple Fence Post
Trash Rack
Santa Cruz County

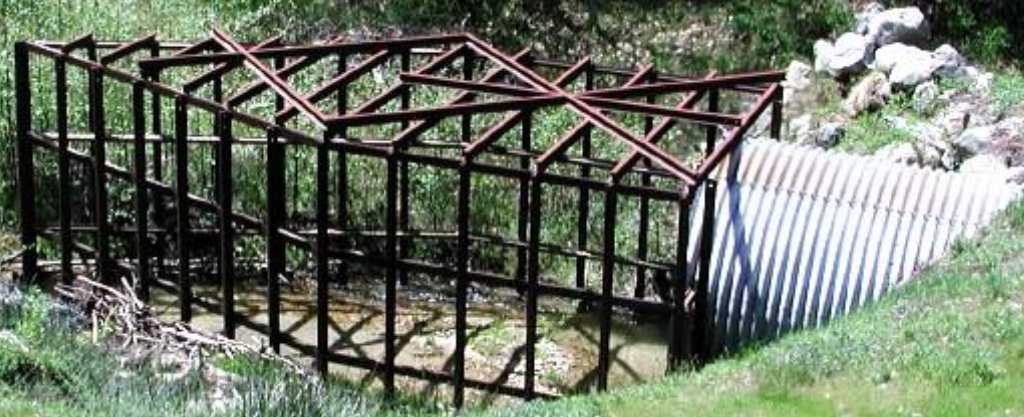
**Caltrans Welded Metal
Trash Rack for 12 ft CMP,
Highway 299 Trinity
County**

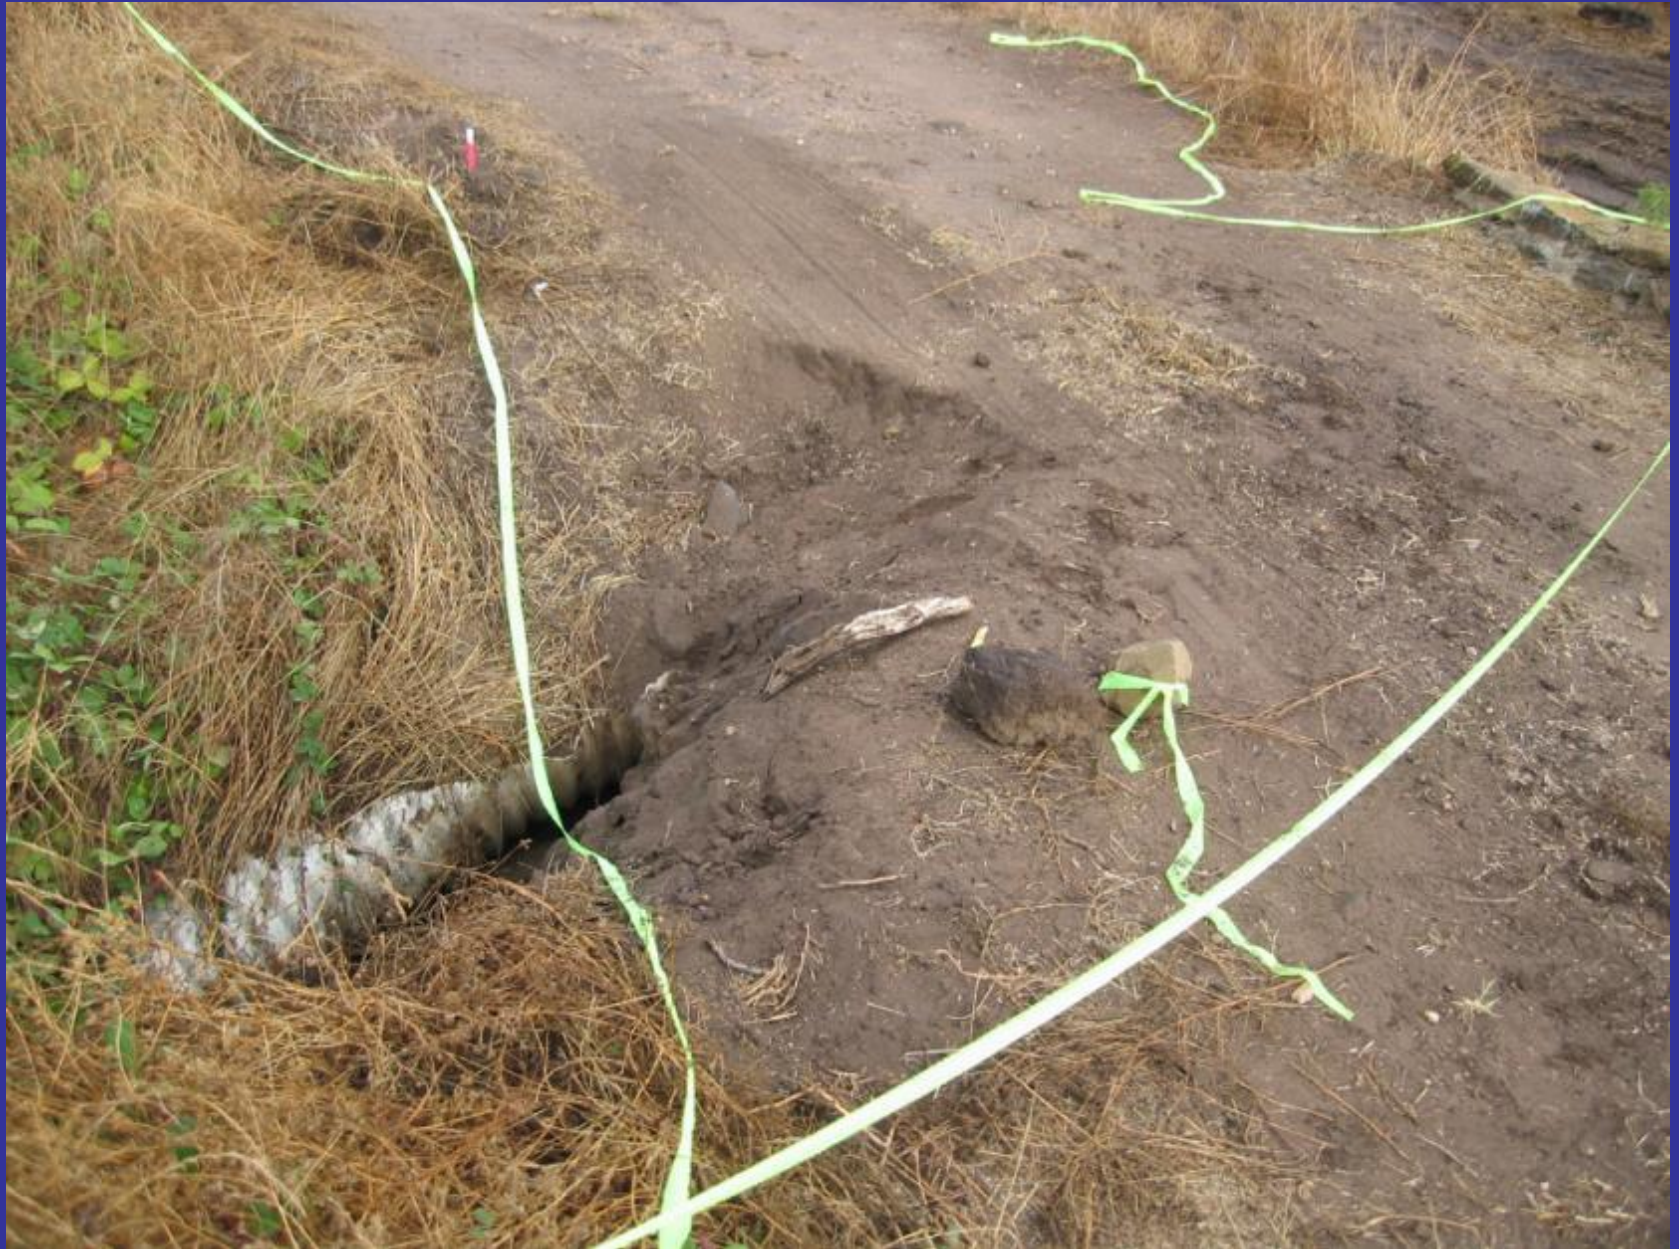
Paradise Fire 2003--Damaged Culvert
