Stream Crossing Alternatives

Pete Cafferata

California Department of Forestry
and Fire Protection

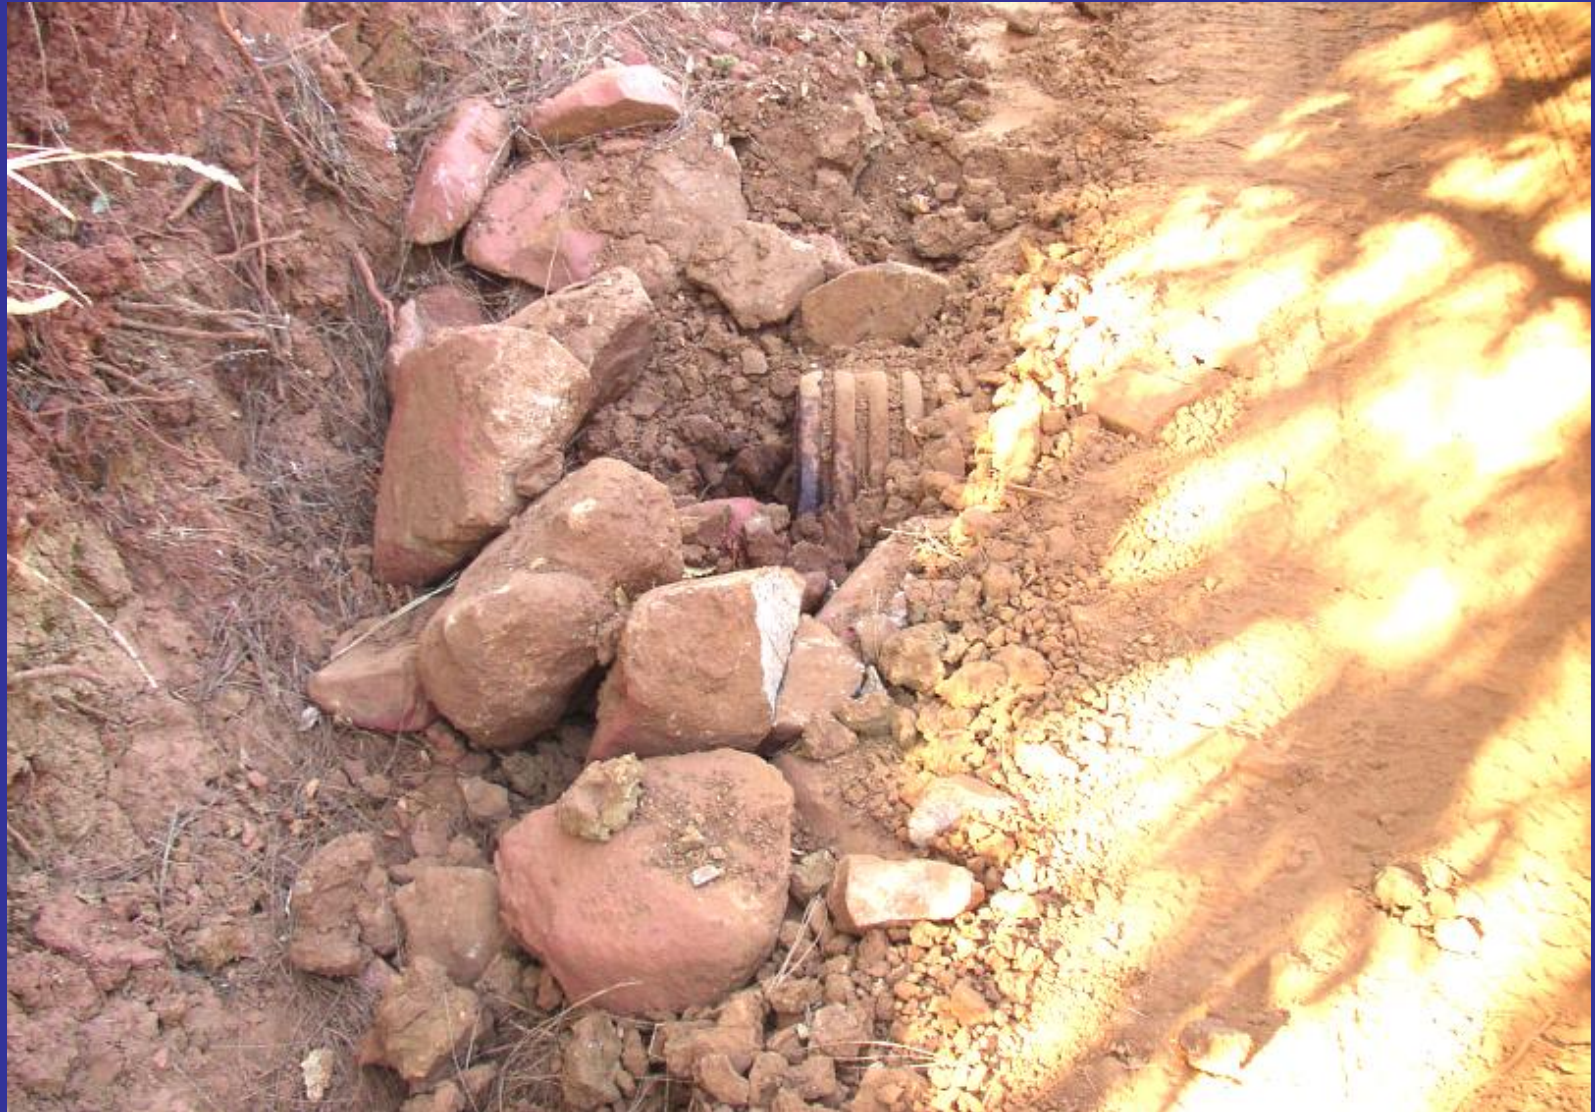
Inside Ditch and Culvert Inlet Filled in by Dozers during Suppression Efforts Willow Fire 2002, Tuolumne County

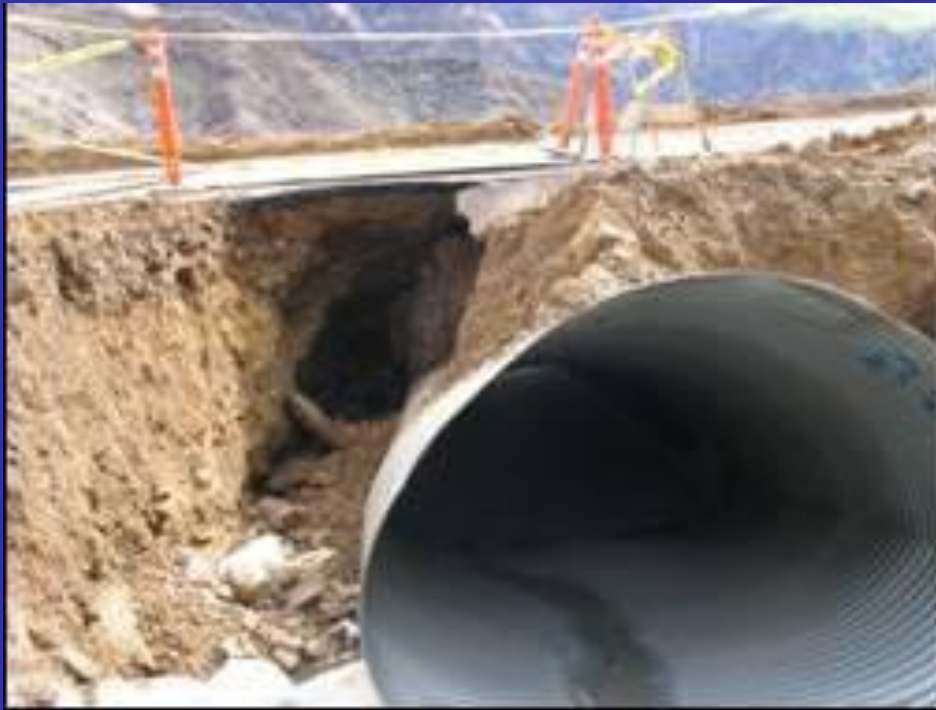
Piru Fire 2003

Crossing Failed Crossing After 2.66 inch Storm

**Peak stream flows
commonly double
first winter.**

**Sediment yields
commonly increase
2 to 40 X depending
on size of storms.**

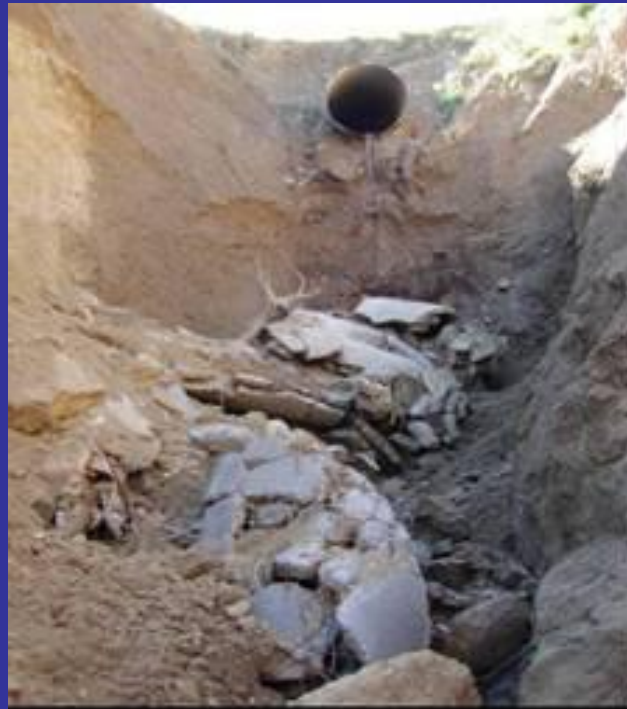
Piru Fire 2003

Channel Scour Following Winter Storms-- Failure of a Check Dam below a 60 inch Pipe

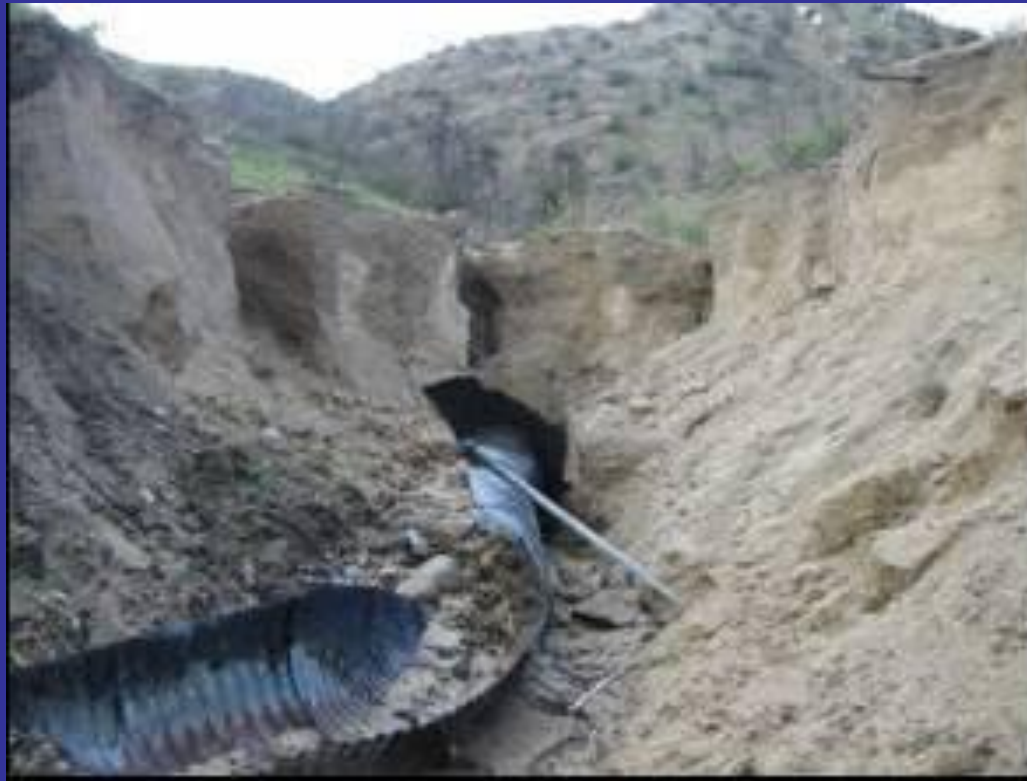
Old and Grand Prix Fires-- Failure of Rolling Dip and Over-side Drain Following October 2004 Storm Events

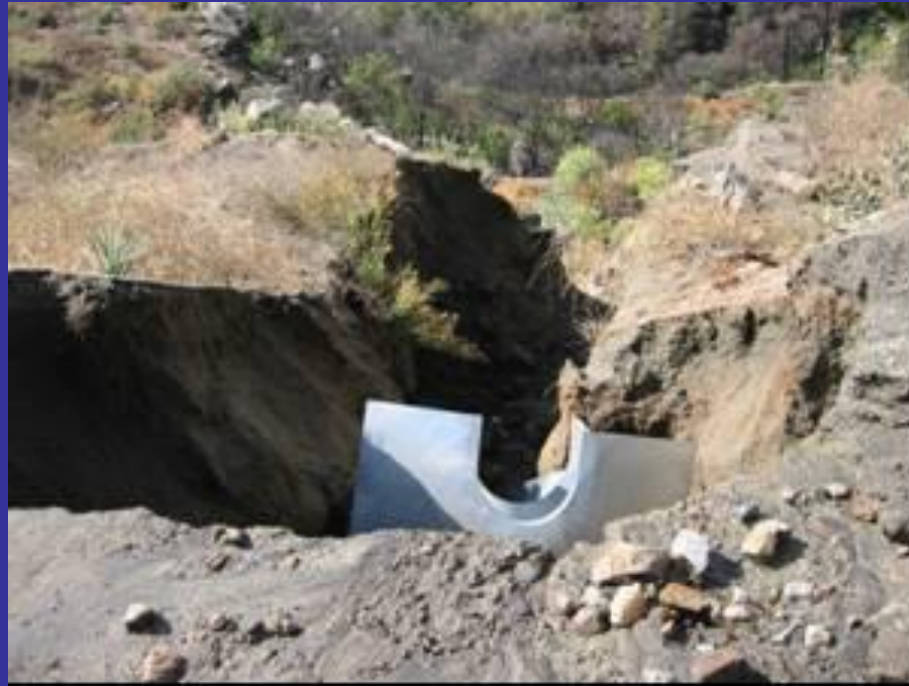
Cedar Fire 2003

Failure of Over-side Drain--Storm Damage that that Occurred During 2nd Year Storms

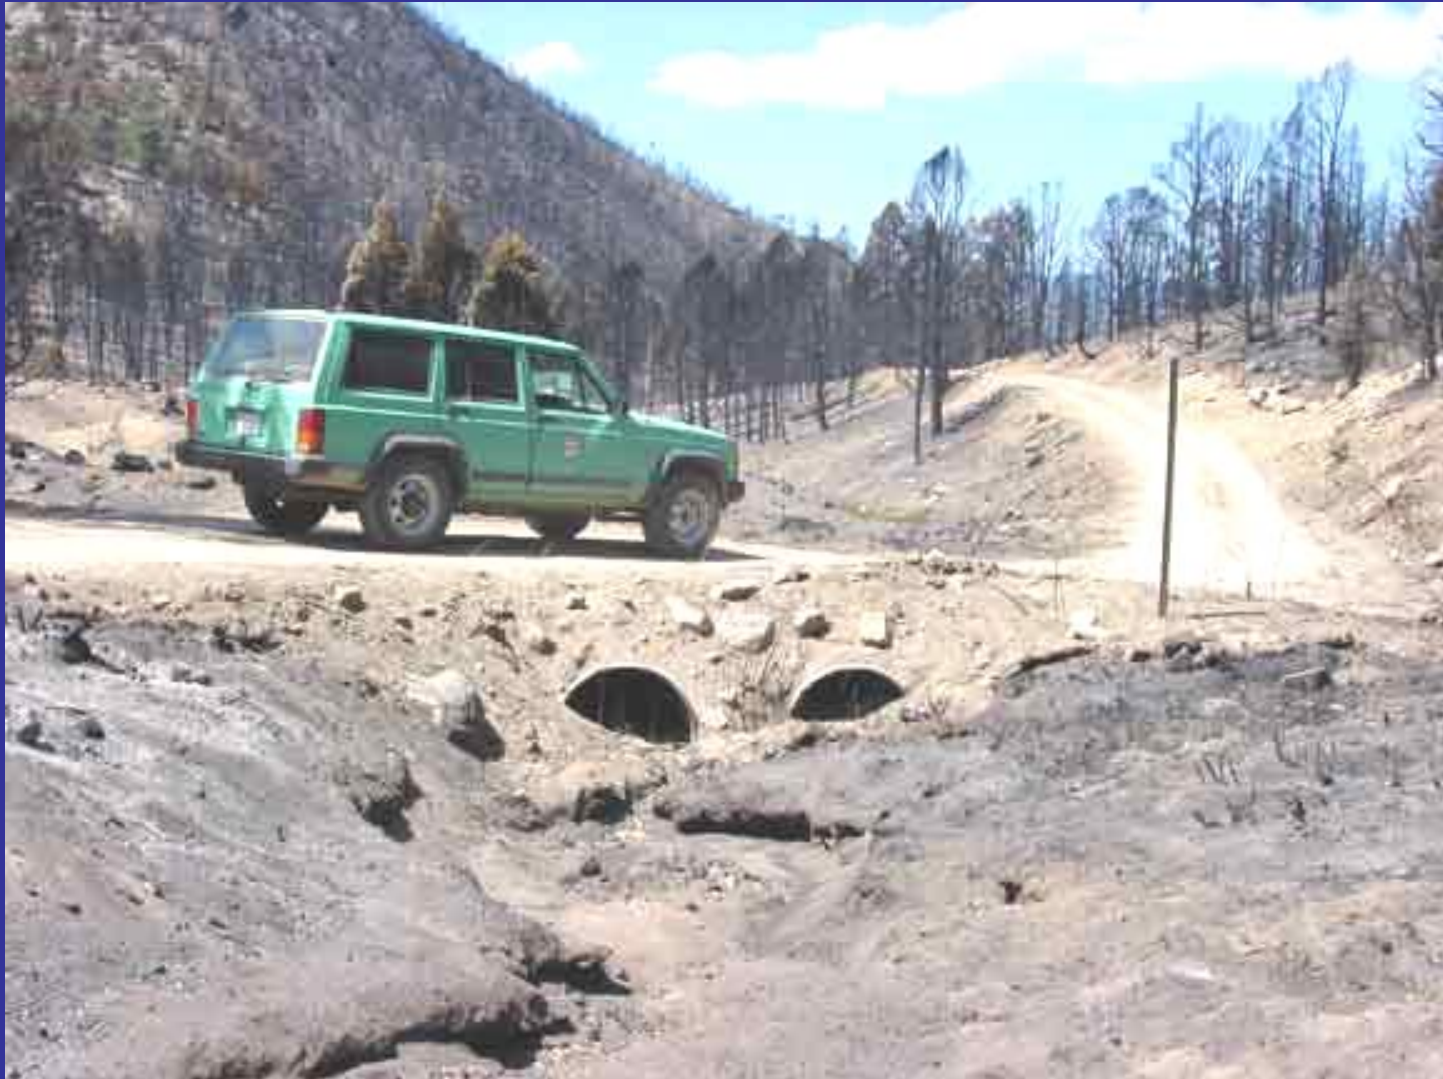
Culverts with High Plugging Potential Inventoried; Manter Fire 2000, Sequoia NF

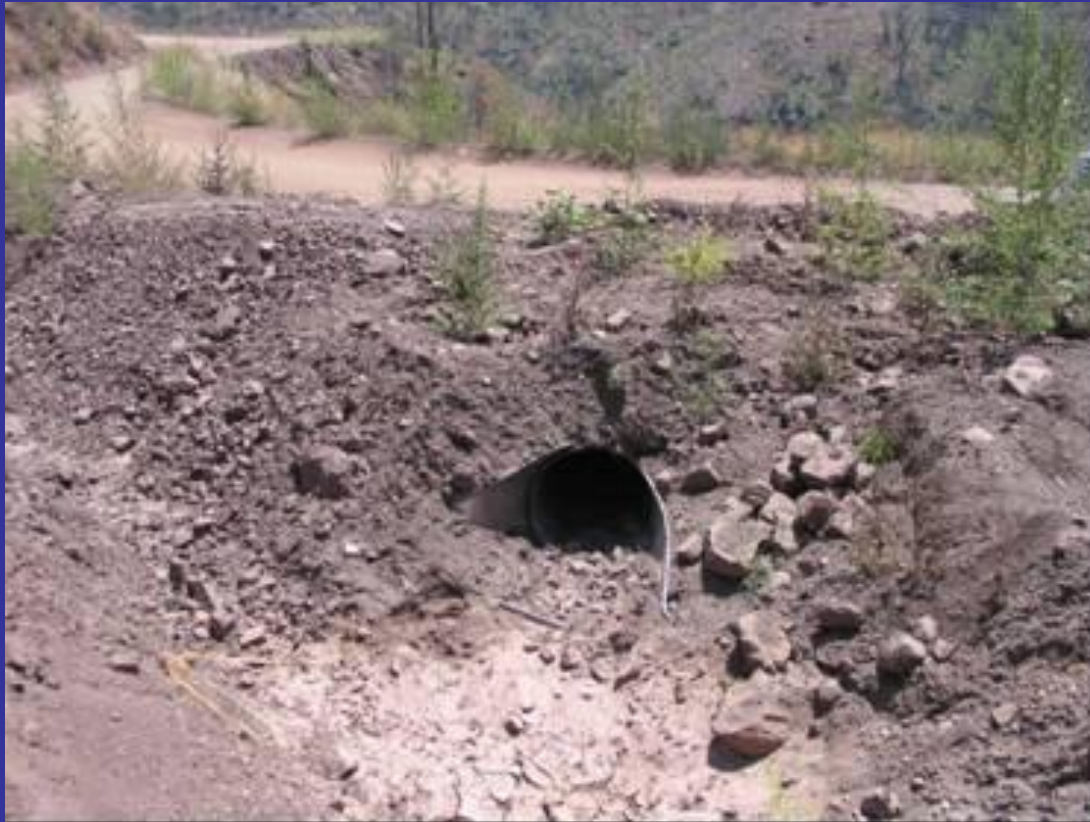
Old and Grand Prix Fires 2003-- Culvert Before Being Cleaned Out

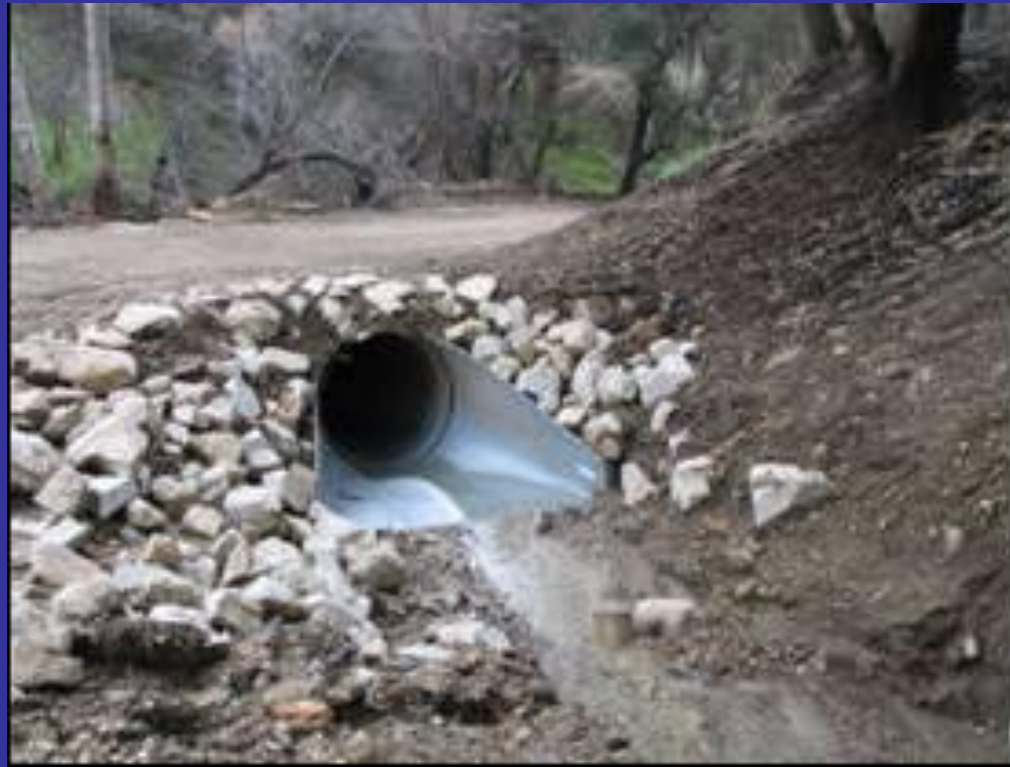
Piru Fire 2003

**12 inch Culvert Replaced with a 48 inch
Pipe—note Rock Armoring at Inlet**

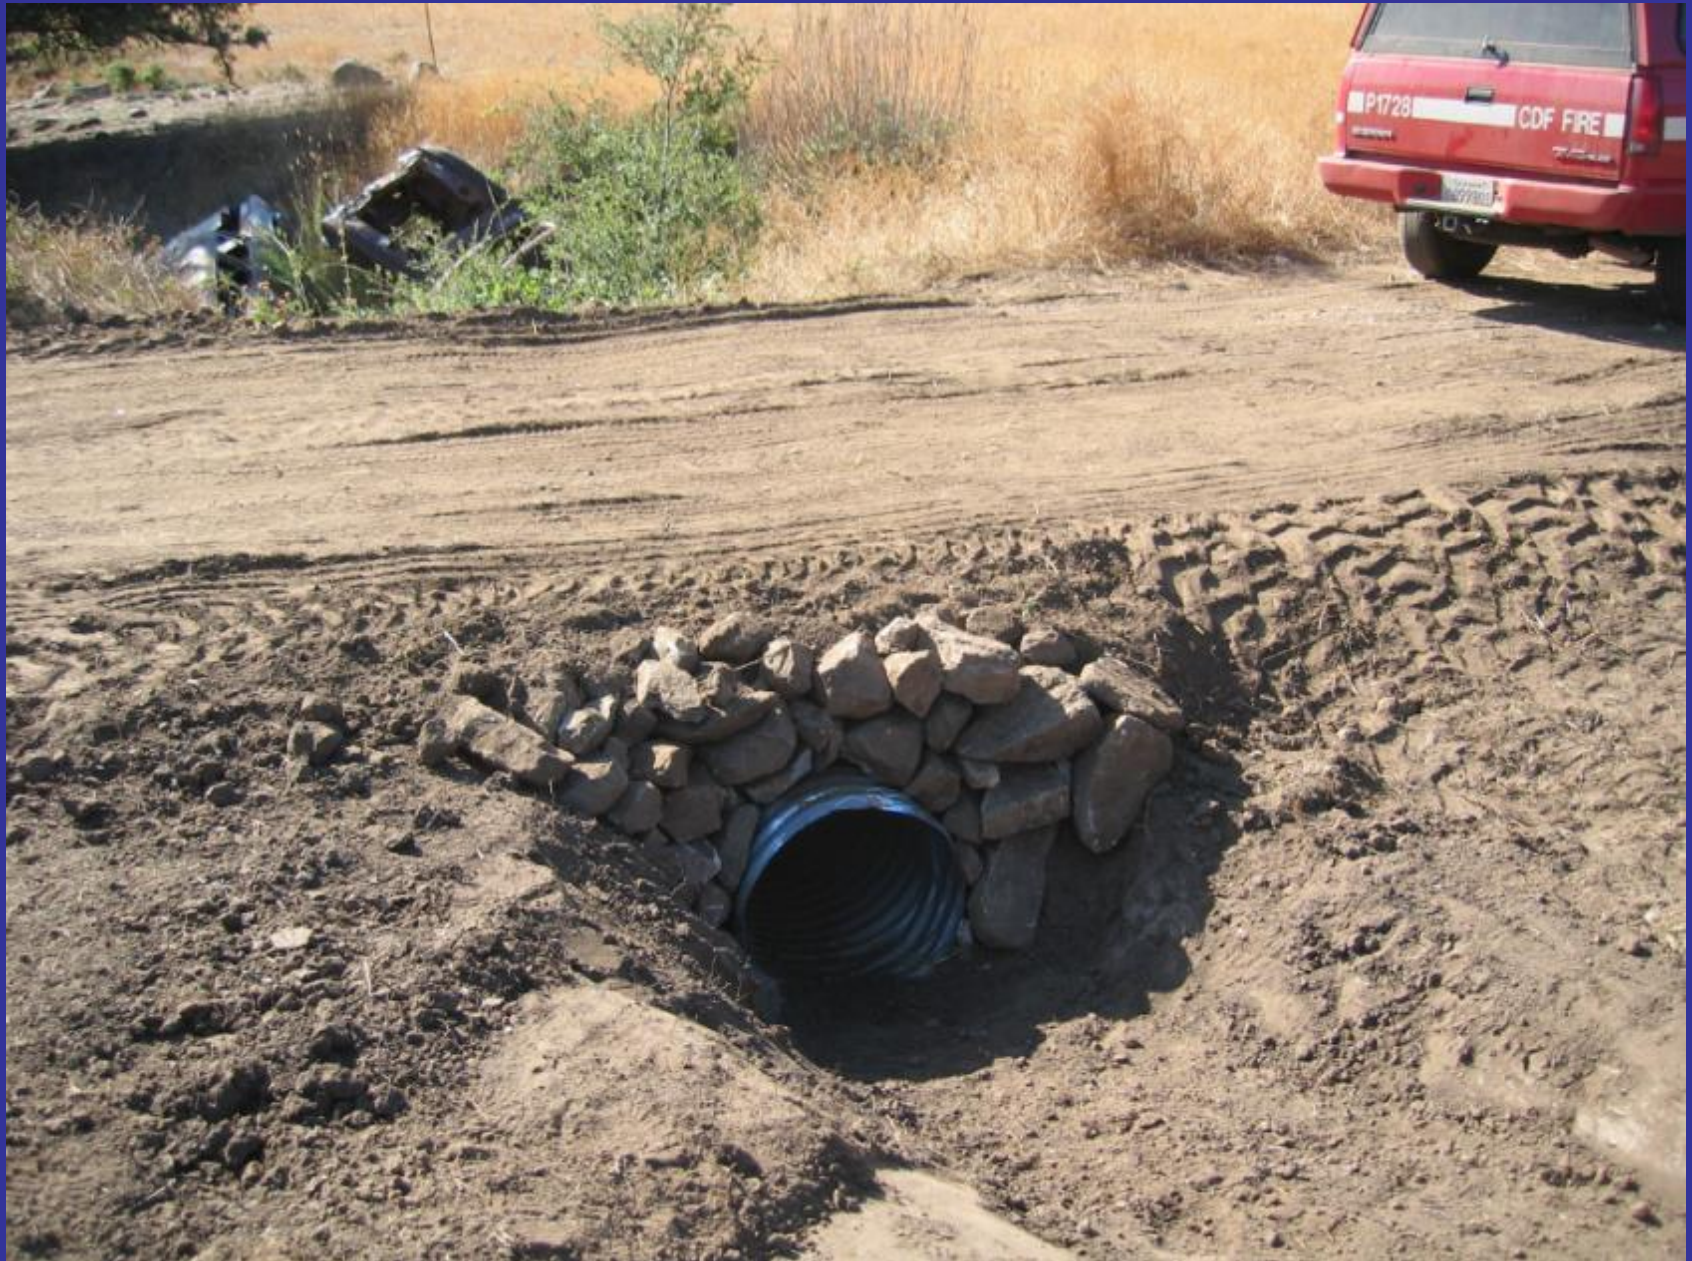
Paradise Fire 2003—Repaired Culvert

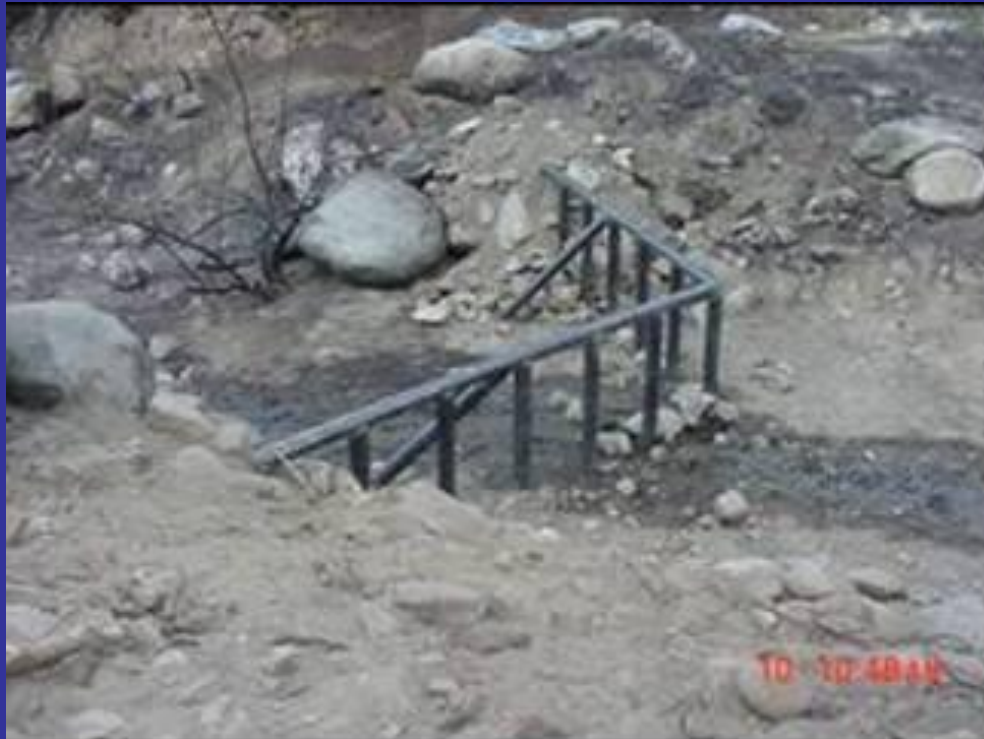
Padua Fire 2003

Debris Deflector Trash Rack in front of Culvert Inlet

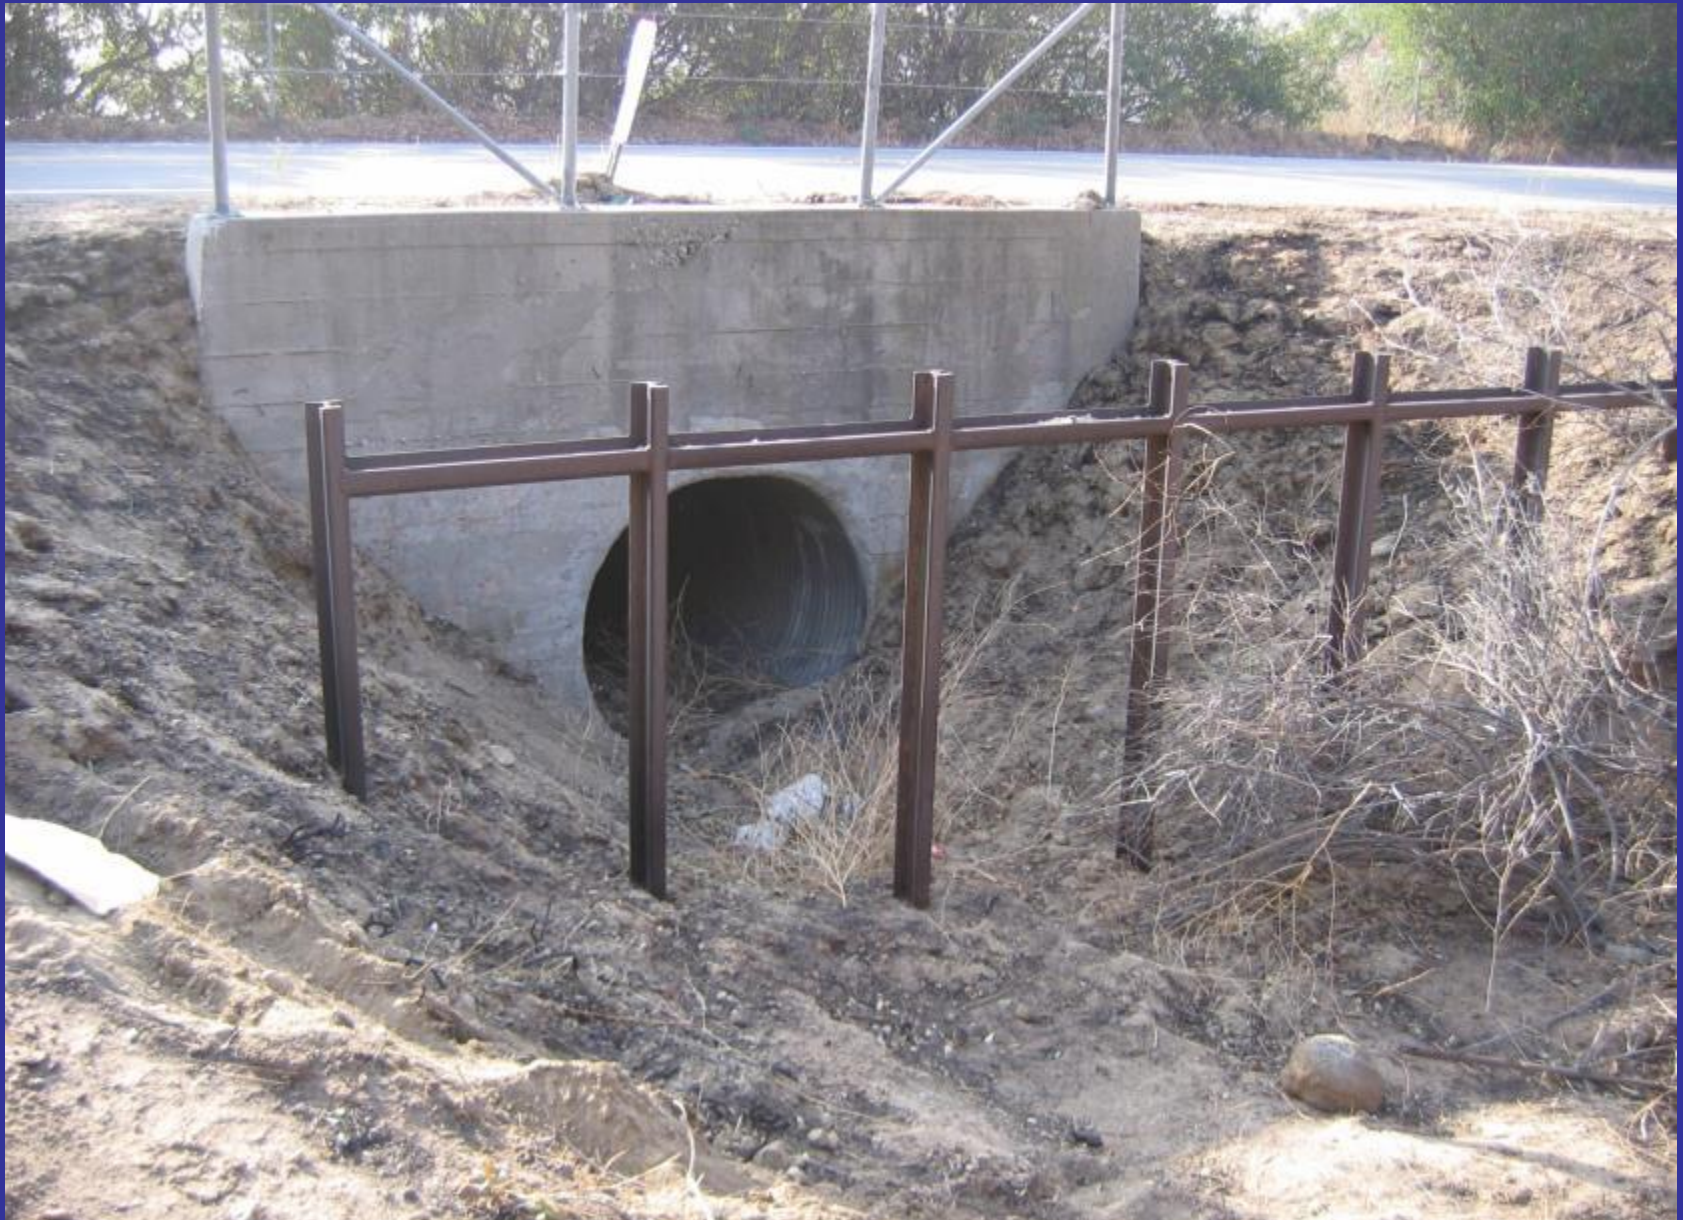
Marek Fire 2008, Los Angeles County

Steel Rail Debris Rack

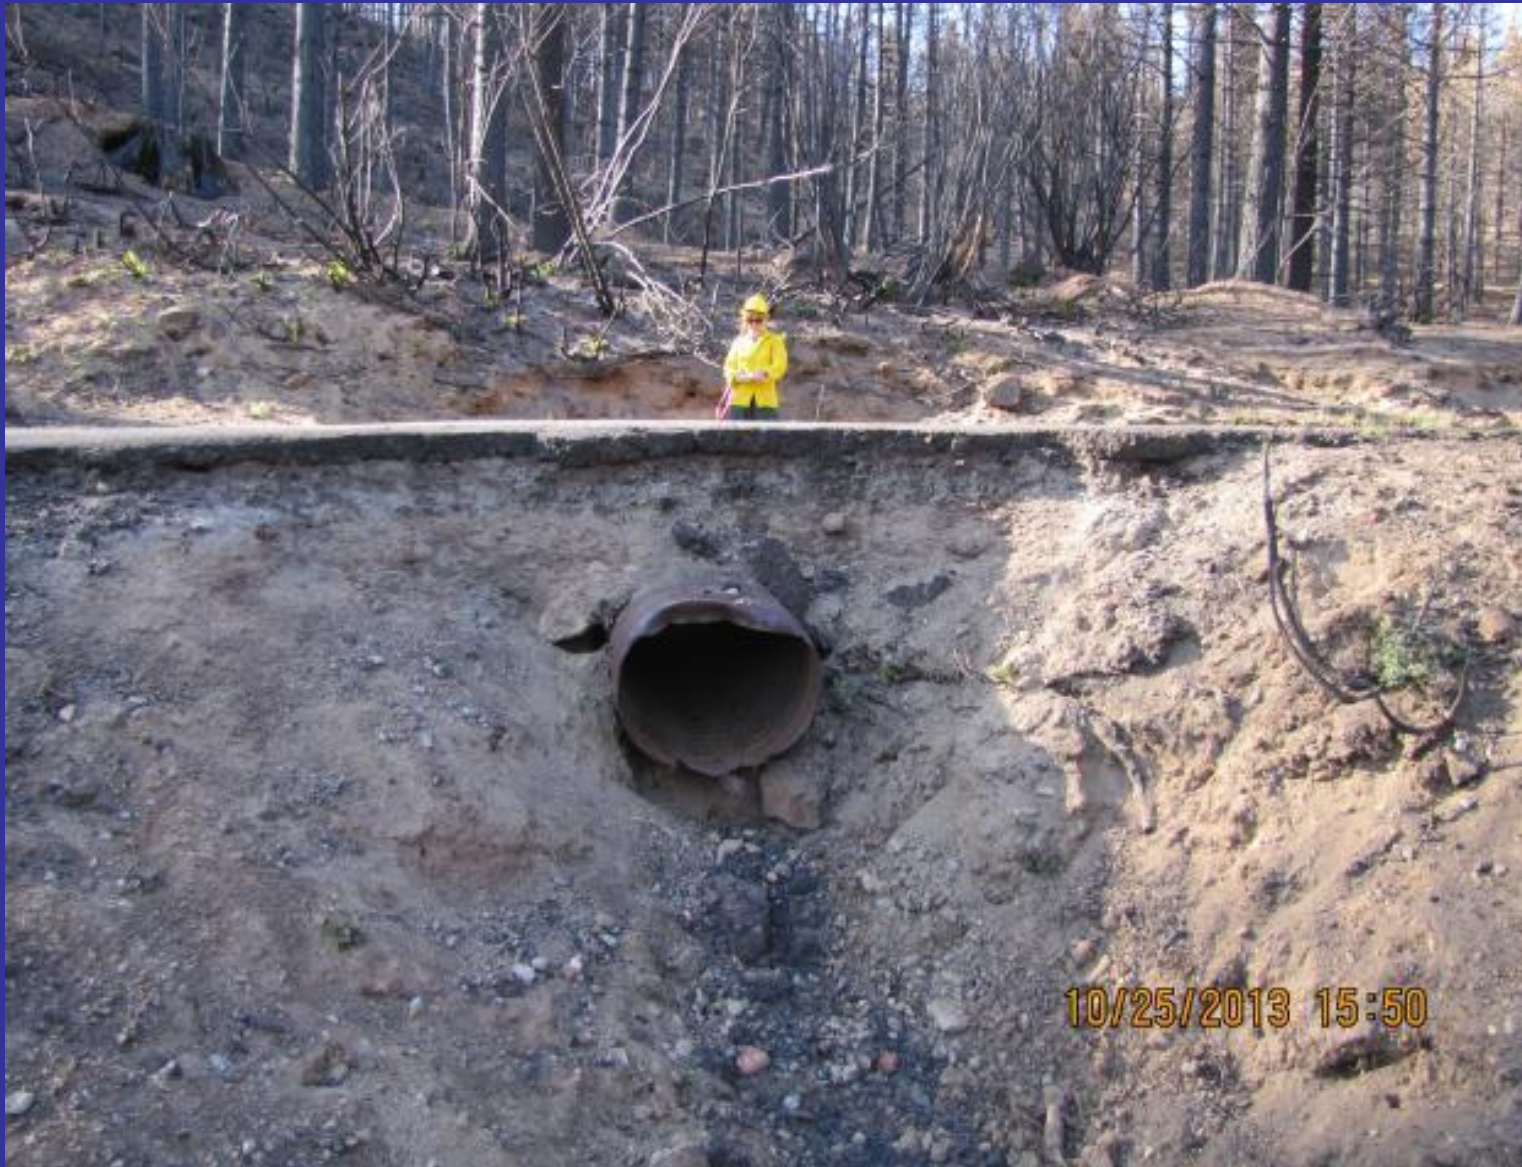
Inventorying Crossings as Part of BAER Team Work

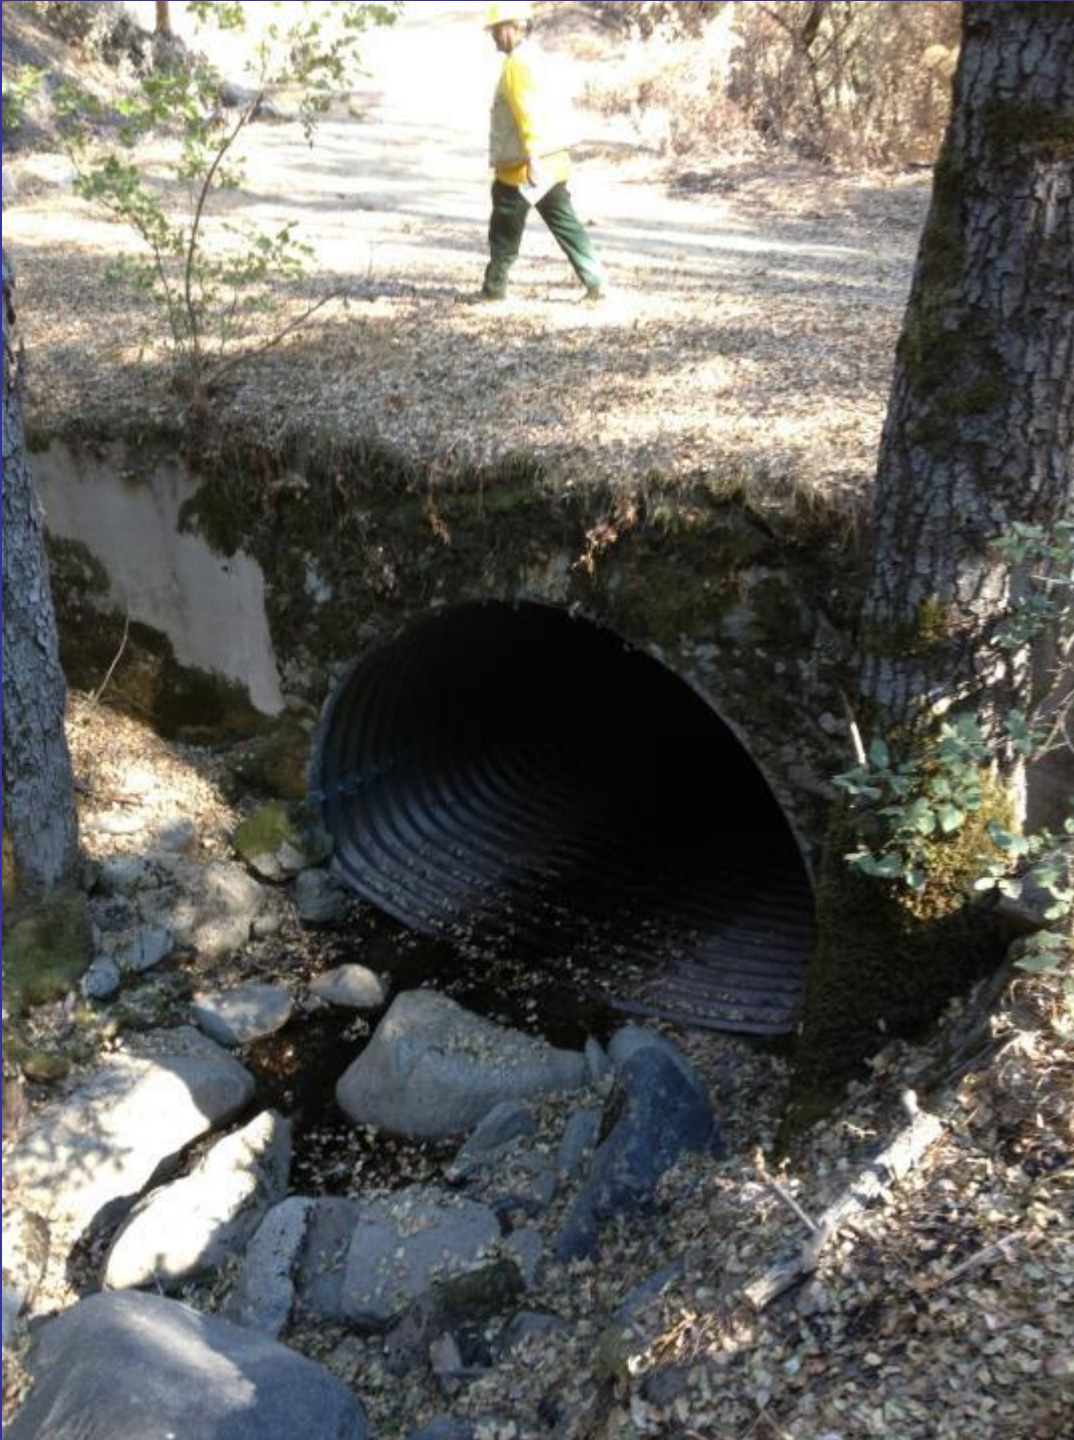
**Debris flow
prone channel,
with a concrete
armored fill**

**Undersized but
relatively low
risk of failure**

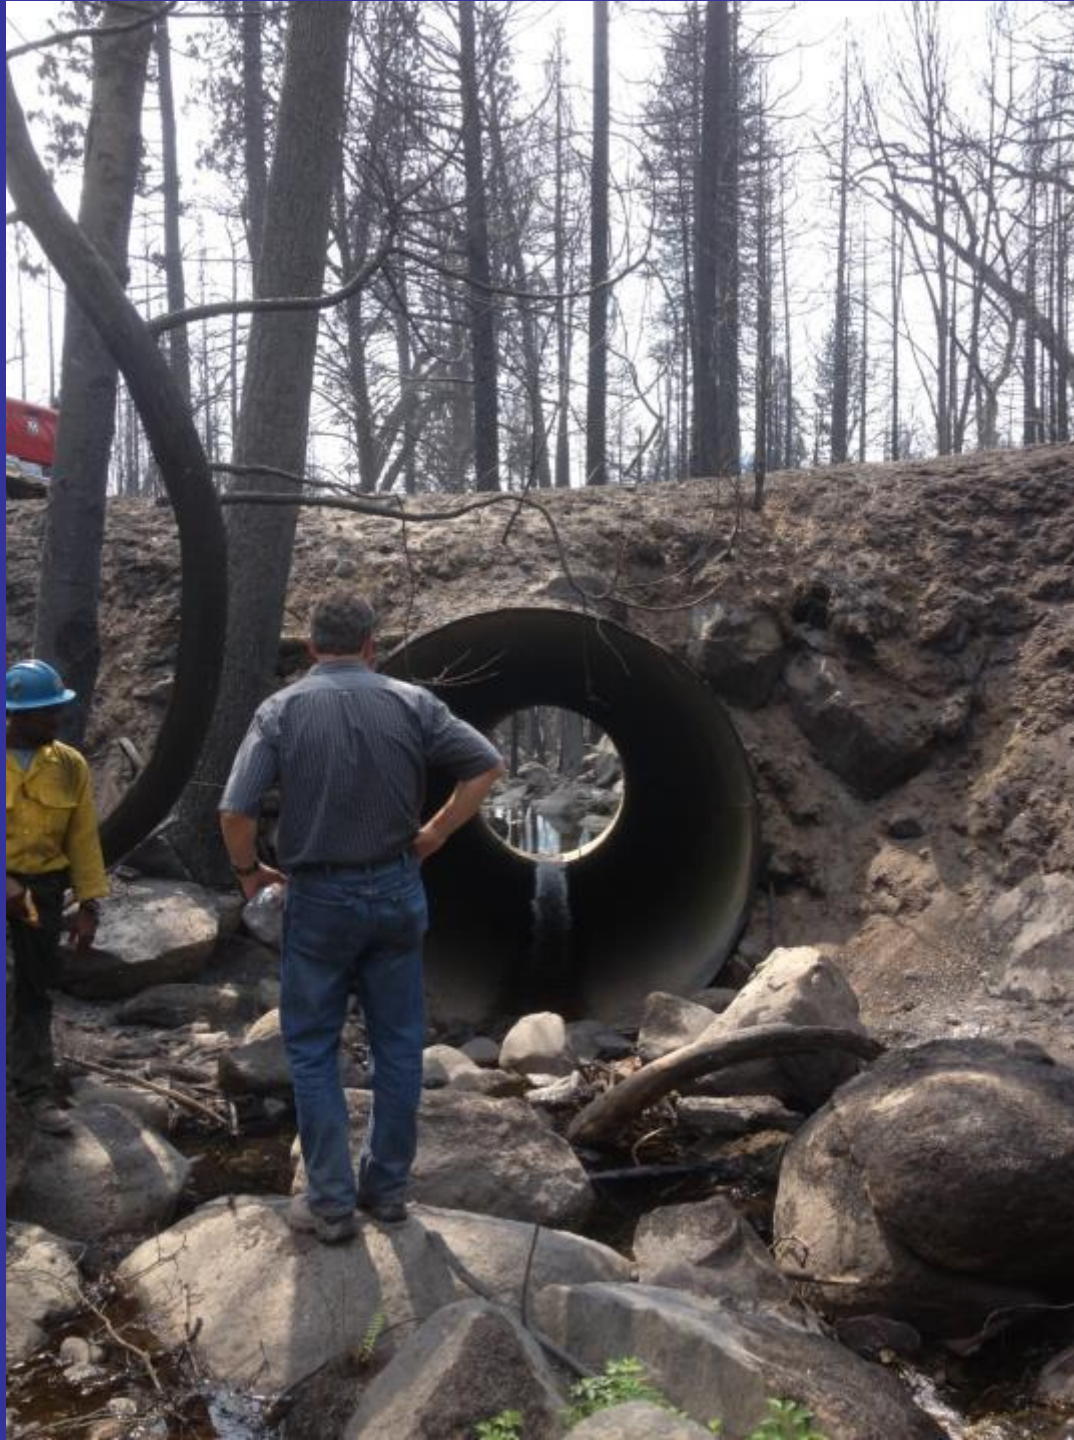
Pipe is half the width of active channel

No diversion potential, but high risk crossing

The watershed above has debris slide slopes in the headwaters, and likely has an inner gorge at the toe of an earth flow

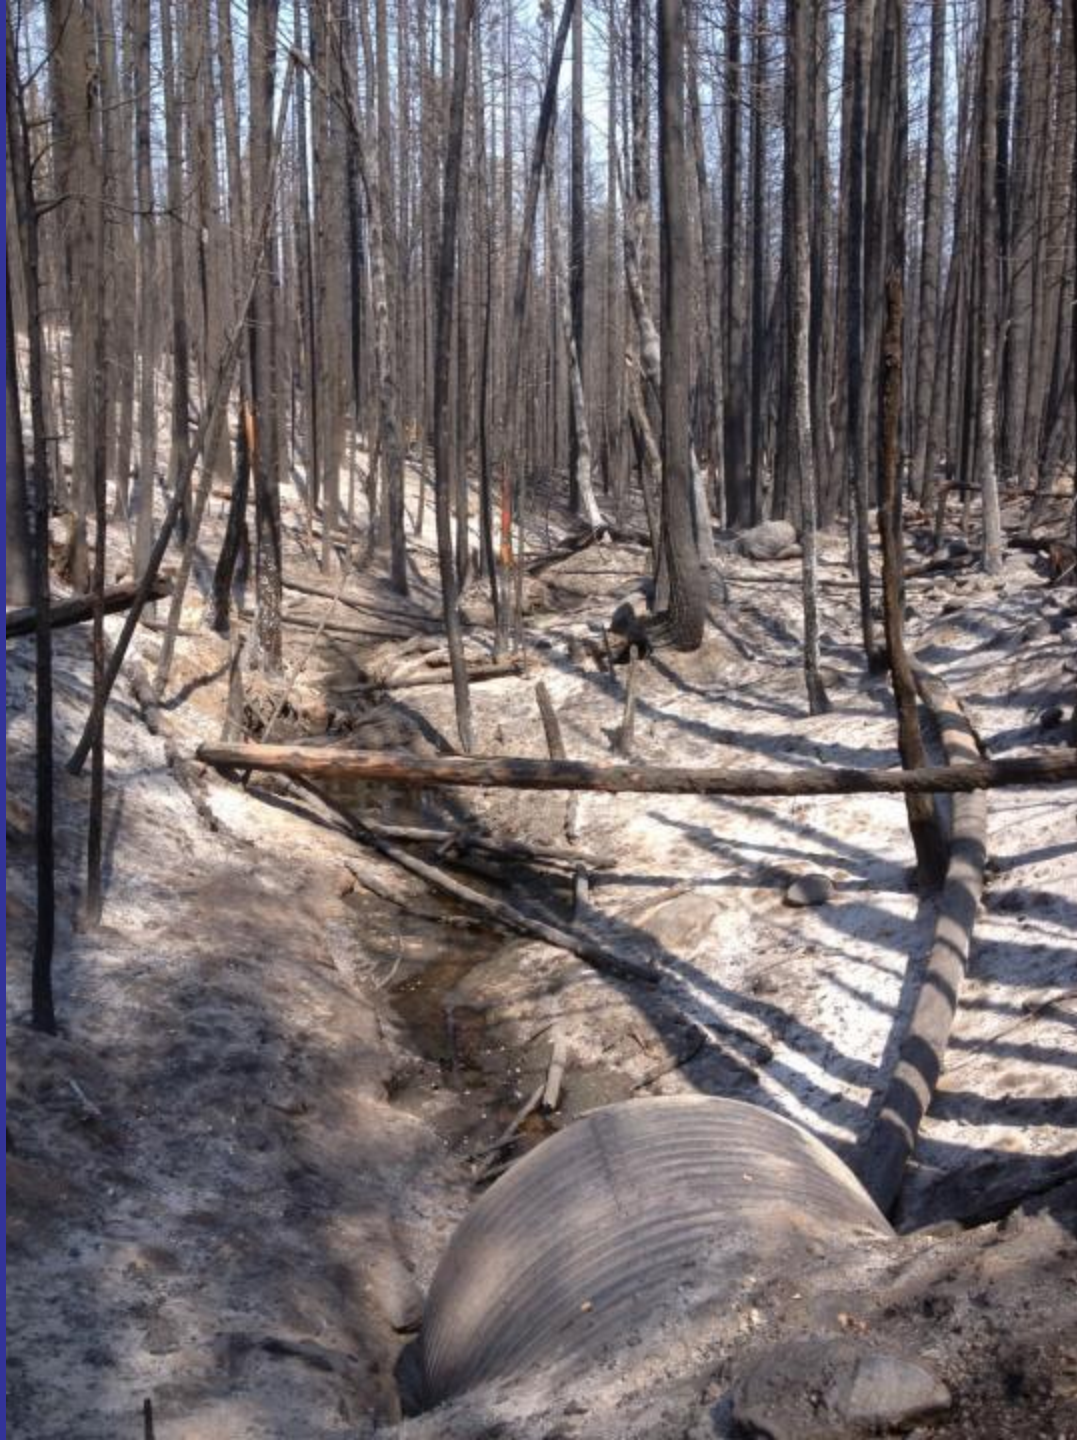
**Culvert at high risk
of failure along a
chip-sealed road**

**Recommendation:
Install an
additional CMP
above the existing
pipe**

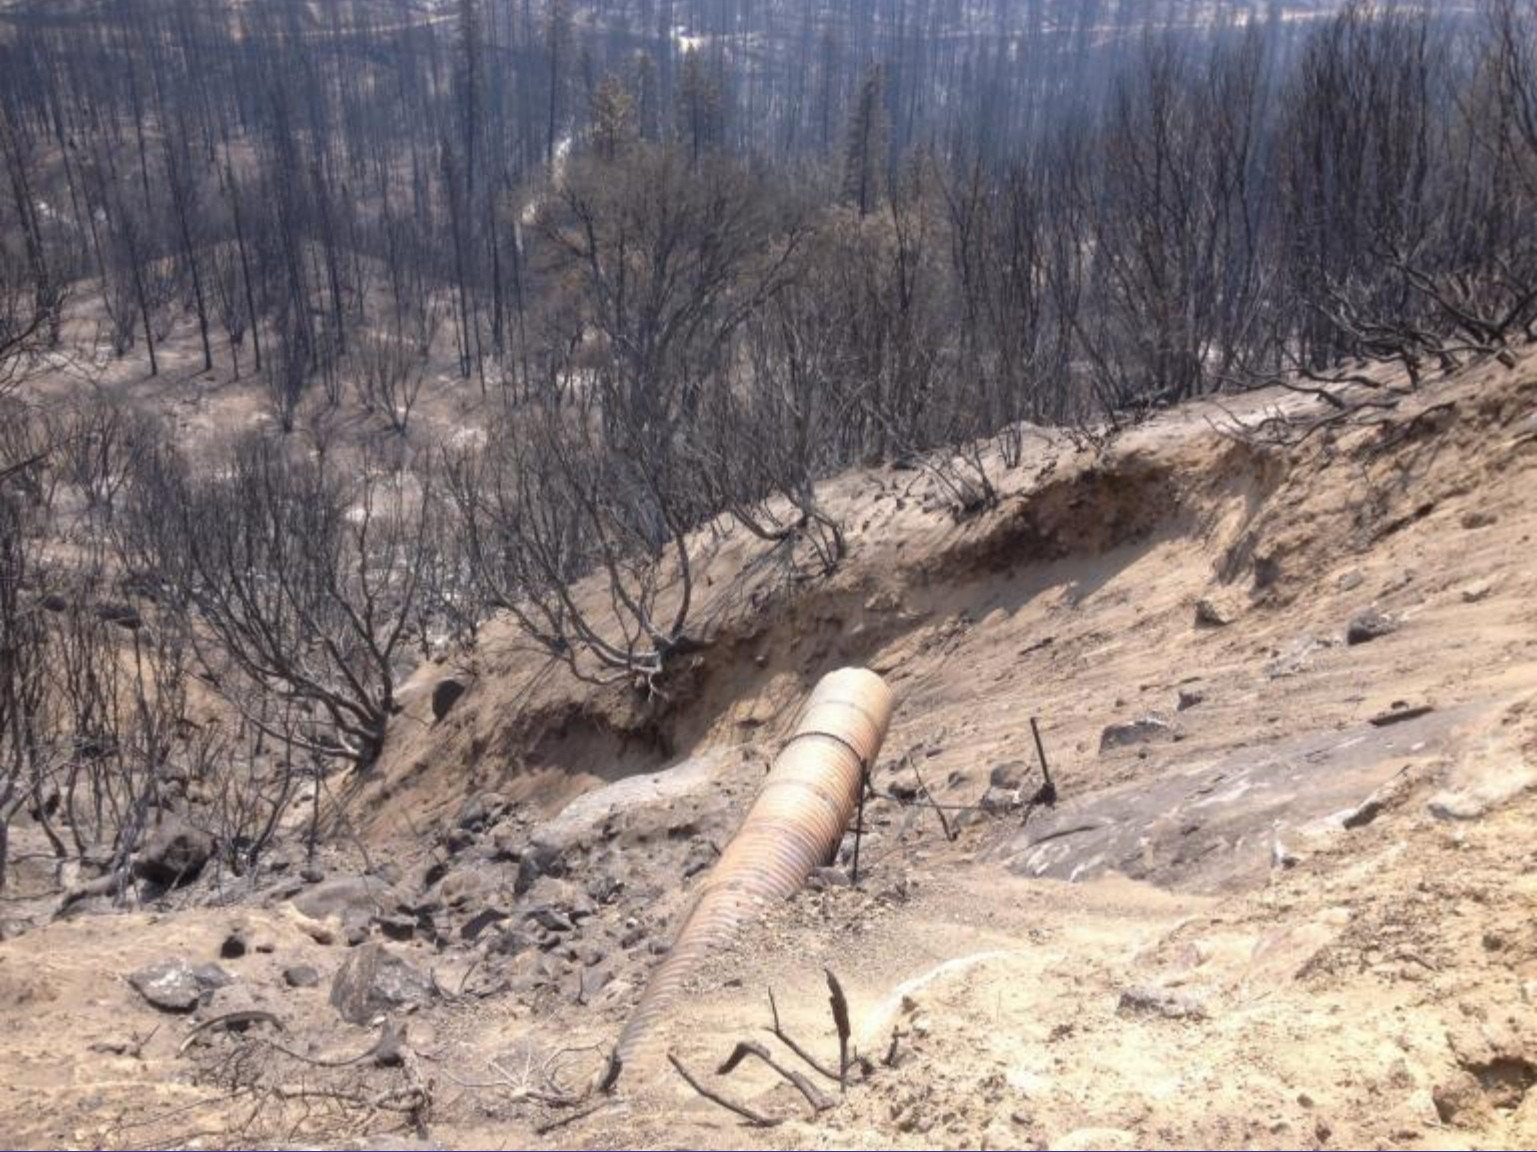
Poorly Aligned Class III Watercourse Crossing; Upgrade Work Required

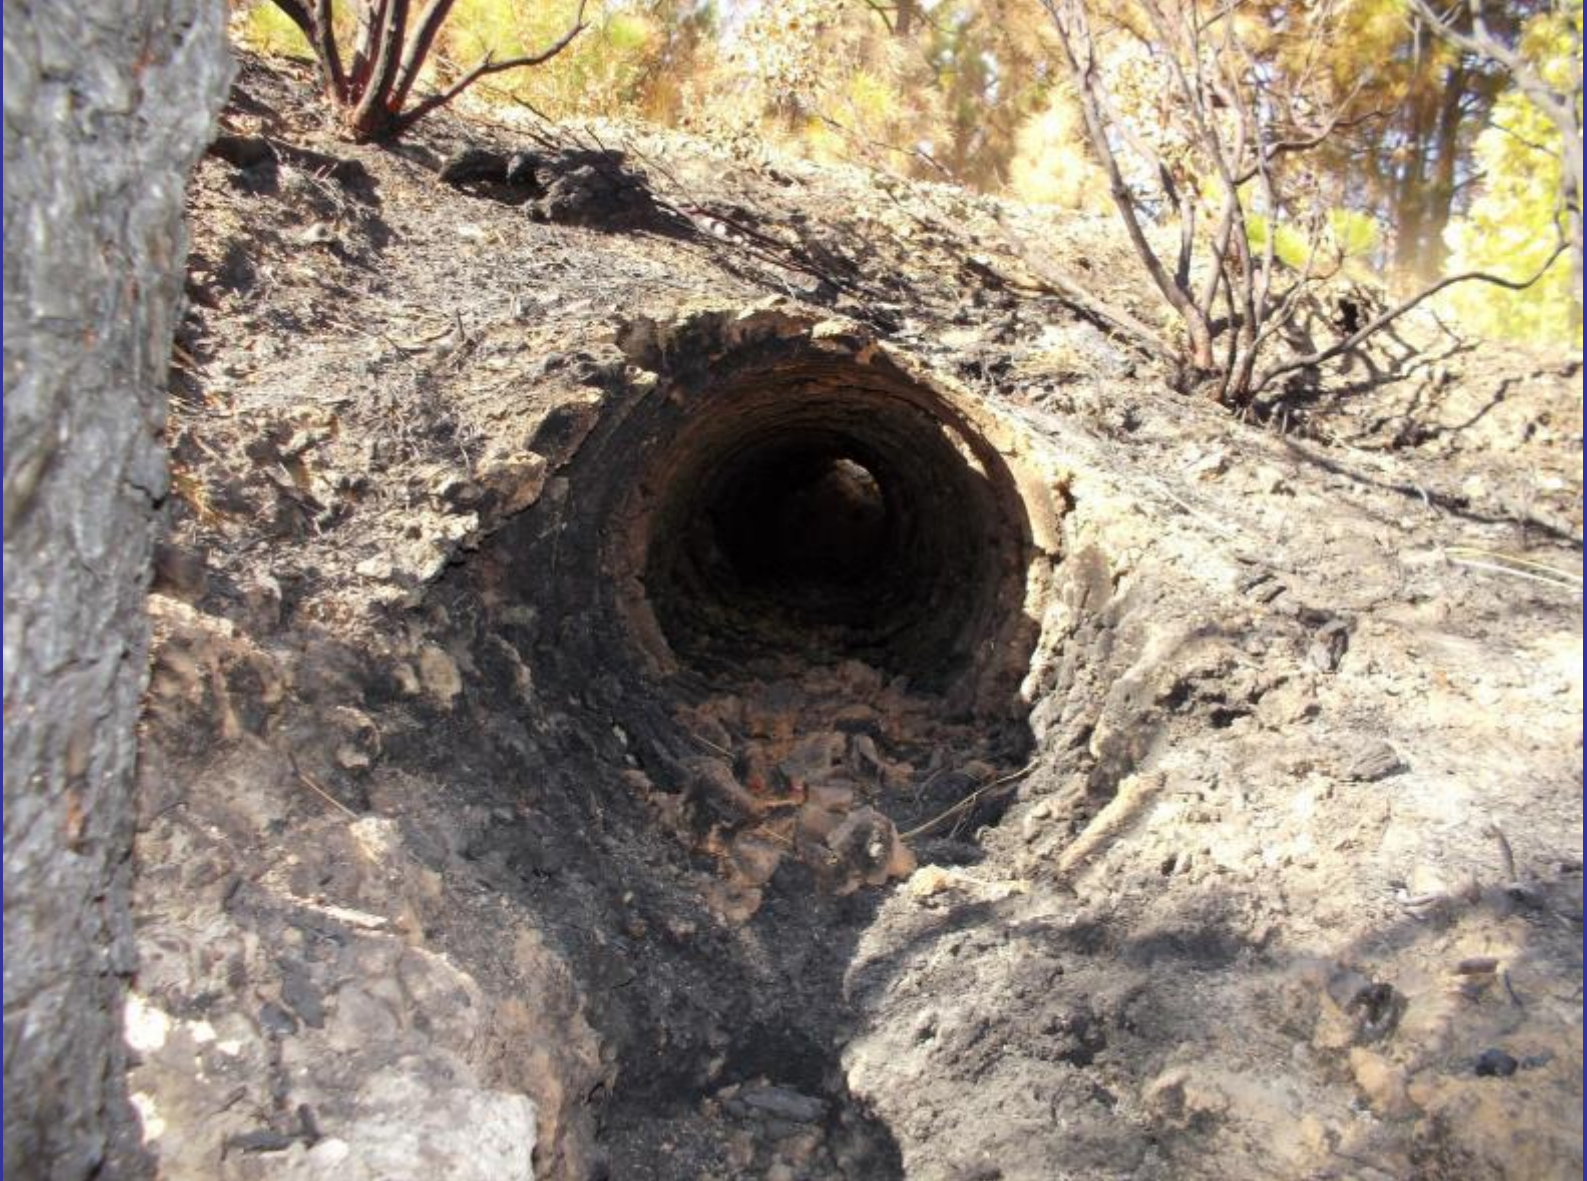
Burned Out Plastic Culvert, Rim Fire
