Stream Crossing Alternatives

Pete Cafferata

California Department of Forestry
and Fire Protection

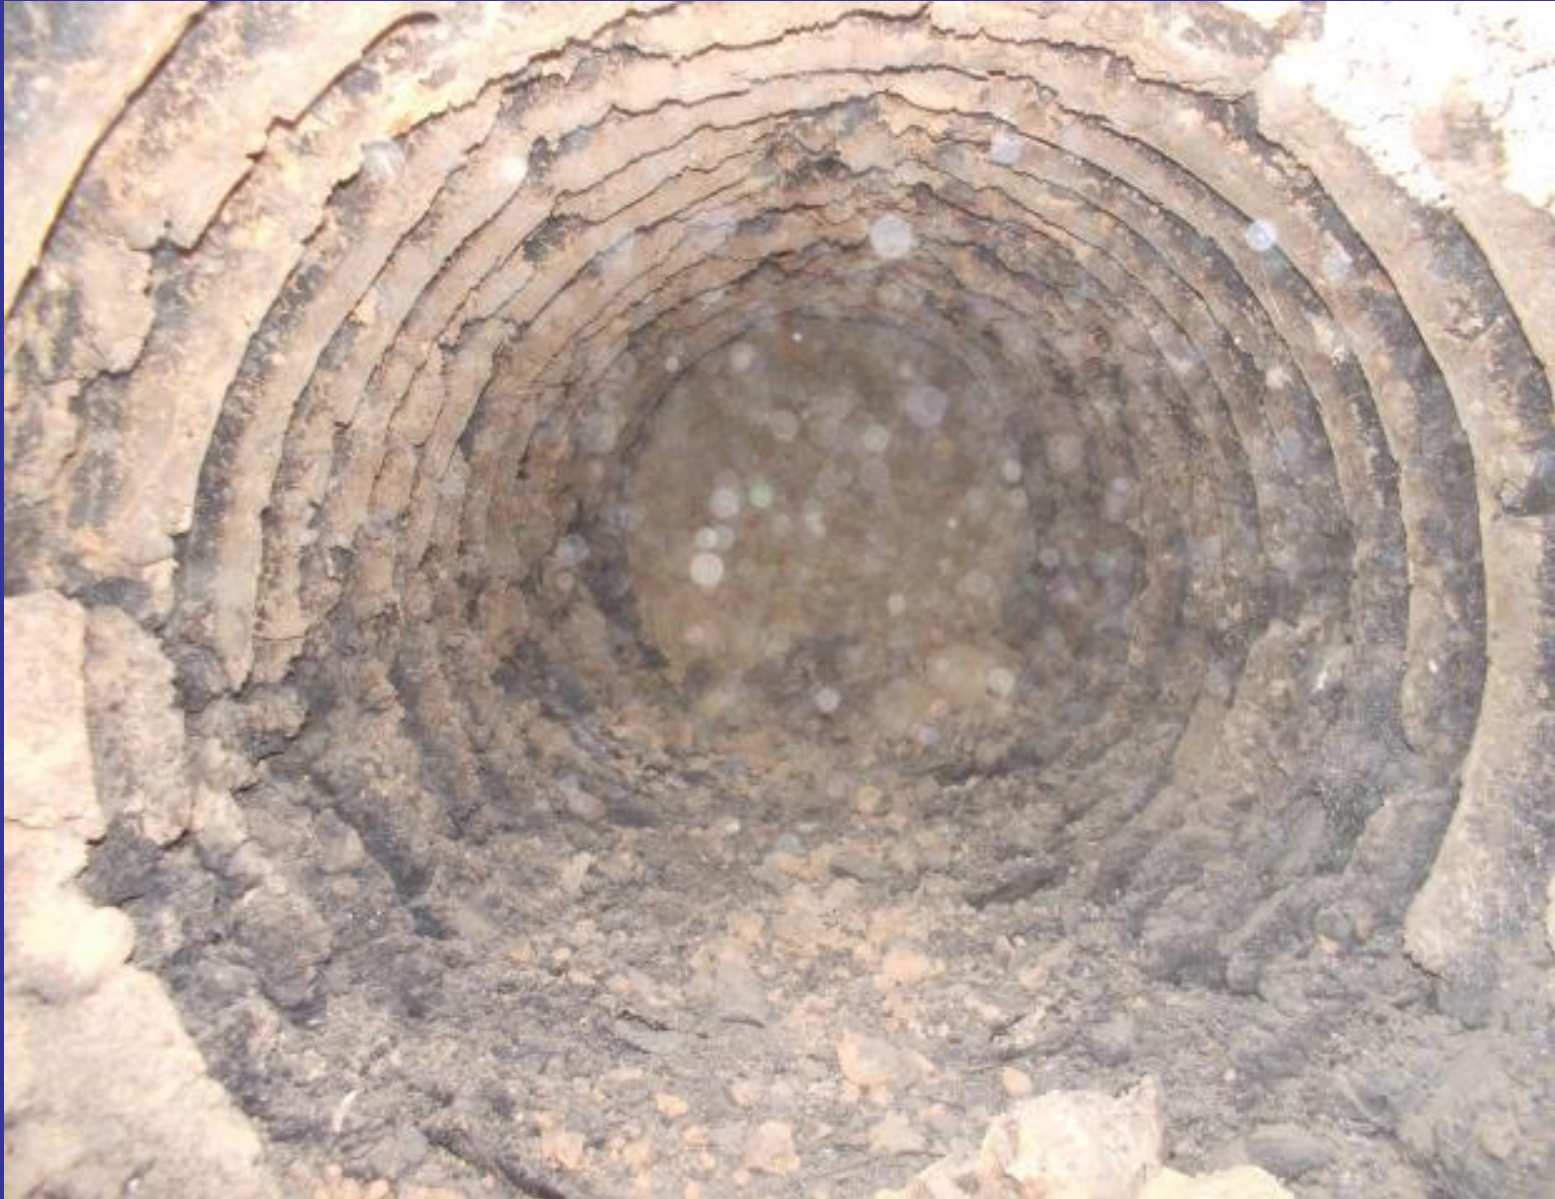
Burned Out Plastic Culvert, Rim Fire

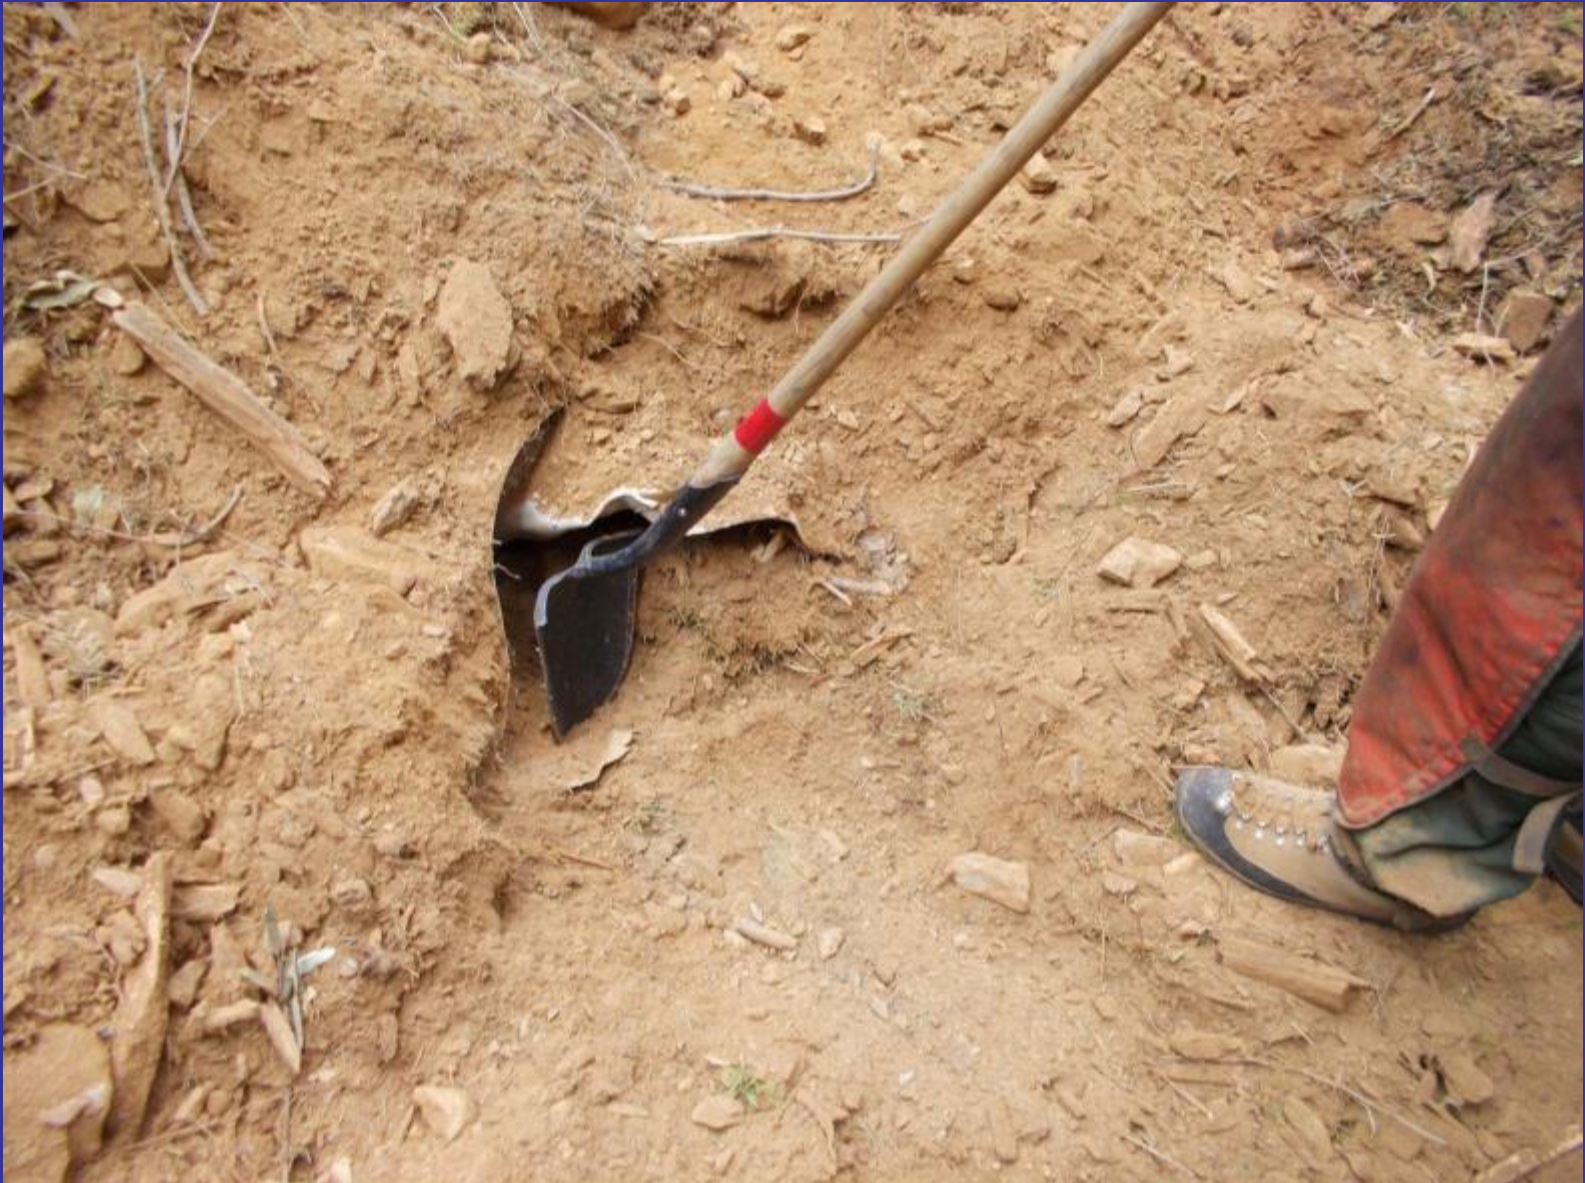
Rim Fire Culvert—Buried with a Damaged Inlet

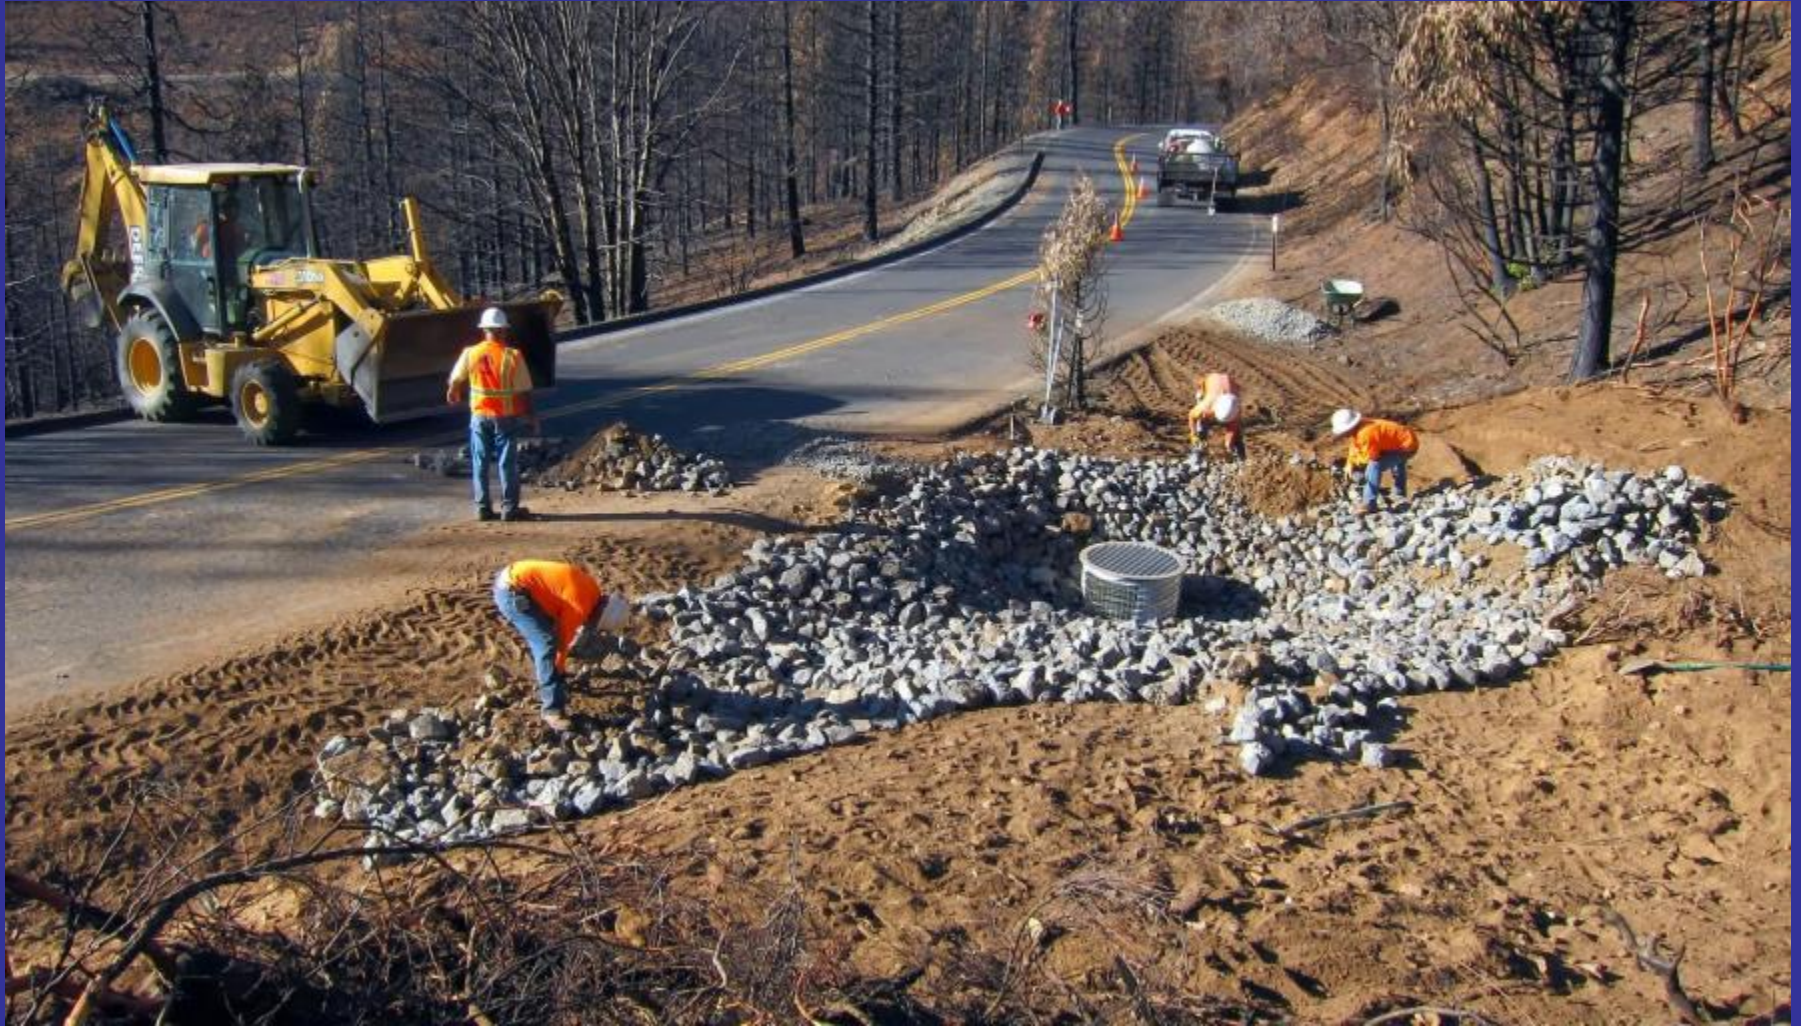
Upgrading a Culvert Impacted by the Rim Fire

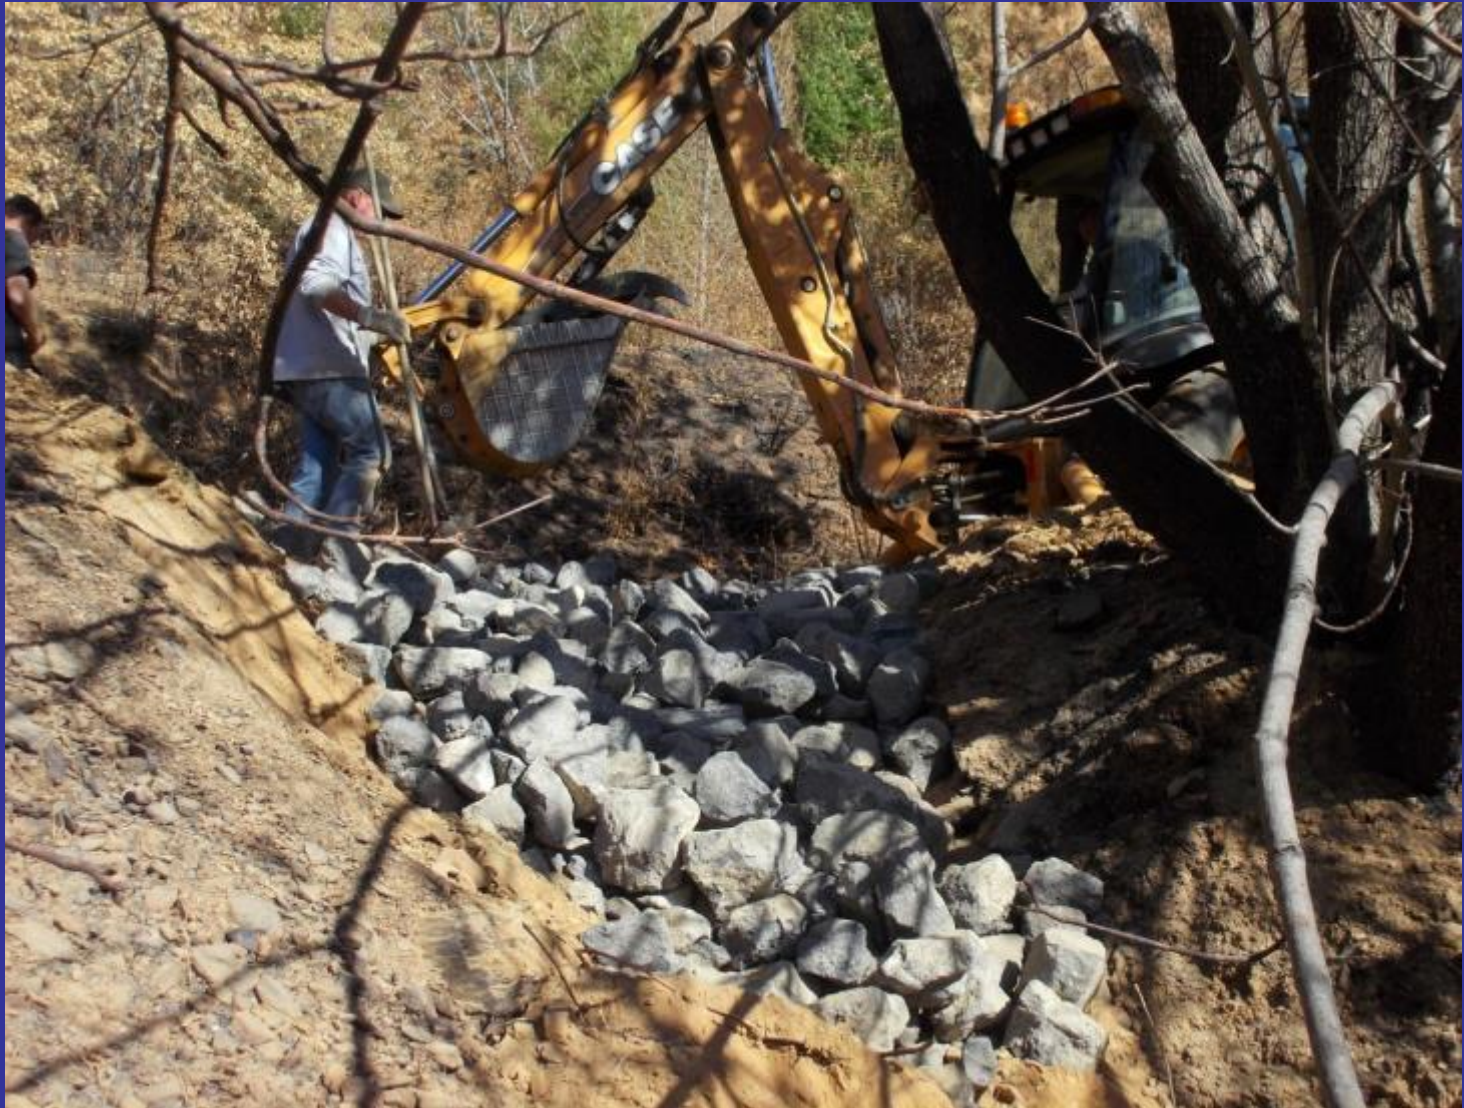
Installing a Rock Ford Crossing

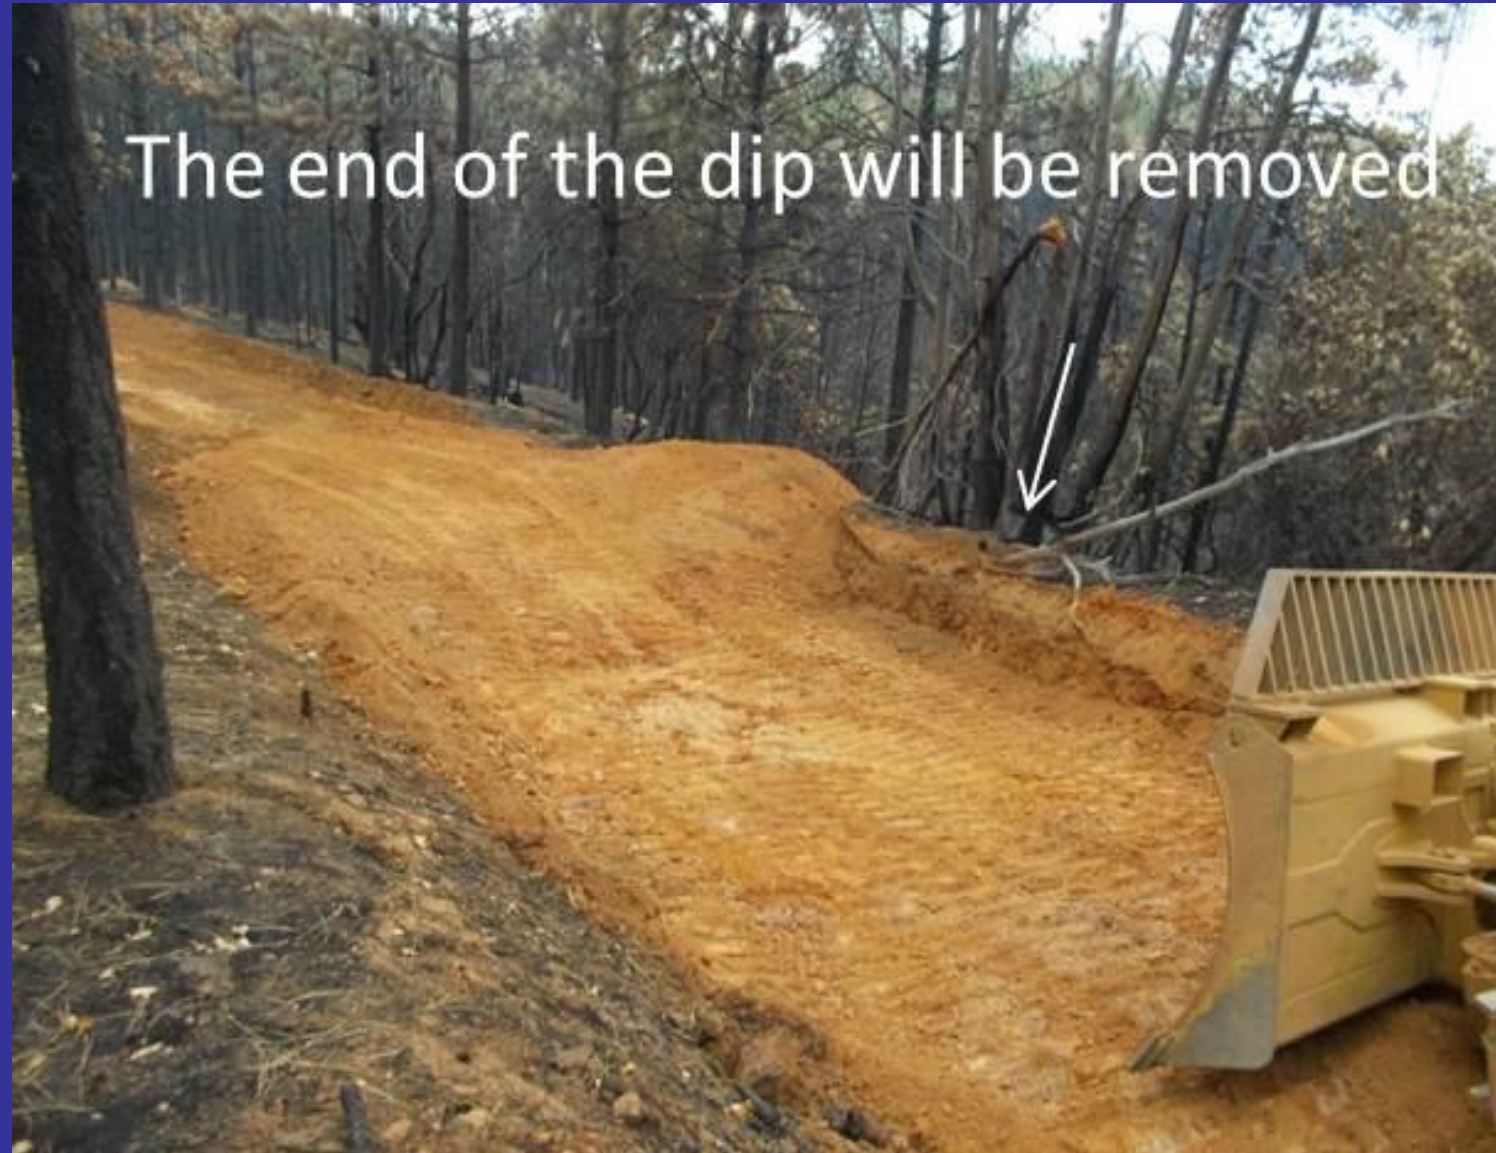
Building a Rolling Dip on a Forest Road
