Cattle grazing has varying impacts on stream-channel erosion in oak woodlands

Melvin R. George
Royce E. Larsen
Neil K. McDougald
Kenneth W. Tate
John D. Gerlach, Jr.
Kenneth O. Fulgham

We conducted a 5-year study on the impact of grazing on stream-channel bare ground and erosion, and a 3-year study of cattle-trail erosion on intermittent stream channels draining grazed oak-woodland watersheds. While the concentration of cattle along stream banks during the dry season resulted in a significant increase in bare ground, we were unable to detect stream-bank erosion resulting from any of the grazing treatments applied. However, we did find that cattle trails are an important mode of sediment transport into stream channels. While cattle trails are common on grazed rangeland, excessive trailing often indicates that stock watering points are too far apart.

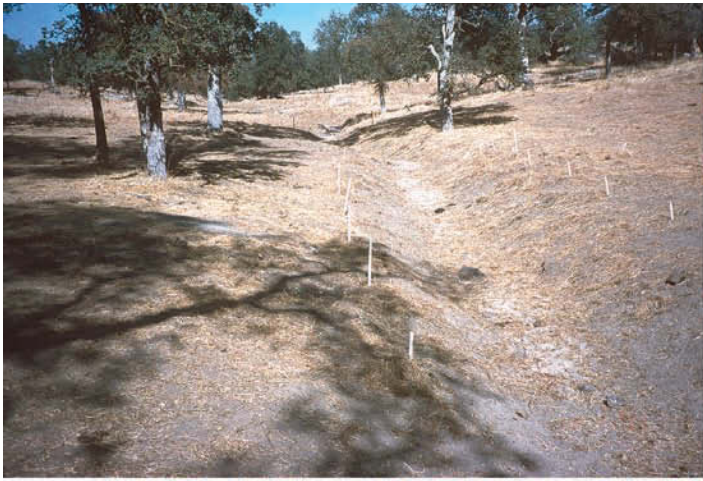
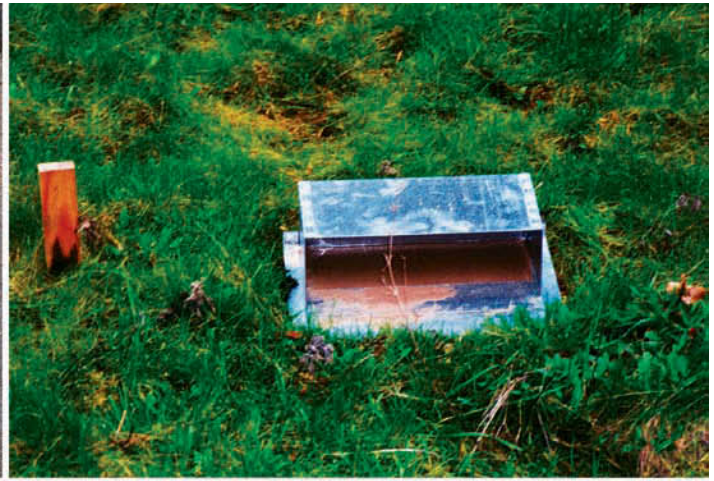
Fall comparison of stream channel in concentrated grazing treatment, *upper*, and no grazing, *lower*.

There were significant ($P < 0.001$) increases in bare ground on the channel bank and approach due to dry-season concentrated grazing when compared to the ungrazed control (fig. 3). Bare ground for the other grazing treatments was not significantly different from the ungrazed control or the dry-season concentrated treatment. These results indicate that practices causing cattle to congregate near stream channels during the dry season can significantly decrease groundcover, which protects the soil surface from erosion. Because these streams are dry during the summer they are generally not attractive to cattle. Therefore, the intensity of grazing and trampling resulting from the concentrated grazing treatment is unlikely to occur under proper stocking rates and grazing practices.

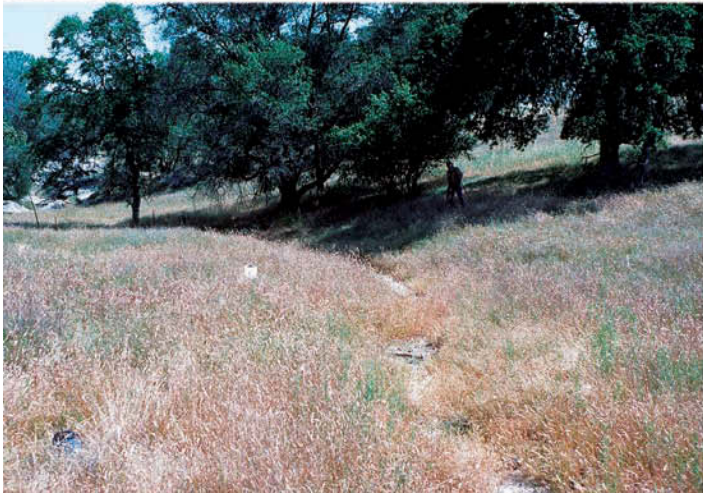
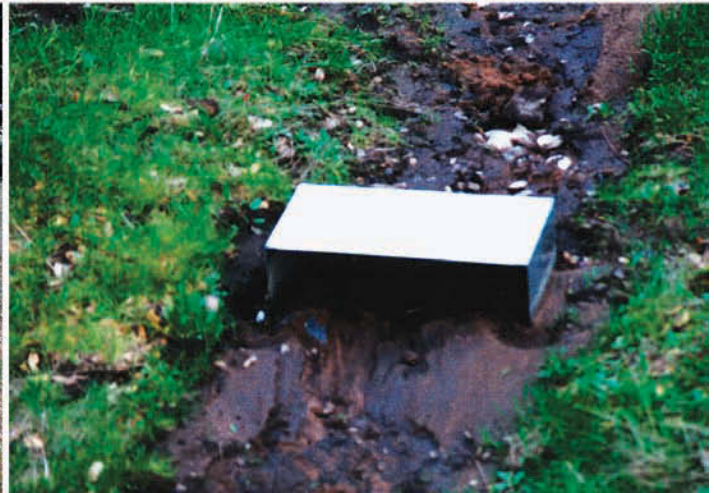
Comparison of sediment trap in a vegetated area, *upper*, and sediment trap in an adjacent trail, *lower*.

During the 1997, 1998 and 1999 water years, sediment traps (Wells and Wohl-gemuth 1987) were placed in pairs at several locations along stream channel 2 (fig. 1) that drains the research watershed at the San Joaquin Experimental Range. Traps were sheet-metal boxes open on one side to catch sediment. One of each pair of traps was placed in

a cattle trail near the point where the trail crosses the stream channel. The second sediment trap of each pair was placed in well-vegetated areas of similar slope and slope-length adjacent to the trap in the trail. Throughout the rainy season the sediment traps were emptied as needed during and following storms. Sediment samples were dried and weighed. ANOVA was used to separate treatment and year differences.

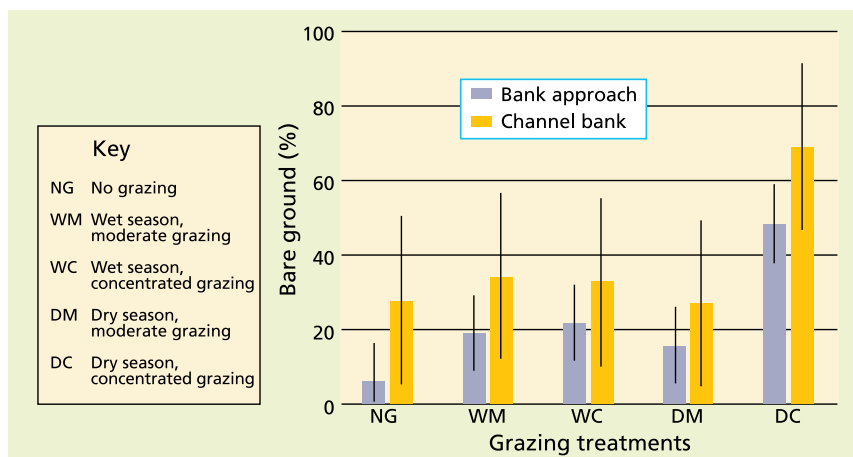
Fig. 3. Comparison of effects of fall treatment on bare ground (%) for bank approach and channel bank. Bars indicate 95% confidence level.

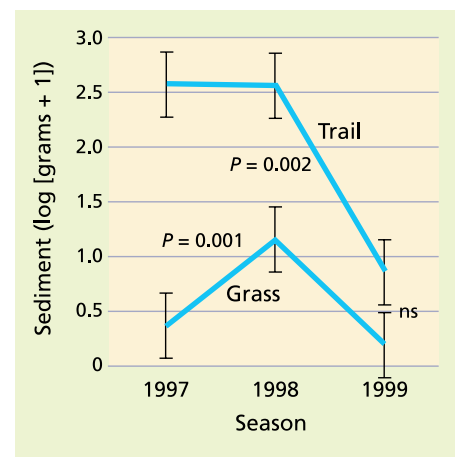
Fig. 4. Comparison of sediment from trails and adjacent grass-covered surfaces for three water years.

Sediment transport was significantly greater in cattle trails than in vegetated areas in the rainfall years ending in 1997 and 1998 (fig. 4). There was no significant difference in 1999. In 1997 and 1998 there was sufficient rainfall to generate measurable runoff, and the intermittent streams began flowing in January of those two rainfall years. Rainfall in 1999 was low, resulting in little runoff and sediment movement in cattle trails. While cattle-trail crossings affect a very small total of the channel length within the watershed, the results of this study suggest that trails can be an important, management-caused conduit of sediment from the variable-source area to the stream channel. Following a major runoff event, we observed diversion of intermittent stream-channel flow into a cattle trail forming a new channel.

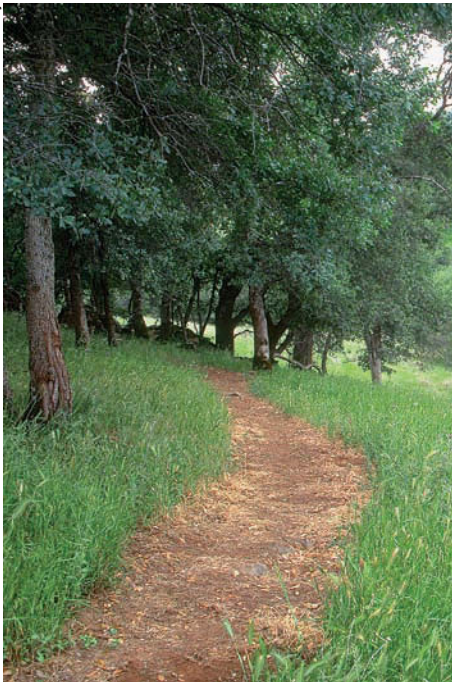
Cattle trails can aid the flow of sediment into streams. By reducing the distance between foraging and watering sites, the formation of cattle trails can be reduced.

several stream channels. Several trails are common in the steep terrain of foothill rangelands, resulting in many trail crossings of each stream channel. Regular trampling by livestock keeps these trails devoid of vegetation throughout the year and reduces the infiltration rate, resulting in increased surface runoff along trails, especially along the downhill approach to stream crossings. During the dry season cattle trampling loosens surface soil, providing a ready source of sediment during the rainy season. The trails become a conduit for surface runoff and a source of sediment.
