# Riparian Revegetation Evaluation on California's North Coast Ranches

## Final Report

University of California Cooperative Extension, County of Sonoma

June 2007

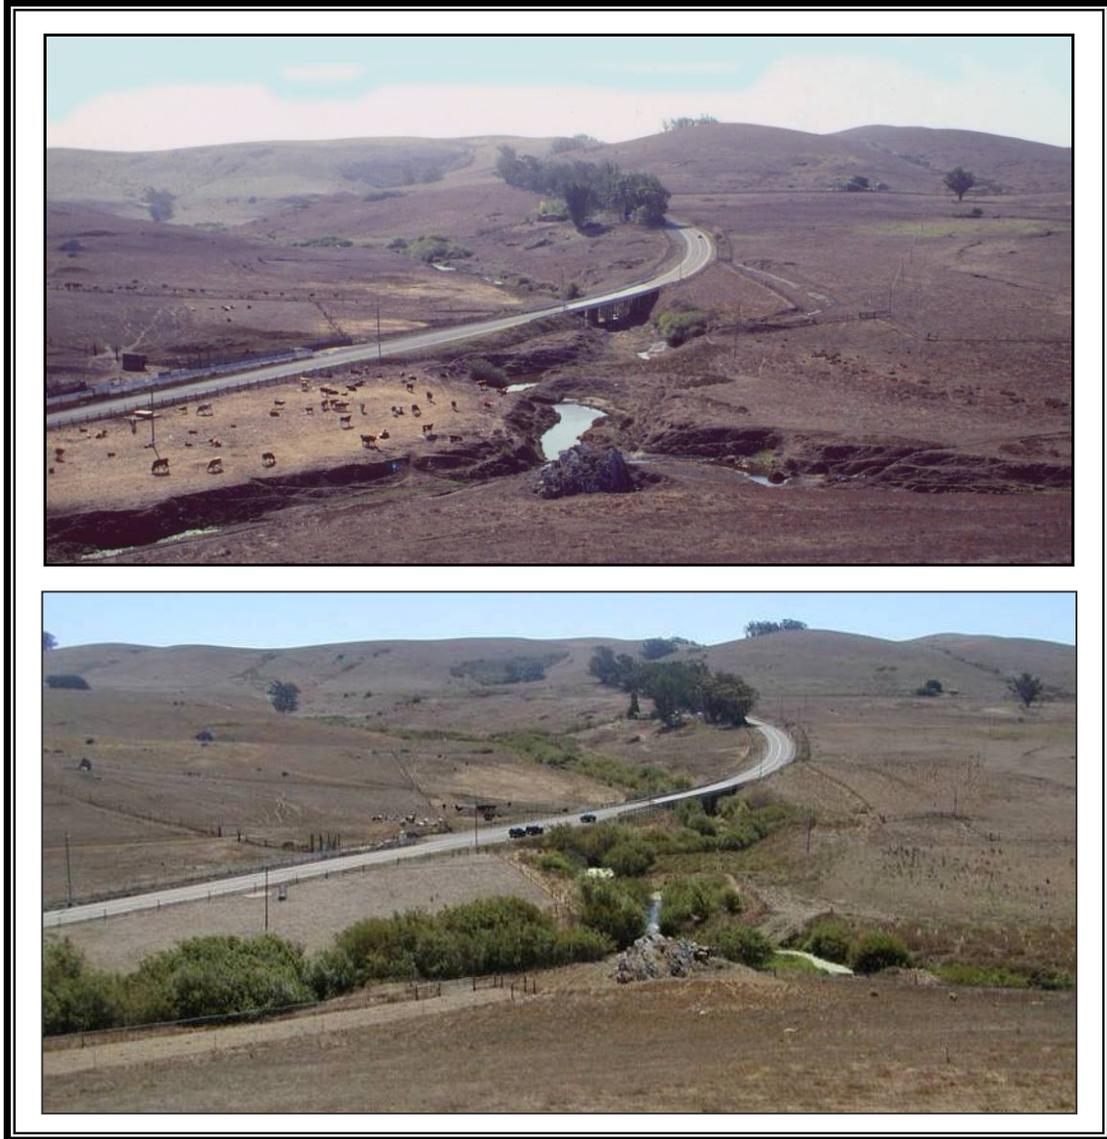
**Cover photographs:** Coastal stream on ranch along Hwy. 1 in 1994 (upper) and in 2004 (lower). Photographs are courtesy of Marin Resource Conservation District.

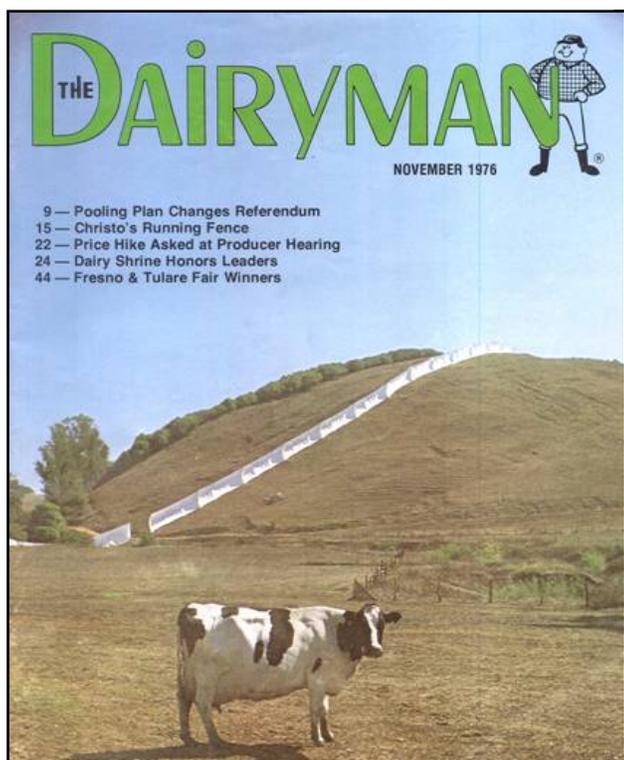
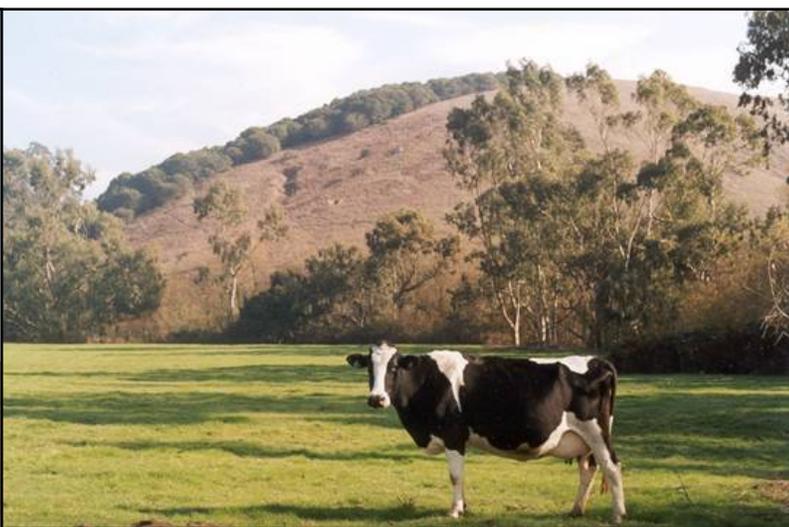
**Figure 1:** Example of survey site in 1976 with Christo's Fence behind the newly fenced stream (left) and 2002 (above) (images courtesy of Tresch Family Dairy).

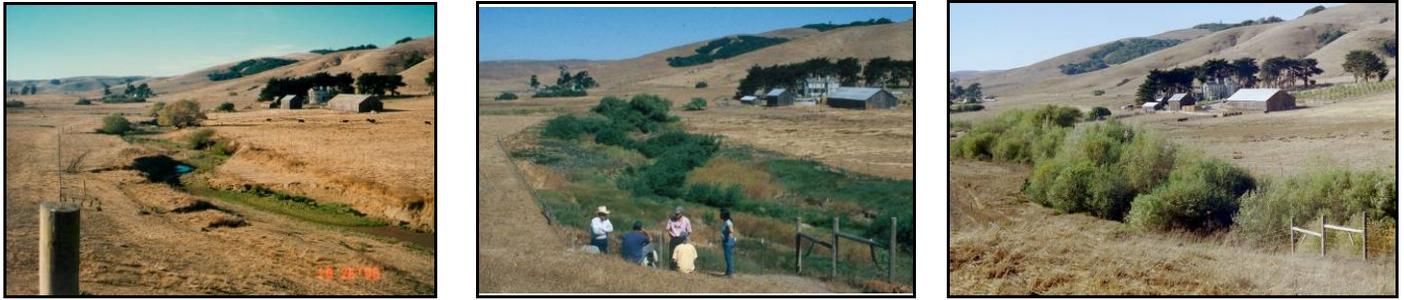
**Figure 3:** Example project site in Chileno Creek. Photographic sequence documents vegetation response at zero, two, and eight years post restoration (images courtesy of Marin Resource Conservation District).

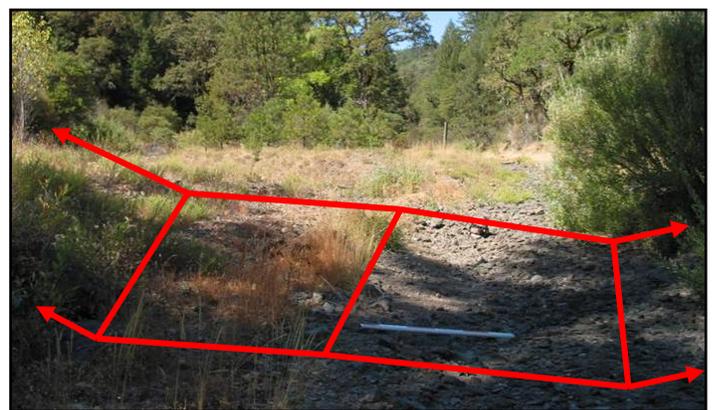
**Figure 4:** Belt transect depicted for 2 vegetation plots.

stream banks from the thalweg (Figure 4) until the upper bank was sampled. Plot length was variable and based upon the extent of the landform class for each plot.

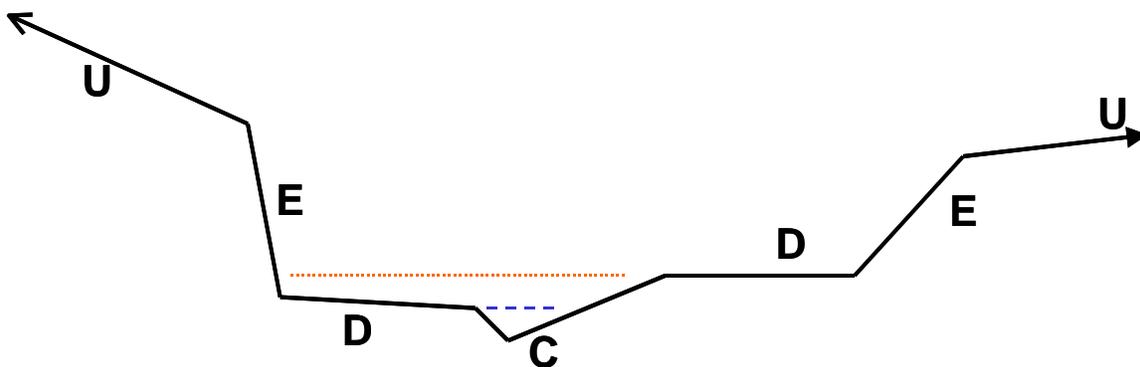
**Figure 5:** Idealized stream channel cross-section depicting landform class (letters), bankfull elevation (lower dashed line), and floodprone elevation (upper dotted line). Landform class designations include *active channel* (C), *erosional flood plain* (E), *depositional flood plain* (D), and *upper bank* (U).

We adapted Harris (1987, 1999) geomorphic classification of plots to form landform class designations which included the *active channel* (C), *erosional flood plain* (E), *depositional flood plain* (D), and *upper bank* (U) (Figure 5). Designations for each plot were based upon field observations of channel morphology and features of aggradation and erosion. Channel plots were considered the active channel from the thalweg up to the bankfull location (Rosgen 1996). Erosional plots had evidence of stream bank cutting. Depositional plots were young and old terraces with flotsam or general evidence of aggradation. Upper bank plots were furthest from the water table and received the least amount of hydrologic disturbance. They extended from the top-of-bank to the fence or field edge and may represent alluvial valley, terrace or upland hillside geomorphic features. These landform categories allowed vegetation data to be linked to specific cross-section morphology given the degree of channel incision.

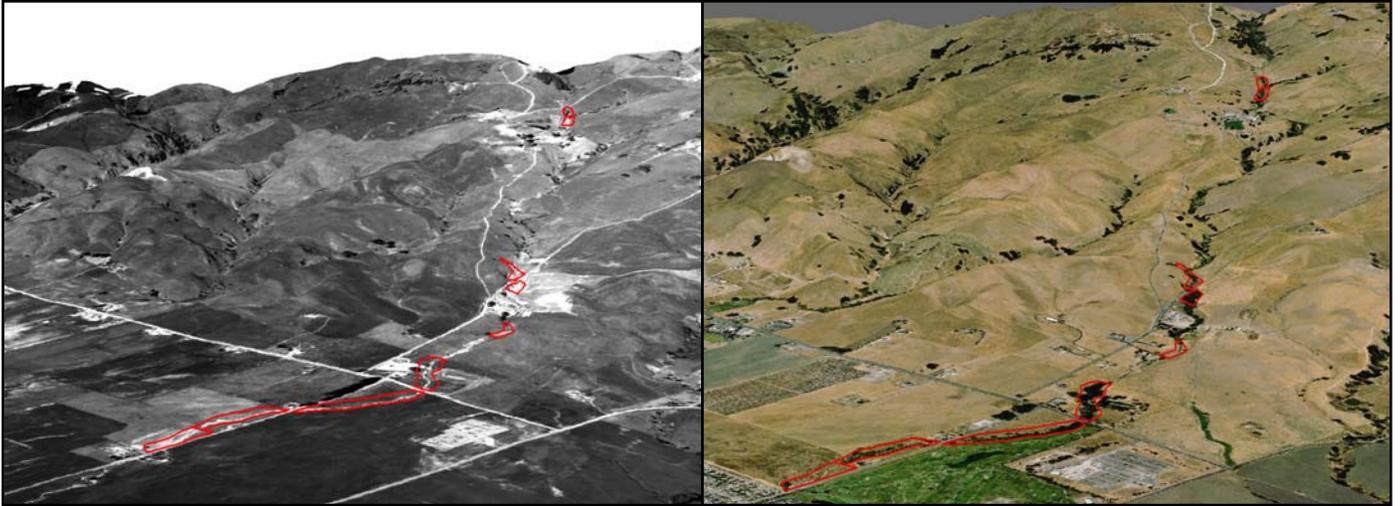
**Figure 6:** The Adobe Creek watershed with surveyed site boundaries in 1971 on the right and 2004 on the left. The oldest revegetation project site characterized in this watershed was implemented in 1972. In the 1971 photographs the surveyed sites generally have sparse riparian vegetation cover compared to the continuous dark green corridor documented in 2004 (images courtesy of Sonoma County GIS Central).

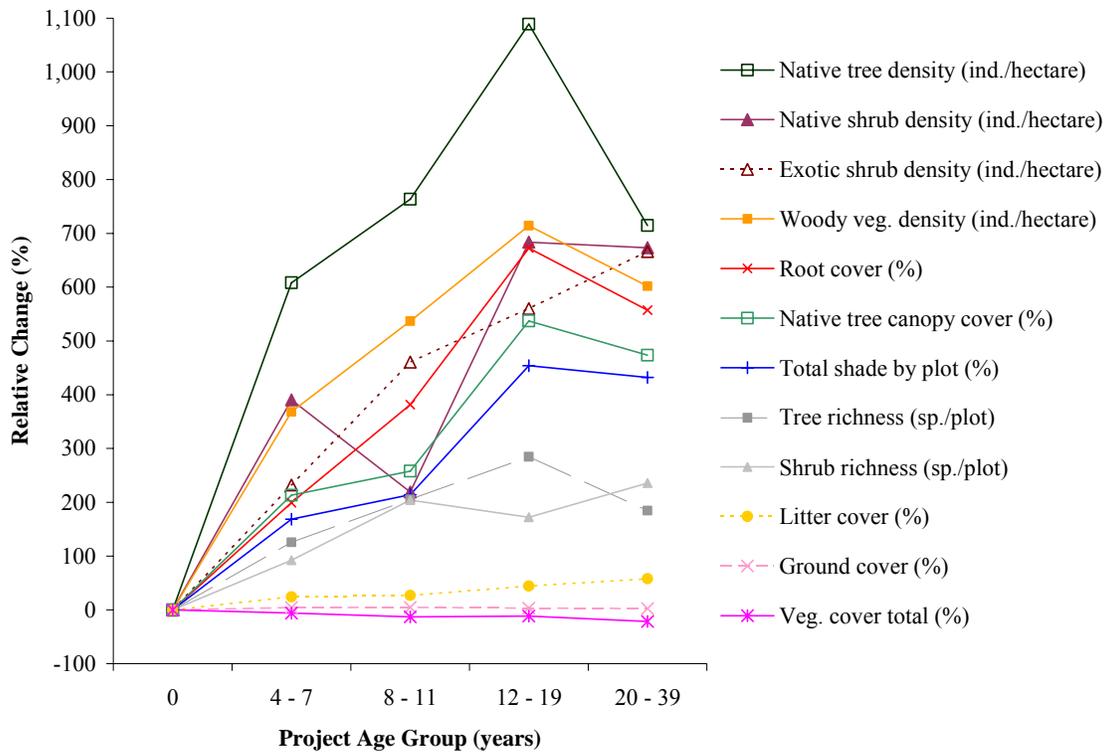
**Figure 7:** Relative percent change of riparian metrics over time.

The intended result of greater native tree abundance was successful in this region with density increasing by over 1,000%. The decrease in density in the 20-39 year old projects was not significant. An unintended and potentially undesirable result of projects was the significant increase in exotic shrub density over time. Unlike the native shrub density, which also increased over time, the exotic shrubs continued significant population growth into the over 20 year age group. The implication is that this density and pervasiveness may continue, thus calling for vegetation management throughout the life of a project. This is particularly true at project sites where relict populations of exotic shrubs before large herbivore access was altered.

To facilitate interpretation of the magnitude of response to restoration, we graphed the relative percent change for each metric (Figure 7). The metrics that did not demonstrate a significant change over time were not graphed. We calculated the relative change using the mean values from Table 2 and the following equation:

A fundamental transition in plant community structure and composition was observed over multiple decades as woody species established and dominated sites (Figure 7). The frequency of woody species observed at project sites was calculated along with the mean density for each species (Appendix B). Arroyo willow (92.0 % of sites) and Himalayan blackberry (88.6% of sites) were the most common species identified at surveyed project sites.

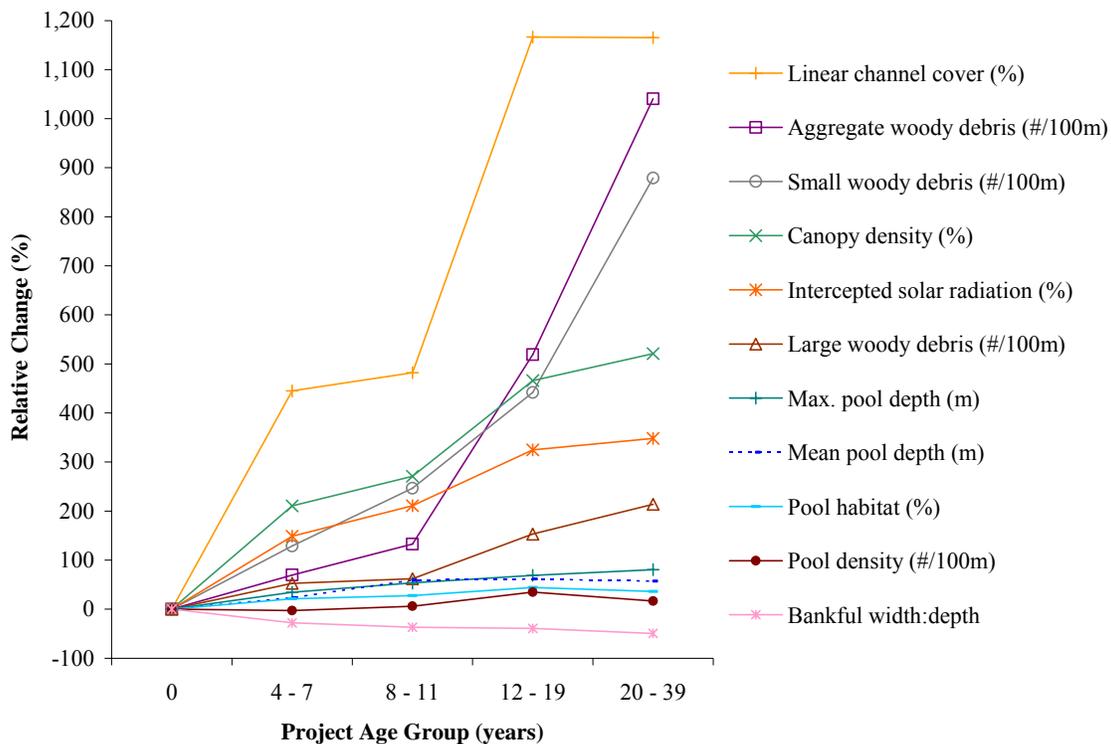
**Figure 8:** Relative percent change of instream metrics over time.

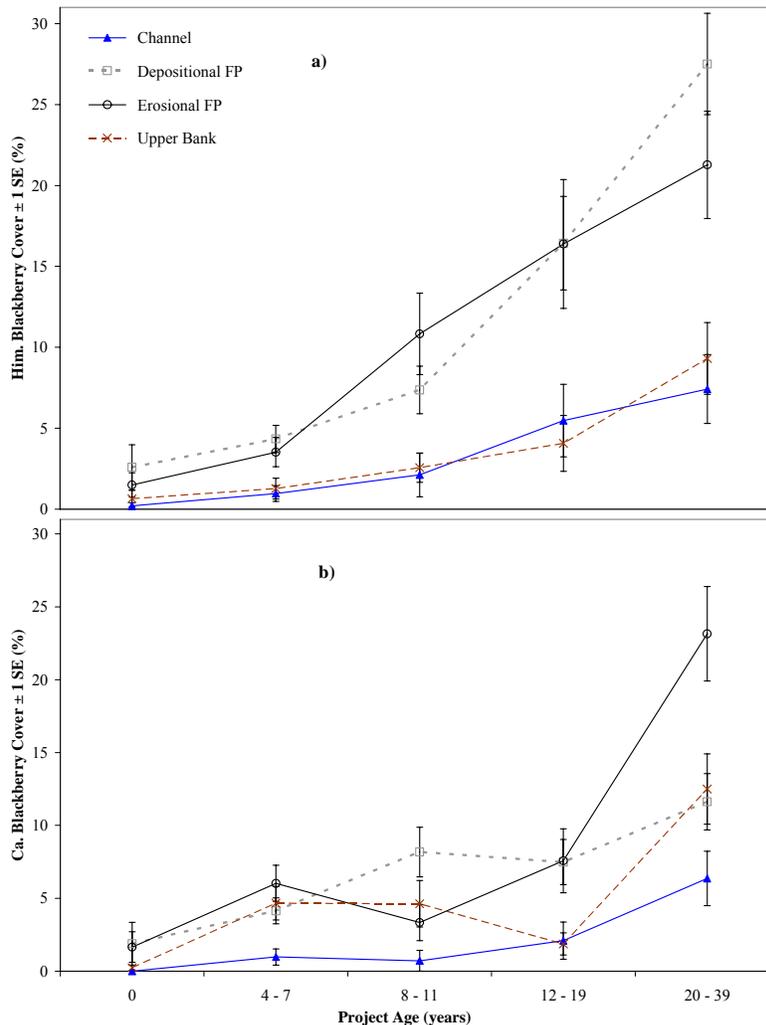
A significant increasing trajectory in cover was documented for multiple species that is dependent upon landform class, or plot location. The exotic Himalayan blackberry colonized the floodplain landforms fastest (Figure 9a). This species was observed to dominate mesic riparian environments, rarely co-occured with other understory species once established, and spread by vegetative production to xeric locations. In contrast, the native California blackberry was observed to co-occur with multiple herbaceous and woody species and had the greatest potential for cover on the erosional floodplain landforms (Figure 9b).

**Figure 9:** a) Himalayan and b) California blackberry cover over time by landform class.

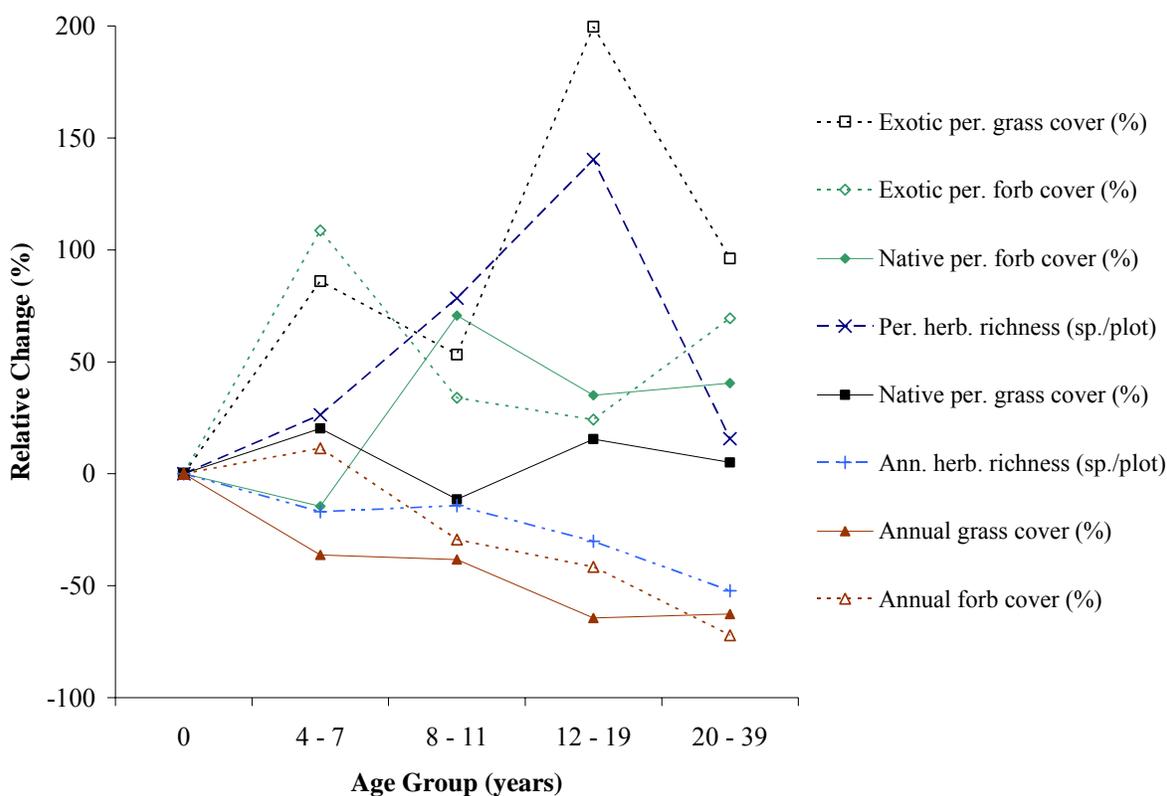
**Figure 10:** Relative percent change of herbaceous species metrics over time.

The results showed no response for native perennial grass. In comparison, cover of the three other perennial functional groups - exotic perennial grass, exotic perennial forb, and native perennial forb increased and decreased with project age. Exotic perennial grass cover was the

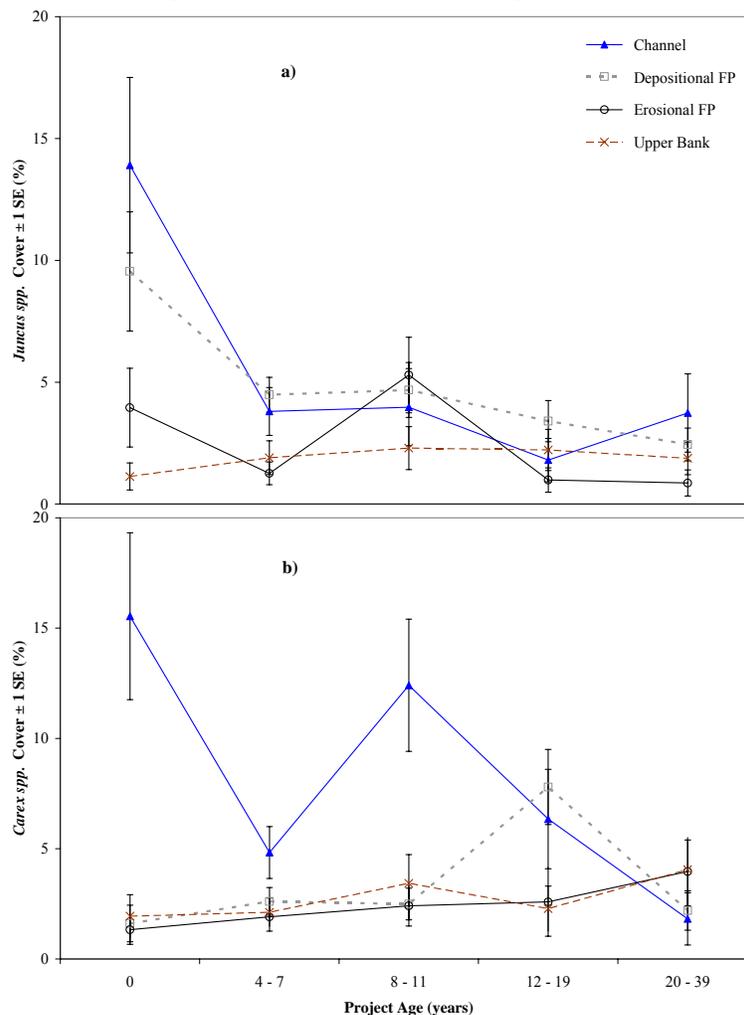
**Figure 11:** a) *Juncus spp.* and b) *Carex spp.* cover over time by landform class.

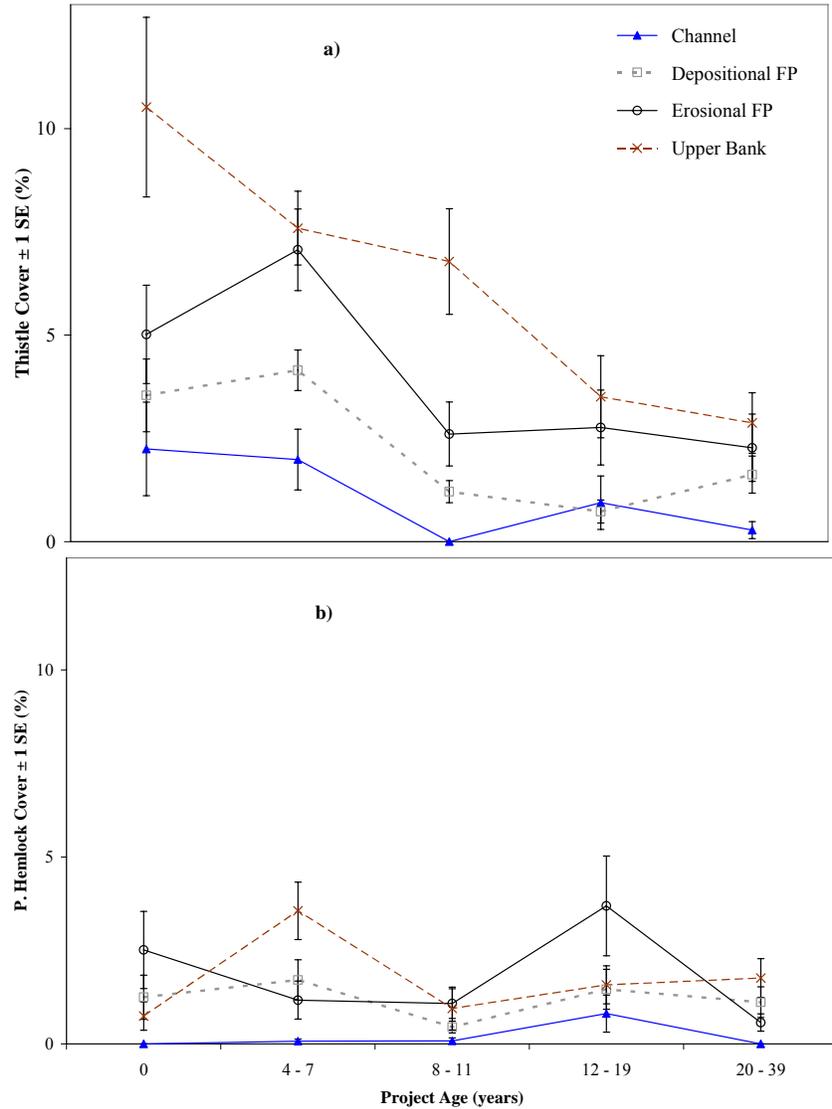
**Figure 12:** a) Poison hemlock and b) thistle cover over time by landform class.

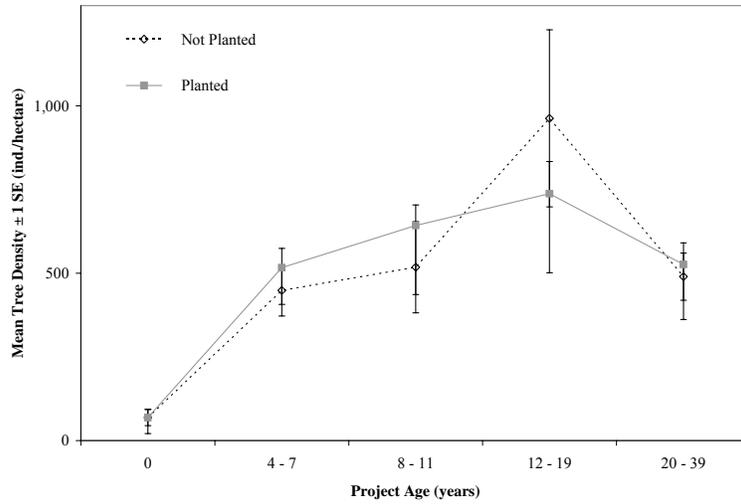
No effect from planting was observed on total native tree density (Figure 13) while the greatest effect of planting was to increase tree species richness (# of species) across all age groups (Figure 14). For native tree cover (Figures 15), intercepted solar radiation (Figure 16), and relative bank stability (Figure 17), the planted sites had a significant improvement at 4-7 year old project sites. Values for these three metrics at non-planted and planted sites converged in the 8-11 year old project sites. The implication is that direct planting of trees can speed the recovery of riparian function relative to passive revegetation approaches. However, the result following 40 years since project implementation is generally the same for both methods. This should give the resource manager useful information for setting site-specific project goals and making decisions about resource and funding allocation for active versus passive revegetation.

**Figure 13:** Native tree density over time by revegetation method.

We were interested in explaining the difference in our results between tree density and tree species richness discussed above (Figures 13 and 14). We expected that the less frequently occurring tree species may be driving the significant effect on richness observed at planted project sites because the common species are more successful at natural regeneration generally. To understand the intricacies of tree response to revegetation methods, we assessed the density of each dominant tree taxa using two sets of data driven models and identified restoration treatments as the predictor variables. The treatments included:

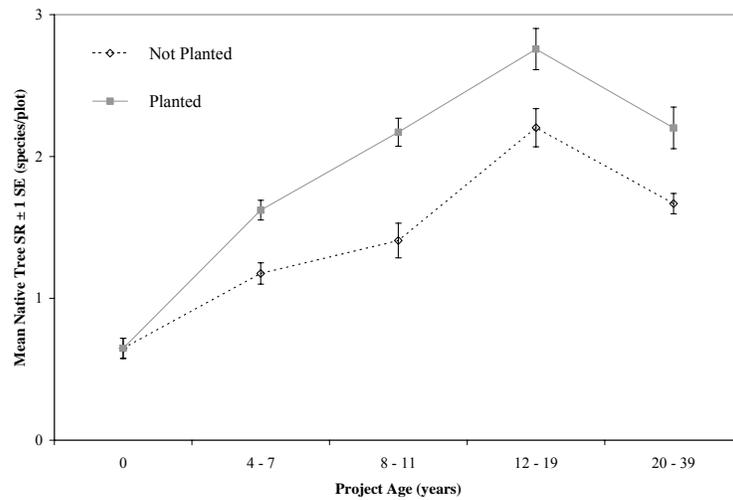
**Figure 14:** Native tree species richness (SR) over time by revegetation method.

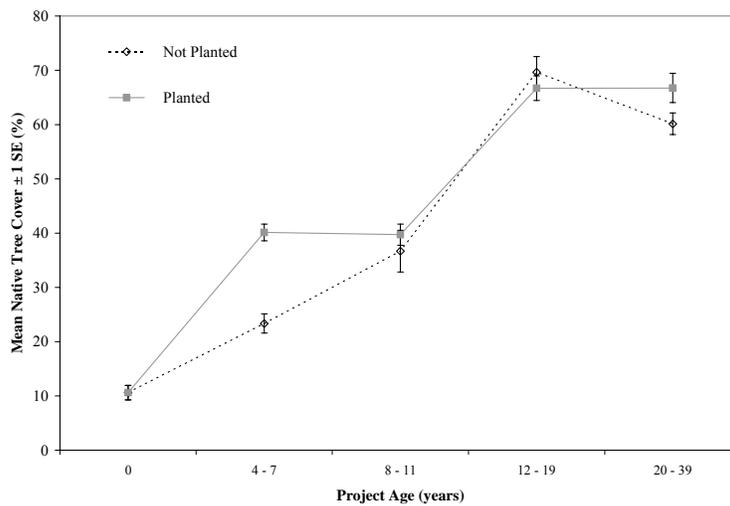
**Figure 15:** Native tree canopy cover over time by revegetation method.

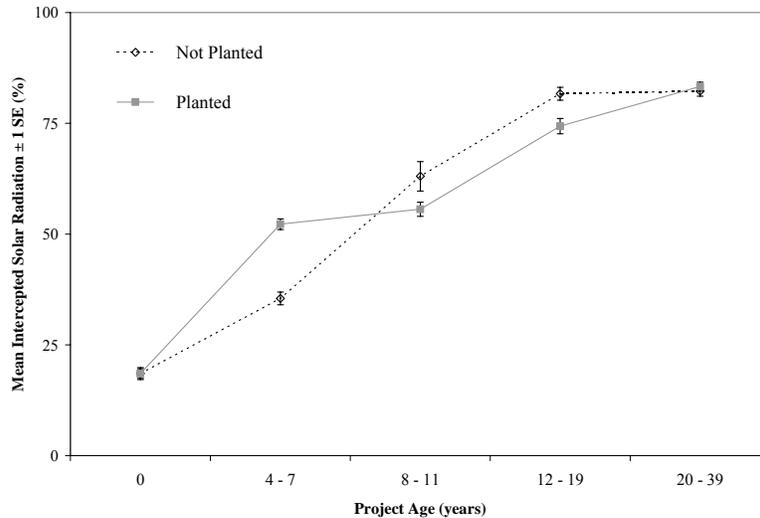
**Figure 16:** Intercepted solar radiation over time by revegetation method.

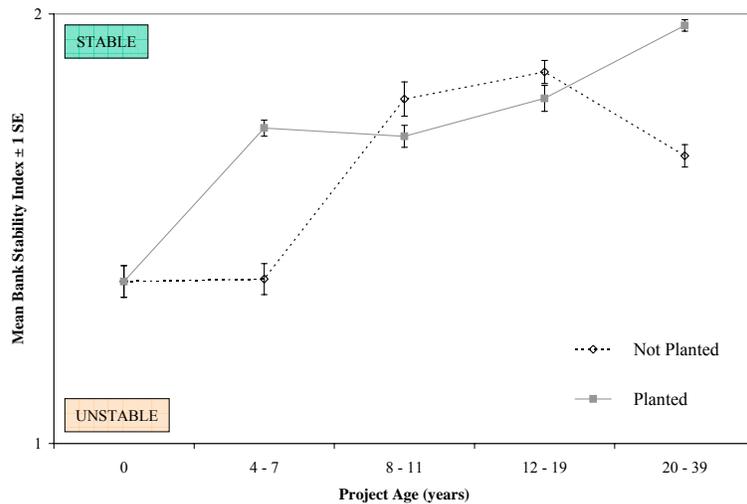
**Figure 17:** Stream bank stability over time by revegetation method.

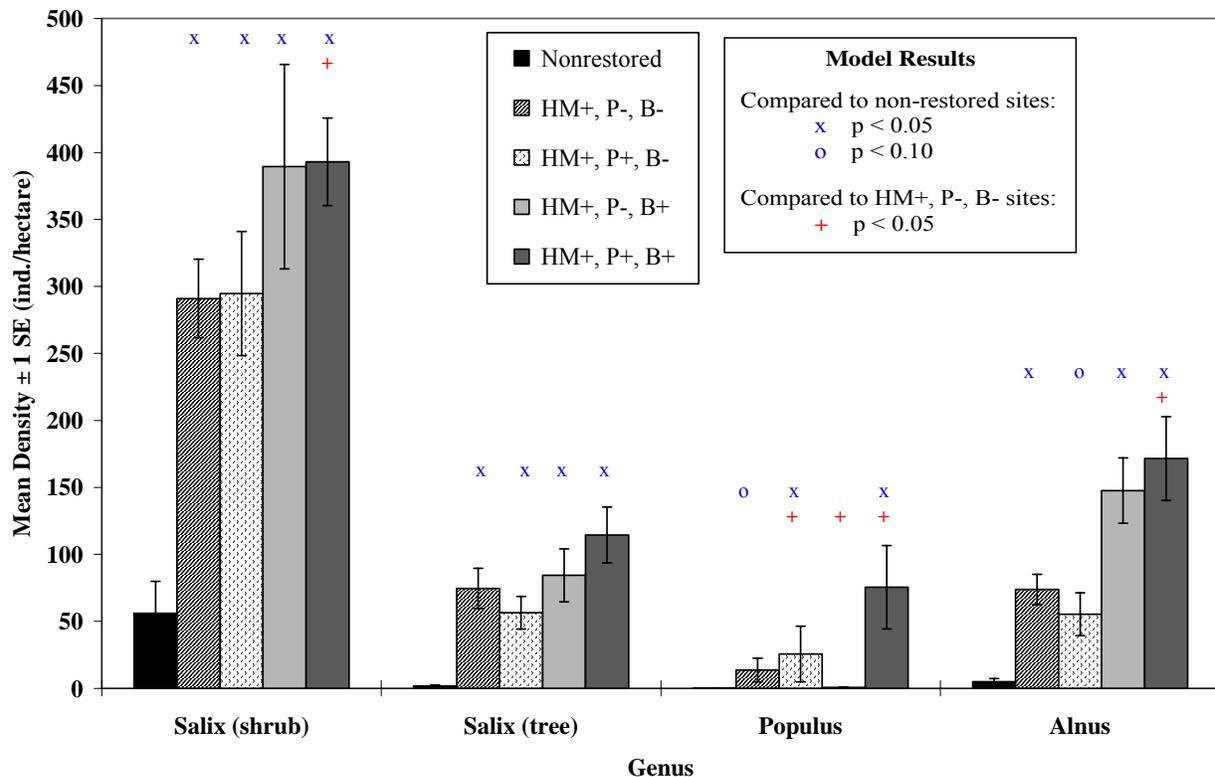
The statistical results from both models were summarized graphically with mean tree density values by treatment level (Figure 18 and 19). Each early seral group showed greater density at projects sites, regardless of treatment group, than non-restored sites. The exception was cottonwood at the bioengineered, non-planted sites. Shrub willow and alder density was the greatest at bioengineered sites where they were also planted (HM+, P+, B+). Tree willows showed a similar trend but this was not significant ( $p = 0.155$ ). Non-planted sites with bioengineering showed a trend of greater shrub willow and alder density than planted sites without bioengineering. Cottonwood response was different and natural regeneration was less compared to other early seral species since the planted sites had significantly greater density than the non-planted sites. Tree willow results did not show a greater effect of planting the genus than passive restoration, which may be due to tree willows being planted less frequently than the common shrub willows. The tree forms are harder to find at most degraded riparian corridors, but they are preferred by many ranch managers and flood control engineers because of their upright form. Thus, potential opportunities for improving future project design include the planting of more tree willow species where appropriate.

**Figure 18:** Early seral tree density response to revegetation method.

In general, our results showed that managing livestock or deer using fencing or other options increased the abundance of the common native early seral tree species. A simple recommendation is to wait for a few years to see where natural regeneration is occurring unless a site has minimal floodplain access for colonization and no perennial flow, or groundwater available, for establishment (Opperman and Merenlander 2003). If early seral species are desired on stream banks above the 2 x bankfull (floodprone) elevation, then planting would be recommended. If stream banks are unstable, bioengineering structures are clearly recommended before planting early seral species. Where alder is desired and no relict population is present, the objective of creating seed source for future natural regeneration should result in more alders than planting each location where a tree is desired (Appendix D).

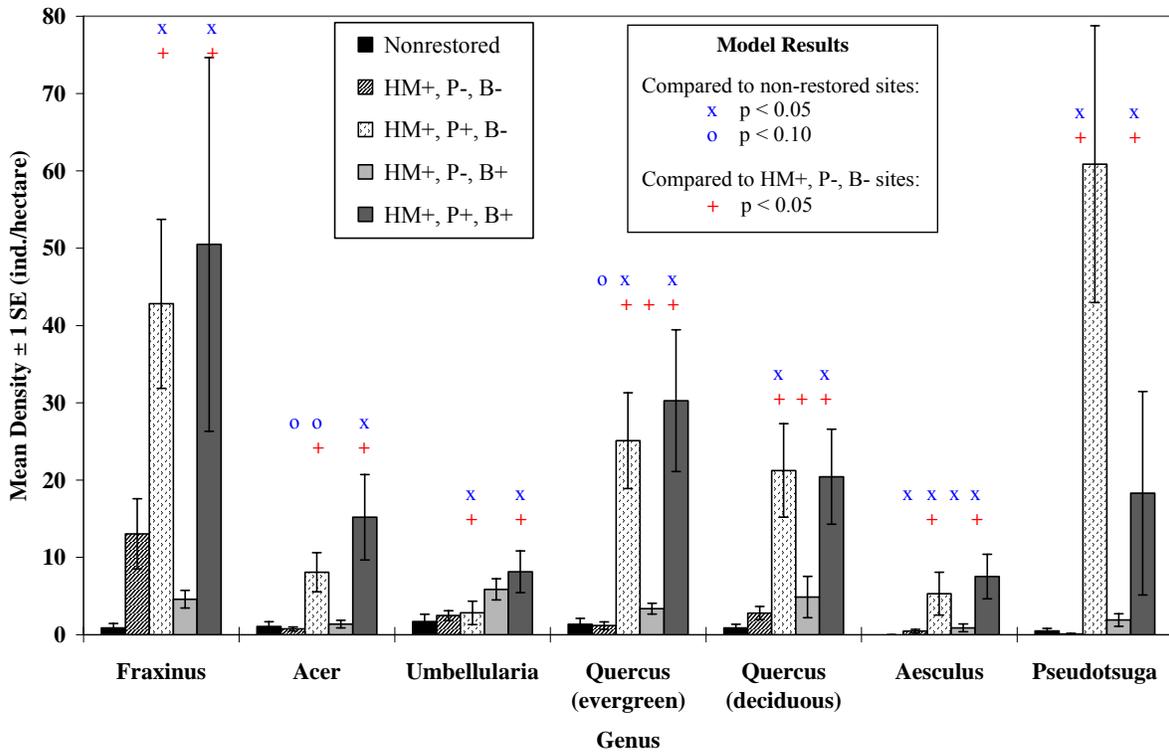
The slow growing late seral genera demonstrated a different pattern in their response to revegetation than early seral taxa (Figure 19). All late seral genera had the greatest increase in density where each was planted, regardless of whether bioengineering was utilized. Most genera showed no significant evidence of natural regeneration. Exceptions included maple, live oak, and buckeye, which had a greater density at non-planted sites than non-restored sites. This indicates successful colonization and establishment similar to the early seral species; however abundance was considerably less where they were not planted. Ash was nearly significant for colonizing passively restored sites but was not significant ( $p=0.150$ ). Both live oak and deciduous oak had a greater density at bioengineered sites where they were not planted than the non-planted, non-bioengineered sites. Bioengineering structures most likely provided suitable habitat for oaks to colonize and establish, though their abundance was significantly less than at sites where they were planted.

**Figure 19:** Late seral tree density response to revegetation method.

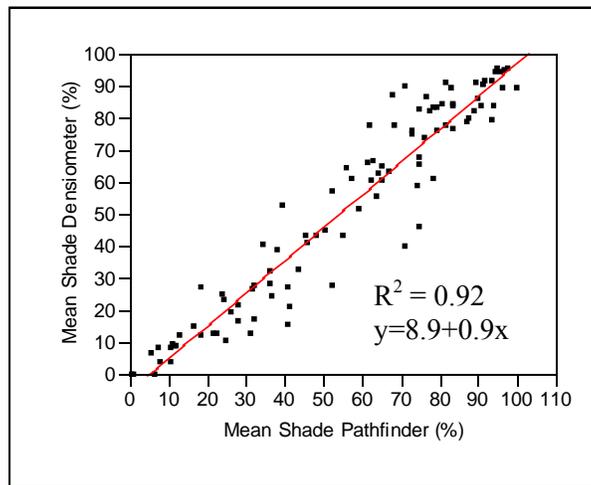
Two current field methods for measuring stream shade are Solar Pathfinder<sup>®</sup> and Spherical Densimeter. Solar Pathfinder method measures intercepted solar radiation while the Densimeter method measures canopy cover. The relationship between both stream shade methods is highly significant ( $R^2 = 0.92$ ,  $p < 0.0001$ ) as shown in Figure 20. Though the Densimeter method appears to produce slightly greater variability, the data may represent

riparian vegetation to a greater degree than the Solar Pathfinder method, which includes greater canyon slopes and upland vegetation. Given the power of the correlation between both methods, restoration project monitoring programs should utilize the method that is convenient and consistent with previous data collected.

**Figure 20:** Relationship between stream shade Solar Pathfinder (intercepted solar radiation) and Densimeter (canopy density).
