## Post-Fire Erosion Control

### Mitigating Hillslope Erosion Following a Wildfire

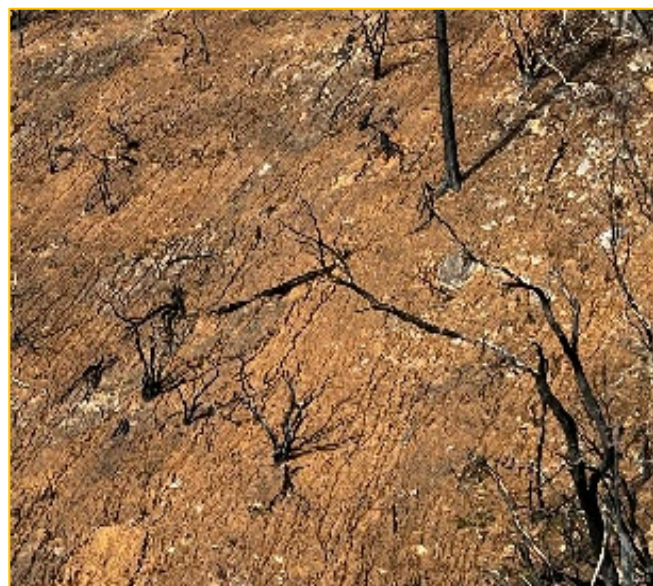
Image 1. Formation of rills following the 2022 Oak Fire  
[Credit: Alison Deak]

Hillslope erosion occurs through three processes: (1) rainsplash when raindrops hit bare soil and detach soil particles; (2) sheeting from water flowing over weakened soils and carrying soil particles along with it; and (3) rilling, the process of water becoming concentrated in incisions on the landscape and developing into larger flow paths if not mitigated (Image 1).

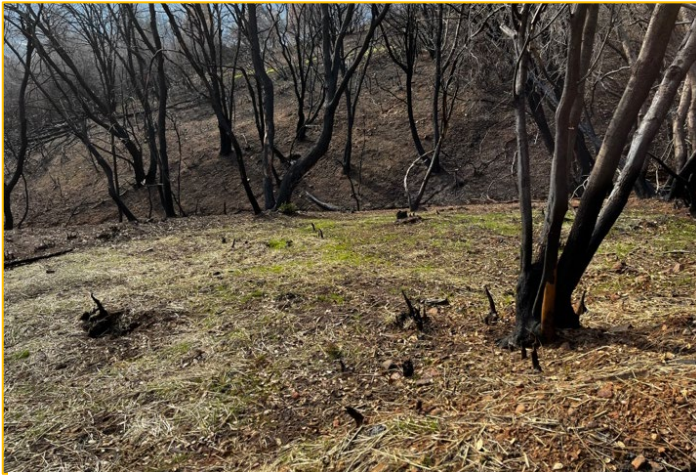
Image 3. A successful straw mulching treatment  
[Credit: Alison Deak]

**Agricultural straw mulching** is a low-cost and effective erosion control strategy, but it may be less effective during high-intensity rainfall events than wood mulch and has the potential to be transported off hillslopes by wind (Image 2). Straw mulches also come with the risk of introducing non-native species that could compete with regenerating native vegetation, even if certified weed-free (Shive et al. 2017).

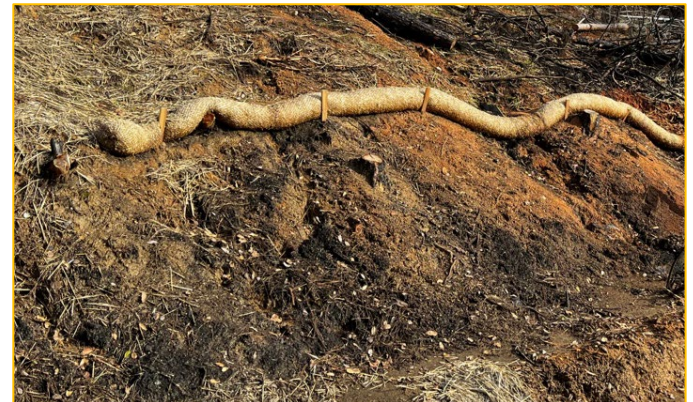
Image 2. A failed erosion barrier that led to channelized flow during a high-intensity rain event [Credit: Alison Deak]

they may be expensive to install if using off-site materials and are likely to fail during short-duration high intensity rainfall events because they do not provide ground cover and can channelize flow if installed incorrectly (Image 3; Robichaud et al 2008). Erosion barriers can be constructed using either contour log felling or straw wattles.
